Profile/Photo Observation Report

Street:	W 41ST AVE & N GUYER ST	Flow Control:	Not Controlled
City:	Hobart, IN	Year Renewed:	
Location:	Other	Tape/Media #:	
Purpose:	Not Known	Dia/Height:	10"
Use:	Sanitary	Material:	VCP
Drain Area:	NA	Lining:	
Category:	NA		
Comment:

Location Details:		Direction of Survey:	Upstream
US MH:	M-504-128	DS MH:	M-504-125
		Total Length Surveyed (ft):	51.4

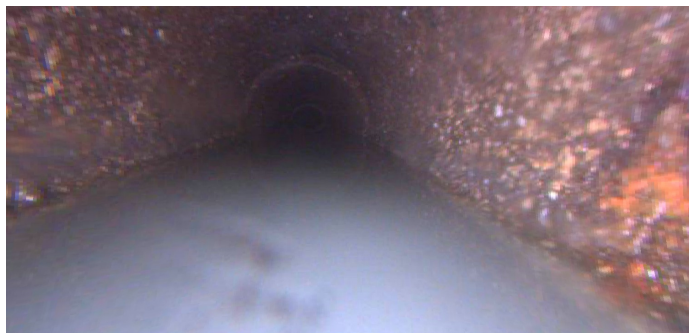
50.2	SAV(F01)	Surface Aggregate Visible	232	S 3
	51.4	AMH	Manhole	246	NA
<div> <div>Code:</div> <div>AMH</div> </div> <div> <div>Description:</div> <div>Manhole</div> </div> <div> <div>Distance (ft):</div> <div>.0</div> </div> <div> <div>Structural Grade:</div> <div>0</div> </div> <div> <div>O&M Grade:</div> <div>0</div> </div> <div> <div>Clock Start/From:</div> <div></div> </div> <div> <div>Clock To:</div> <div></div> </div> <div> <div>1st Value:</div> <div></div> </div> <div> <div>2nd Value:</div> <div></div> </div> <div> <div>Value Percent:</div> <div></div> </div> <div> <div>Continuous Index:</div> <div></div> </div> <div> <div>Within 8" of Joint:</div> <div>NO</div> </div> <div> <div>Remarks:</div> <div>M-504-125</div> </div>

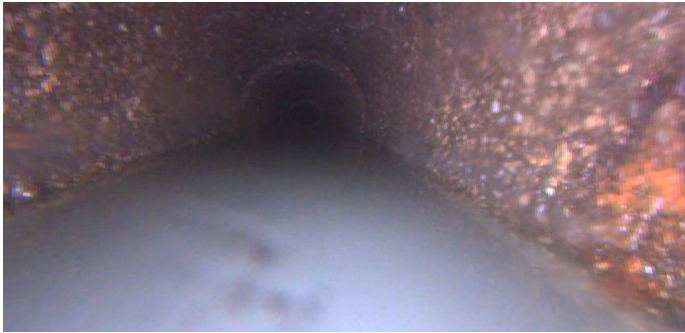
Code:	MWL
Description:	Water Level

Distance (ft):	.0
Structural Grade:	0
O&M Grade:	0
Clock Start/From:	
Clock To:	
1st Value:	
2nd Value:	
Value Percent:	10.000
Continuous Index:	
Within 8" of Joint:	NO
Remarks:

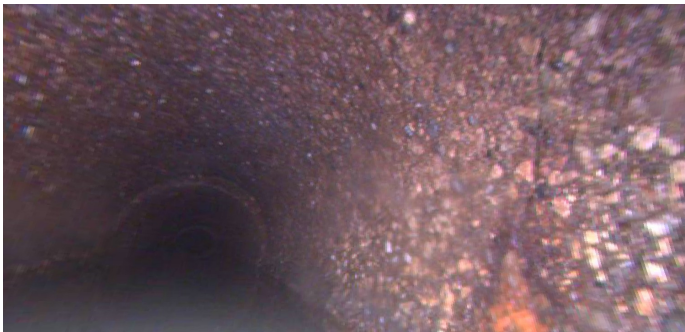
Code:	CC
Description:	Crack Circumferential

Distance (ft):	.0
Structural Grade:	1
O&M Grade:	0
Clock Start/From:	7
Clock To:	5
1st Value:	
2nd Value:	
Value Percent:	
Continuous Index:	
Within 8" of Joint:	
Remarks:

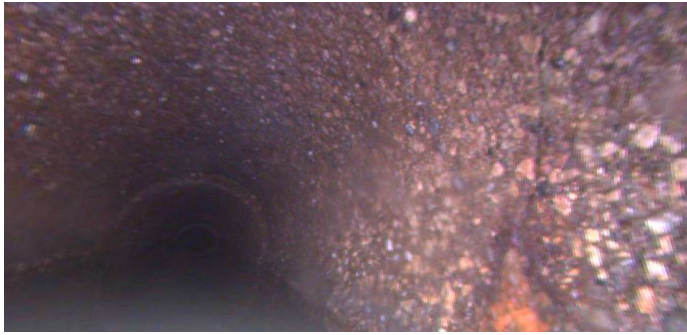
Code:	SAV
Description:	Surface Aggregate Visible
Distance (ft):	.0
Structural Grade:	3
O&M Grade:	0
Clock Start/From:	7
Clock To:	5
1st Value:	
2nd Value:	
Value Percent:	
Continuous Index:	S01
Within 8" of Joint:	
Remarks:

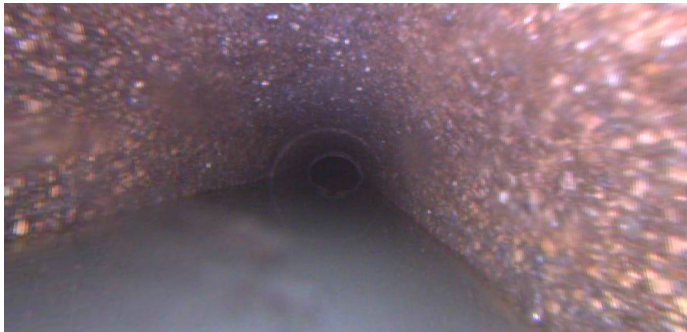
Code:	MWL
Description:	Water Level
Distance (ft):	4.4
Structural Grade:	0
O&M Grade:	0
Clock Start/From:	
Clock To:	
1st Value:	
2nd Value:	
Value Percent:	35.000
Continuous Index:	
Within 8" of Joint:	NO
Remarks:

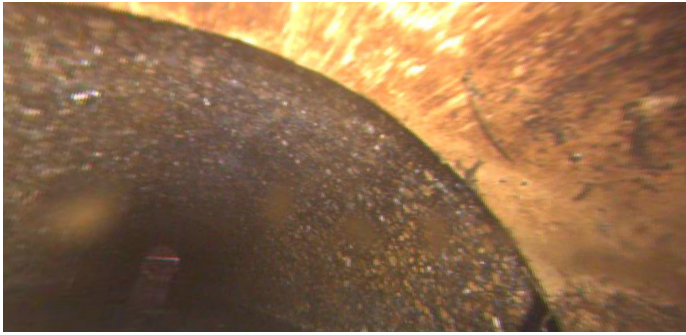
Code: **MMC**
Description: **Material Change**

Distance (ft): **9.1**
Structural Grade: **0**
O&M Grade: **0**
Clock Start/From:
Clock To:
1st Value:
2nd Value:
Value Percent:
Continuous Index:
Within 8" of Joint: **NO**
Remarks: **pvc**

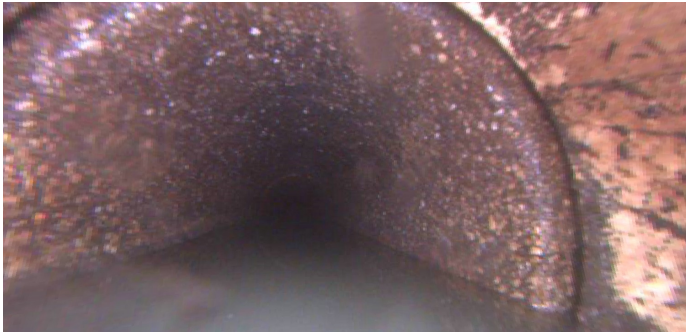
Code: **MMC**
Description: **Material Change**

Distance (ft): **18.4**
Structural Grade: **0**
O&M Grade: **0**
Clock Start/From:
Clock To:
1st Value:
2nd Value:
Value Percent:
Continuous Index:
Within 8" of Joint: **NO**
Remarks: **cp**

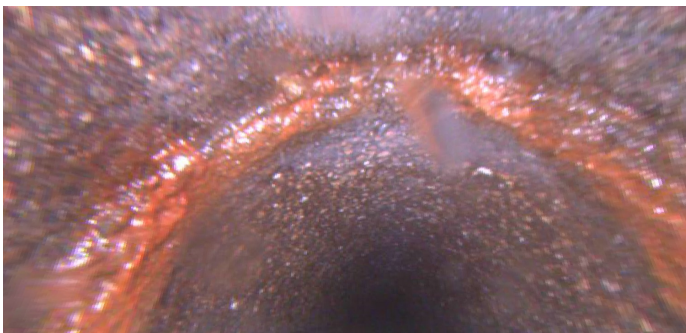
Code: **IS**
Description: **Infil Stain**

Distance (ft): **21.5**
Structural Grade: **0**
O&M Grade: **0**
Clock Start/From: **9**
Clock To: **3**
1st Value:
2nd Value:
Value Percent:
Continuous Index:
Within 8" of Joint: **YES**
Remarks:

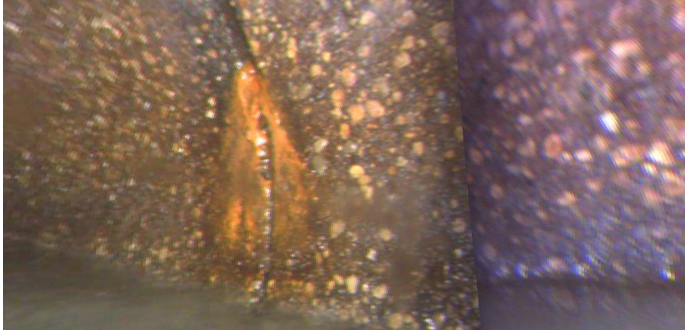
Code: **IS**
Description: **Infil Stain**

Distance (ft): **43.9**
Structural Grade: **0**
O&M Grade: **0**
Clock Start/From: **7**
Clock To: **9**
1st Value:
2nd Value:
Value Percent:
Continuous Index:
Within 8" of Joint: **YES**
Remarks:

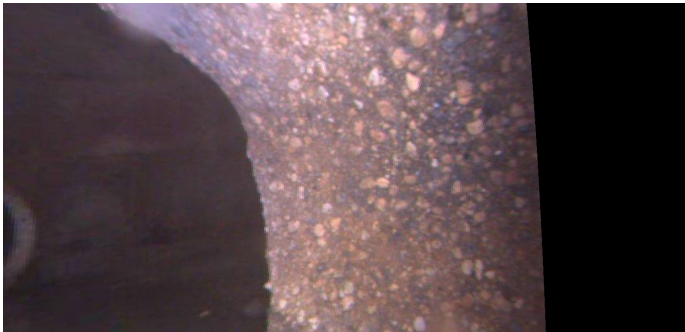
Code: **SAV**
Description: **Surface Aggregate Visible**

Distance (ft): **50.2**
Structural Grade: **3**
O&M Grade: **0**
Clock Start/From: **7**
Clock To: **5**
1st Value:
2nd Value:
Value Percent:
Continuous Index: **F01**
Within 8" of Joint:
Remarks:

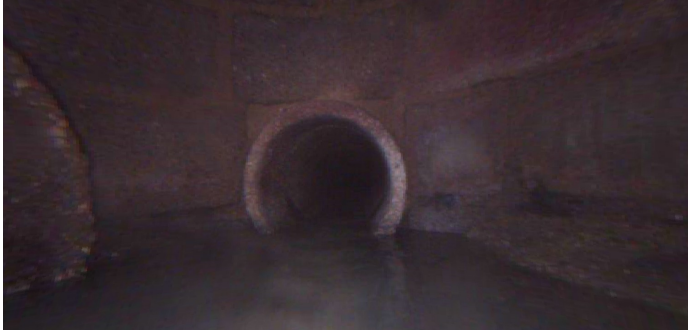
Code:	AMH
Description:	Manhole
Distance (ft):	51.4
Structural Grade:	0
O&M Grade:	0
Clock Start/From:	
Clock To:	
1st Value:	
2nd Value:	
Value Percent:	
Continuous Index:	
Within 8" of Joint:	NO
Remarks:	M-504-128
