## Profile/Photo Observation Report

Street:	<b>W 40th ave</b>	Flow Control:	<b>Not Controlled</b>
City:	<b>Hobart, IN</b>	Year Renewed:	
Location:	<b>Other</b>	Tape/Media #:	
Purpose:	<b>Not Known</b>	Dia/Height:	<b>10"</b>
Use:	<b>Sanitary</b>	Material:	<b>VCP</b>
Drain Area:	<b>NA</b>	Lining:	
Category:	<b>NA</b>		
Comment:

Location Details:		Direction of Survey:	<b>Upstream</b>
US MH:	<b>M-504-128</b>	DS MH:	<b>M-504-125</b>
		Total Length Surveyed (ft):	<b>51.4</b>

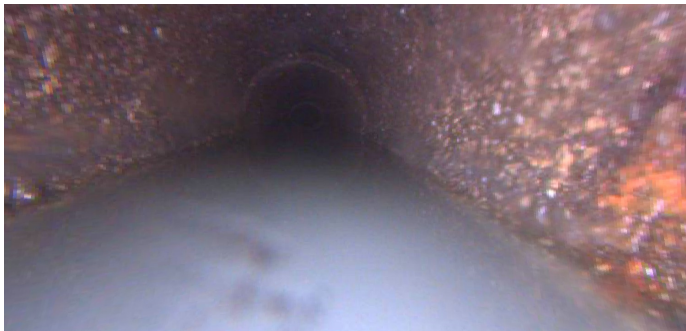
Code: **AMH**  
Description: **Manhole**

Distance (ft): **.0**  
Structural Grade: **0**  
O&M Grade: **0**  
Clock Start/From:  
Clock To:  
1st Value:  
2nd Value:  
Value Percent:  
Continuous Index:  
Within 8" of Joint: **NO**  
Remarks: **M-504-125**

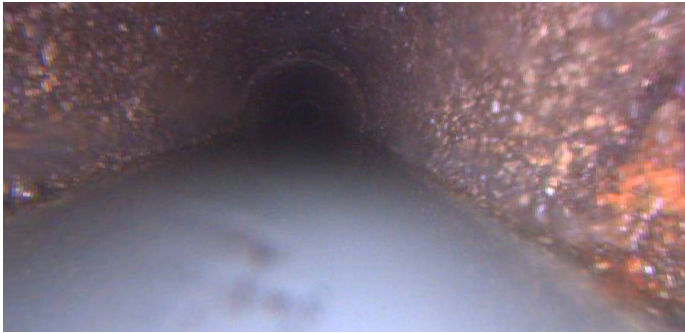
Code:	<b>MWL</b>
Description:	<b>Water Level</b>

Distance (ft):	<b>.0</b>
Structural Grade:	<b>0</b>
O&M Grade:	<b>0</b>
Clock Start/From:	
Clock To:	
1st Value:	
2nd Value:	
Value Percent:	<b>10.000</b>
Continuous Index:	
Within 8" of Joint:	<b>NO</b>
Remarks:

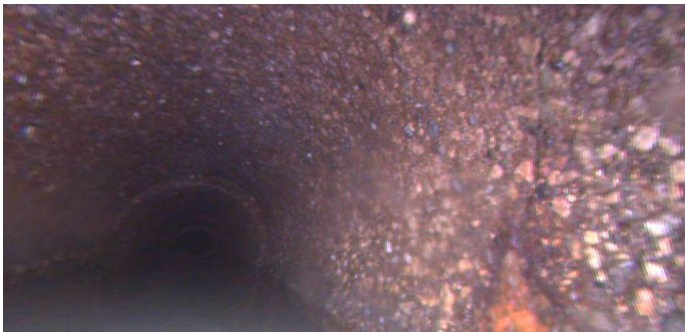
Code:	<b>CC</b>
Description:	<b>Crack Circumferential</b>

Distance (ft):	<b>.0</b>
Structural Grade:	<b>1</b>
O&M Grade:	<b>0</b>
Clock Start/From:	<b>7</b>
Clock To:	<b>5</b>
1st Value:	
2nd Value:	
Value Percent:	
Continuous Index:	
Within 8" of Joint:	
Remarks:

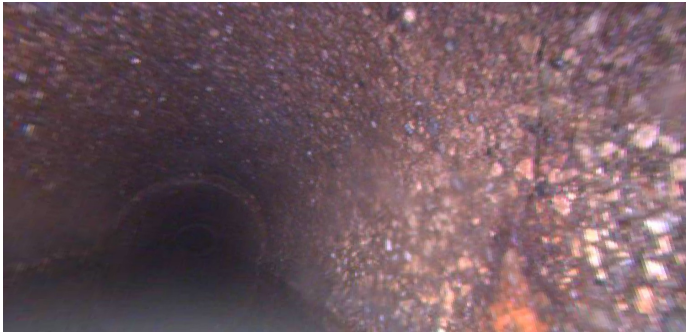
Code: **SAV**  
Description: **Surface Aggregate Visible**

Distance (ft): **.0**  
Structural Grade: **3**  
O&M Grade: **0**  
Clock Start/From: **7**  
Clock To: **5**  
1st Value:  
2nd Value:  
Value Percent:  
Continuous Index: **S01**  
Within 8" of Joint:  
Remarks:

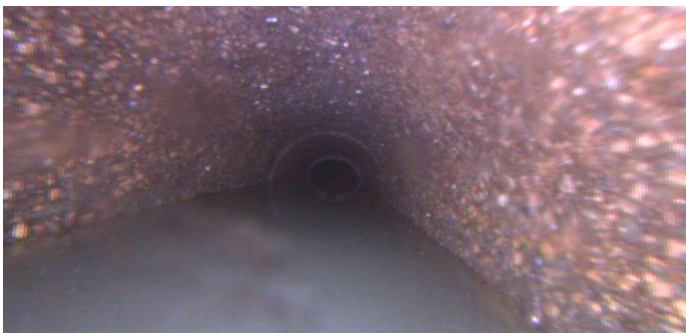
Code: **MWL**  
Description: **Water Level**

Distance (ft): **4.4**  
Structural Grade: **0**  
O&M Grade: **0**  
Clock Start/From:  
Clock To:  
1st Value:  
2nd Value:  
Value Percent: **35.000**  
Continuous Index:  
Within 8" of Joint: **NO**  
Remarks:

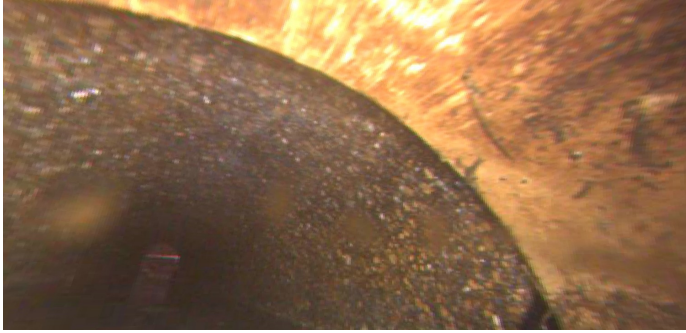
Code: **MMC**  
Description: **Material Change**

Distance (ft): **9.1**  
Structural Grade: **0**  
O&M Grade: **0**  
Clock Start/From:  
Clock To:  
1st Value:  
2nd Value:  
Value Percent:  
Continuous Index:  
Within 8" of Joint: **NO**  
Remarks: **pvc**

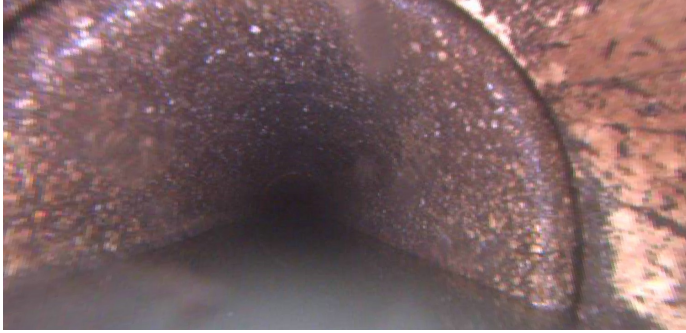
Code: **MMC**  
Description: **Material Change**

Distance (ft): **18.4**  
Structural Grade: **0**  
O&M Grade: **0**  
Clock Start/From:  
Clock To:  
1st Value:  
2nd Value:  
Value Percent:  
Continuous Index:  
Within 8" of Joint: **NO**  
Remarks: **cp**

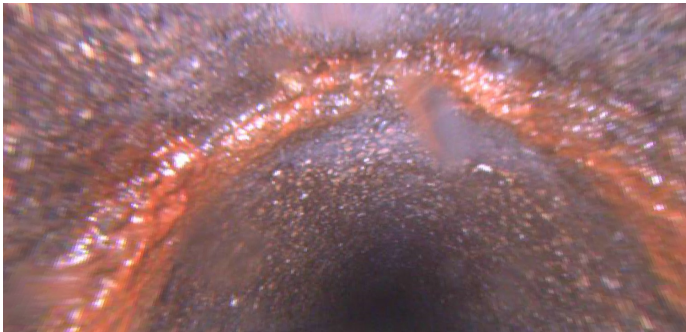
Code: **IS**  
Description: **Infil Stain**

Distance (ft): **21.5**  
Structural Grade: **0**  
O&M Grade: **0**  
Clock Start/From: **9**  
Clock To: **3**  
1st Value:  
2nd Value:  
Value Percent:  
Continuous Index:  
Within 8" of Joint: **YES**  
Remarks:

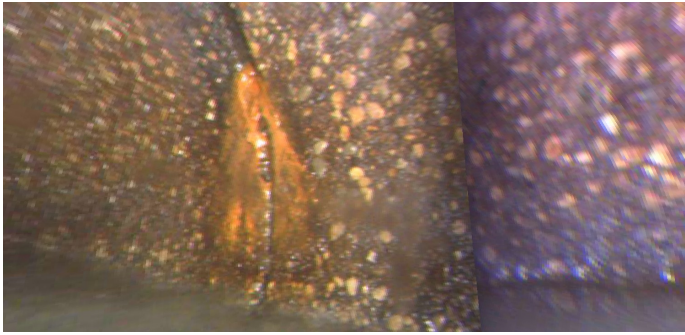
Code: **IS**  
Description: **Infil Stain**

Distance (ft): **43.9**  
Structural Grade: **0**  
O&M Grade: **0**  
Clock Start/From: **7**  
Clock To: **9**  
1st Value:  
2nd Value:  
Value Percent:  
Continuous Index:  
Within 8" of Joint: **YES**  
Remarks:

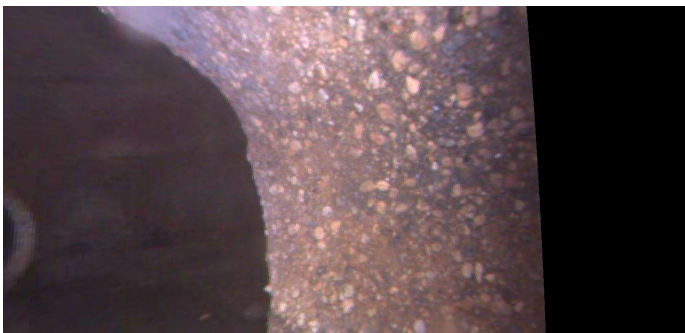
Code: **SAV**  
Description: **Surface Aggregate Visible**

Distance (ft): **50.2**  
Structural Grade: **3**  
O&M Grade: **0**  
Clock Start/From: **7**  
Clock To: **5**  
1st Value:  
2nd Value:  
Value Percent:  
Continuous Index: **F01**  
Within 8" of Joint:  
Remarks:

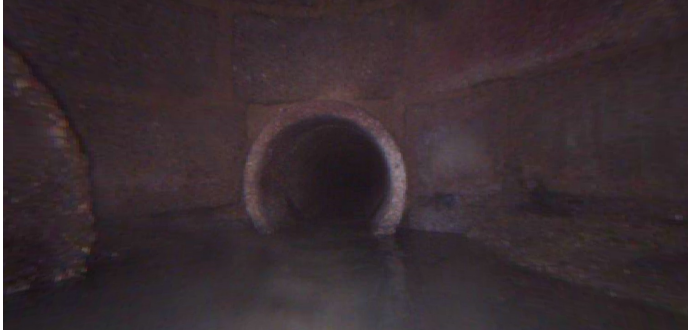
Code:	<b>AMH</b>
Description:	<b>Manhole</b>
Distance (ft):	<b>51.4</b>
Structural Grade:	<b>0</b>
O&M Grade:	<b>0</b>
Clock Start/From:	
Clock To:	
1st Value:	
2nd Value:	
Value Percent:	
Continuous Index:	
Within 8" of Joint:	<b>NO</b>
Remarks:	<b>M-504-128</b>
