Profile/Photo Observation Report

Date:	04/16/2018	Weather:		Coding:	PACP 6.0
Pipe Length (ft):	320.0	Owner:	NA	Pre Clean:	Not Known
P.O.#:		Surveyor:	Selasie Honu	PSR:	P-504-126.1-126
Customer:		Clean Date:	01/01/1900	Shape:	C

Street:	ALLEY BETWEEN N GUYER ST & N WI	Flow Control:	Not Controlled
City:	Hobart, IN	Year Renewed:	
Location:	Light Highway	Tape/Media #:	
Purpose:	Not Known	Dia/Height:	10"
Use:	Sanitary	Material:	CP
Drain Area:	NA	Lining:	
Category:	NA		
Comment:			
Location Details:		Direction of Survey:	Downstream
US MH:	M-504-126	DS MH:	M-504-126.1
		Total Length Surveyed (ft):	261.0

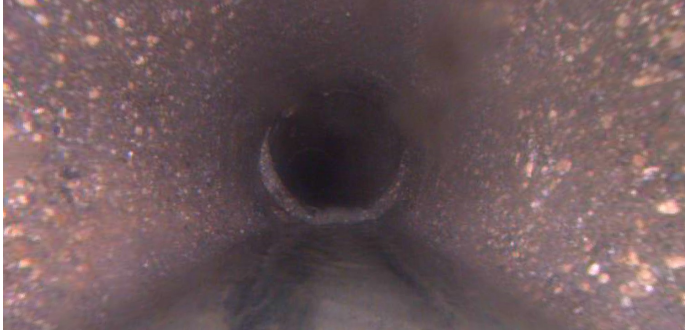
Code: **SAP**
Description: **Surface Aggregate Projecting**

Distance (ft): **.0**
Structural Grade: **3**
O&M Grade: **0**
Clock Start/From: **7**
Clock To: **5**
1st Value:
2nd Value:
Value Percent:
Continuous Index: **S02**
Within 8" of Joint:
Remarks:

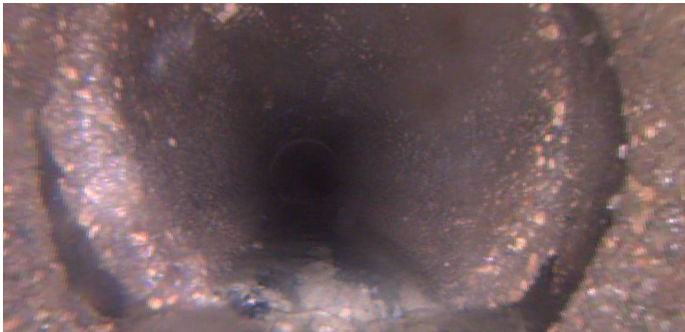
Code: **JOM**
Description: **Joint Offset Medium**

Distance (ft): **2.4**
Structural Grade: **1**
O&M Grade: **0**
Clock Start/From:
Clock To:
1st Value:
2nd Value:
Value Percent:
Continuous Index:
Within 8" of Joint: **NO**
Remarks:

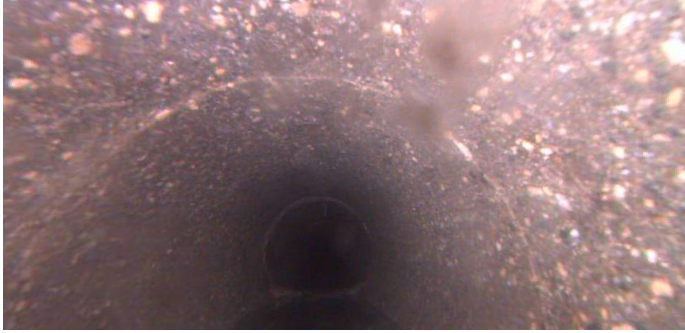
Code: **FC**
Description: **Fracture Circumferential**

Distance (ft): **6.3**
Structural Grade: **2**
O&M Grade: **0**
Clock Start/From: **8**
Clock To: **4**
1st Value:
2nd Value:
Value Percent:
Continuous Index:
Within 8" of Joint:
Remarks:

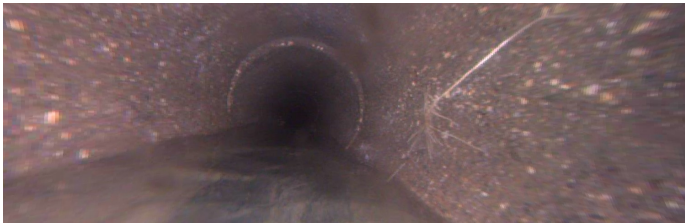
Code: **RFB**
Description: **Roots Fine Barrel**

Distance (ft): **16.1**
Structural Grade: **0**
O&M Grade: **2**
Clock Start/From: **3**
Clock To:
1st Value:
2nd Value:
Value Percent:
Continuous Index:
Within 8" of Joint: **NO**
Remarks:

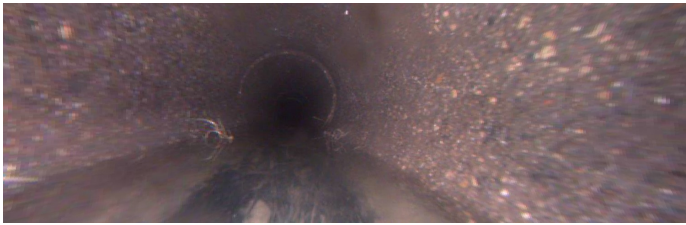
Code: **RFB**
Description: **Roots Fine Barrel**

Distance (ft): **18.4**
Structural Grade: **0**
O&M Grade: **2**
Clock Start/From: **5**
Clock To: **7**
1st Value:
2nd Value:
Value Percent:
Continuous Index:
Within 8" of Joint: **NO**
Remarks:

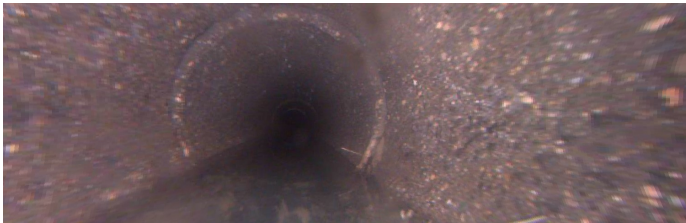
Code: **RFJ**
Description: **Roots Fine Joint**

Distance (ft): **19.4**
Structural Grade: **0**
O&M Grade: **1**
Clock Start/From: **5**
Clock To:
1st Value:
2nd Value:
Value Percent:
Continuous Index:
Within 8" of Joint: **YES**
Remarks:

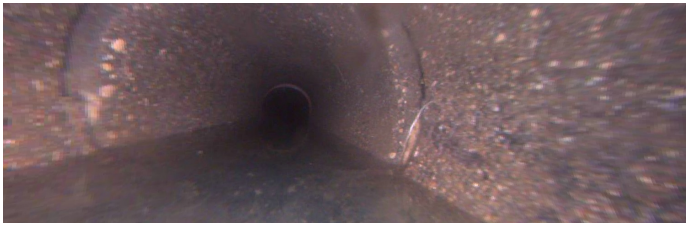
Code: **RFB**
Description: **Roots Fine Barrel**

Distance (ft): **22.6**
Structural Grade: **0**
O&M Grade: **2**
Clock Start/From: **4**
Clock To:
1st Value:
2nd Value:
Value Percent:
Continuous Index:
Within 8" of Joint: **NO**
Remarks:

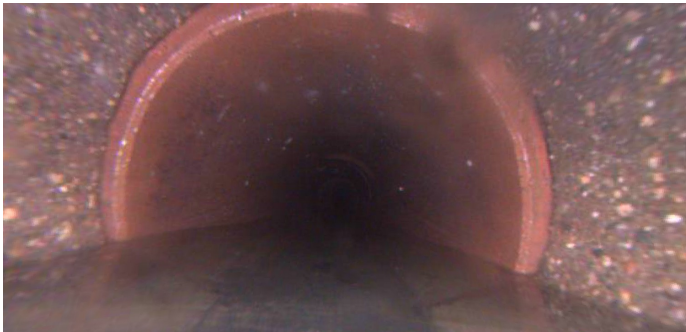
Code: **SAP**
Description: **Surface Aggregate Projecting**

Distance (ft): **25.5**
Structural Grade: **3**
O&M Grade: **0**
Clock Start/From: **7**
Clock To: **5**
1st Value:
2nd Value:
Value Percent:
Continuous Index: **F02**
Within 8" of Joint:
Remarks:

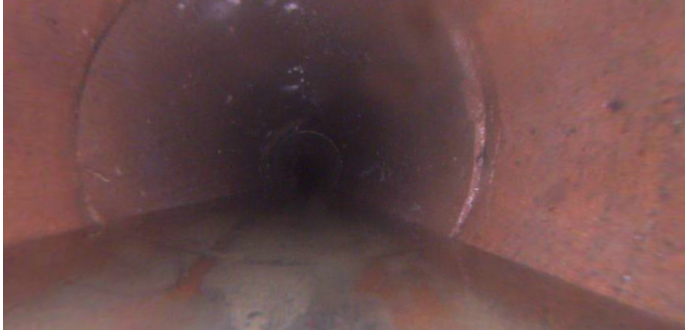
Code: **RFJ**
Description: **Roots Fine Joint**

Distance (ft): **28.4**
Structural Grade: **0**
O&M Grade: **1**
Clock Start/From: **8**
Clock To:
1st Value:
2nd Value:
Value Percent:
Continuous Index:
Within 8" of Joint: **YES**
Remarks:

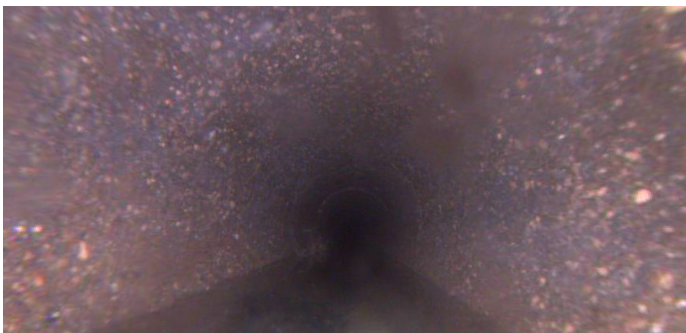
Code: **SAP**
Description: **Surface Aggregate Projecting**

Distance (ft): **31.6**
Structural Grade: **3**
O&M Grade: **0**
Clock Start/From: **8**
Clock To: **4**
1st Value:
2nd Value:
Value Percent:
Continuous Index: **S03**
Within 8" of Joint:
Remarks:

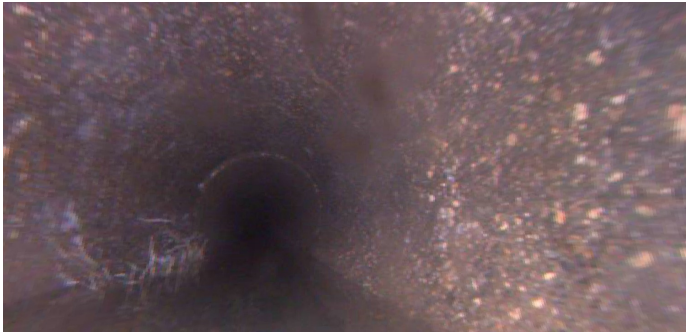
Code: **RFB**
Description: **Roots Fine Barrel**

Distance (ft): **32.7**
Structural Grade: **0**
O&M Grade: **2**
Clock Start/From: **7**
Clock To: **9**
1st Value:
2nd Value:
Value Percent:
Continuous Index:
Within 8" of Joint: **NO**
Remarks:

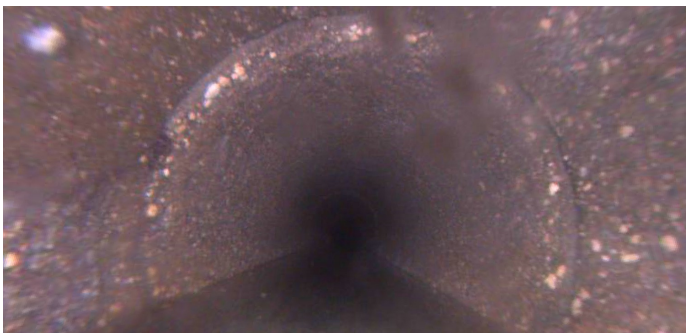
Code: **RFJ**
Description: **Roots Fine Joint**

Distance (ft): **34.2**
Structural Grade: **0**
O&M Grade: **1**
Clock Start/From: **8**
Clock To: **9**
1st Value:
2nd Value:
Value Percent:
Continuous Index:
Within 8" of Joint: **YES**
Remarks:

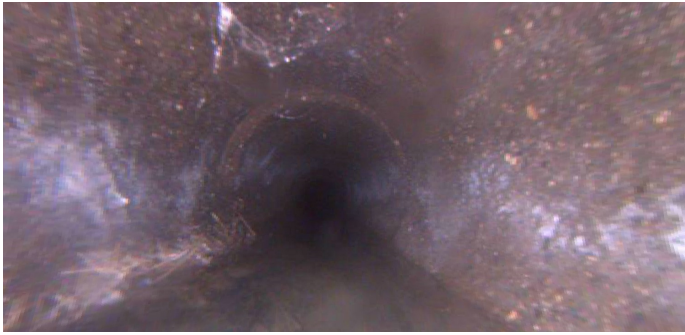
Code: **RFB**
Description: **Roots Fine Barrel**

Distance (ft): **39.4**
Structural Grade: **0**
O&M Grade: **2**
Clock Start/From: **7**
Clock To:
1st Value:
2nd Value:
Value Percent:
Continuous Index:
Within 8" of Joint: **NO**
Remarks:

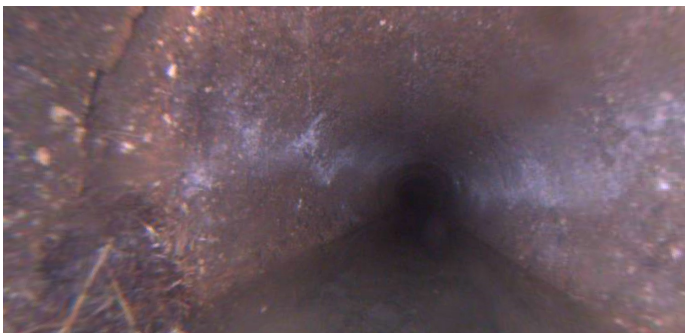
Code: **RFJ**
Description: **Roots Fine Joint**

Distance (ft): **40.4**
Structural Grade: **0**
O&M Grade: **1**
Clock Start/From: **8**
Clock To: **4**
1st Value:
2nd Value:
Value Percent:
Continuous Index: **S04**
Within 8" of Joint: **YES**
Remarks:

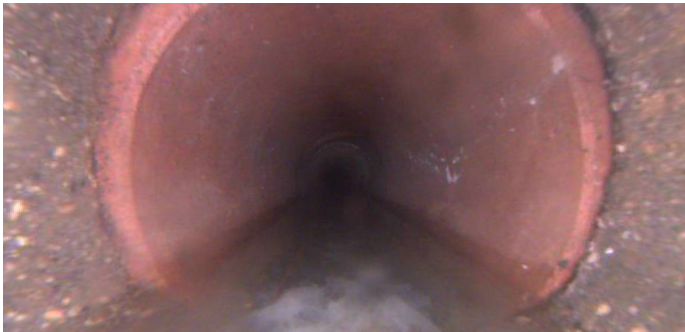
Code: **SAP**
Description: **Surface Aggregate Projecting**

Distance (ft): **46.1**
Structural Grade: **3**
O&M Grade: **0**
Clock Start/From: **8**
Clock To: **4**
1st Value:
2nd Value:
Value Percent:
Continuous Index: **F03**
Within 8" of Joint:
Remarks:

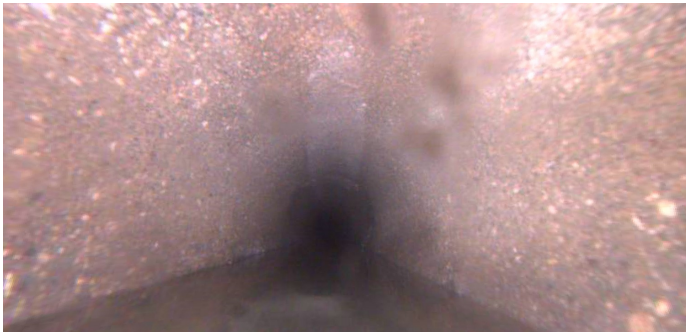
Code: **SAP**
Description: **Surface Aggregate Projecting**

Distance (ft): **49.6**
Structural Grade: **3**
O&M Grade: **0**
Clock Start/From: **8**
Clock To: **4**
1st Value:
2nd Value:
Value Percent:
Continuous Index: **S05**
Within 8" of Joint:
Remarks:

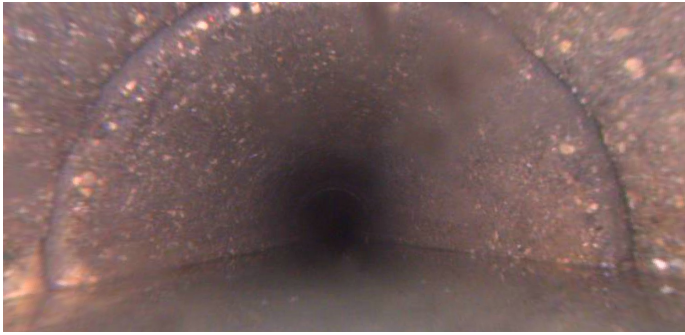
Code: **RFJ**
Description: **Roots Fine Joint**

Distance (ft): **89.3**
Structural Grade: **0**
O&M Grade: **1**
Clock Start/From: **8**
Clock To: **4**
1st Value:
2nd Value:
Value Percent:
Continuous Index: **F04**
Within 8" of Joint: **YES**
Remarks:

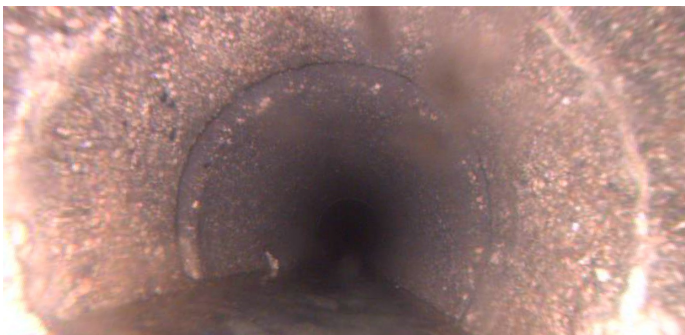
Code: **FC**
Description: **Fracture Circumferential**

Distance (ft): **97.8**
Structural Grade: **2**
O&M Grade: **0**
Clock Start/From: **8**
Clock To: **4**
1st Value:
2nd Value:
Value Percent:
Continuous Index:
Within 8" of Joint:
Remarks:

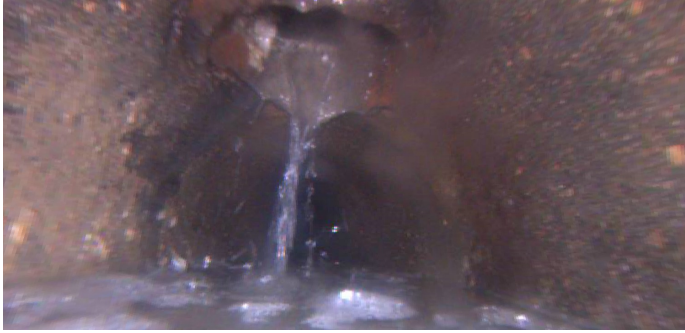
Code: **TBI**
Description: **Tap Break-in Intruding**

Distance (ft): **113.8**
Structural Grade: **0**
O&M Grade: **2**
Clock Start/From: **12**
Clock To:
1st Value: **4.000**
2nd Value: **1.000**
Value Percent:
Continuous Index:
Within 8" of Joint:
Remarks: **active**

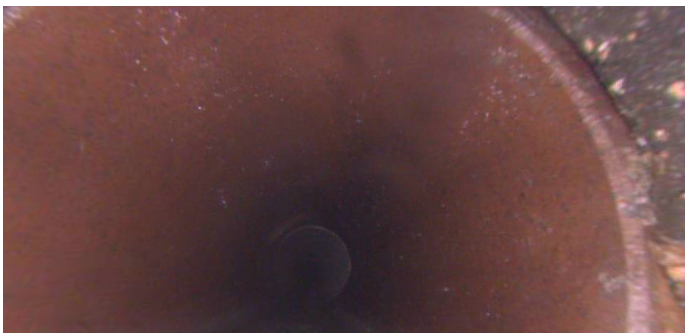
Code: **SAP**
Description: **Surface Aggregate Projecting**

Distance (ft): **119.2**
Structural Grade: **3**
O&M Grade: **0**
Clock Start/From: **8**
Clock To: **4**
1st Value:
2nd Value:
Value Percent:
Continuous Index: **F05**
Within 8" of Joint:
Remarks:

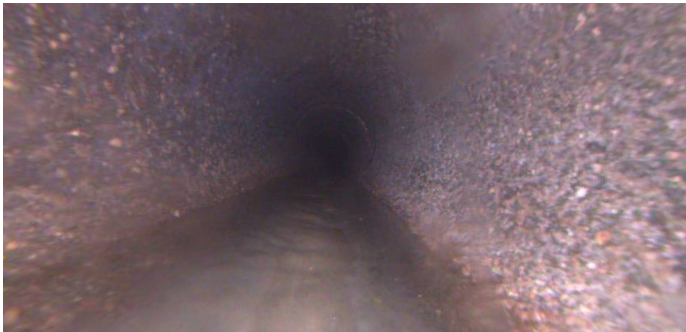
Code: **SAP**
Description: **Surface Aggregate Projecting**

Distance (ft): **122.3**
Structural Grade: **3**
O&M Grade: **0**
Clock Start/From: **7**
Clock To: **5**
1st Value:
2nd Value:
Value Percent:
Continuous Index: **S06**
Within 8" of Joint:
Remarks:

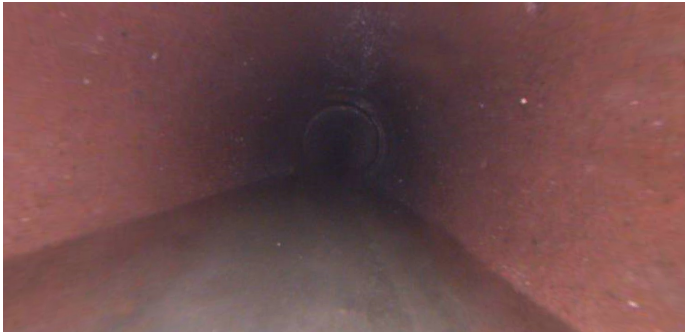
Code: **SAP**
Description: **Surface Aggregate Projecting**

Distance (ft): **128.2**
Structural Grade: **3**
O&M Grade: **0**
Clock Start/From: **7**
Clock To: **5**
1st Value:
2nd Value:
Value Percent:
Continuous Index: **F06**
Within 8" of Joint:
Remarks:

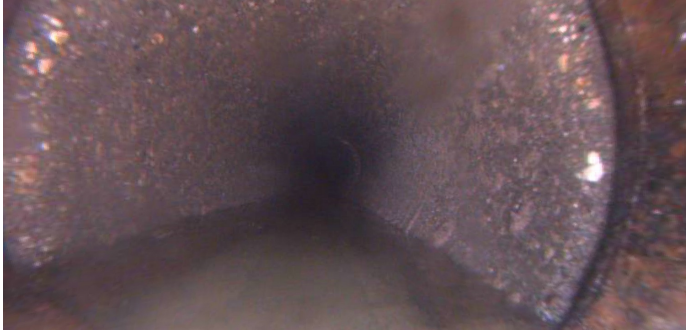
Code: **SAP**
Description: **Surface Aggregate Projecting**

Distance (ft): **131.0**
Structural Grade: **3**
O&M Grade: **0**
Clock Start/From: **8**
Clock To: **4**
1st Value:
2nd Value:
Value Percent:
Continuous Index: **S07**
Within 8" of Joint:
Remarks:

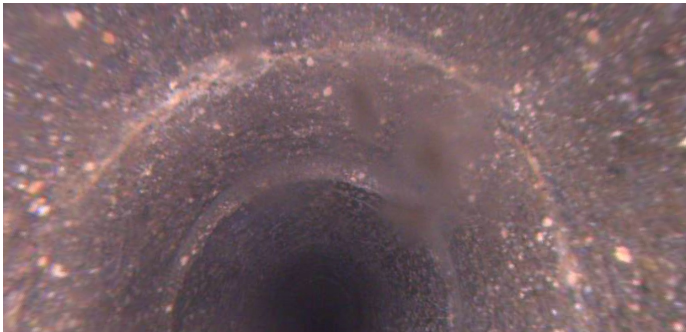
Code: **CC**
Description: **Crack Circumferential**

Distance (ft): **139.4**
Structural Grade: **1**
O&M Grade: **0**
Clock Start/From: **8**
Clock To: **4**
1st Value:
2nd Value:
Value Percent:
Continuous Index:
Within 8" of Joint:
Remarks:

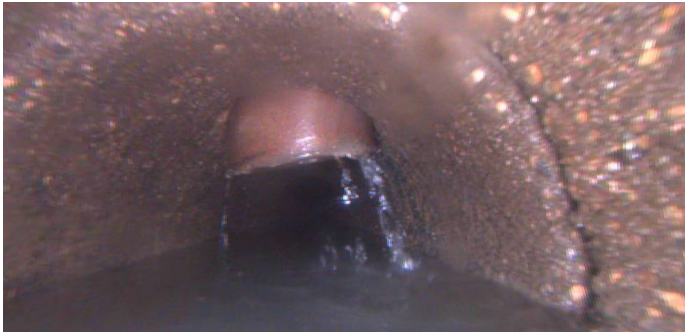
Code: **TBI**
Description: **Tap Break-in Intruding**

Distance (ft): **148.9**
Structural Grade: **0**
O&M Grade: **2**
Clock Start/From: **12**
Clock To:
1st Value: **6.000**
2nd Value: **3.000**
Value Percent:
Continuous Index:
Within 8" of Joint:
Remarks:

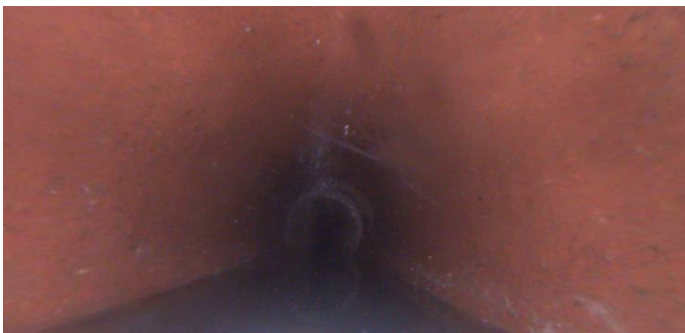
Code: **SAP**
Description: **Surface Aggregate Projecting**

Distance (ft): **163.9**
Structural Grade: **3**
O&M Grade: **0**
Clock Start/From: **8**
Clock To: **4**
1st Value:
2nd Value:
Value Percent:
Continuous Index: **F07**
Within 8" of Joint:
Remarks:

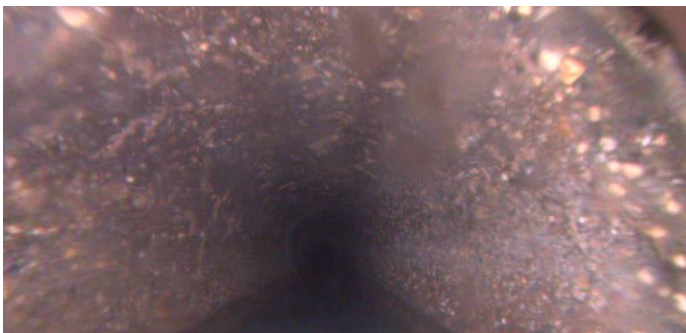
Code: **SAP**
Description: **Surface Aggregate Projecting**

Distance (ft): **166.7**
Structural Grade: **3**
O&M Grade: **0**
Clock Start/From: **7**
Clock To: **5**
1st Value:
2nd Value:
Value Percent:
Continuous Index: **S08**
Within 8" of Joint:
Remarks:

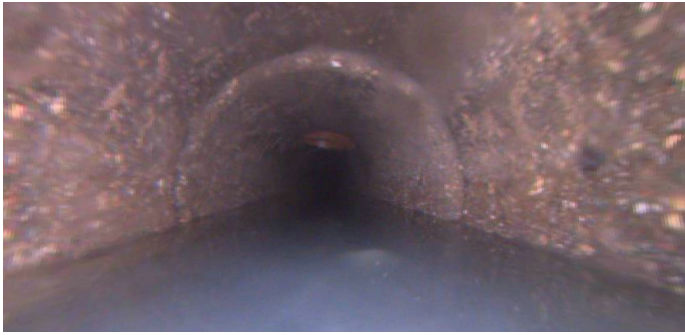
Code: **TBI**
Description: **Tap Break-in Intruding**

Distance (ft): **172.0**
Structural Grade: **0**
O&M Grade: **2**
Clock Start/From: **12**
Clock To:
1st Value: **6.000**
2nd Value: **2.000**
Value Percent:
Continuous Index:
Within 8" of Joint:
Remarks:

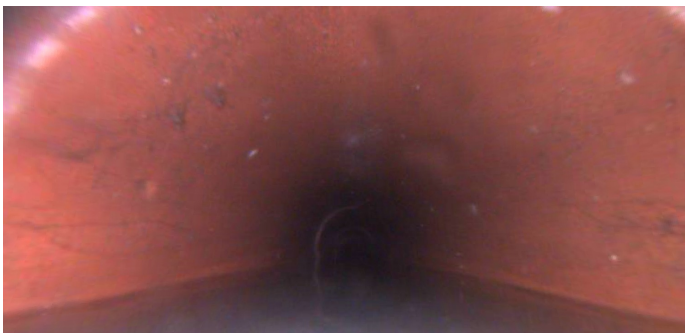
Code: **SAP**
Description: **Surface Aggregate Projecting**

Distance (ft): **196.5**
Structural Grade: **3**
O&M Grade: **0**
Clock Start/From: **7**
Clock To: **5**
1st Value:
2nd Value:
Value Percent:
Continuous Index: **F08**
Within 8" of Joint:
Remarks:

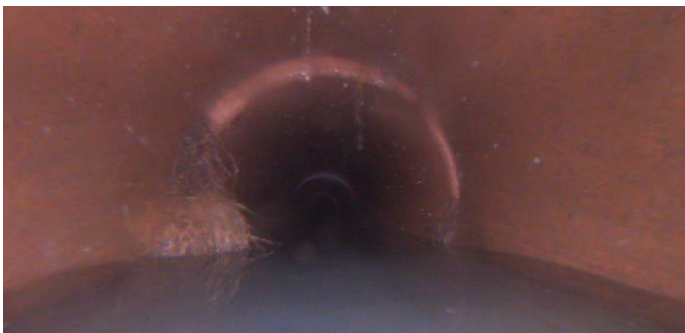
Code: **RMJ**
Description: **Roots Medium Joint**

Distance (ft): **207.7**
Structural Grade: **0**
O&M Grade: **3**
Clock Start/From: **7**
Clock To: **5**
1st Value:
2nd Value:
Value Percent: **15.000**
Continuous Index: **S01**
Within 8" of Joint: **YES**
Remarks:

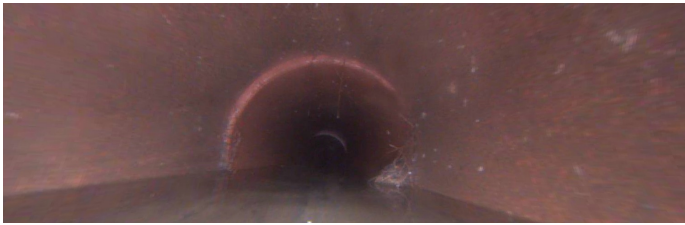
Code: **RMJ**
Description: **Roots Medium Joint**

Distance (ft): **219.3**
Structural Grade: **0**
O&M Grade: **3**
Clock Start/From: **7**
Clock To: **5**
1st Value:
2nd Value:
Value Percent: **15.000**
Continuous Index: **F01**
Within 8" of Joint: **YES**
Remarks:

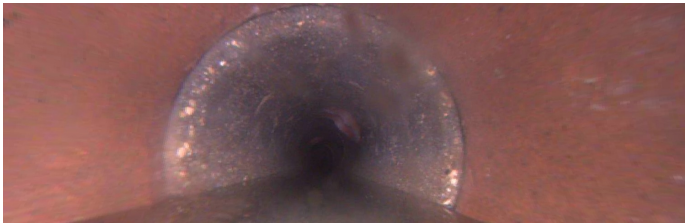
Code: **TBI**
Description: **Tap Break-in Intruding**

Distance (ft): **225.3**
Structural Grade: **0**
O&M Grade: **2**
Clock Start/From: **1**
Clock To:
1st Value: **6.000**
2nd Value: **2.000**
Value Percent:
Continuous Index:
Within 8" of Joint:
Remarks:

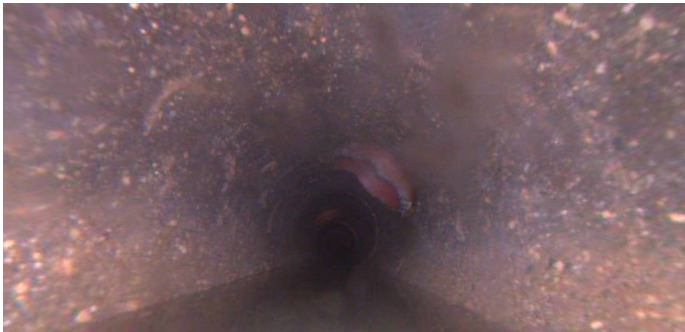
Code: **SAP**
Description: **Surface Aggregate Projecting**

Distance (ft): **225.9**
Structural Grade: **3**
O&M Grade: **0**
Clock Start/From: **8**
Clock To: **4**
1st Value:
2nd Value:
Value Percent:
Continuous Index: **S09**
Within 8" of Joint:
Remarks:

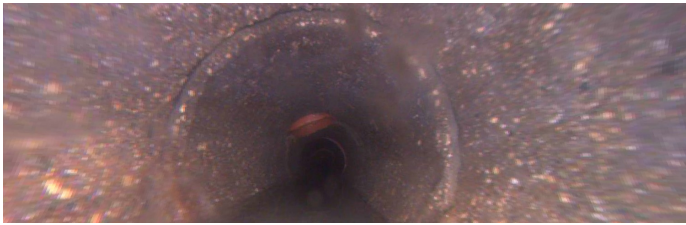
Code: **TBI**
Description: **Tap Break-in Intruding**

Distance (ft): **228.3**
Structural Grade: **0**
O&M Grade: **2**
Clock Start/From: **11**
Clock To:
1st Value: **6.000**
2nd Value: **2.000**
Value Percent:
Continuous Index:
Within 8" of Joint:
Remarks:

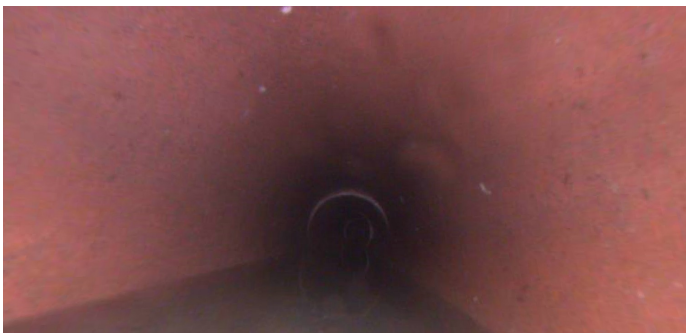
Code: **SAP**
Description: **Surface Aggregate Projecting**

Distance (ft): **231.8**
Structural Grade: **3**
O&M Grade: **0**
Clock Start/From: **8**
Clock To: **4**
1st Value:
2nd Value:
Value Percent:
Continuous Index: **F09**
Within 8" of Joint:
Remarks:

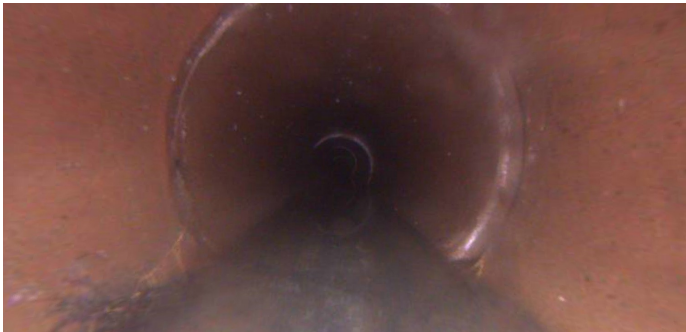
Code: **RFJ**
Description: **Roots Fine Joint**

Distance (ft): **242.9**
Structural Grade: **0**
O&M Grade: **1**
Clock Start/From: **8**
Clock To:
1st Value:
2nd Value:
Value Percent:
Continuous Index:
Within 8" of Joint: **YES**
Remarks:

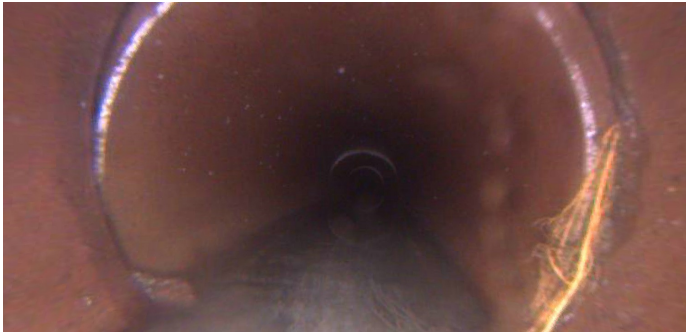
Code: **RFJ**
Description: **Roots Fine Joint**

Distance (ft): **249.2**
Structural Grade: **0**
O&M Grade: **1**
Clock Start/From: **3**
Clock To: **5**
1st Value:
2nd Value:
Value Percent:
Continuous Index:
Within 8" of Joint: **YES**
Remarks:

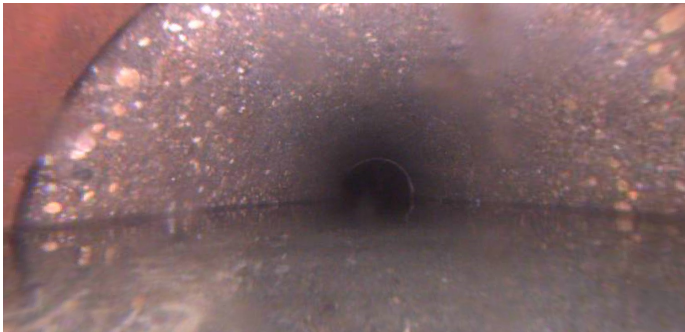
Code: **SAP**
Description: **Surface Aggregate Projecting**

Distance (ft): **258.4**
Structural Grade: **3**
O&M Grade: **0**
Clock Start/From: **8**
Clock To: **4**
1st Value:
2nd Value:
Value Percent:
Continuous Index:
Within 8" of Joint:
Remarks:

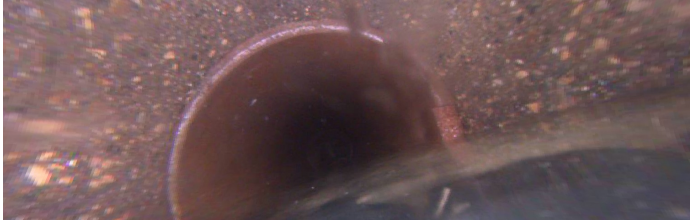
Code:	MSA
Description:	Abandoned Survey
Distance (ft):	261.0
Structural Grade:	0
O&M Grade:	0
Clock Start/From:	
Clock To:	
1st Value:	
2nd Value:	
Value Percent:	
Continuous Index:	
Within 8" of Joint:	NO
Remarks:	camera stopped under water
