Profile/Photo Observation Report

Date:	04/16/2018	Weather:		Coding:	PACP 6.0
Pipe Length (ft):	320.0	Owner:	NA	Pre Clean:	Not Known
P.O.#:		Surveyor:	Selasie Honu	PSR:	P-504-126.1-126
Customer:		Clean Date:	01/01/1900	Shape:	C

Street:	Summerlin	Flow Control:	Not Controlled
City:	Hobart, IN	Year Renewed:	
Location:	Light Highway	Tape/Media #:	
Purpose:	Not Known	Dia/Height:	10"
Use:	Sanitary	Material:	CP
Drain Area:	NA	Lining:	
Category:	NA		
Comment:			
Location Details:		Direction of Survey:	Downstream
US MH:	M-504-126	DS MH:	M-504-126.1
		Total Length Surveyed (ft):	261.0

O&M Index:	1.52	O&M Quick:	322A	O&M Rating:	41.00
Structural Index:	2.86	Structural Quick:	3F22	Structural Rating:	120.00
Overall Index:	2.33	Overall Quick:	3G2A	Overall Rating:	161.00

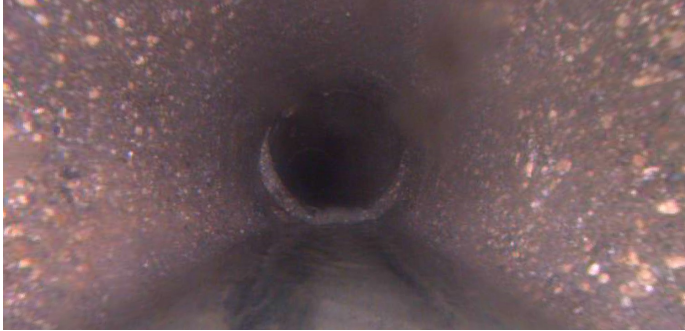
Code: **SAP**
Description: **Surface Aggregate Projecting**

Distance (ft): **.0**
Structural Grade: **3**
O&M Grade: **0**
Clock Start/From: **7**
Clock To: **5**
1st Value:
2nd Value:
Value Percent:
Continuous Index: **S02**
Within 8" of Joint:
Remarks:

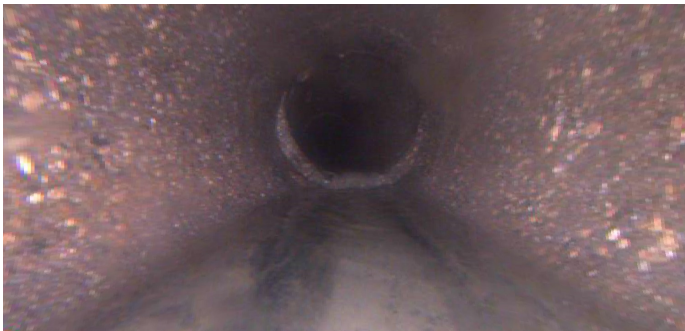
Code: **AMH**
Description: **Manhole**

Distance (ft): **.0**
Structural Grade: **0**
O&M Grade: **0**
Clock Start/From:
Clock To:
1st Value:
2nd Value:
Value Percent:
Continuous Index:
Within 8" of Joint: **NO**
Remarks: **M-504-126**

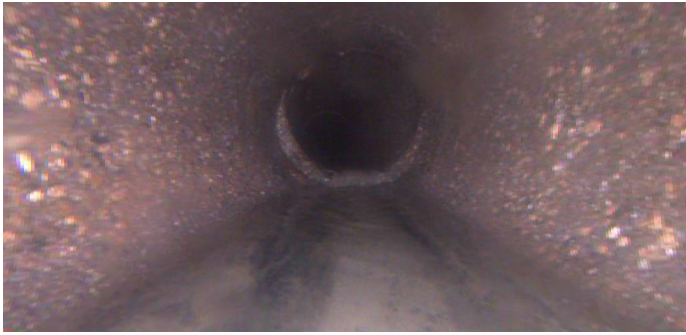
Code: **MWL**
Description: **Water Level**

Distance (ft): **.0**
Structural Grade: **0**
O&M Grade: **0**
Clock Start/From:
Clock To:
1st Value:
2nd Value:
Value Percent: **5.000**
Continuous Index:
Within 8" of Joint: **NO**
Remarks:

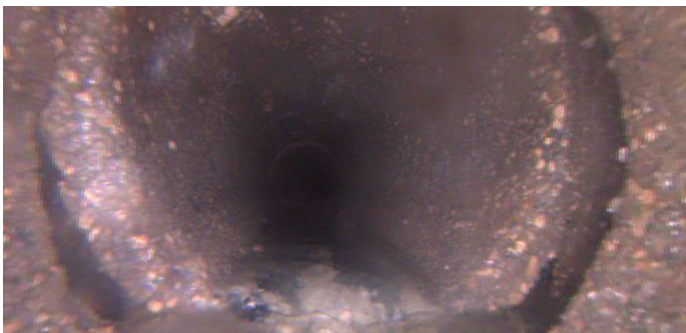
Code: **JOM**
Description: **Joint Offset Medium**

Distance (ft): **2.4**
Structural Grade: **1**
O&M Grade: **0**
Clock Start/From:
Clock To:
1st Value:
2nd Value:
Value Percent:
Continuous Index:
Within 8" of Joint: **NO**
Remarks:

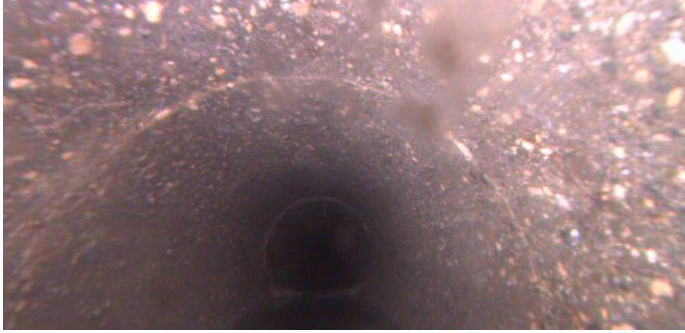
Code: **FC**
Description: **Fracture Circumferential**

Distance (ft): **6.3**
Structural Grade: **2**
O&M Grade: **0**
Clock Start/From: **8**
Clock To: **4**
1st Value:
2nd Value:
Value Percent:
Continuous Index:
Within 8" of Joint:
Remarks:

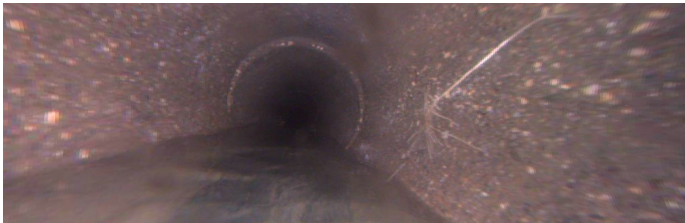
Code: **RFB**
Description: **Roots Fine Barrel**

Distance (ft): **16.1**
Structural Grade: **0**
O&M Grade: **2**
Clock Start/From: **3**
Clock To:
1st Value:
2nd Value:
Value Percent:
Continuous Index:
Within 8" of Joint: **NO**
Remarks:

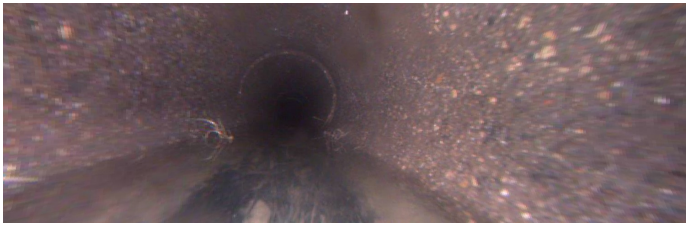
Code: **RFB**
Description: **Roots Fine Barrel**

Distance (ft): **18.4**
Structural Grade: **0**
O&M Grade: **2**
Clock Start/From: **5**
Clock To: **7**
1st Value:
2nd Value:
Value Percent:
Continuous Index:
Within 8" of Joint: **NO**
Remarks:

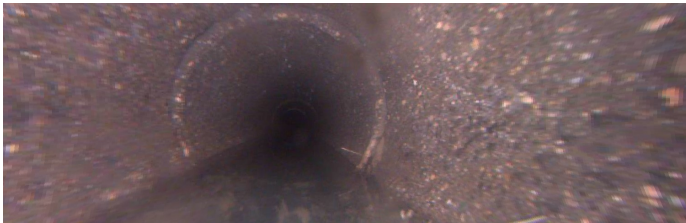
Code: **RFJ**
Description: **Roots Fine Joint**

Distance (ft): **19.4**
Structural Grade: **0**
O&M Grade: **1**
Clock Start/From: **5**
Clock To:
1st Value:
2nd Value:
Value Percent:
Continuous Index:
Within 8" of Joint: **YES**
Remarks:

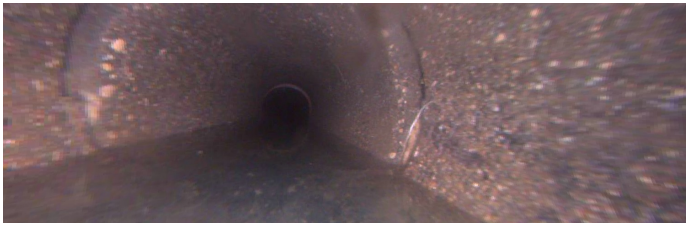
Code: **RFB**
Description: **Roots Fine Barrel**

Distance (ft): **22.6**
Structural Grade: **0**
O&M Grade: **2**
Clock Start/From: **4**
Clock To:
1st Value:
2nd Value:
Value Percent:
Continuous Index:
Within 8" of Joint: **NO**
Remarks:

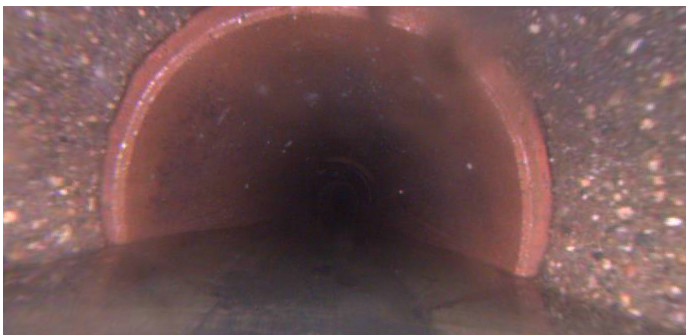
Code: **SAP**
Description: **Surface Aggregate Projecting**

Distance (ft): **25.5**
Structural Grade: **3**
O&M Grade: **0**
Clock Start/From: **7**
Clock To: **5**
1st Value:
2nd Value:
Value Percent:
Continuous Index: **F02**
Within 8" of Joint:
Remarks:

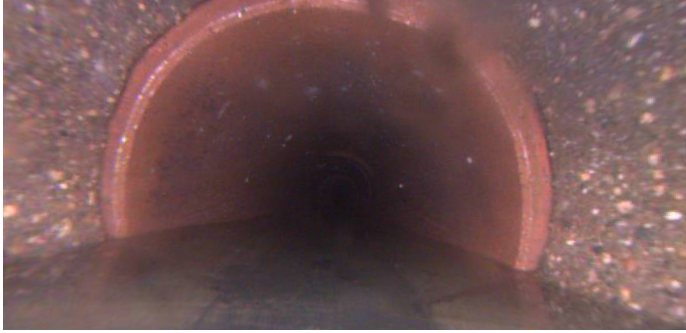
Code: **MMC**
Description: **Material Change**

Distance (ft): **25.5**
Structural Grade: **0**
O&M Grade: **0**
Clock Start/From:
Clock To:
1st Value:
2nd Value:
Value Percent:
Continuous Index:
Within 8" of Joint: **NO**
Remarks: **VCP**

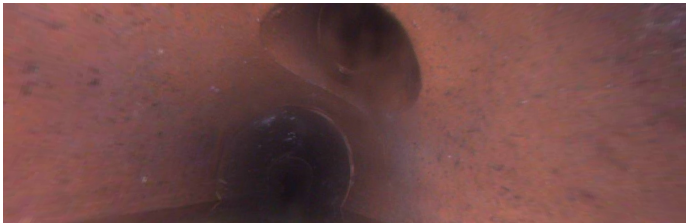
Code: **TF**
Description: **Tap Factory**

Distance (ft): **27.7**
Structural Grade: **0**
O&M Grade: **0**
Clock Start/From: **1**
Clock To:
1st Value: **4.000**
2nd Value:
Value Percent:
Continuous Index:
Within 8" of Joint:
Remarks:

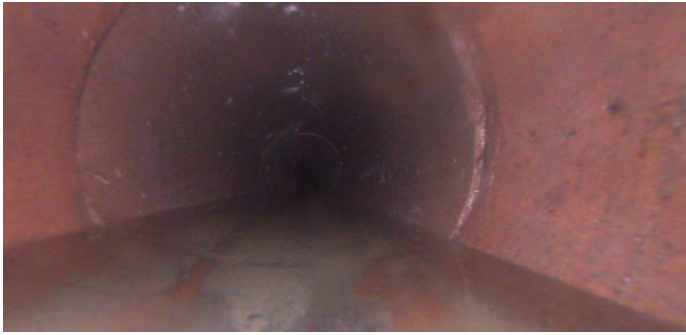
Code: **RFJ**
Description: **Roots Fine Joint**

Distance (ft): **28.4**
Structural Grade: **0**
O&M Grade: **1**
Clock Start/From: **8**
Clock To:
1st Value:
2nd Value:
Value Percent:
Continuous Index:
Within 8" of Joint: **YES**
Remarks:

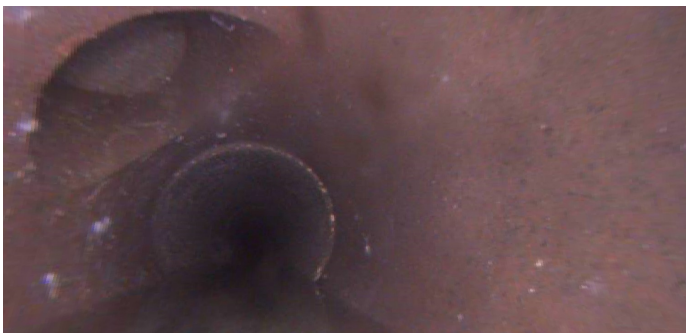
Code: **TFC**
Description: **Tap Factory Capped**

Distance (ft): **30.4**
Structural Grade: **0**
O&M Grade: **0**
Clock Start/From: **11**
Clock To:
1st Value: **4.000**
2nd Value:
Value Percent:
Continuous Index:
Within 8" of Joint:
Remarks:

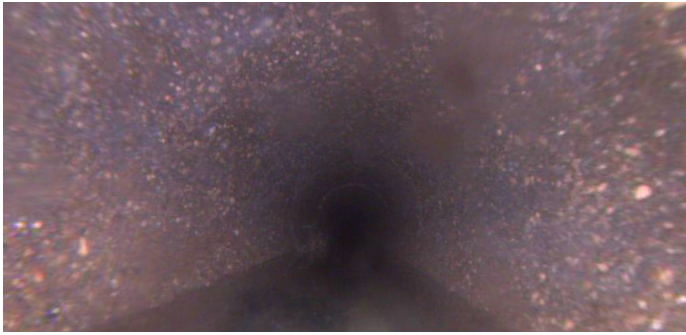
Code: **MMC**
Description: **Material Change**

Distance (ft): **31.6**
Structural Grade: **0**
O&M Grade: **0**
Clock Start/From:
Clock To:
1st Value:
2nd Value:
Value Percent:
Continuous Index:
Within 8" of Joint: **NO**
Remarks: **CP**

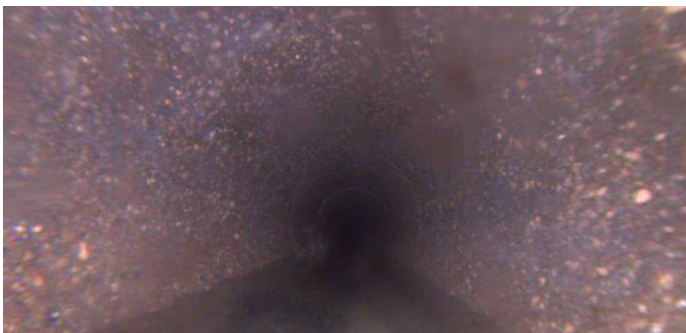
Code: **SAP**
Description: **Surface Aggregate Projecting**

Distance (ft): **31.6**
Structural Grade: **3**
O&M Grade: **0**
Clock Start/From: **8**
Clock To: **4**
1st Value:
2nd Value:
Value Percent:
Continuous Index: **S03**
Within 8" of Joint:
Remarks:

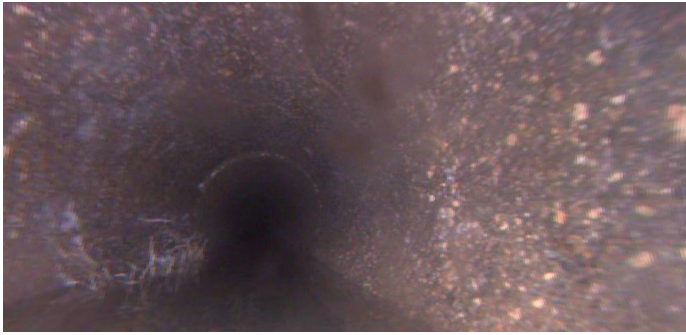
Code: **RFB**
Description: **Roots Fine Barrel**

Distance (ft): **32.7**
Structural Grade: **0**
O&M Grade: **2**
Clock Start/From: **7**
Clock To: **9**
1st Value:
2nd Value:
Value Percent:
Continuous Index:
Within 8" of Joint: **NO**
Remarks:

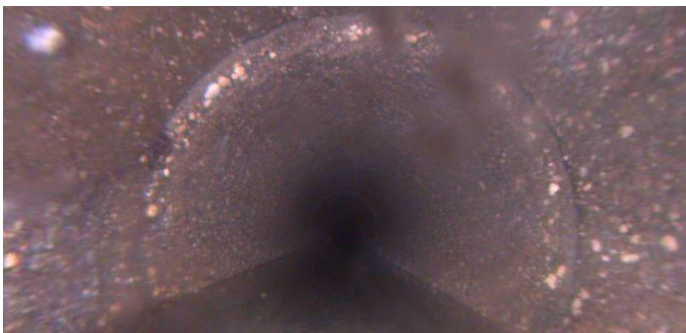
Code: **RFJ**
Description: **Roots Fine Joint**

Distance (ft): **34.2**
Structural Grade: **0**
O&M Grade: **1**
Clock Start/From: **8**
Clock To: **9**
1st Value:
2nd Value:
Value Percent:
Continuous Index:
Within 8" of Joint: **YES**
Remarks:

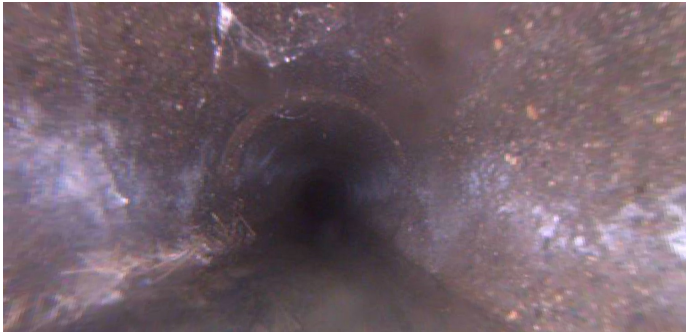
Code: **RFB**
Description: **Roots Fine Barrel**

Distance (ft): **39.4**
Structural Grade: **0**
O&M Grade: **2**
Clock Start/From: **7**
Clock To:
1st Value:
2nd Value:
Value Percent:
Continuous Index:
Within 8" of Joint: **NO**
Remarks:

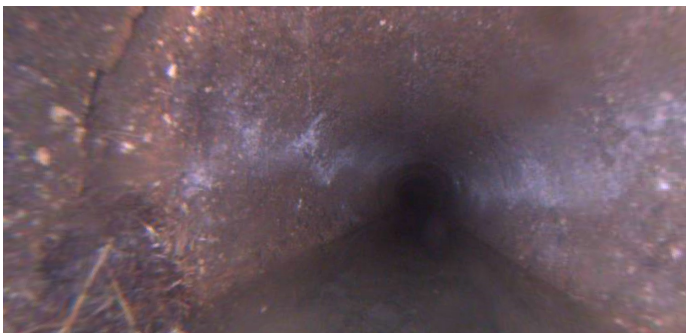
Code: **RFJ**
Description: **Roots Fine Joint**

Distance (ft): **40.4**
Structural Grade: **0**
O&M Grade: **1**
Clock Start/From: **8**
Clock To: **4**
1st Value:
2nd Value:
Value Percent:
Continuous Index: **S04**
Within 8" of Joint: **YES**
Remarks:

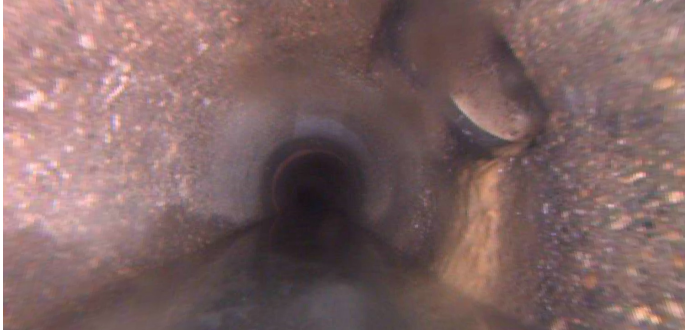
Code: **TF**
Description: **Tap Factory**

Distance (ft): **43.6**
Structural Grade: **0**
O&M Grade: **0**
Clock Start/From: **2**
Clock To:
1st Value: **4.000**
2nd Value:
Value Percent:
Continuous Index:
Within 8" of Joint:
Remarks:

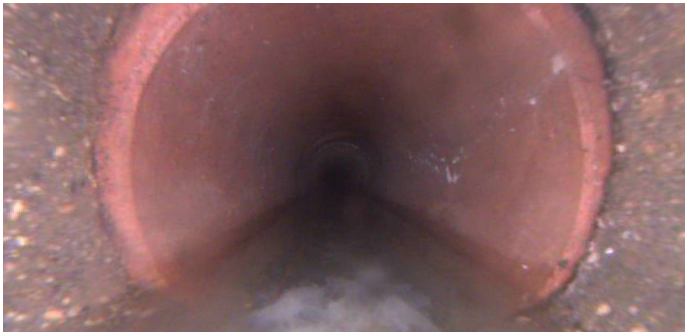
Code: **SAP**
Description: **Surface Aggregate Projecting**

Distance (ft): **46.1**
Structural Grade: **3**
O&M Grade: **0**
Clock Start/From: **8**
Clock To: **4**
1st Value:
2nd Value:
Value Percent:
Continuous Index: **F03**
Within 8" of Joint:
Remarks:

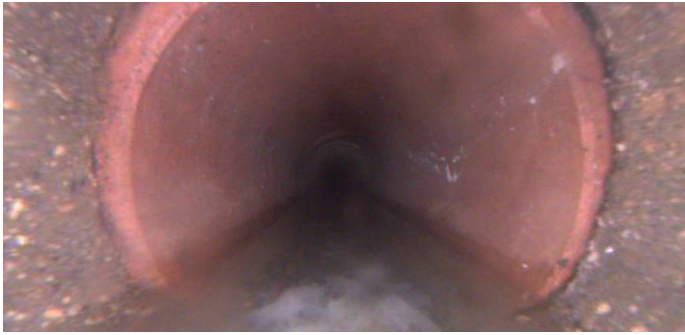
Code: **MMC**
Description: **Material Change**

Distance (ft): **46.1**
Structural Grade: **0**
O&M Grade: **0**
Clock Start/From:
Clock To:
1st Value:
2nd Value:
Value Percent:
Continuous Index:
Within 8" of Joint: **NO**
Remarks: **VCP**

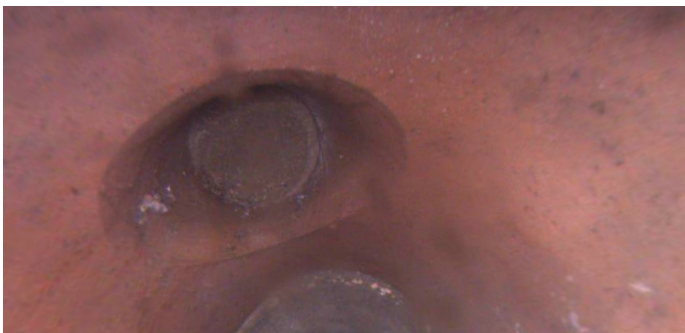
Code: **TFC**
Description: **Tap Factory Capped**

Distance (ft): **48.2**
Structural Grade: **0**
O&M Grade: **0**
Clock Start/From: **11**
Clock To:
1st Value: **4.000**
2nd Value:
Value Percent:
Continuous Index:
Within 8" of Joint:
Remarks:

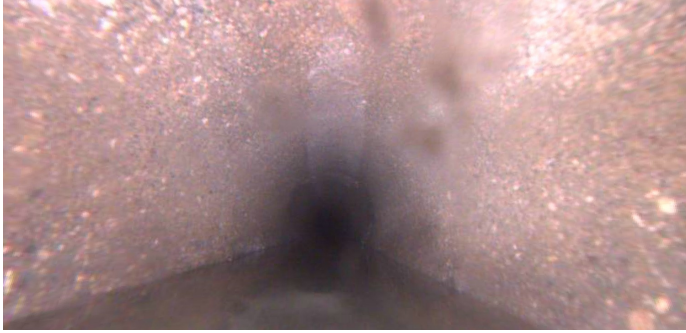
Code: **MMC**
Description: **Material Change**

Distance (ft): **49.6**
Structural Grade: **0**
O&M Grade: **0**
Clock Start/From:
Clock To:
1st Value:
2nd Value:
Value Percent:
Continuous Index:
Within 8" of Joint: **NO**
Remarks: **cp**

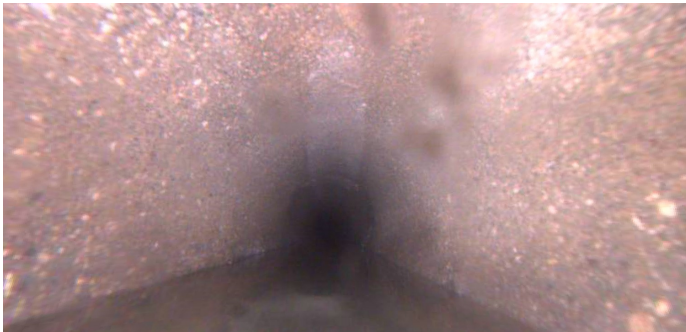
Code: **SAP**
Description: **Surface Aggregate Projecting**

Distance (ft): **49.6**
Structural Grade: **3**
O&M Grade: **0**
Clock Start/From: **8**
Clock To: **4**
1st Value:
2nd Value:
Value Percent:
Continuous Index: **S05**
Within 8" of Joint:
Remarks:

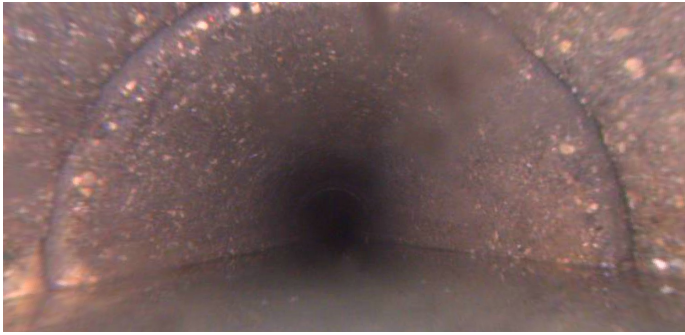
Code: **RFJ**
Description: **Roots Fine Joint**

Distance (ft): **89.3**
Structural Grade: **0**
O&M Grade: **1**
Clock Start/From: **8**
Clock To: **4**
1st Value:
2nd Value:
Value Percent:
Continuous Index: **F04**
Within 8" of Joint: **YES**
Remarks:

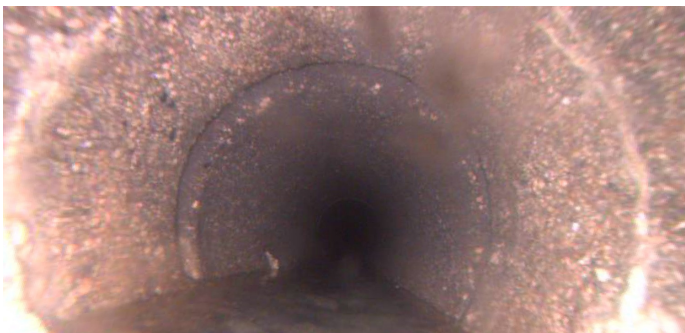
Code: **FC**
Description: **Fracture Circumferential**

Distance (ft): **97.8**
Structural Grade: **2**
O&M Grade: **0**
Clock Start/From: **8**
Clock To: **4**
1st Value:
2nd Value:
Value Percent:
Continuous Index:
Within 8" of Joint:
Remarks:

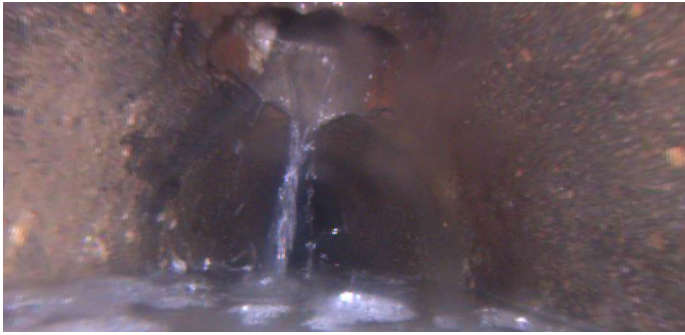
Code: **TBI**
Description: **Tap Break-in Intruding**

Distance (ft): **113.8**
Structural Grade: **0**
O&M Grade: **2**
Clock Start/From: **12**
Clock To:
1st Value: **4.000**
2nd Value: **1.000**
Value Percent:
Continuous Index:
Within 8" of Joint:
Remarks: **active**

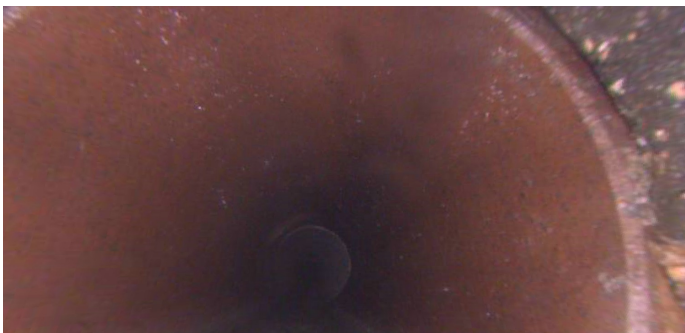
Code: **SAP**
Description: **Surface Aggregate Projecting**

Distance (ft): **119.2**
Structural Grade: **3**
O&M Grade: **0**
Clock Start/From: **8**
Clock To: **4**
1st Value:
2nd Value:
Value Percent:
Continuous Index: **F05**
Within 8" of Joint:
Remarks:

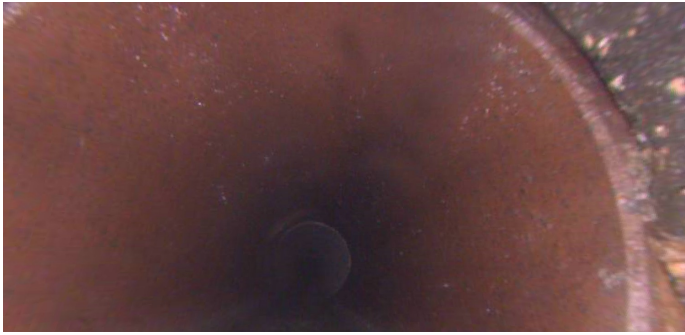
Code: **MMC**
Description: **Material Change**

Distance (ft): **119.2**
Structural Grade: **0**
O&M Grade: **0**
Clock Start/From:
Clock To:
1st Value:
2nd Value:
Value Percent:
Continuous Index:
Within 8" of Joint: **NO**
Remarks: **VCP**

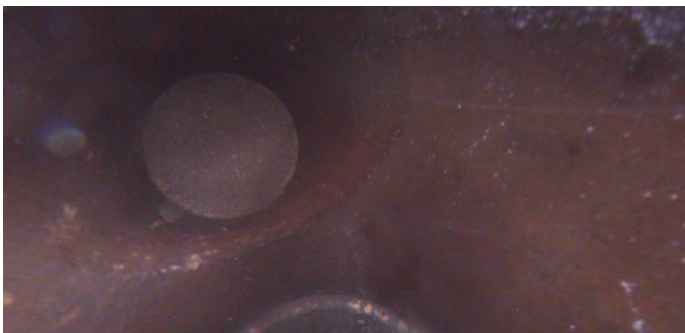
Code: **TFC**
Description: **Tap Factory Capped**

Distance (ft): **121.5**
Structural Grade: **0**
O&M Grade: **0**
Clock Start/From: **11**
Clock To:
1st Value: **4.000**
2nd Value:
Value Percent:
Continuous Index:
Within 8" of Joint:
Remarks:

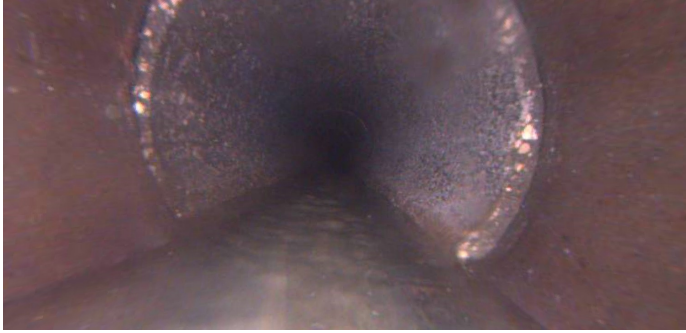
Code: **MMC**
Description: **Material Change**

Distance (ft): **121.9**
Structural Grade: **0**
O&M Grade: **0**
Clock Start/From:
Clock To:
1st Value:
2nd Value:
Value Percent:
Continuous Index:
Within 8" of Joint: **NO**
Remarks: **cp**

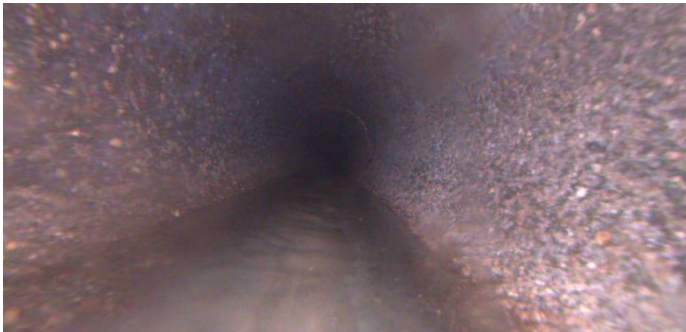
Code: **SAP**
Description: **Surface Aggregate Projecting**

Distance (ft): **122.3**
Structural Grade: **3**
O&M Grade: **0**
Clock Start/From: **7**
Clock To: **5**
1st Value:
2nd Value:
Value Percent:
Continuous Index: **S06**
Within 8" of Joint:
Remarks:

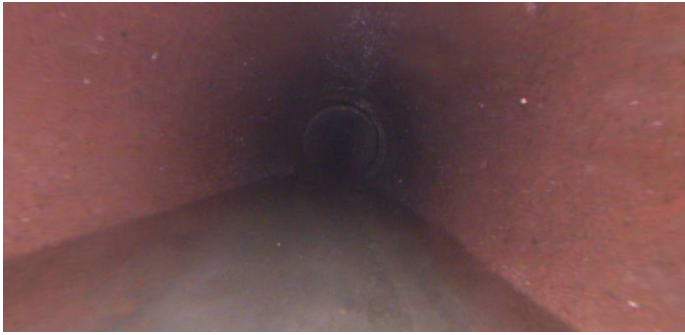
Code: **SAP**
Description: **Surface Aggregate Projecting**

Distance (ft): **128.2**
Structural Grade: **3**
O&M Grade: **0**
Clock Start/From: **7**
Clock To: **5**
1st Value:
2nd Value:
Value Percent:
Continuous Index: **F06**
Within 8" of Joint:
Remarks:

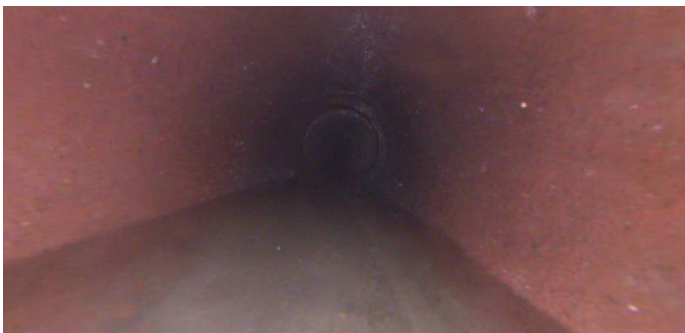
Code: **MMC**
Description: **Material Change**

Distance (ft): **128.2**
Structural Grade: **0**
O&M Grade: **0**
Clock Start/From:
Clock To:
1st Value:
2nd Value:
Value Percent:
Continuous Index:
Within 8" of Joint: **NO**
Remarks: **VCP**

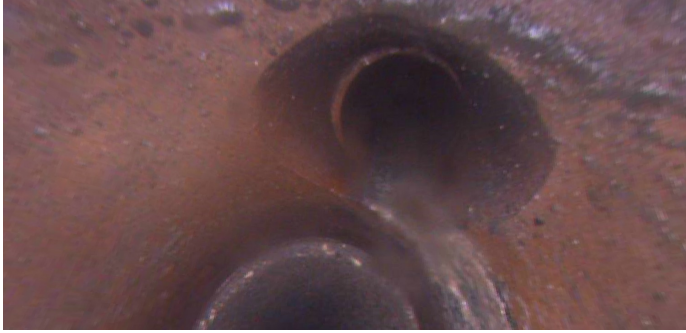
Code: **TF**
Description: **Tap Factory**

Distance (ft): **130.1**
Structural Grade: **0**
O&M Grade: **0**
Clock Start/From: **1**
Clock To:
1st Value: **4.000**
2nd Value:
Value Percent:
Continuous Index:
Within 8" of Joint:
Remarks:

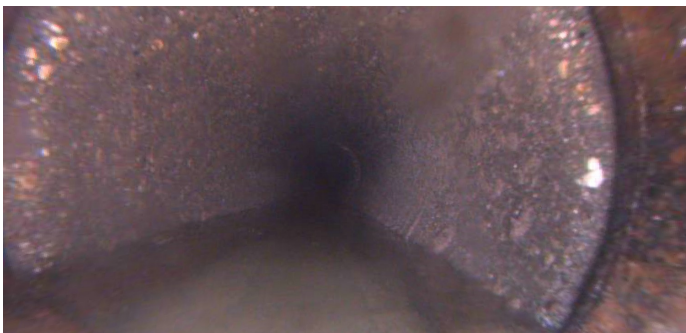
Code: **MMC**
Description: **Material Change**

Distance (ft): **131.0**
Structural Grade: **0**
O&M Grade: **0**
Clock Start/From:
Clock To:
1st Value:
2nd Value:
Value Percent:
Continuous Index:
Within 8" of Joint: **NO**
Remarks: **vcp**

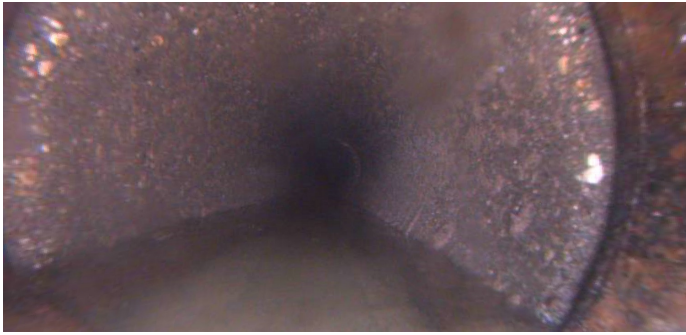
Code: **SAP**
Description: **Surface Aggregate Projecting**

Distance (ft): **131.0**
Structural Grade: **3**
O&M Grade: **0**
Clock Start/From: **8**
Clock To: **4**
1st Value:
2nd Value:
Value Percent:
Continuous Index: **S07**
Within 8" of Joint:
Remarks:

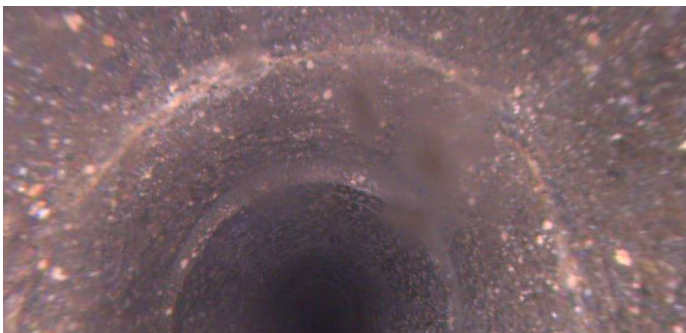
Code: **CC**
Description: **Crack Circumferential**

Distance (ft): **139.4**
Structural Grade: **1**
O&M Grade: **0**
Clock Start/From: **8**
Clock To: **4**
1st Value:
2nd Value:
Value Percent:
Continuous Index:
Within 8" of Joint:
Remarks:

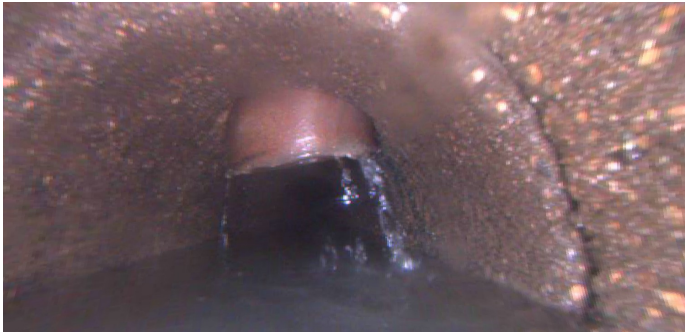
Code: **TBI**
Description: **Tap Break-in Intruding**

Distance (ft): **148.9**
Structural Grade: **0**
O&M Grade: **2**
Clock Start/From: **12**
Clock To:
1st Value: **6.000**
2nd Value: **3.000**
Value Percent:
Continuous Index:
Within 8" of Joint:
Remarks:

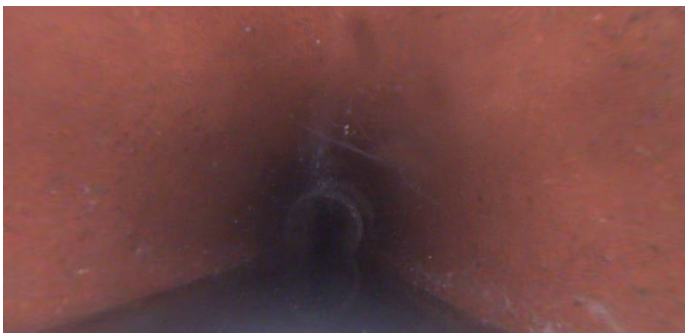
Code: **SAP**
Description: **Surface Aggregate Projecting**

Distance (ft): **163.9**
Structural Grade: **3**
O&M Grade: **0**
Clock Start/From: **8**
Clock To: **4**
1st Value:
2nd Value:
Value Percent:
Continuous Index: **F07**
Within 8" of Joint:
Remarks:

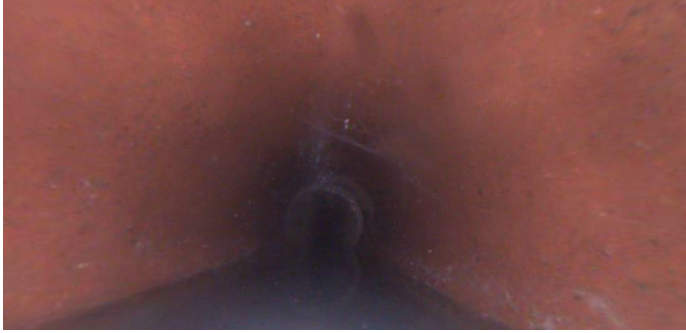
Code: **MMC**
Description: **Material Change**

Distance (ft): **163.9**
Structural Grade: **0**
O&M Grade: **0**
Clock Start/From:
Clock To:
1st Value:
2nd Value:
Value Percent:
Continuous Index:
Within 8" of Joint: **NO**
Remarks: **VCP**

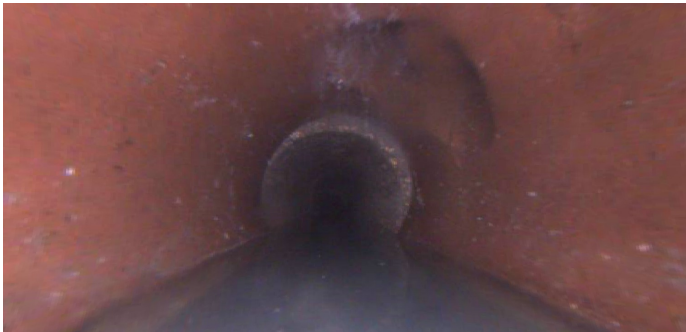
Code: **TF**
Description: **Tap Factory**

Distance (ft): **165.4**
Structural Grade: **0**
O&M Grade: **0**
Clock Start/From: **1**
Clock To:
1st Value: **4.000**
2nd Value:
Value Percent:
Continuous Index:
Within 8" of Joint:
Remarks:

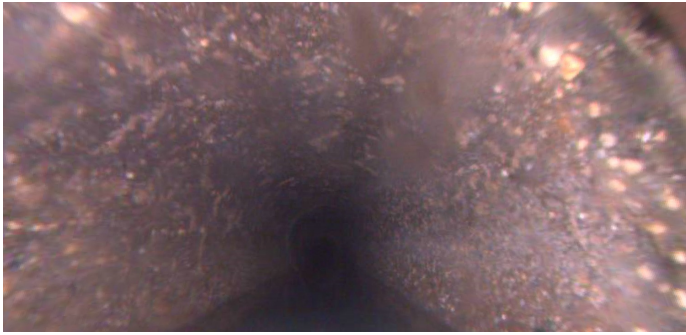
Code: **MMC**
Description: **Material Change**

Distance (ft): **166.7**
Structural Grade: **0**
O&M Grade: **0**
Clock Start/From:
Clock To:
1st Value:
2nd Value:
Value Percent:
Continuous Index:
Within 8" of Joint: **NO**
Remarks: **cp**

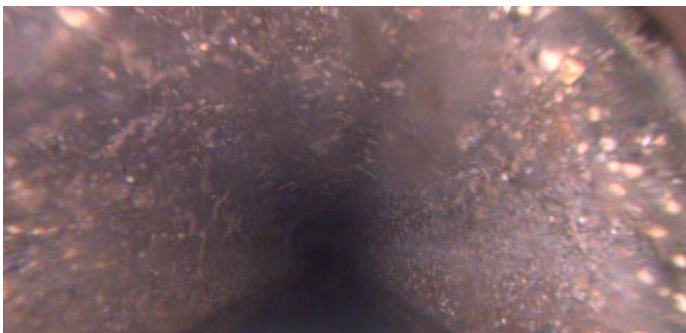
Code: **SAP**
Description: **Surface Aggregate Projecting**

Distance (ft): **166.7**
Structural Grade: **3**
O&M Grade: **0**
Clock Start/From: **7**
Clock To: **5**
1st Value:
2nd Value:
Value Percent:
Continuous Index: **S08**
Within 8" of Joint:
Remarks:

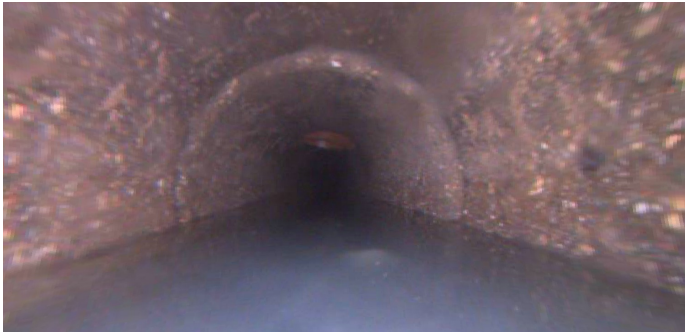
Code: **TBI**
Description: **Tap Break-in Intruding**

Distance (ft): **172.0**
Structural Grade: **0**
O&M Grade: **2**
Clock Start/From: **12**
Clock To:
1st Value: **6.000**
2nd Value: **2.000**
Value Percent:
Continuous Index:
Within 8" of Joint:
Remarks:

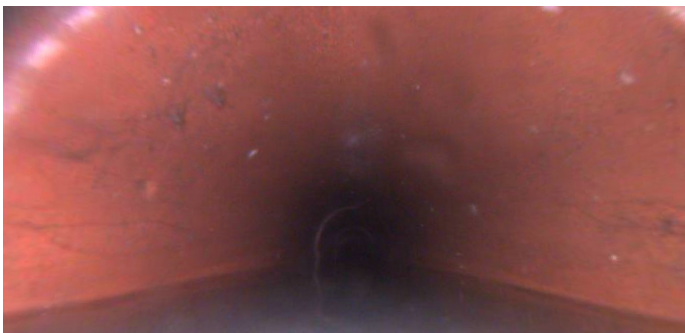
Code: **SAP**
Description: **Surface Aggregate Projecting**

Distance (ft): **196.5**
Structural Grade: **3**
O&M Grade: **0**
Clock Start/From: **7**
Clock To: **5**
1st Value:
2nd Value:
Value Percent:
Continuous Index: **F08**
Within 8" of Joint:
Remarks:

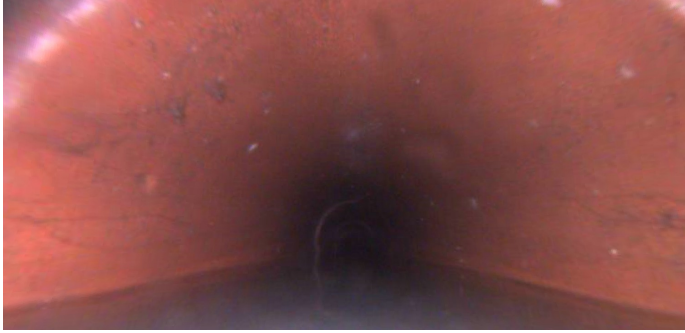
Code: **MMC**
Description: **Material Change**

Distance (ft): **196.5**
Structural Grade: **0**
O&M Grade: **0**
Clock Start/From:
Clock To:
1st Value:
2nd Value:
Value Percent:
Continuous Index:
Within 8" of Joint: **NO**
Remarks: **vcp**

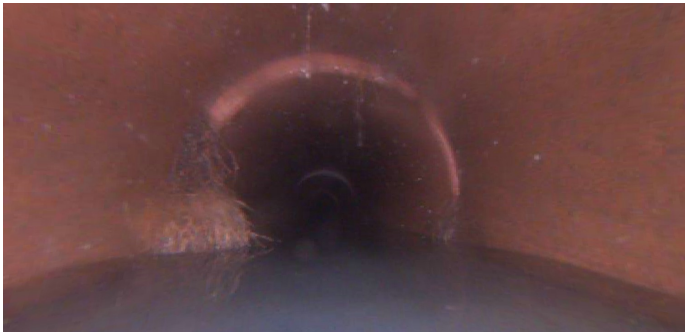
Code: **RMJ**
Description: **Roots Medium Joint**

Distance (ft): **207.7**
Structural Grade: **0**
O&M Grade: **3**
Clock Start/From: **7**
Clock To: **5**
1st Value:
2nd Value:
Value Percent: **15.000**
Continuous Index: **S01**
Within 8" of Joint: **YES**
Remarks:

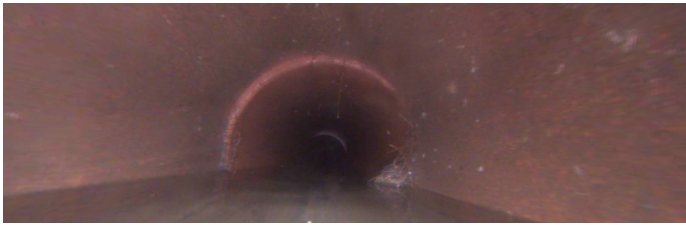
Code: **RMJ**
Description: **Roots Medium Joint**

Distance (ft): **219.3**
Structural Grade: **0**
O&M Grade: **3**
Clock Start/From: **7**
Clock To: **5**
1st Value:
2nd Value:
Value Percent: **15.000**
Continuous Index: **F01**
Within 8" of Joint: **YES**
Remarks:

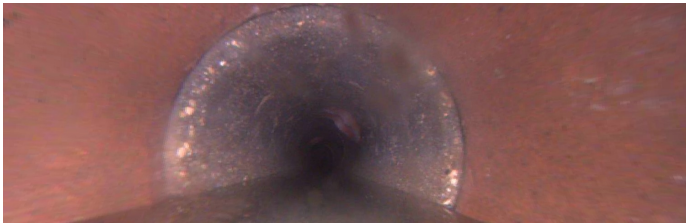
Code: **TBI**
Description: **Tap Break-in Intruding**

Distance (ft): **225.3**
Structural Grade: **0**
O&M Grade: **2**
Clock Start/From: **1**
Clock To:
1st Value: **6.000**
2nd Value: **2.000**
Value Percent:
Continuous Index:
Within 8" of Joint:
Remarks:

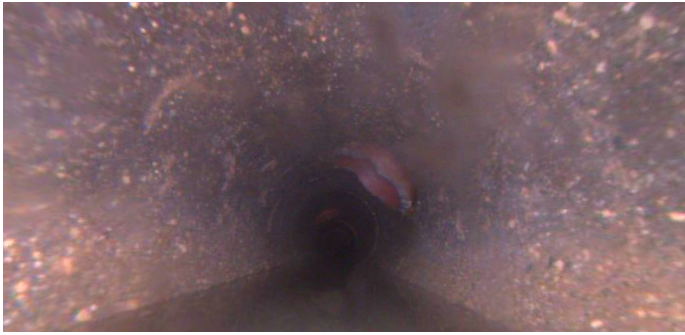
Code: **MMC**
Description: **Material Change**

Distance (ft): **225.9**
Structural Grade: **0**
O&M Grade: **0**
Clock Start/From:
Clock To:
1st Value:
2nd Value:
Value Percent:
Continuous Index:
Within 8" of Joint: **NO**
Remarks: **CP**

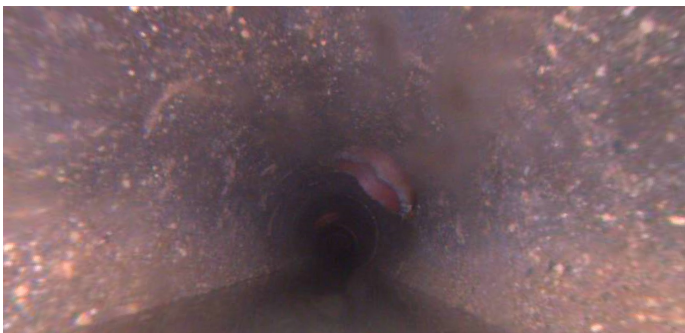
Code: **SAP**
Description: **Surface Aggregate Projecting**

Distance (ft): **225.9**
Structural Grade: **3**
O&M Grade: **0**
Clock Start/From: **8**
Clock To: **4**
1st Value:
2nd Value:
Value Percent:
Continuous Index: **S09**
Within 8" of Joint:
Remarks:

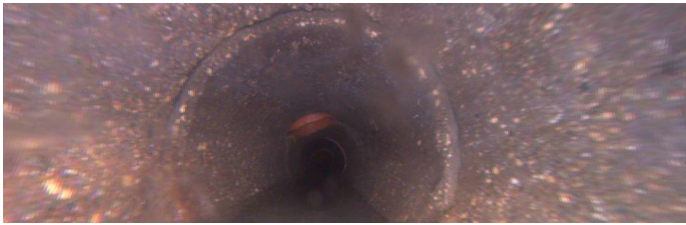
Code: **TBI**
Description: **Tap Break-in Intruding**

Distance (ft): **228.3**
Structural Grade: **0**
O&M Grade: **2**
Clock Start/From: **11**
Clock To:
1st Value: **6.000**
2nd Value: **2.000**
Value Percent:
Continuous Index:
Within 8" of Joint:
Remarks:

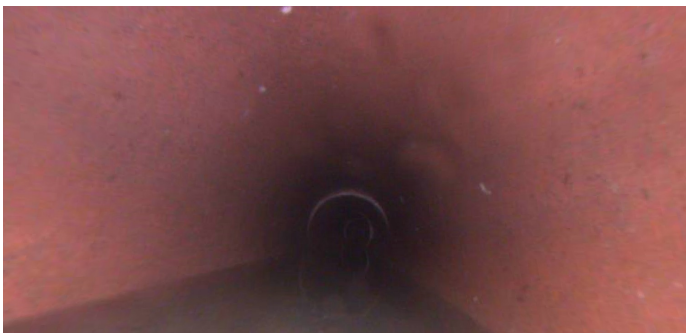
Code: **SAP**
Description: **Surface Aggregate Projecting**

Distance (ft): **231.8**
Structural Grade: **3**
O&M Grade: **0**
Clock Start/From: **8**
Clock To: **4**
1st Value:
2nd Value:
Value Percent:
Continuous Index: **F09**
Within 8" of Joint:
Remarks:

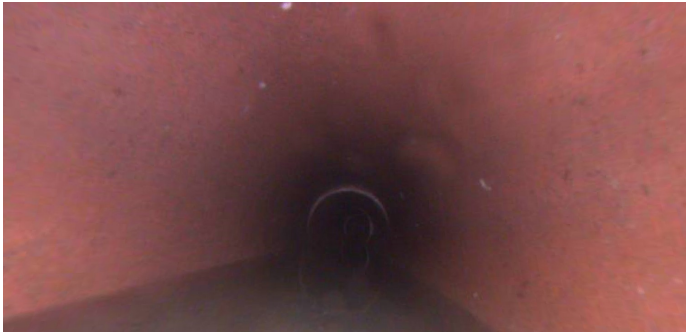
Code: **MMC**
Description: **Material Change**

Distance (ft): **231.8**
Structural Grade: **0**
O&M Grade: **0**
Clock Start/From:
Clock To:
1st Value:
2nd Value:
Value Percent:
Continuous Index:
Within 8" of Joint: **NO**
Remarks: **VCP**

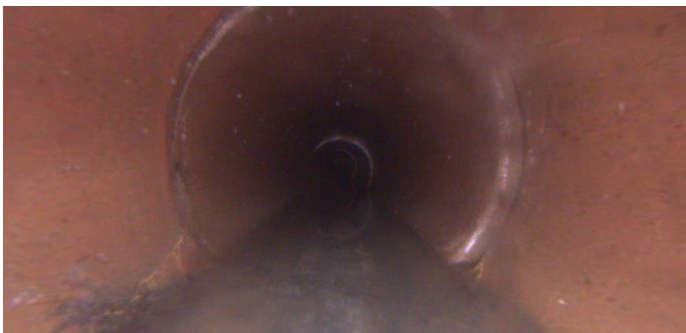
Code: **RFJ**
Description: **Roots Fine Joint**

Distance (ft): **242.9**
Structural Grade: **0**
O&M Grade: **1**
Clock Start/From: **8**
Clock To:
1st Value:
2nd Value:
Value Percent:
Continuous Index:
Within 8" of Joint: **YES**
Remarks:

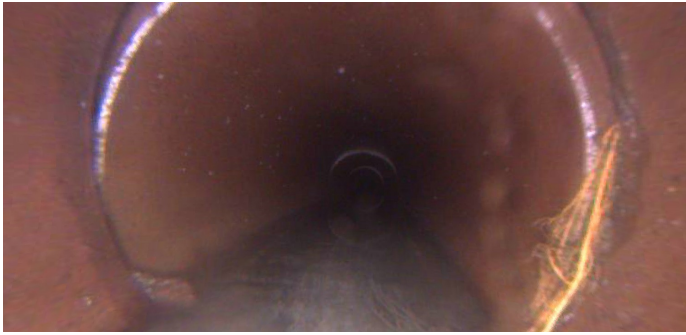
Code: **RFJ**
Description: **Roots Fine Joint**

Distance (ft): **249.2**
Structural Grade: **0**
O&M Grade: **1**
Clock Start/From: **3**
Clock To: **5**
1st Value:
2nd Value:
Value Percent:
Continuous Index:
Within 8" of Joint: **YES**
Remarks:

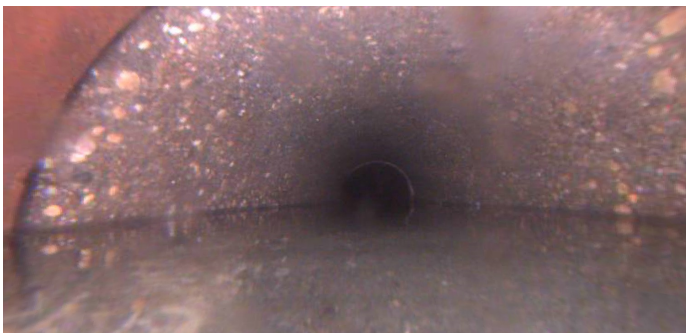
Code: **MWL**
Description: **Water Level**

Distance (ft): **258.4**
Structural Grade: **0**
O&M Grade: **0**
Clock Start/From:
Clock To:
1st Value:
2nd Value:
Value Percent: **40.000**
Continuous Index:
Within 8" of Joint: **NO**
Remarks:

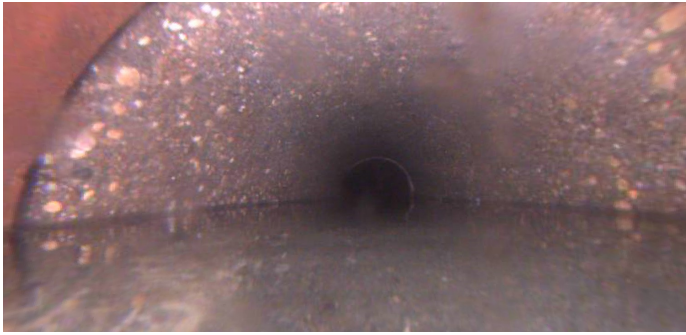
Code: **MMC**
Description: **Material Change**

Distance (ft): **258.4**
Structural Grade: **0**
O&M Grade: **0**
Clock Start/From:
Clock To:
1st Value:
2nd Value:
Value Percent:
Continuous Index:
Within 8" of Joint: **NO**
Remarks: **CP**

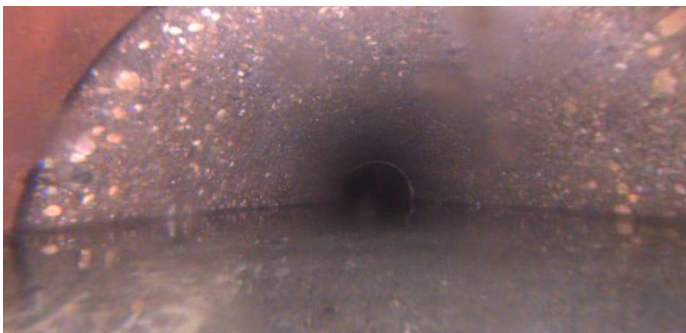
Code: **SAP**
Description: **Surface Aggregate Projecting**

Distance (ft): **258.4**
Structural Grade: **3**
O&M Grade: **0**
Clock Start/From: **8**
Clock To: **4**
1st Value:
2nd Value:
Value Percent:
Continuous Index:
Within 8" of Joint:
Remarks:

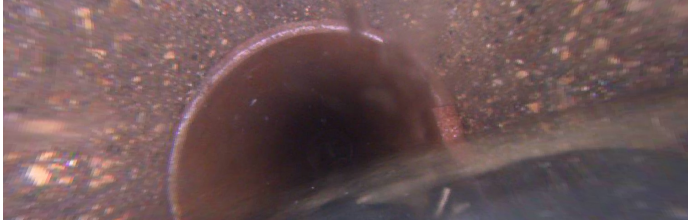
Code:	MSA
Description:	Abandoned Survey
Distance (ft):	261.0
Structural Grade:	0
O&M Grade:	0
Clock Start/From:	
Clock To:	
1st Value:	
2nd Value:	
Value Percent:	
Continuous Index:	
Within 8" of Joint:	NO
Remarks:	camera stopped under water
