Profile/Photo Observation Report

Date:	09/03/2021	Weather:		Coding:	PACP 7.0
Pipe Length (ft):	277.0	Owner:	City of Hobart	Pre Clean:	Light Cleaning
P.O.#:	YES502259	Surveyor:	S. Bucklin	PSR:	P-504-126.1-126
Customer:	City of Hobart	Clean Date:	08/30/2021	Shape:	C

Street:	Old Ridge Road	Flow Control:	Not Controlled
City:	Hobart, IN	Year Renewed:	
Location:	Alley	Tape/Media #:	
Purpose:	Routine Assessment	Dia/Height:	10"
Use:	Sanitary Sewage Pipe	Material:	CP
Drain Area:		Lining:	
Category:	NA		
Comment:			
Location Details:		Direction of Survey:	Downstream
US MH:	M-504-126	DS MH:	M-504-126.1
		Total Length Surveyed (ft):	277.0

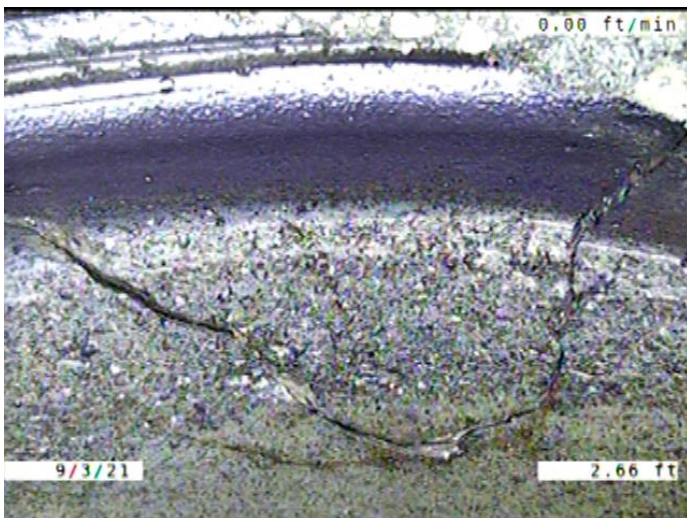
Code: **B**
 Description: **Broken**

Distance (ft): **2.7**
 Structural Grade: **4**
 O&M Grade: **0**
 Clock Start/From: **1**
 Clock To: **3**
 1st Value:
 2nd Value:
 Value Percent:
 Continuous Index:
 Within 8" of Joint: **YES**
 Remarks: **OUTSIDE OF THE JOINT**

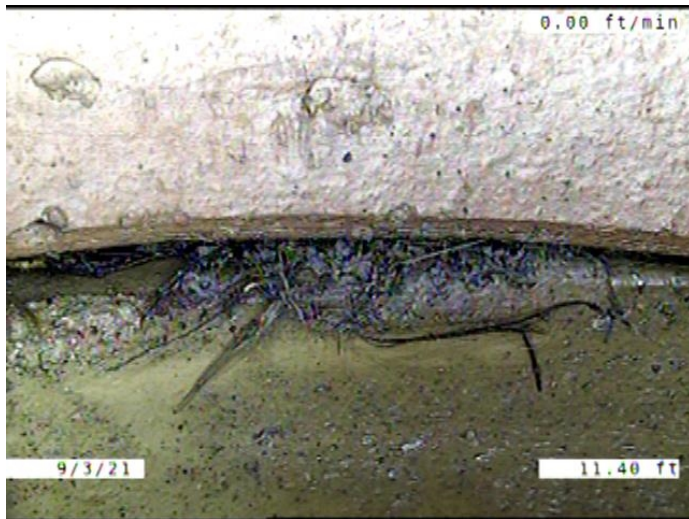
Code: **RFJ**
 Description: **Roots Fine Joint**

Distance (ft): **11.4**
 Structural Grade: **0**
 O&M Grade: **1**
 Clock Start/From: **9**
 Clock To: **10**
 1st Value:
 2nd Value:
 Value Percent:
 Continuous Index:
 Within 8" of Joint: **YES**
 Remarks:

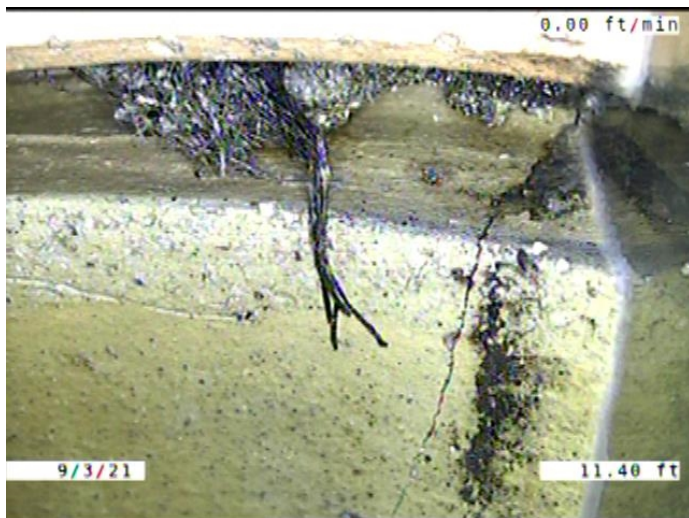
Code: **CL**
 Description: **Crack Longitudinal**

Distance (ft): **11.4**
 Structural Grade: **2**
 O&M Grade: **0**
 Clock Start/From: **3**
 Clock To:
 1st Value:
 2nd Value:
 Value Percent:
 Continuous Index:
 Within 8" of Joint: **YES**
 Remarks:

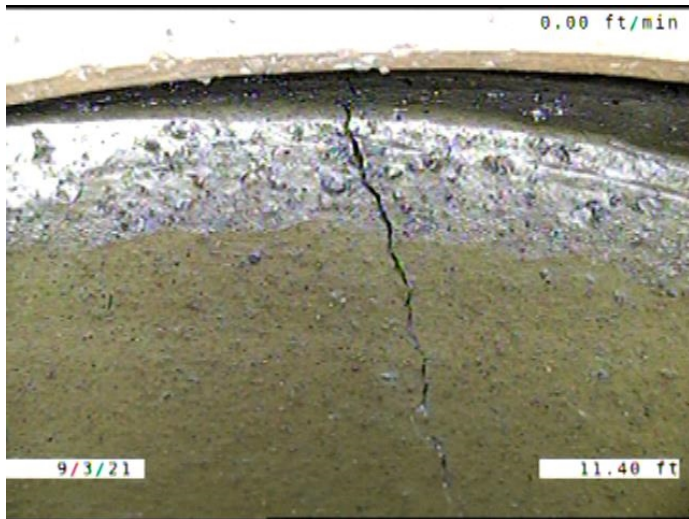
Code: **CL**
 Description: **Crack Longitudinal**

Distance (ft): **11.4**
 Structural Grade: **2**
 O&M Grade: **0**
 Clock Start/From: **12**
 Clock To:
 1st Value:
 2nd Value:
 Value Percent:
 Continuous Index:
 Within 8" of Joint: **YES**
 Remarks:

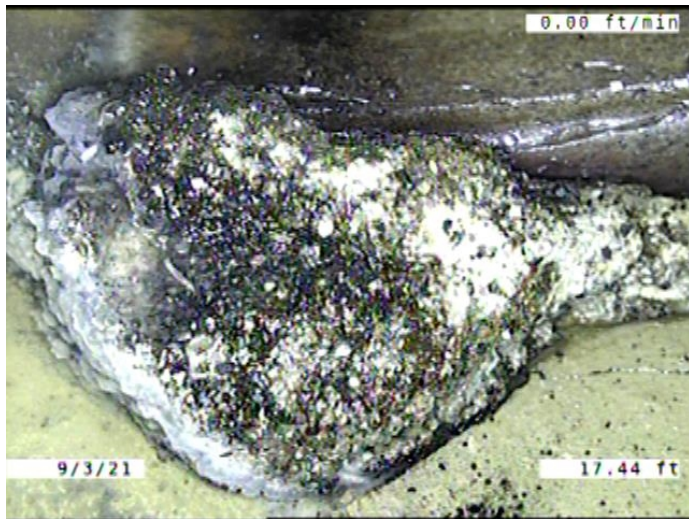
Code: **DAE**
 Description: **Deposits Attached Encrustation**

Distance (ft): **17.4**
 Structural Grade: **0**
 O&M Grade: **2**
 Clock Start/From: **4**
 Clock To: **5**
 1st Value:
 2nd Value:
 Value Percent: **5.000**
 Continuous Index:
 Within 8" of Joint: **YES**
 Remarks:

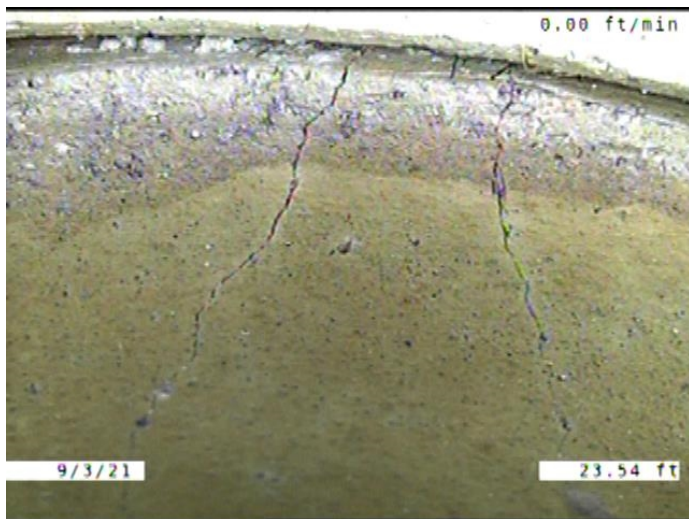
Code: **CM**
Description: **Crack Multiple**

Distance (ft): **23.5**
Structural Grade: **3**
O&M Grade: **0**
Clock Start/From: **9**
Clock To: **1**
1st Value:
2nd Value:
Value Percent:
Continuous Index: **S03**
Within 8" of Joint: **YES**
Remarks:

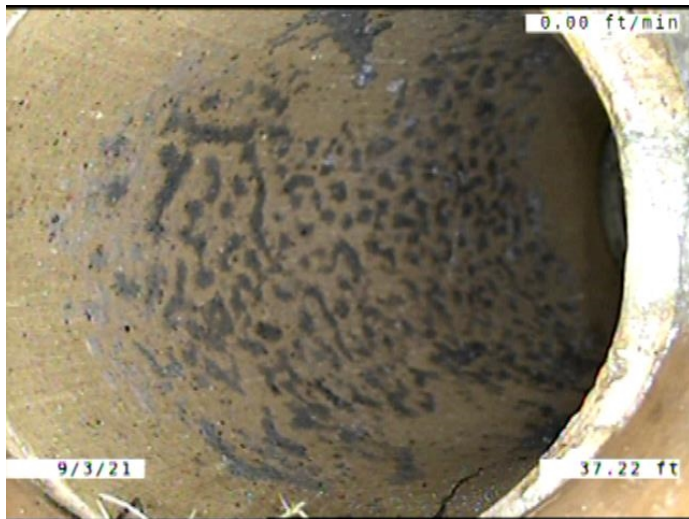
Code: **TBI**
 Description: **Tap Break-in Intruding**

Distance (ft): **37.2**
 Structural Grade: **0**
 O&M Grade: **2**
 Clock Start/From: **1**
 Clock To:
 1st Value: **6.000**
 2nd Value: **1.000**
 Value Percent:
 Continuous Index:
 Within 8" of Joint: **NO**
 Remarks:

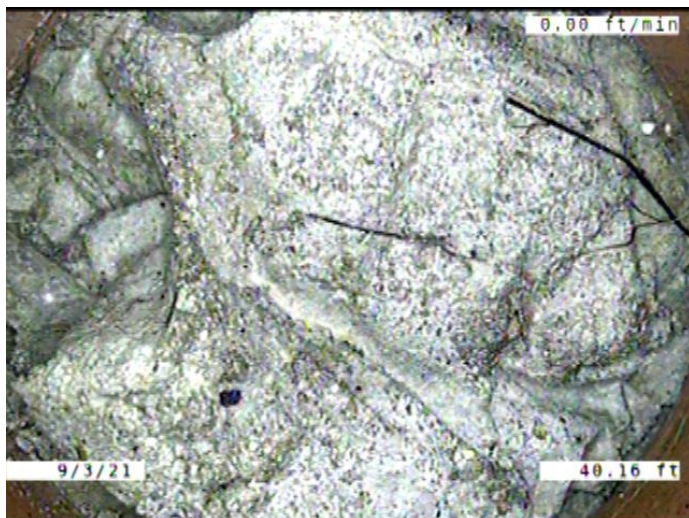
Code: **TBI**
 Description: **Tap Break-in Intruding**

Distance (ft): **40.2**
 Structural Grade: **0**
 O&M Grade: **2**
 Clock Start/From: **11**
 Clock To:
 1st Value: **6.000**
 2nd Value: **1.000**
 Value Percent:
 Continuous Index:
 Within 8" of Joint: **NO**
 Remarks: **LOOKS TO BE PLUGGED OFF**

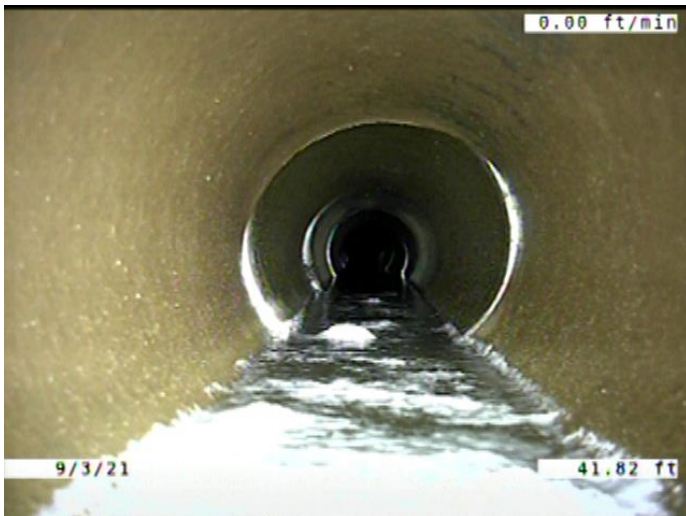
Code:	CM
Description:	Crack Multiple
Distance (ft):	41.8
Structural Grade:	3
O&M Grade:	0
Clock Start/From:	9
Clock To:	1
1st Value:	
2nd Value:	
Value Percent:	
Continuous Index:	F03
Within 8" of Joint:	YES
Remarks:

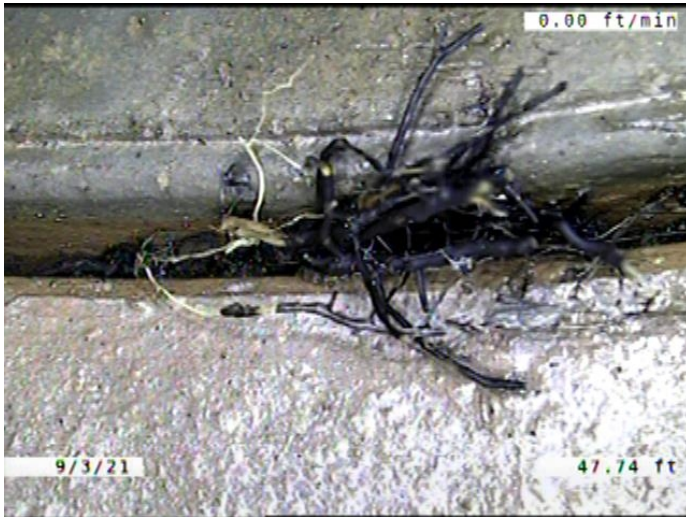
Code: **RFJ**
Description: **Roots Fine Joint**

Distance (ft): **47.7**
Structural Grade: **0**
O&M Grade: **1**
Clock Start/From: **8**
Clock To: **9**
1st Value:
2nd Value:
Value Percent:
Continuous Index:
Within 8" of Joint: **YES**
Remarks:

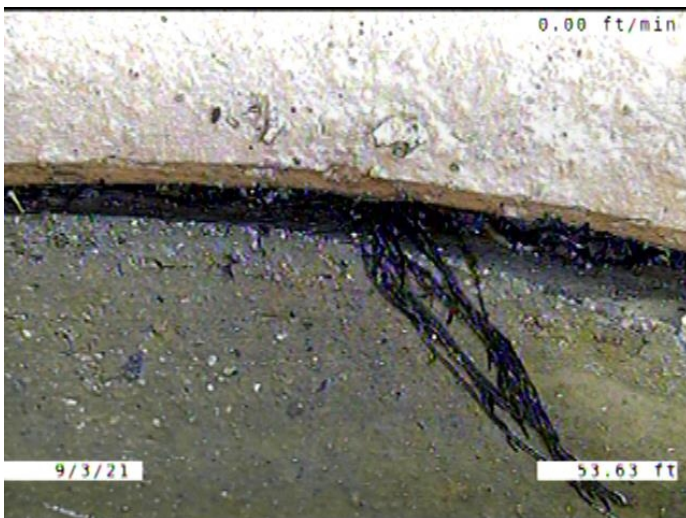
Code: **RFJ**
Description: **Roots Fine Joint**

Distance (ft): **53.6**
Structural Grade: **0**
O&M Grade: **1**
Clock Start/From: **1**
Clock To: **3**
1st Value:
2nd Value:
Value Percent:
Continuous Index:
Within 8" of Joint: **YES**
Remarks:

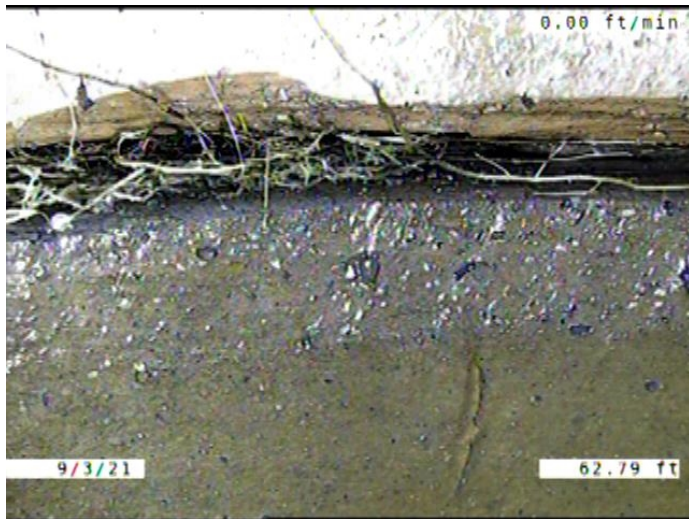
Code: **RFJ**
 Description: **Roots Fine Joint**

Distance (ft): **62.8**
 Structural Grade: **0**
 O&M Grade: **1**
 Clock Start/From: **9**
 Clock To: **3**
 1st Value:
 2nd Value:
 Value Percent:
 Continuous Index:
 Within 8" of Joint: **YES**
 Remarks:

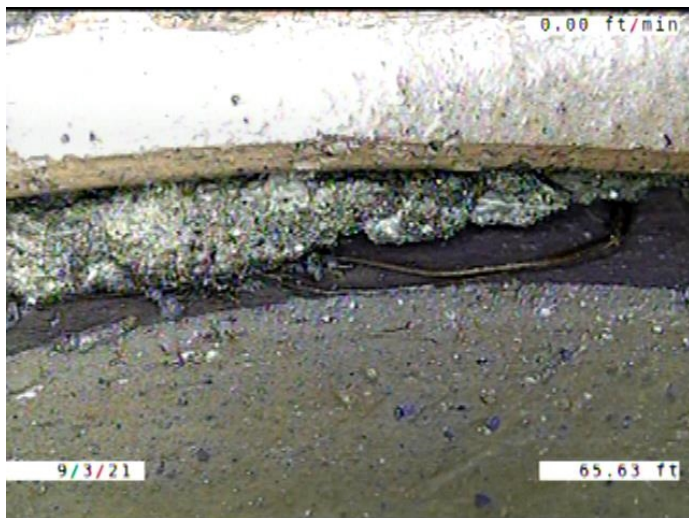
Code: **RFJ**
 Description: **Roots Fine Joint**

Distance (ft): **65.6**
 Structural Grade: **0**
 O&M Grade: **1**
 Clock Start/From: **10**
 Clock To: **11**
 1st Value:
 2nd Value:
 Value Percent:
 Continuous Index:
 Within 8" of Joint: **YES**
 Remarks:

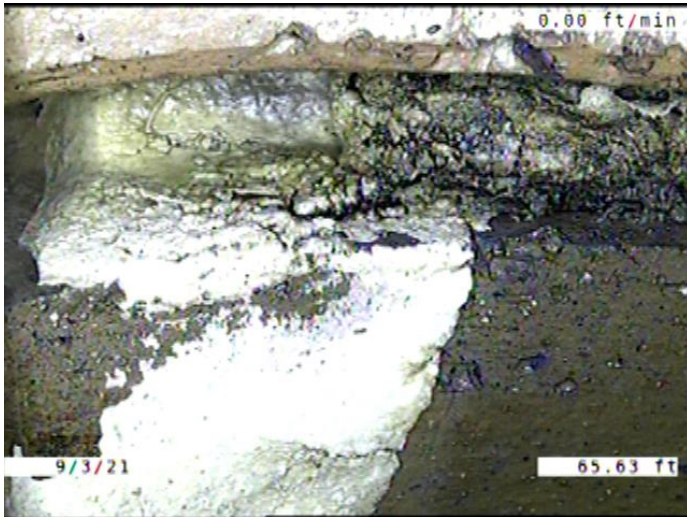
Code: **DAE**
 Description: **Deposits Attached Encrustation**

Distance (ft): **65.6**
 Structural Grade: **0**
 O&M Grade: **2**
 Clock Start/From: **9**
 Clock To: **11**
 1st Value:
 2nd Value:
 Value Percent: **5.000**
 Continuous Index:
 Within 8" of Joint: **YES**
 Remarks:

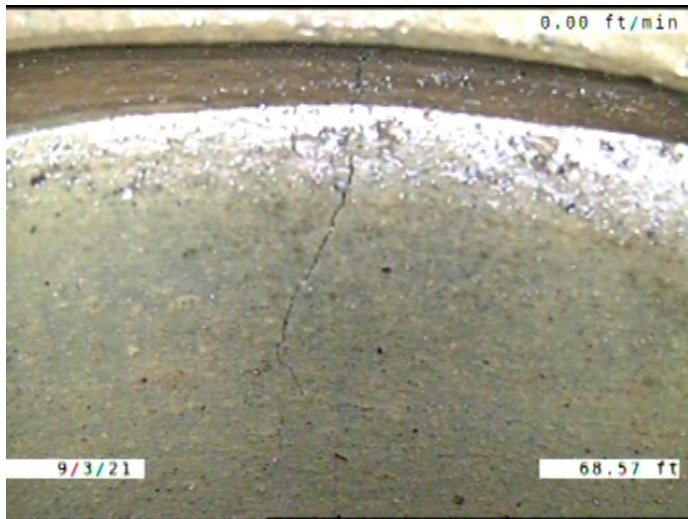
Code: **CM**
 Description: **Crack Multiple**

Distance (ft): **68.6**
 Structural Grade: **3**
 O&M Grade: **0**
 Clock Start/From: **10**
 Clock To: **2**
 1st Value:
 2nd Value:
 Value Percent:
 Continuous Index:
 Within 8" of Joint: **YES**
 Remarks:

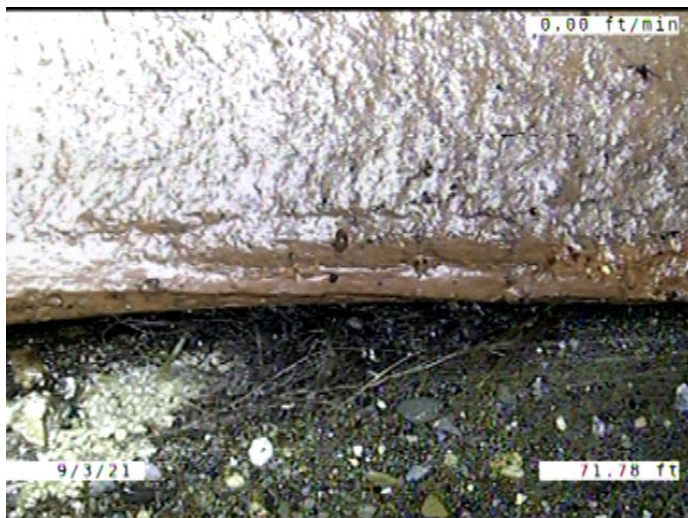
Code: **RFJ**
 Description: **Roots Fine Joint**

Distance (ft): **71.8**
 Structural Grade: **0**
 O&M Grade: **1**
 Clock Start/From: **9**
 Clock To: **10**
 1st Value:
 2nd Value:
 Value Percent:
 Continuous Index:
 Within 8" of Joint: **YES**
 Remarks:

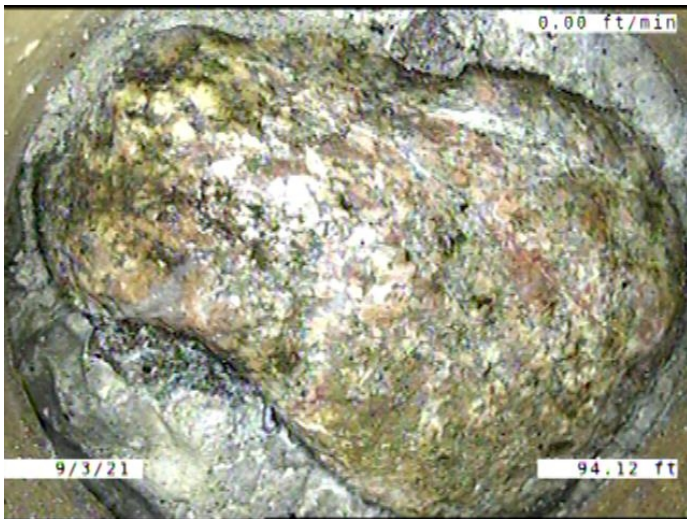
Code: **TBI**
Description: **Tap Break-in Intruding**

Distance (ft): **94.1**
Structural Grade: **0**
O&M Grade: **2**
Clock Start/From: **11**
Clock To:
1st Value: **6.000**
2nd Value: **1.000**
Value Percent:
Continuous Index:
Within 8" of Joint: **NO**
Remarks: **ROCK BLOCKING THE TAP**

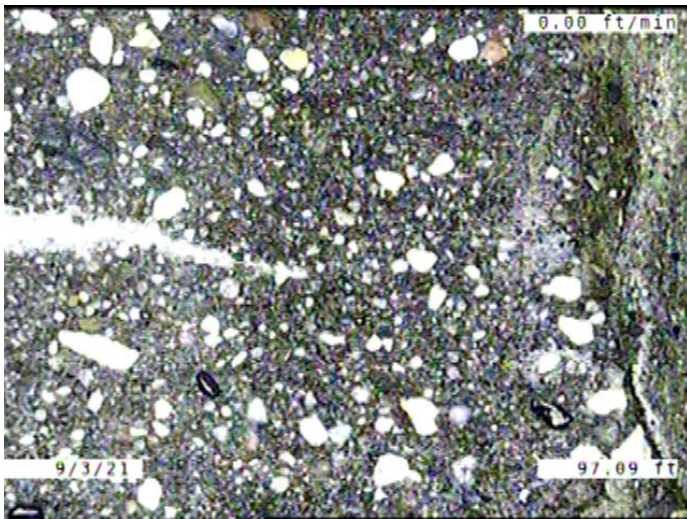
Code: **FC**
 Description: **Fracture Circumferential**

Distance (ft): **97.1**
 Structural Grade: **2**
 O&M Grade: **0**
 Clock Start/From: **9**
 Clock To: **2**
 1st Value:
 2nd Value:
 Value Percent:
 Continuous Index:
 Within 8" of Joint: **NO**
 Remarks:

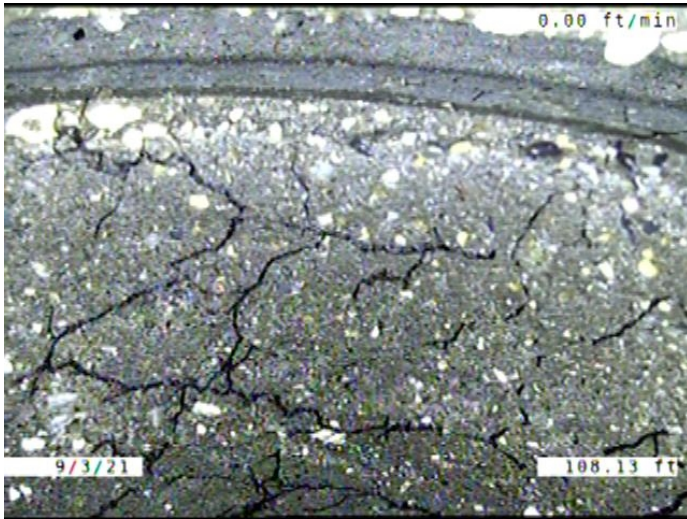
Code: **RFJ**
 Description: **Roots Fine Joint**

Distance (ft): **108.1**
 Structural Grade: **0**
 O&M Grade: **1**
 Clock Start/From: **10**
 Clock To: **3**
 1st Value:
 2nd Value:
 Value Percent:
 Continuous Index:
 Within 8" of Joint: **YES**
 Remarks:

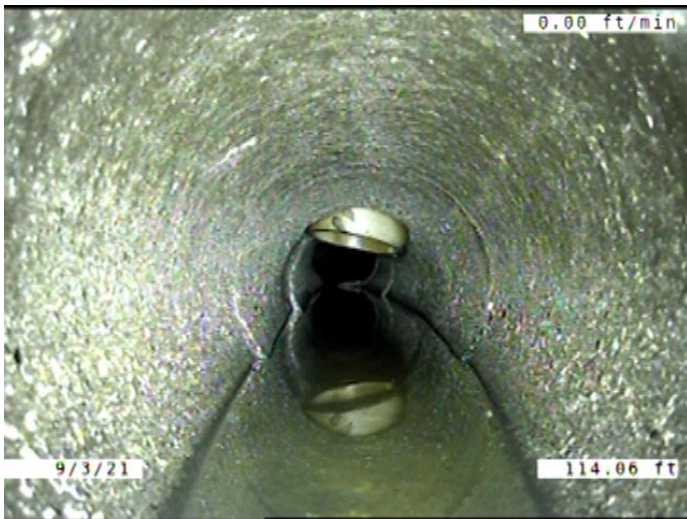
Code: **MWLS**
 Description: **Miscellaneous Water Level Sag**

Distance (ft): **114.1**
 Structural Grade: **2**
 O&M Grade: **0**
 Clock Start/From:
 Clock To:
 1st Value:
 2nd Value:
 Value Percent: **10.000**
 Continuous Index: **S04**
 Within 8" of Joint: **NO**
 Remarks:

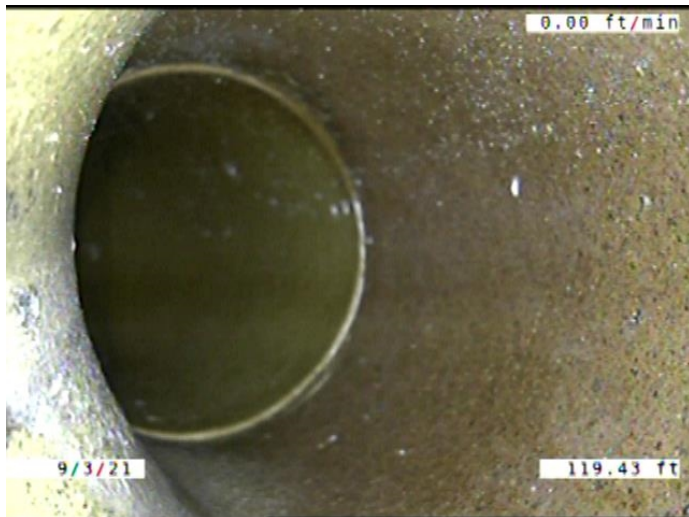
Code: **TBI**
 Description: **Tap Break-in Intruding**

Distance (ft): **119.4**
 Structural Grade: **0**
 O&M Grade: **2**
 Clock Start/From: **12**
 Clock To:
 1st Value: **6.000**
 2nd Value: **3.000**
 Value Percent:
 Continuous Index:
 Within 8" of Joint: **NO**
 Remarks:

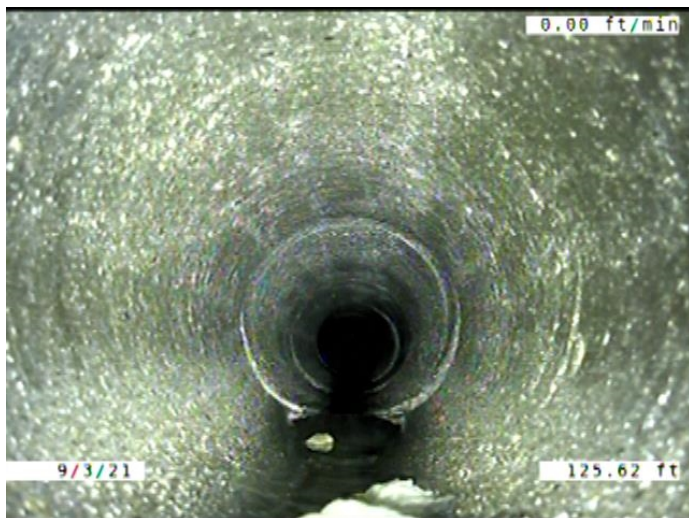
Code: **MWLS**
 Description: **Miscellaneous Water Level Sag**

Distance (ft): **125.6**
 Structural Grade: **2**
 O&M Grade: **0**
 Clock Start/From:
 Clock To:
 1st Value:
 2nd Value:
 Value Percent: **10.000**
 Continuous Index: **F04**
 Within 8" of Joint: **NO**
 Remarks:

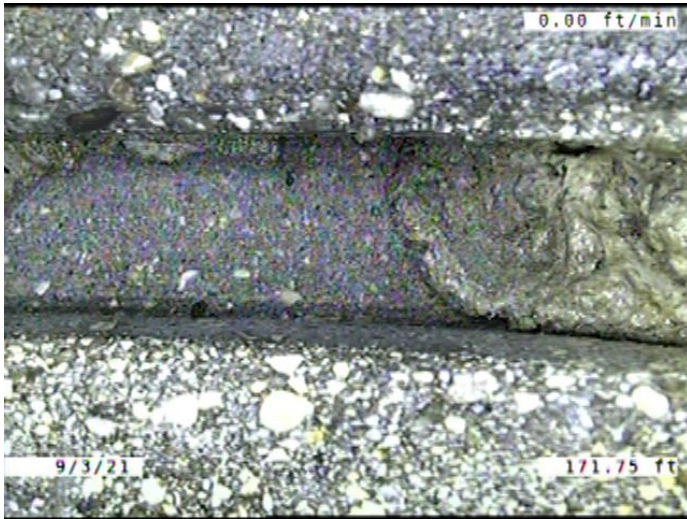
Code: **JAM**
Description: **Joint Angular Medium**

Distance (ft): **171.8**
Structural Grade: **3**
O&M Grade: **0**
Clock Start/From:
Clock To:
1st Value:
2nd Value:
Value Percent:
Continuous Index:
Within 8" of Joint: **NO**
Remarks:

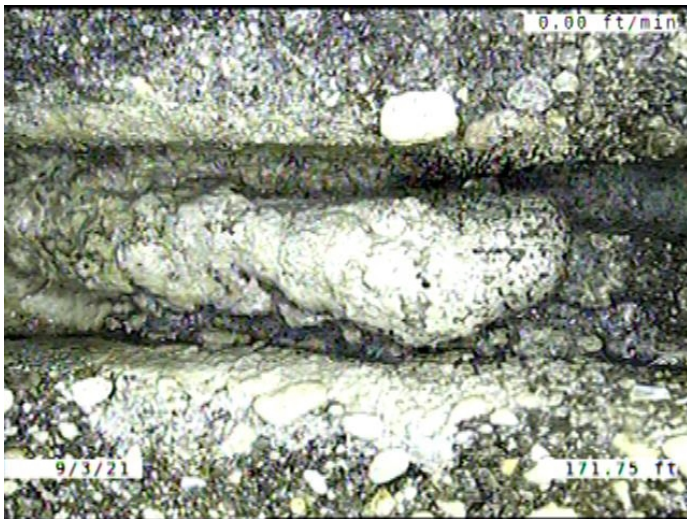
Code: **DAE**
Description: **Deposits Attached Encrustation**

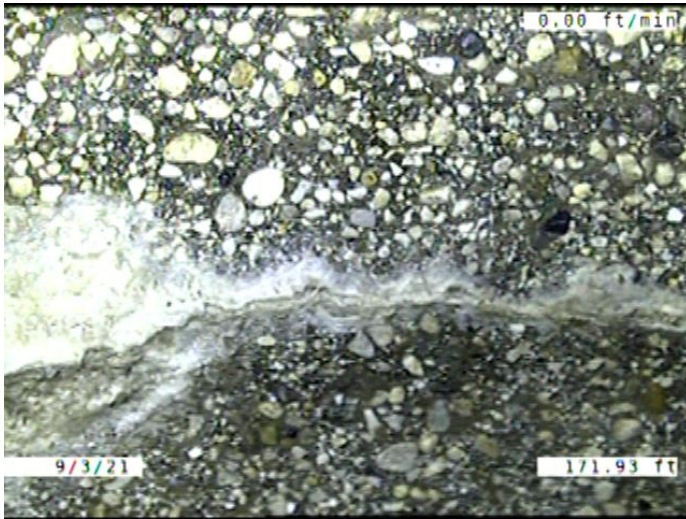
Code: **CM**
 Description: **Crack Multiple**

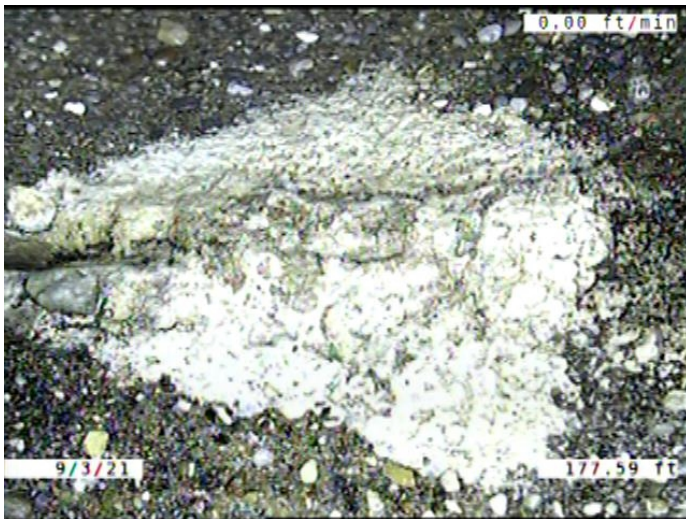
Code: **DAE**
 Description: **Deposits Attached Encrustation**

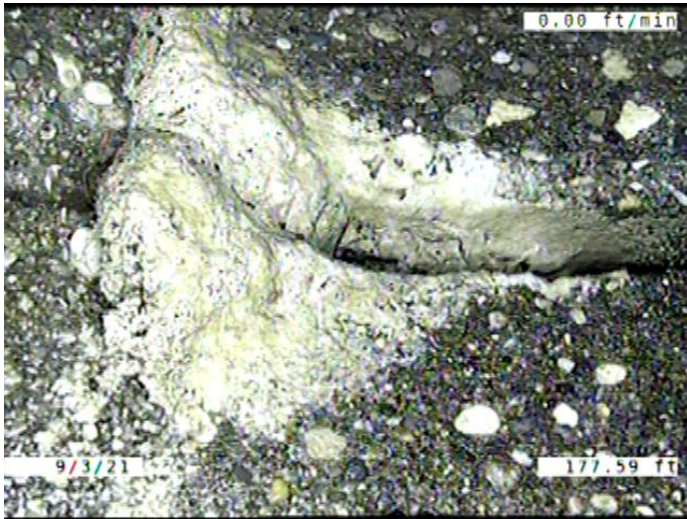
Code: **DAE**
Description: **Deposits Attached Encrustation**

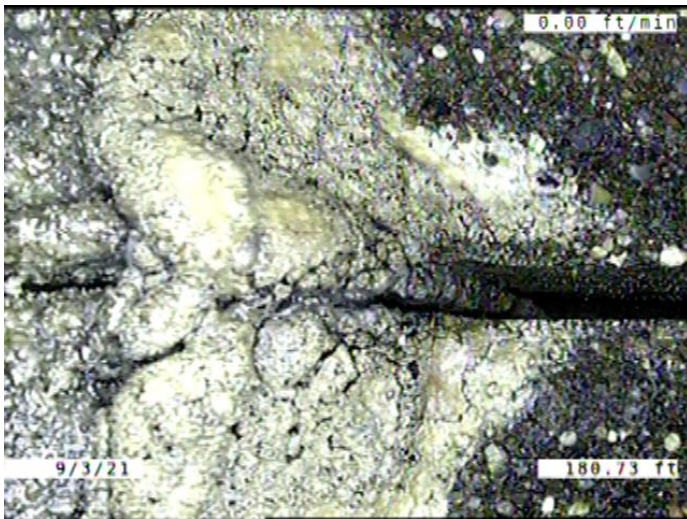
Code: **DAE**
Description: **Deposits Attached Encrustation**

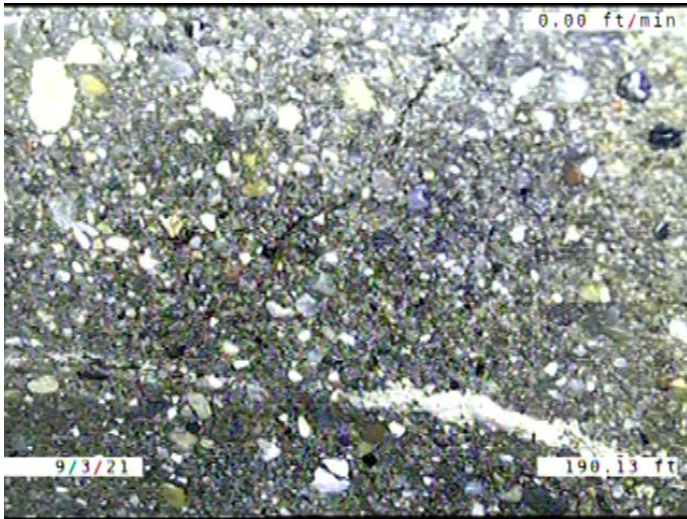
Code: **CM**
 Description: **Crack Multiple**

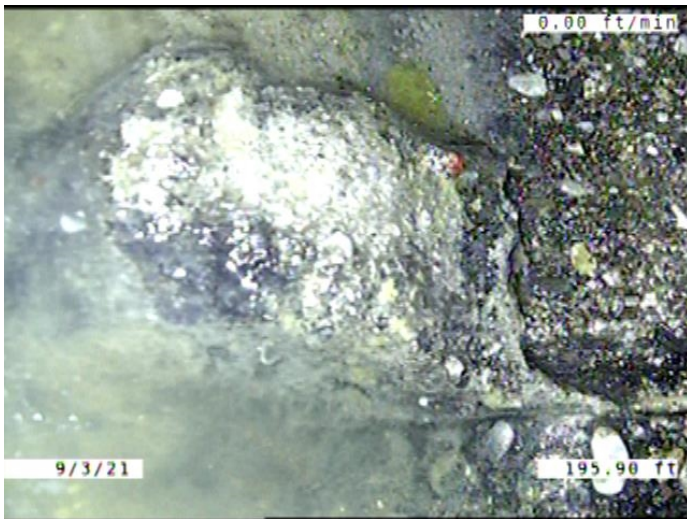
Code: **DAE**
 Description: **Deposits Attached Encrustation**

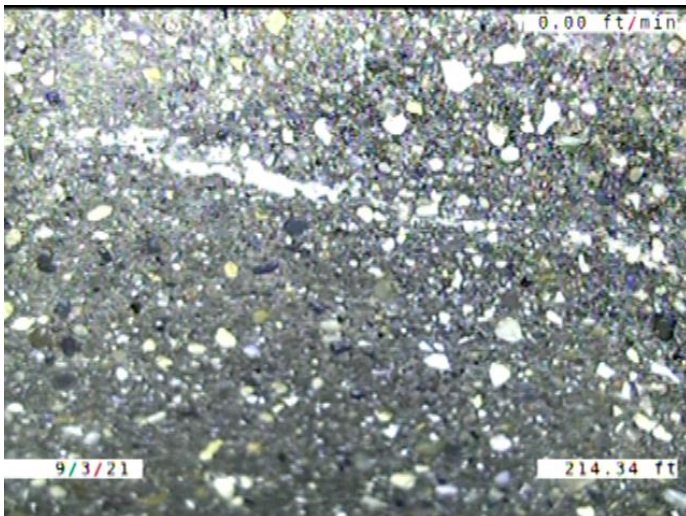
Code: **CS**
 Description: **Crack Spiral**

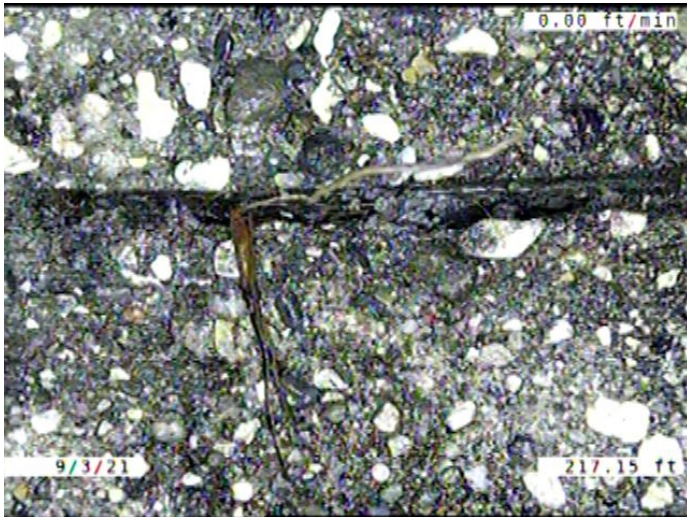
Code: **RFJ**
 Description: **Roots Fine Joint**

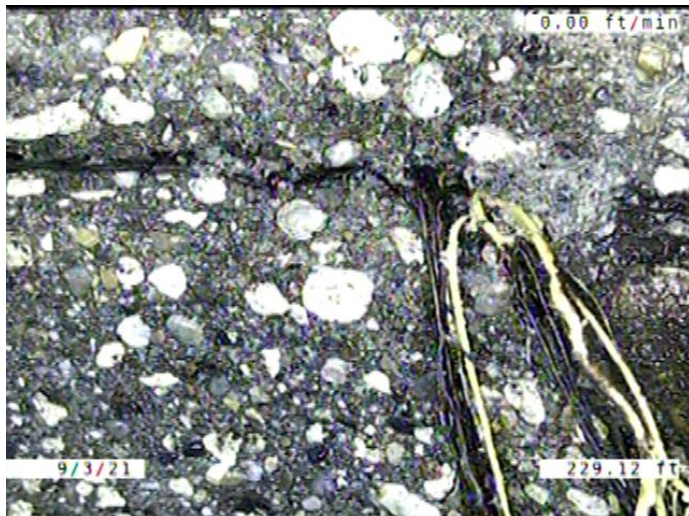
Code: **RFJ**
 Description: **Roots Fine Joint**

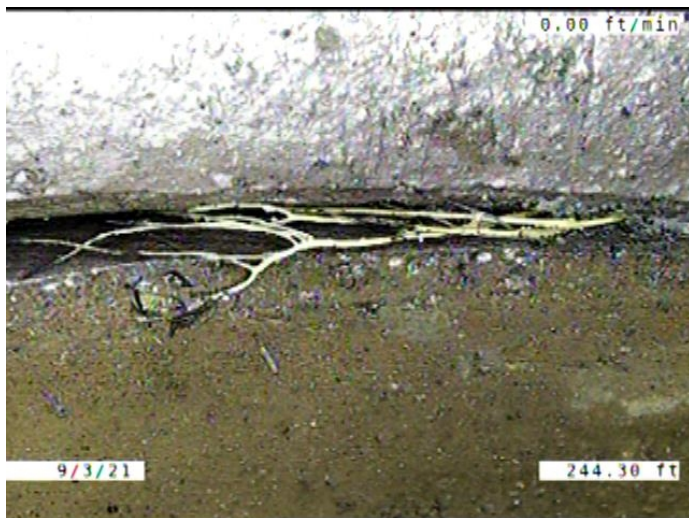
Code: **RFJ**
Description: **Roots Fine Joint**

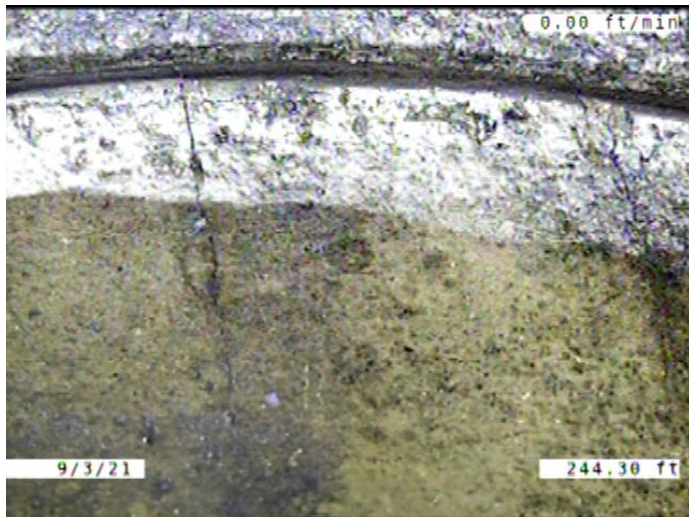
Code: **CM**
 Description: **Crack Multiple**

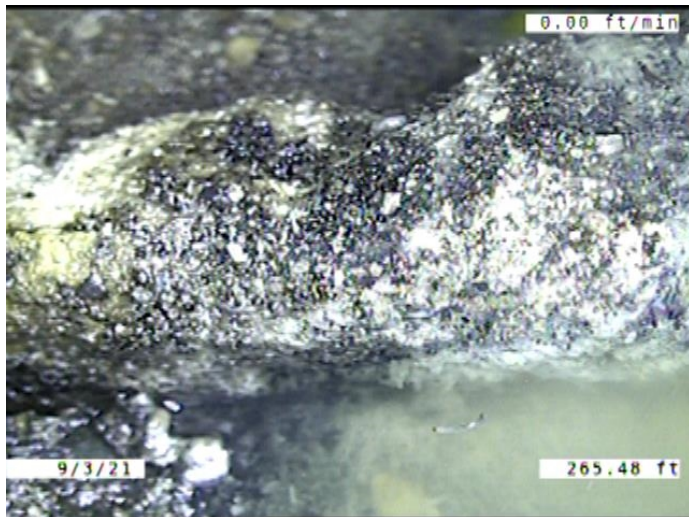
Code: **DAE**
 Description: **Deposits Attached Encrustation**

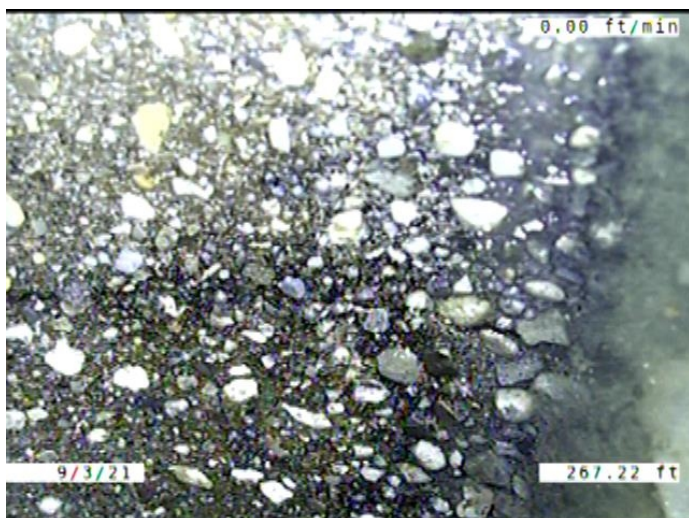
Code: **CM**
 Description: **Crack Multiple**

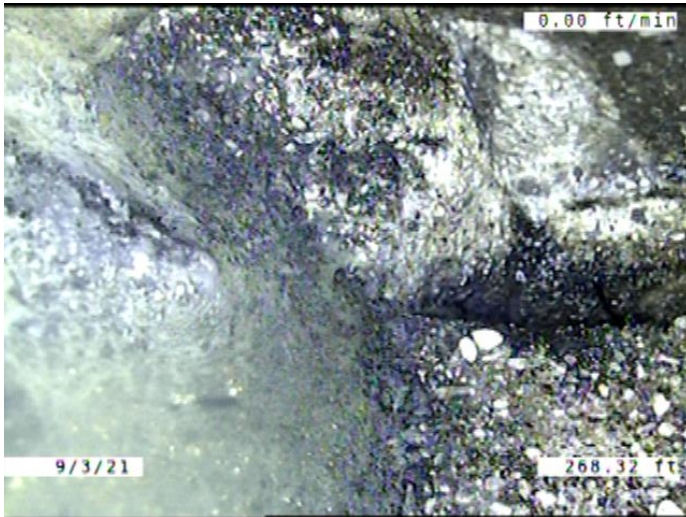
Code: **DAE**
 Description: **Deposits Attached Encrustation**

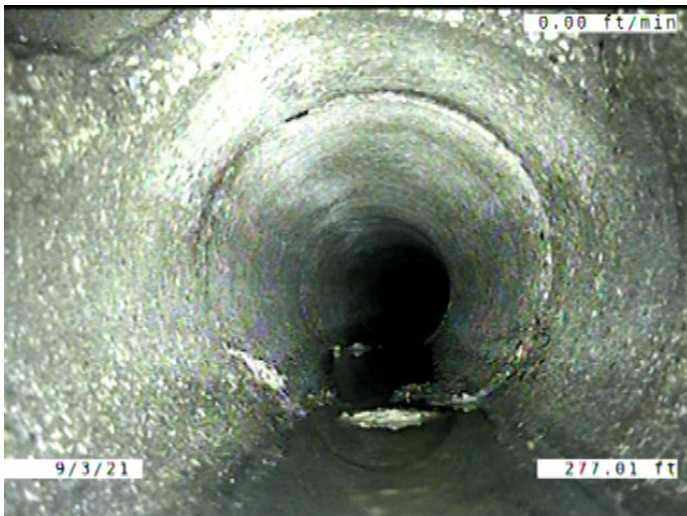
Code: **DSF**
Description: **Deposits Settled Fine**
