# Profile/Photo Observation Report

Date:	09/03/2021	Weather:		Coding:	PACP 7.0
Pipe Length (ft):	277.0	Owner:	City of Hobart	Pre Clean:	Light Cleaning
P.O.#:	YES502259	Surveyor:	S. Bucklin	PSR:	P-504-126.1-126
Customer:	City of Hobart	Clean Date:	08/30/2021	Shape:	C

Street:	Old Ridge Road	Flow Control:	Not Controlled
City:	Hobart, IN	Year Renewed:	
Location:	Alley	Tape/Media #:	
Purpose:	Routine Assessment	Dia/Height:	10"
Use:	Sanitary Sewage Pipe	Material:	CP
Drain Area:		Lining:	
Category:	NA		
Comment:			
Location Details:		Direction of Survey:	Downstream
US MH:	M-504-126	DS MH:	M-504-126.1
		Total Length Surveyed (ft):	277.0

O&M Index:	1.79	O&M Quick:	312N	O&M Rating:	184.00
Structural Index:	2.85	Structural Quick:	5243	Structural Rating:	94.00
Overall Index:	2.04	Overall Quick:	5243	Overall Rating:	278.00

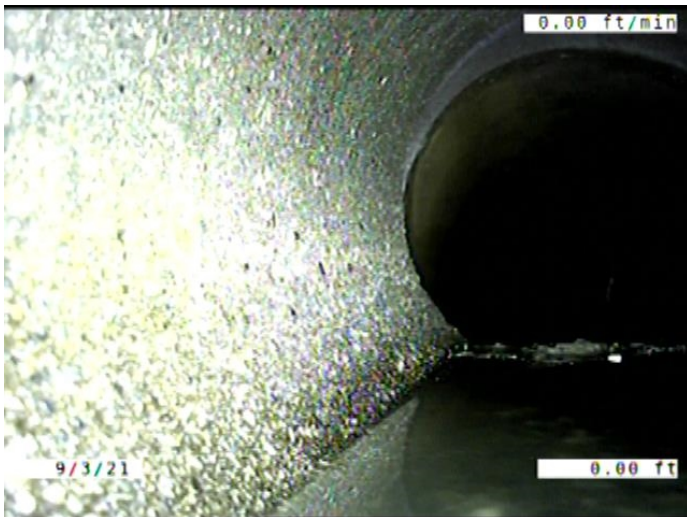
Code: **MWL**  
Description: **Miscellaneous Water Level**

Distance (ft): **.0**  
Structural Grade: **0**  
O&M Grade: **0**  
Clock Start/From:  
Clock To:  
1st Value:  
2nd Value:  
Value Percent: **5.000**  
Continuous Index:  
Within 8" of Joint: **NO**  
Remarks:

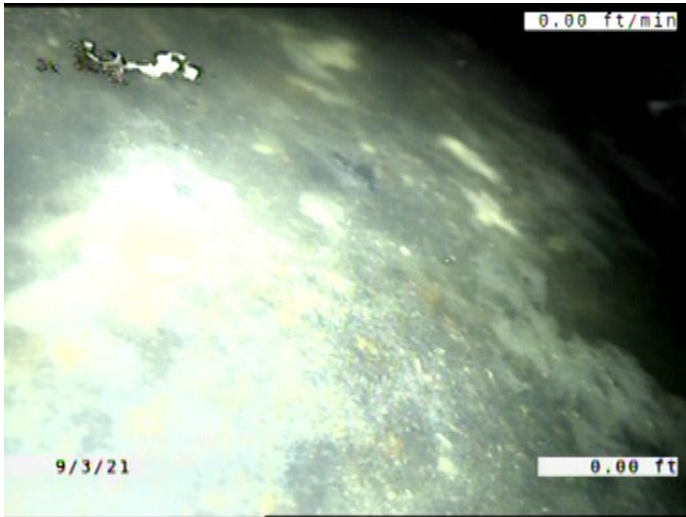
Code: **DSF**  
 Description: **Deposits Settled Fine**

Distance (ft): **.0**  
 Structural Grade: **0**  
 O&M Grade: **2**  
 Clock Start/From: **5**  
 Clock To: **7**  
 1st Value:  
 2nd Value:  
 Value Percent: **5.000**  
 Continuous Index: **S01**  
 Within 8" of Joint: **YES**  
 Remarks:

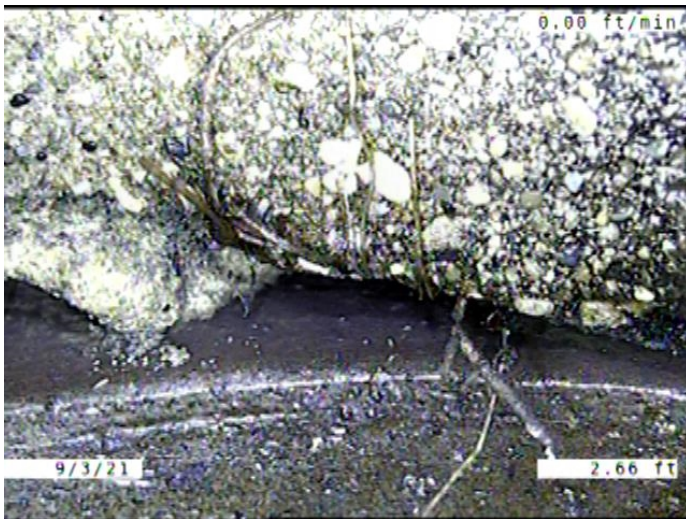
Code: **RFJ**  
 Description: **Roots Fine Joint**

Distance (ft): **2.7**  
 Structural Grade: **0**  
 O&M Grade: **1**  
 Clock Start/From: **3**  
 Clock To: **4**  
 1st Value:  
 2nd Value:  
 Value Percent:  
 Continuous Index:  
 Within 8" of Joint: **YES**  
 Remarks:

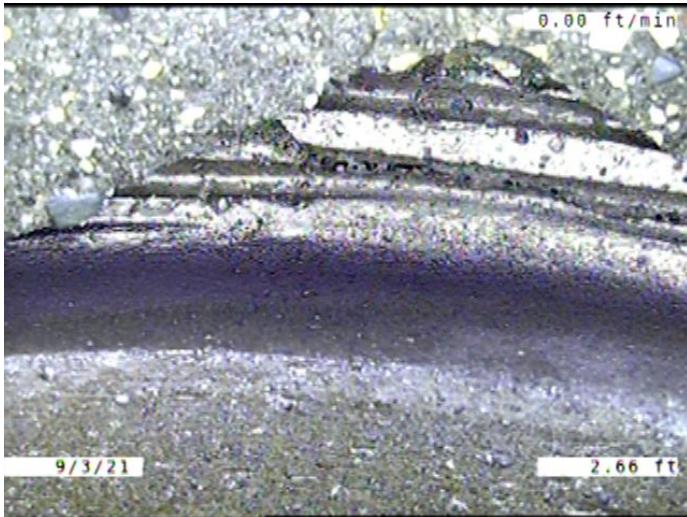
Code: **SMW**  
 Description: **Surface Damage Missing Wall**

Distance (ft): **2.7**  
 Structural Grade: **5**  
 O&M Grade: **0**  
 Clock Start/From: **10**  
 Clock To: **2**  
 1st Value:  
 2nd Value:  
 Value Percent:  
 Continuous Index:  
 Within 8" of Joint: **YES**  
 Remarks: **INSIDE OF THE JOINT**

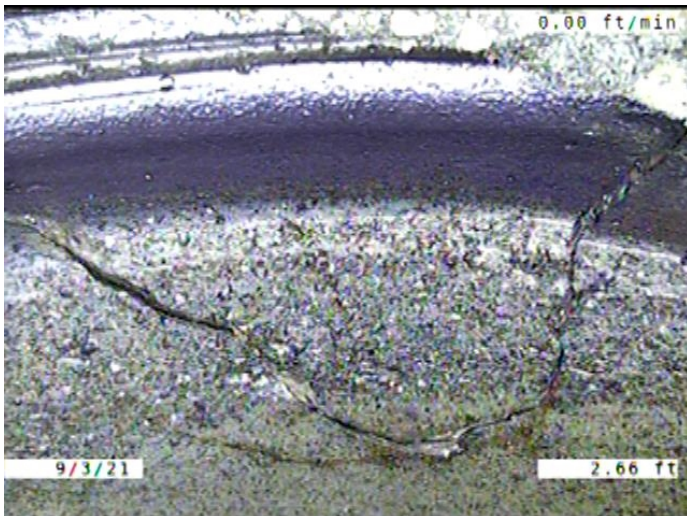
Code: **B**  
 Description: **Broken**

Distance (ft): **2.7**  
 Structural Grade: **4**  
 O&M Grade: **0**  
 Clock Start/From: **1**  
 Clock To: **3**  
 1st Value:  
 2nd Value:  
 Value Percent:  
 Continuous Index:  
 Within 8" of Joint: **YES**  
 Remarks: **OUTSIDE OF THE JOINT**

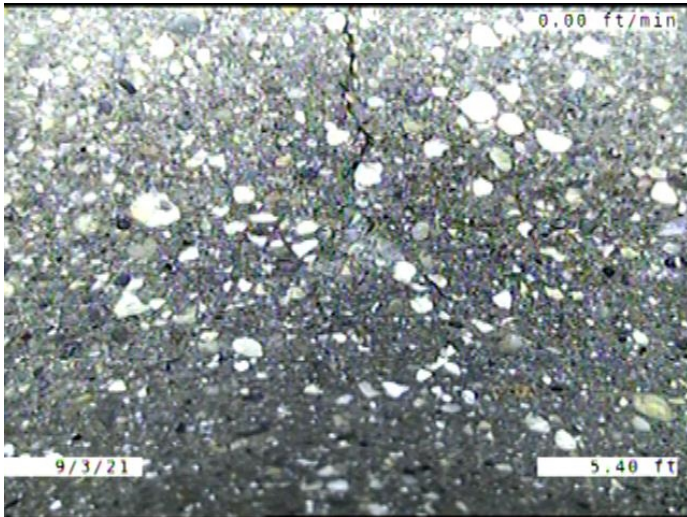
Code: **FM**  
 Description: **Fracture Multiple**

Distance (ft): **5.4**  
 Structural Grade: **4**  
 O&M Grade: **0**  
 Clock Start/From: **9**  
 Clock To: **3**  
 1st Value:  
 2nd Value:  
 Value Percent:  
 Continuous Index:  
 Within 8" of Joint: **YES**  
 Remarks:

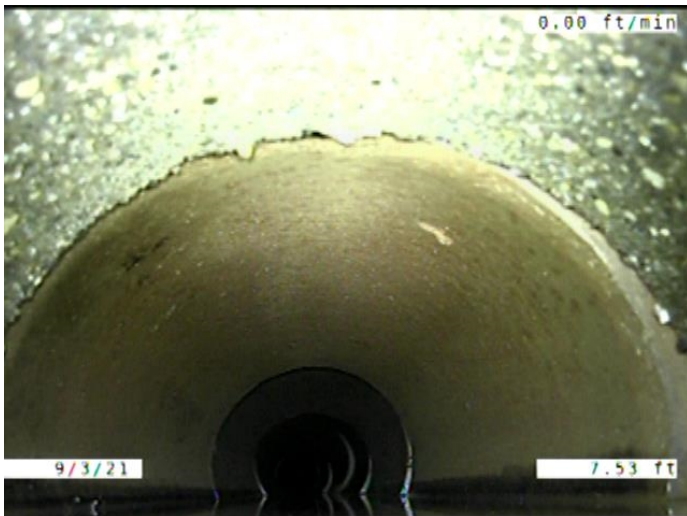
Code: **MWLS**  
 Description: **Miscellaneous Water Level Sag**

Distance (ft): **7.5**  
 Structural Grade: **2**  
 O&M Grade: **0**  
 Clock Start/From:  
 Clock To:  
 1st Value:  
 2nd Value:  
 Value Percent: **15.000**  
 Continuous Index: **S02**  
 Within 8" of Joint: **NO**  
 Remarks:

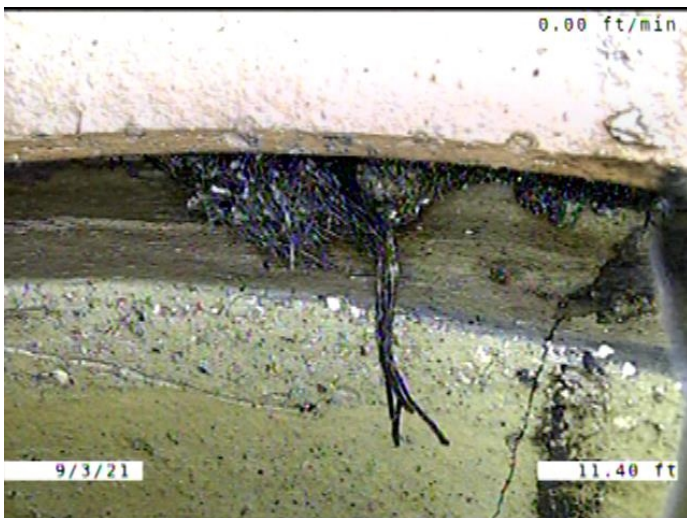
Code: **RFJ**  
 Description: **Roots Fine Joint**

Distance (ft): **11.4**  
 Structural Grade: **0**  
 O&M Grade: **1**  
 Clock Start/From: **9**  
 Clock To: **10**  
 1st Value:  
 2nd Value:  
 Value Percent:  
 Continuous Index:  
 Within 8" of Joint: **YES**  
 Remarks:

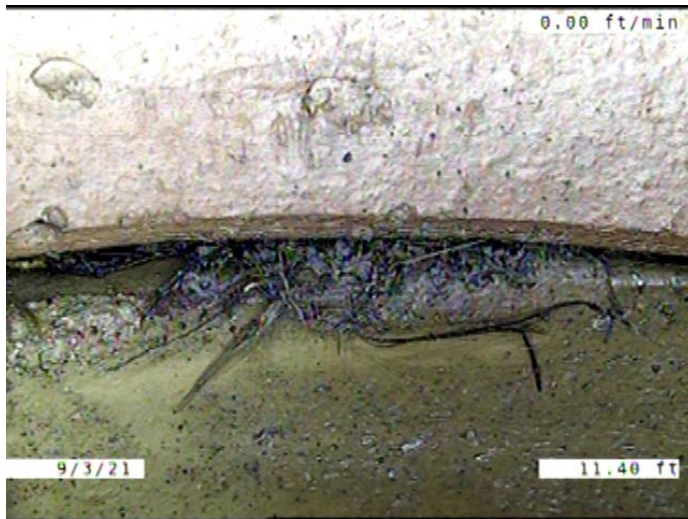
Code: **CL**  
 Description: **Crack Longitudinal**

Distance (ft): **11.4**  
 Structural Grade: **2**  
 O&M Grade: **0**  
 Clock Start/From: **3**  
 Clock To:  
 1st Value:  
 2nd Value:  
 Value Percent:  
 Continuous Index:  
 Within 8" of Joint: **YES**  
 Remarks:

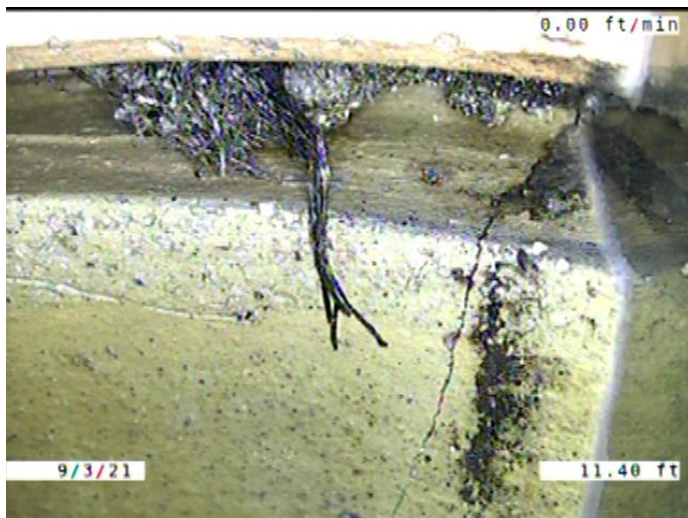
Code: **CL**  
 Description: **Crack Longitudinal**

Distance (ft): **11.4**  
 Structural Grade: **2**  
 O&M Grade: **0**  
 Clock Start/From: **12**  
 Clock To:  
 1st Value:  
 2nd Value:  
 Value Percent:  
 Continuous Index:  
 Within 8" of Joint: **YES**  
 Remarks:

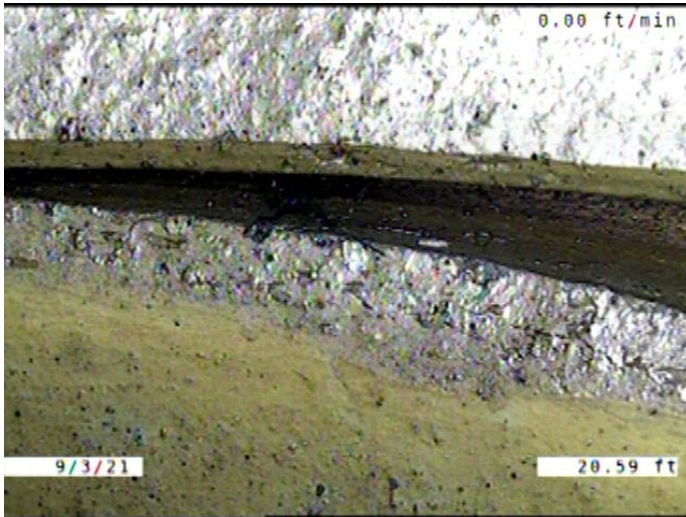
Code: **CM**  
 Description: **Crack Multiple**

Distance (ft): **20.6**  
 Structural Grade: **3**  
 O&M Grade: **0**  
 Clock Start/From: **7**  
 Clock To: **11**  
 1st Value:  
 2nd Value:  
 Value Percent:  
 Continuous Index:  
 Within 8" of Joint: **YES**  
 Remarks:

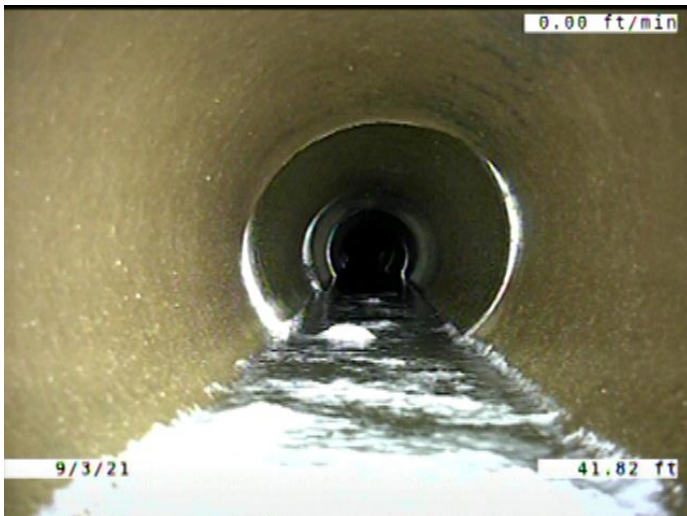
Code: **CM**  
 Description: **Crack Multiple**

Distance (ft): **41.8**  
 Structural Grade: **3**  
 O&M Grade: **0**  
 Clock Start/From: **9**  
 Clock To: **1**  
 1st Value:  
 2nd Value:  
 Value Percent:  
 Continuous Index: **F03**  
 Within 8" of Joint: **YES**  
 Remarks:

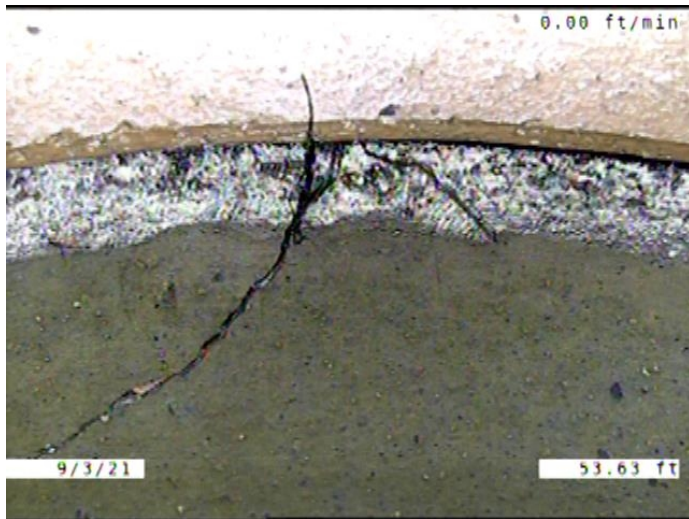
Code: **CM**  
 Description: **Crack Multiple**

Distance (ft): **53.6**  
 Structural Grade: **3**  
 O&M Grade: **0**  
 Clock Start/From: **8**  
 Clock To: **11**  
 1st Value:  
 2nd Value:  
 Value Percent:  
 Continuous Index:  
 Within 8" of Joint: **YES**  
 Remarks:

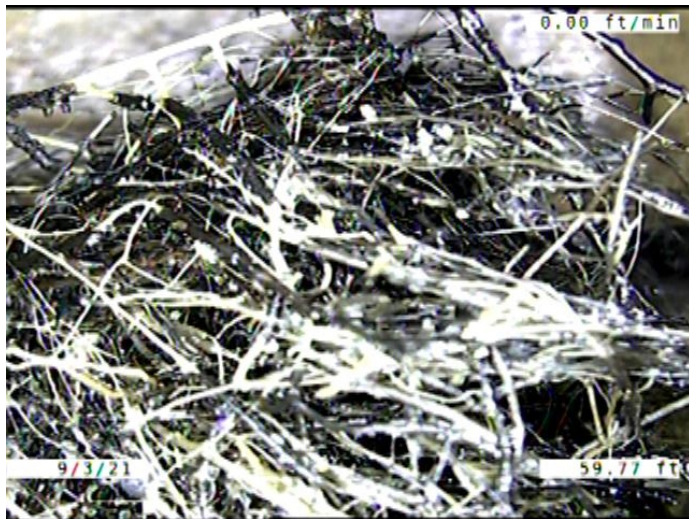
Code: **RMJ**  
 Description: **Roots Medium Joint**

Distance (ft): **59.8**  
 Structural Grade: **0**  
 O&M Grade: **3**  
 Clock Start/From: **9**  
 Clock To: **4**  
 1st Value:  
 2nd Value:  
 Value Percent: **5.000**  
 Continuous Index:  
 Within 8" of Joint: **YES**  
 Remarks:

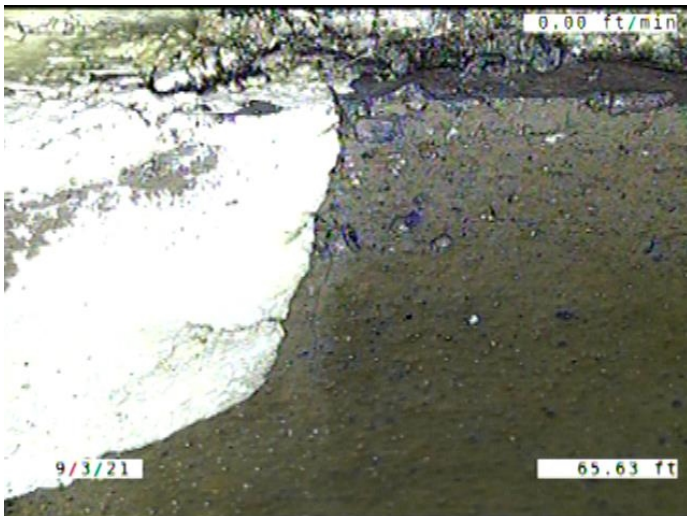
Code: **CL**  
 Description: **Crack Longitudinal**

Distance (ft): **65.6**  
 Structural Grade: **2**  
 O&M Grade: **0**  
 Clock Start/From: **9**  
 Clock To:  
 1st Value:  
 2nd Value:  
 Value Percent:  
 Continuous Index:  
 Within 8" of Joint: **YES**  
 Remarks:

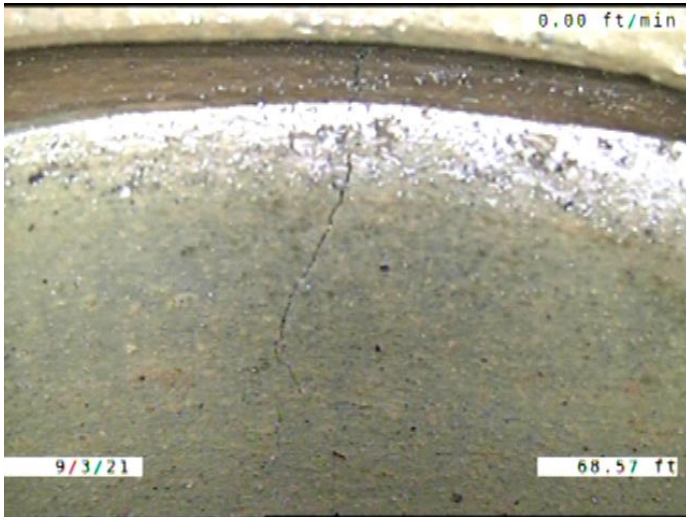
Code: **CM**  
 Description: **Crack Multiple**

Distance (ft): **68.6**  
 Structural Grade: **3**  
 O&M Grade: **0**  
 Clock Start/From: **10**  
 Clock To: **2**  
 1st Value:  
 2nd Value:  
 Value Percent:  
 Continuous Index:  
 Within 8" of Joint: **YES**  
 Remarks:

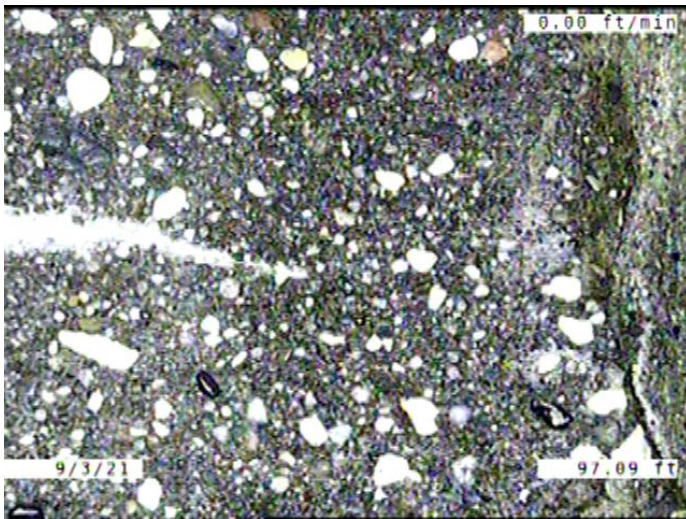
Code: **FC**  
 Description: **Fracture Circumferential**

Distance (ft): **97.1**  
 Structural Grade: **2**  
 O&M Grade: **0**  
 Clock Start/From: **9**  
 Clock To: **2**  
 1st Value:  
 2nd Value:  
 Value Percent:  
 Continuous Index:  
 Within 8" of Joint: **NO**  
 Remarks:

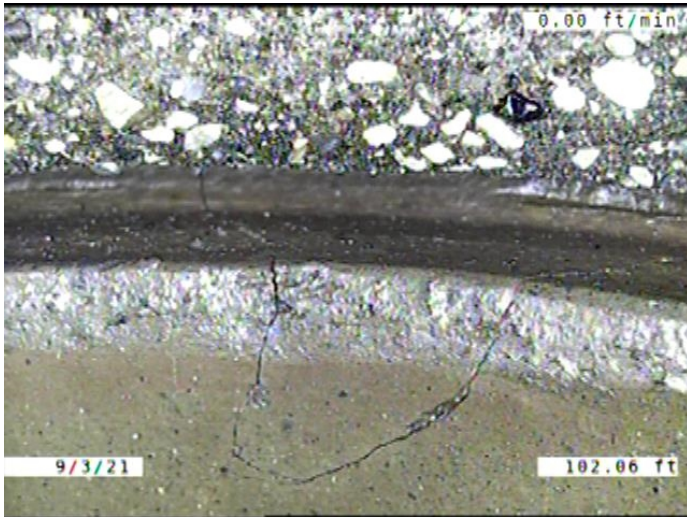
Code: **CM**  
 Description: **Crack Multiple**

Distance (ft): **102.1**  
 Structural Grade: **3**  
 O&M Grade: **0**  
 Clock Start/From: **12**  
 Clock To: **3**  
 1st Value:  
 2nd Value:  
 Value Percent:  
 Continuous Index:  
 Within 8" of Joint: **YES**  
 Remarks:

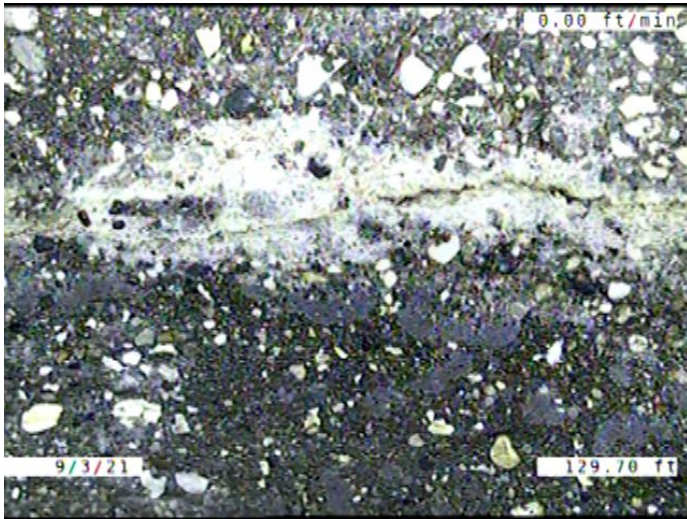
Code: **CM**  
 Description: **Crack Multiple**

Distance (ft): **129.7**  
 Structural Grade: **3**  
 O&M Grade: **0**  
 Clock Start/From: **12**  
 Clock To: **12**  
 1st Value:  
 2nd Value:  
 Value Percent:  
 Continuous Index:  
 Within 8" of Joint: **NO**  
 Remarks:

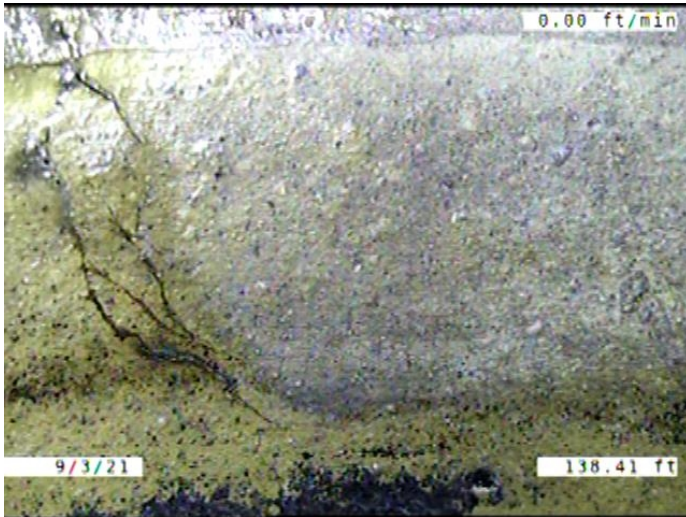
Code: **CM**  
 Description: **Crack Multiple**

Distance (ft): **138.4**  
 Structural Grade: **3**  
 O&M Grade: **0**  
 Clock Start/From: **10**  
 Clock To: **2**  
 1st Value:  
 2nd Value:  
 Value Percent:  
 Continuous Index:  
 Within 8" of Joint: **YES**  
 Remarks:

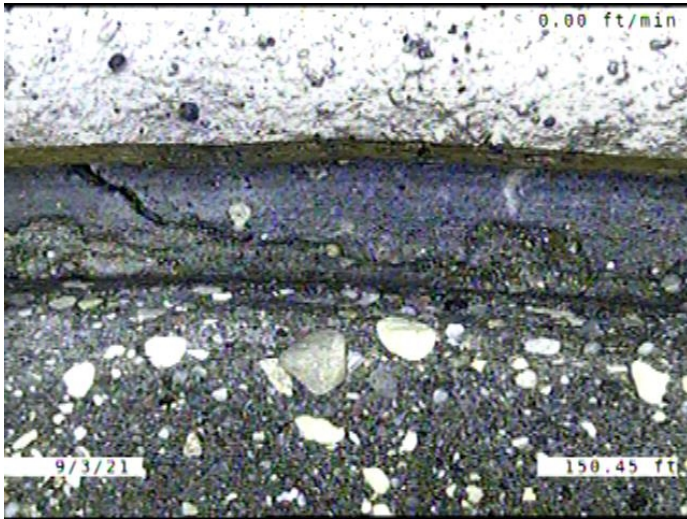
Code: **FM**  
 Description: **Fracture Multiple**

Distance (ft): **150.4**  
 Structural Grade: **4**  
 O&M Grade: **0**  
 Clock Start/From: **12**  
 Clock To: **5**  
 1st Value:  
 2nd Value:  
 Value Percent:  
 Continuous Index:  
 Within 8" of Joint: **YES**  
 Remarks: **OUTSIDE OF THE BELL**

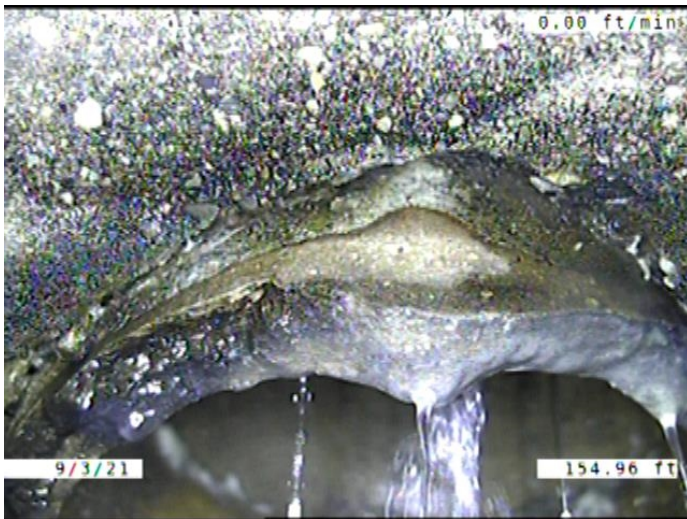
Code: **TBI**  
 Description: **Tap Break-in Intruding**

Distance (ft): **155.0**  
 Structural Grade: **0**  
 O&M Grade: **2**  
 Clock Start/From: **12**  
 Clock To:  
 1st Value: **6.000**  
 2nd Value: **1.000**  
 Value Percent:  
 Continuous Index:  
 Within 8" of Joint: **NO**  
 Remarks: **CONSTANTLY RUNNING WATER**

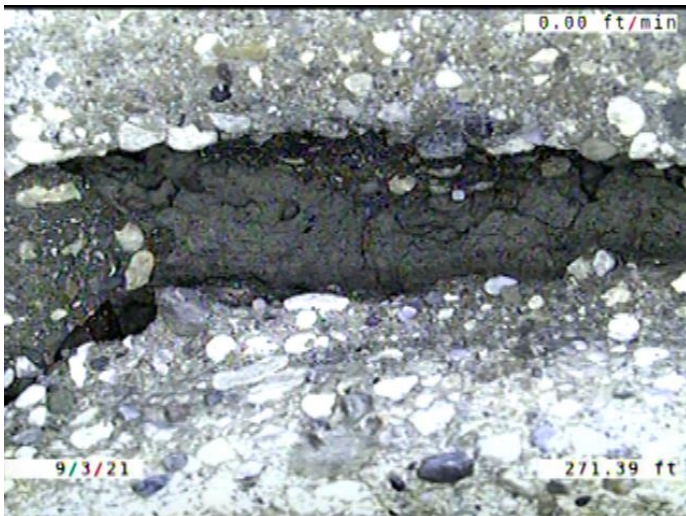
Code: **BSV**  
 Description: **Broken Soil Visible**

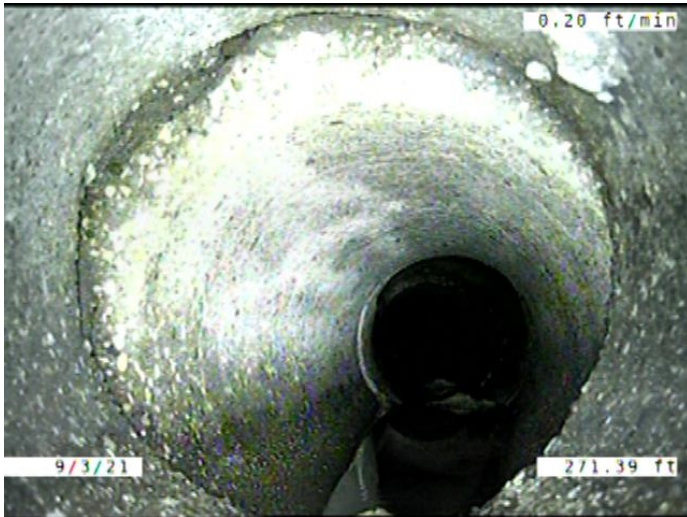
Code: **JOMD**  
Description: **Joint Offset Medium Defective**
