Profile/Photo Observation Report

Street:	ALLEY BETWEEN N GUYER ST & N WI	Flow Control:	Not Controlled
City:	Hobart, IN	Year Renewed:	
Location:	Light Highway	Tape/Media #:	
Purpose:	Not Known	Dia/Height:	10"
Use:	Sanitary	Material:	CP
Drain Area:	NA	Lining:	
Category:	NA		
Comment:

Location Details:		Direction of Survey:	Downstream
US MH:	M-504-127	DS MH:	M-504-126
		Total Length Surveyed (ft):	72.2

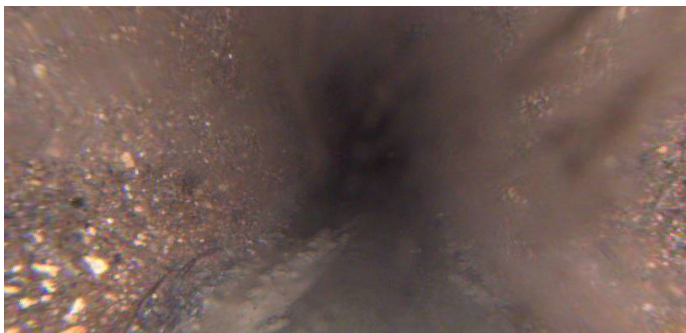
Code: **SAP**
Description: **Surface Aggregate Projecting**

Distance (ft): **.0**
Structural Grade: **3**
O&M Grade: **0**
Clock Start/From: **7**
Clock To: **5**
1st Value:
2nd Value:
Value Percent:
Continuous Index: **S04**
Within 8" of Joint:
Remarks:

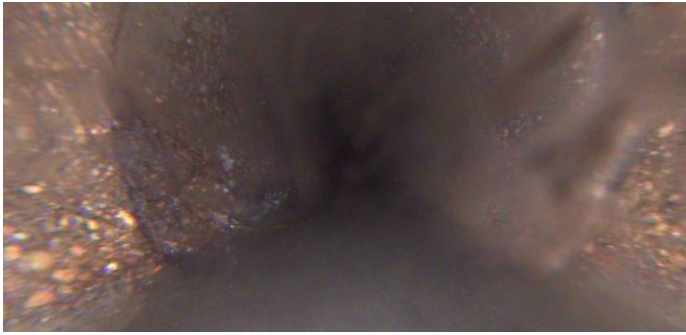
Code: **RFJ**
Description: **Roots Fine Joint**

Distance (ft): **8.8**
Structural Grade: **0**
O&M Grade: **1**
Clock Start/From: **8**
Clock To: **4**
1st Value:
2nd Value:
Value Percent:
Continuous Index: **S05**
Within 8" of Joint: **YES**
Remarks:

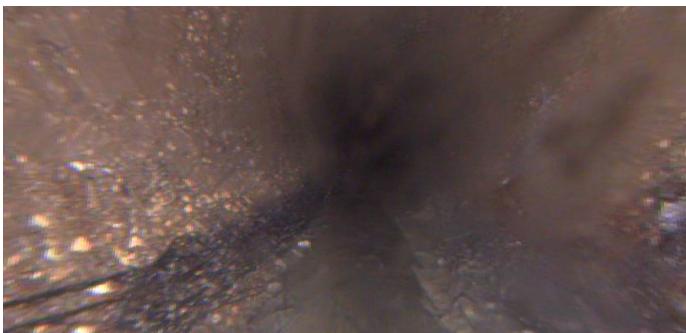
Code: **RFB**
Description: **Roots Fine Barrel**

Distance (ft): **12.4**
Structural Grade: **0**
O&M Grade: **2**
Clock Start/From: **2**
Clock To: **8**
1st Value:
2nd Value:
Value Percent:
Continuous Index: **S01**
Within 8" of Joint: **NO**
Remarks:

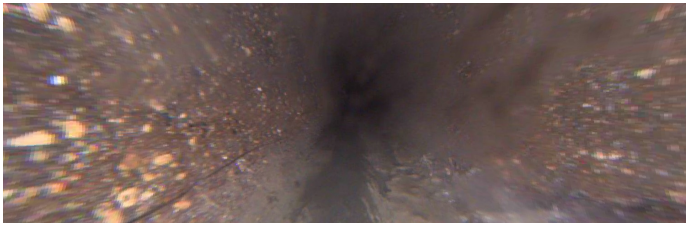
Code: **RFB**
Description: **Roots Fine Barrel**

Distance (ft): **15.4**
Structural Grade: **0**
O&M Grade: **2**
Clock Start/From: **2**
Clock To: **8**
1st Value:
2nd Value:
Value Percent:
Continuous Index: **F01**
Within 8" of Joint: **NO**
Remarks:

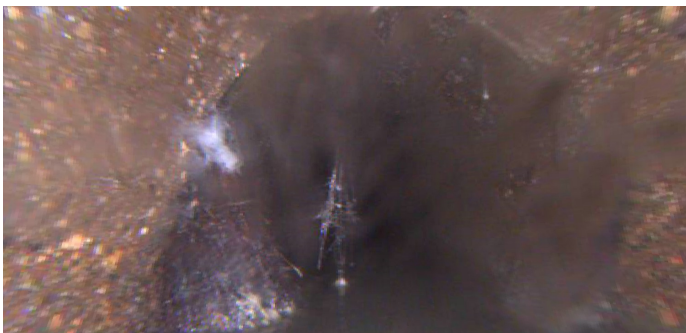
Code: **RMJ**
Description: **Roots Medium Joint**

Distance (ft): **20.6**
Structural Grade: **0**
O&M Grade: **3**
Clock Start/From: **7**
Clock To: **5**
1st Value:
2nd Value:
Value Percent: **15.000**
Continuous Index:
Within 8" of Joint: **YES**
Remarks:

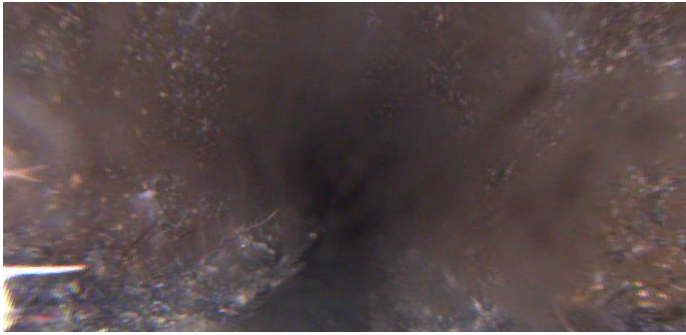
Code: **RFB**
Description: **Roots Fine Barrel**

Distance (ft): **39.0**
Structural Grade: **0**
O&M Grade: **2**
Clock Start/From: **7**
Clock To: **8**
1st Value:
2nd Value:
Value Percent:
Continuous Index:
Within 8" of Joint: **NO**
Remarks:

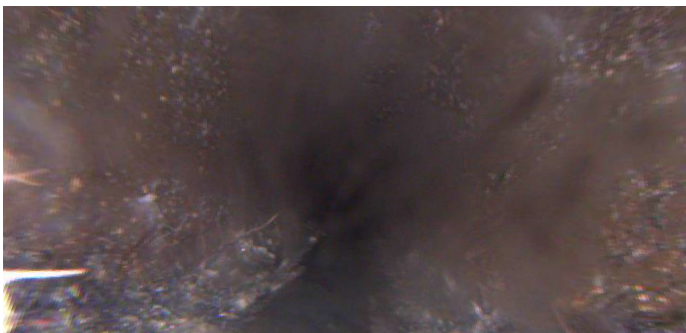
Code: **RFB**
Description: **Roots Fine Barrel**

Distance (ft): **39.0**
Structural Grade: **0**
O&M Grade: **2**
Clock Start/From: **4**
Clock To: **5**
1st Value:
2nd Value:
Value Percent:
Continuous Index:
Within 8" of Joint: **NO**
Remarks:

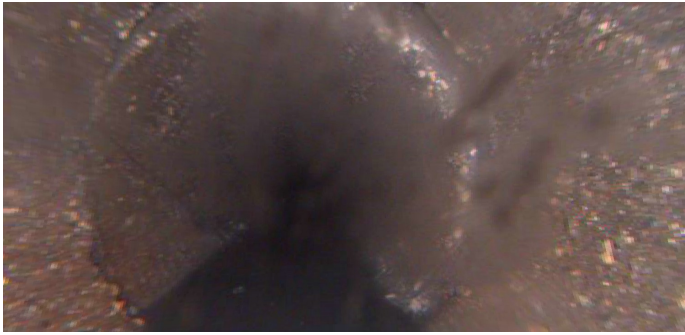
Code: **RFB**
Description: **Roots Fine Barrel**

Distance (ft): **53.1**
Structural Grade: **0**
O&M Grade: **2**
Clock Start/From: **7**
Clock To: **9**
1st Value:
2nd Value:
Value Percent:
Continuous Index:
Within 8" of Joint: **NO**
Remarks:

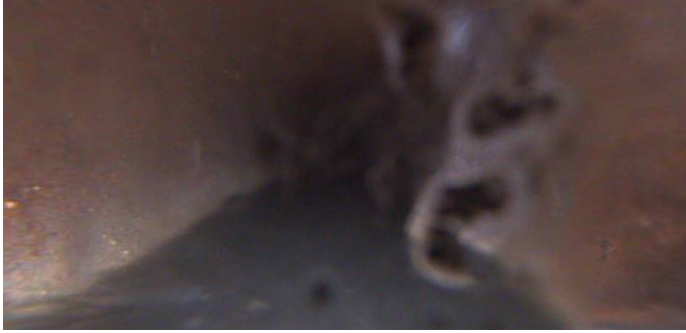
Code: **RFJ**
Description: **Roots Fine Joint**

Distance (ft): **68.4**
Structural Grade: **0**
O&M Grade: **1**
Clock Start/From: **8**
Clock To: **4**
1st Value:
2nd Value:
Value Percent:
Continuous Index: **F05**
Within 8" of Joint: **YES**
Remarks:

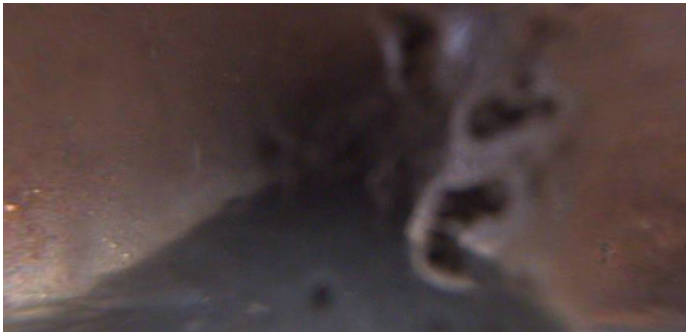
Code: **SAP**
Description: **Surface Aggregate Projecting**

Distance (ft): **68.4**
Structural Grade: **3**
O&M Grade: **0**
Clock Start/From: **7**
Clock To: **5**
1st Value:
2nd Value:
Value Percent:
Continuous Index: **F04**
Within 8" of Joint:
Remarks:

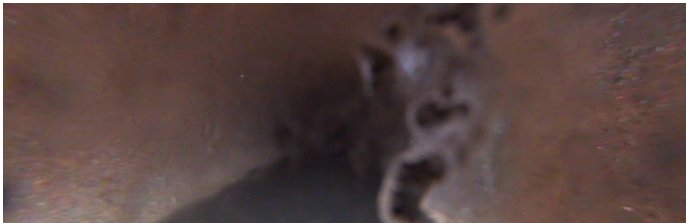
Code: **TFD**
Description: **Tap Factory Defective**

Distance (ft): **68.5**
Structural Grade: **0**
O&M Grade: **2**
Clock Start/From: **1**
Clock To:
1st Value: **4.000**
2nd Value:
Value Percent:
Continuous Index:
Within 8" of Joint:
Remarks: **root infiltration**

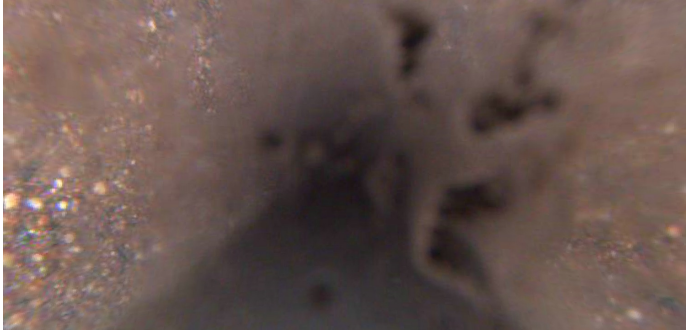
Code: **SAP**
Description: **Surface Aggregate Projecting**

Distance (ft): **72.2**
Structural Grade: **3**
O&M Grade: **0**
Clock Start/From: **8**
Clock To: **4**
1st Value:
2nd Value:
Value Percent:
Continuous Index:
Within 8" of Joint:
Remarks:

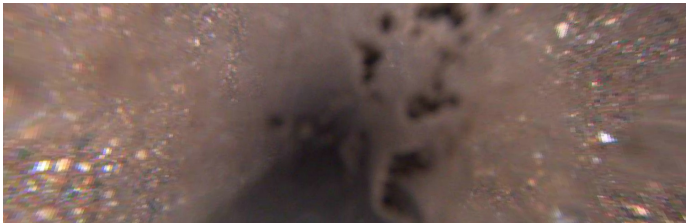
Code: **MSA**
Description: **Abandoned Survey**

Distance (ft): **72.2**
Structural Grade: **0**
O&M Grade: **0**
Clock Start/From:
Clock To:
1st Value:
2nd Value:
Value Percent:
Continuous Index:
Within 8" of Joint: **NO**
Remarks: **camera stopped**
