Profile/Photo Observation Report

Date:	04/16/2018	Weather:		Coding:	PACP 6.0
Pipe Length (ft):	315.0	Owner:	NA	Pre Clean:	Not Known
P.O.#:		Surveyor:	Selasie Honu	PSR:	P-504-126-127
Customer:		Clean Date:	01/01/1900	Shape:	C

Street:	Summerlin	Flow Control:	Not Controlled
City:	Hobart, IN	Year Renewed:	
Location:	Light Highway	Tape/Media #:	
Purpose:	Not Known	Dia/Height:	10"
Use:	Sanitary	Material:	CP
Drain Area:	NA	Lining:	
Category:	NA		
Comment:

Location Details:		Direction of Survey:	Downstream
US MH:	M-504-127	DS MH:	M-504-126
		Total Length Surveyed (ft):	72.2

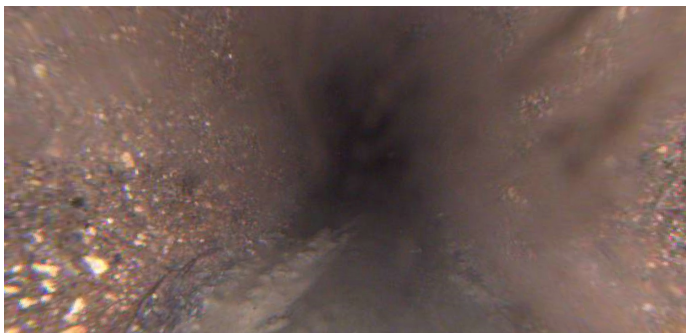
Code: **SAP**
Description: **Surface Aggregate Projecting**

Distance (ft): **.0**
Structural Grade: **3**
O&M Grade: **0**
Clock Start/From: **7**
Clock To: **5**
1st Value:
2nd Value:
Value Percent:
Continuous Index: **S04**
Within 8" of Joint:
Remarks:

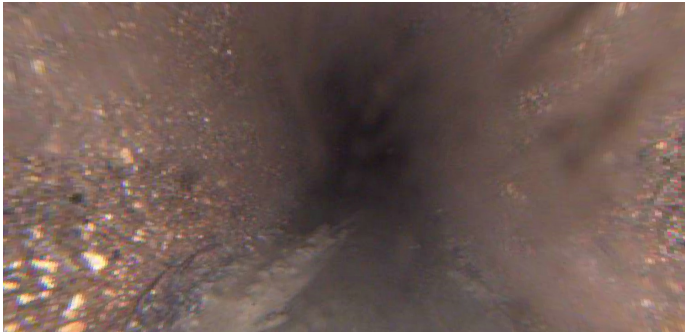
Code:	AMH
Description:	Manhole

Distance (ft):	.0
Structural Grade:	0
O&M Grade:	0
Clock Start/From:	
Clock To:	
1st Value:	
2nd Value:	
Value Percent:	
Continuous Index:	
Within 8" of Joint:	NO
Remarks:	M-504-127

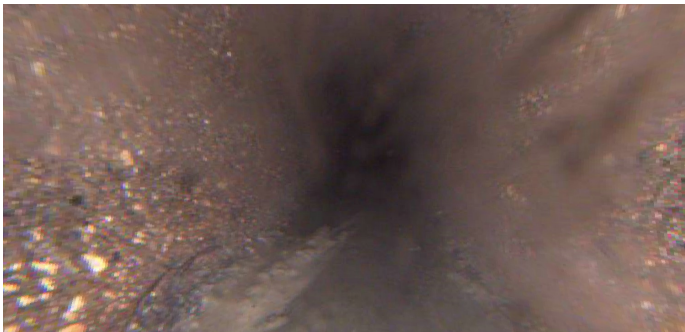
Code:	MWL
Description:	Water Level

Distance (ft):	.0
Structural Grade:	0
O&M Grade:	0
Clock Start/From:	
Clock To:	
1st Value:	
2nd Value:	
Value Percent:	5.000
Continuous Index:	
Within 8" of Joint:	NO
Remarks:

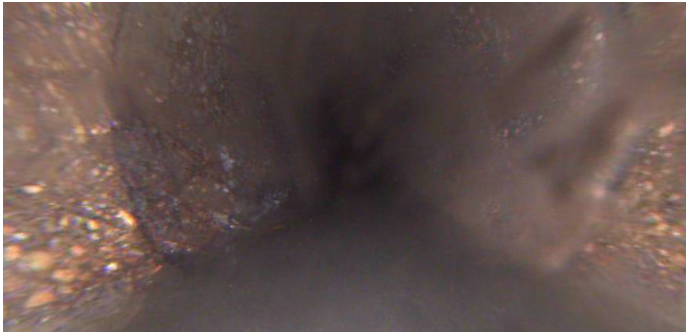
Code: **RFJ**
Description: **Roots Fine Joint**

Distance (ft): **8.8**
Structural Grade: **0**
O&M Grade: **1**
Clock Start/From: **8**
Clock To: **4**
1st Value:
2nd Value:
Value Percent:
Continuous Index: **S05**
Within 8" of Joint: **YES**
Remarks:

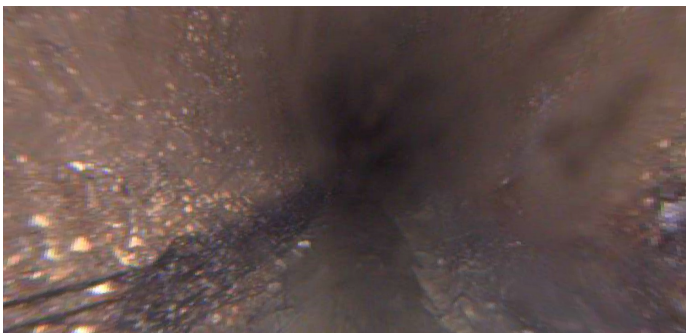
Code: **RFB**
Description: **Roots Fine Barrel**

Distance (ft): **12.4**
Structural Grade: **0**
O&M Grade: **2**
Clock Start/From: **2**
Clock To: **8**
1st Value:
2nd Value:
Value Percent:
Continuous Index: **S01**
Within 8" of Joint: **NO**
Remarks:

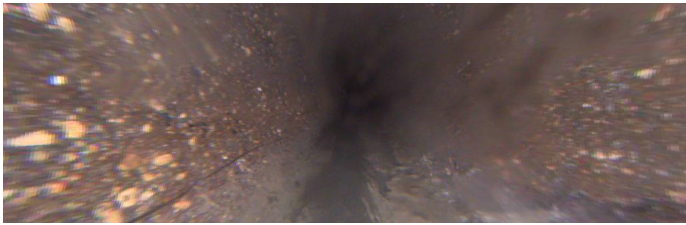
Code: **RFB**
Description: **Roots Fine Barrel**

Distance (ft): **15.4**
Structural Grade: **0**
O&M Grade: **2**
Clock Start/From: **2**
Clock To: **8**
1st Value:
2nd Value:
Value Percent:
Continuous Index: **F01**
Within 8" of Joint: **NO**
Remarks:

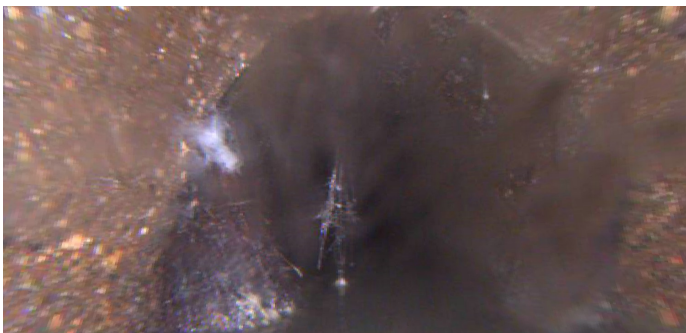
Code: **RMJ**
Description: **Roots Medium Joint**

Distance (ft): **20.6**
Structural Grade: **0**
O&M Grade: **3**
Clock Start/From: **7**
Clock To: **5**
1st Value:
2nd Value:
Value Percent: **15.000**
Continuous Index:
Within 8" of Joint: **YES**
Remarks:

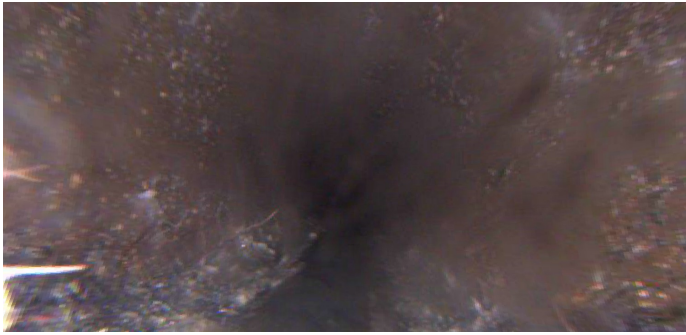
Code: **RFB**
Description: **Roots Fine Barrel**

Distance (ft): **39.0**
Structural Grade: **0**
O&M Grade: **2**
Clock Start/From: **7**
Clock To: **8**
1st Value:
2nd Value:
Value Percent:
Continuous Index:
Within 8" of Joint: **NO**
Remarks:

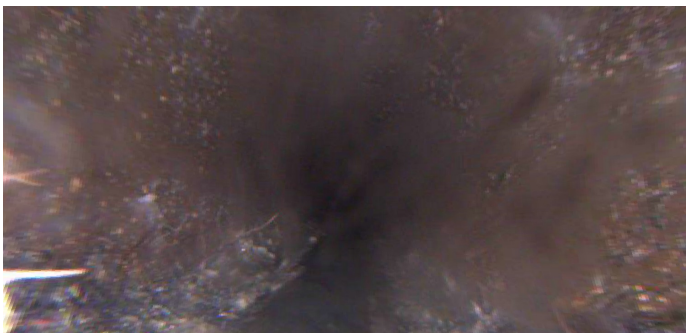
Code: **RFB**
Description: **Roots Fine Barrel**

Distance (ft): **39.0**
Structural Grade: **0**
O&M Grade: **2**
Clock Start/From: **4**
Clock To: **5**
1st Value:
2nd Value:
Value Percent:
Continuous Index:
Within 8" of Joint: **NO**
Remarks:

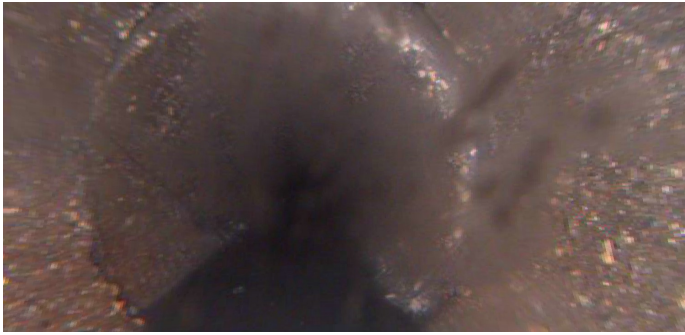
Code: **RFB**
Description: **Roots Fine Barrel**

Distance (ft): **53.1**
Structural Grade: **0**
O&M Grade: **2**
Clock Start/From: **7**
Clock To: **9**
1st Value:
2nd Value:
Value Percent:
Continuous Index:
Within 8" of Joint: **NO**
Remarks:

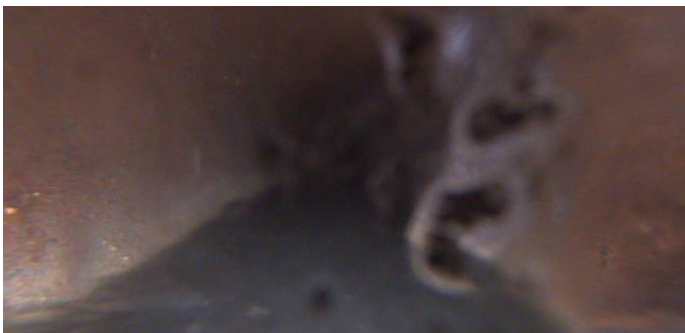
Code: **MMC**
Description: **Material Change**

Distance (ft): **68.4**
Structural Grade: **0**
O&M Grade: **0**
Clock Start/From:
Clock To:
1st Value:
2nd Value:
Value Percent:
Continuous Index:
Within 8" of Joint: **NO**
Remarks: **vcp**

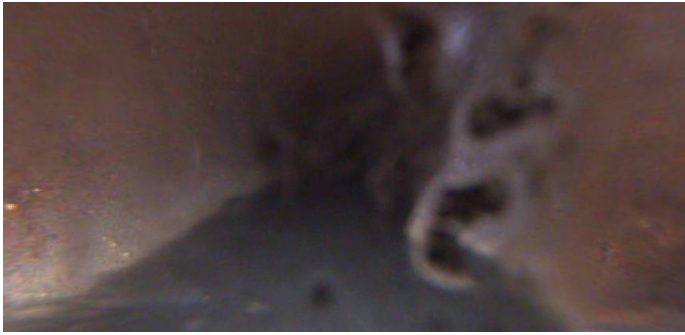
Code: **RFJ**
Description: **Roots Fine Joint**

Distance (ft): **68.4**
Structural Grade: **0**
O&M Grade: **1**
Clock Start/From: **8**
Clock To: **4**
1st Value:
2nd Value:
Value Percent:
Continuous Index: **F05**
Within 8" of Joint: **YES**
Remarks:

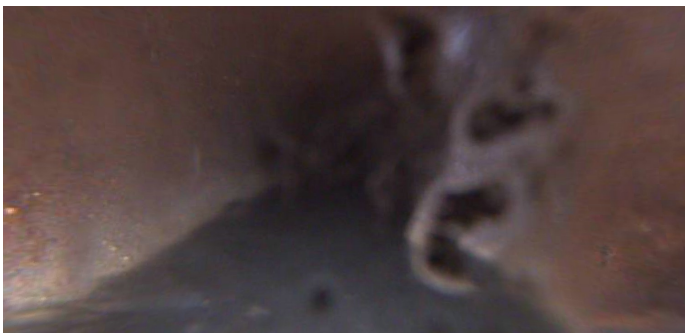
Code: **SAP**
Description: **Surface Aggregate Projecting**

Distance (ft): **68.4**
Structural Grade: **3**
O&M Grade: **0**
Clock Start/From: **7**
Clock To: **5**
1st Value:
2nd Value:
Value Percent:
Continuous Index: **F04**
Within 8" of Joint:
Remarks:

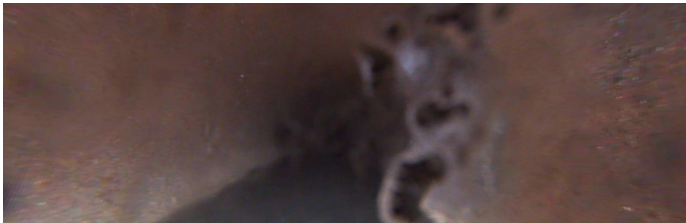
Code: **TFD**
Description: **Tap Factory Defective**

Distance (ft): **68.5**
Structural Grade: **0**
O&M Grade: **2**
Clock Start/From: **1**
Clock To:
1st Value: **4.000**
2nd Value:
Value Percent:
Continuous Index:
Within 8" of Joint:
Remarks: **root infiltration**

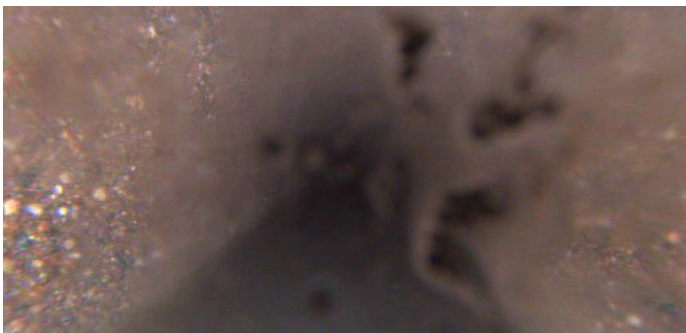
Code: **MMC**
Description: **Material Change**

Distance (ft): **72.2**
Structural Grade: **0**
O&M Grade: **0**
Clock Start/From:
Clock To:
1st Value:
2nd Value:
Value Percent:
Continuous Index:
Within 8" of Joint: **NO**
Remarks: **CP**

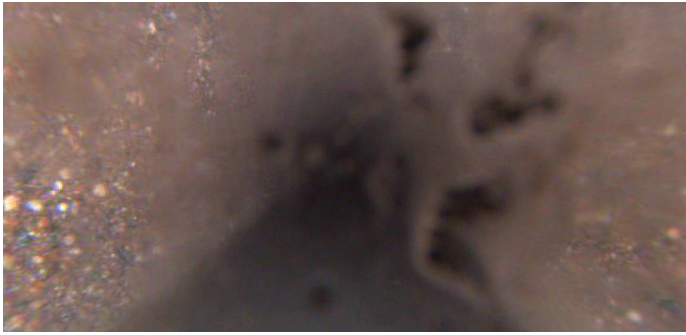
Code: **SAP**
Description: **Surface Aggregate Projecting**

Distance (ft): **72.2**
Structural Grade: **3**
O&M Grade: **0**
Clock Start/From: **8**
Clock To: **4**
1st Value:
2nd Value:
Value Percent:
Continuous Index:
Within 8" of Joint:
Remarks:

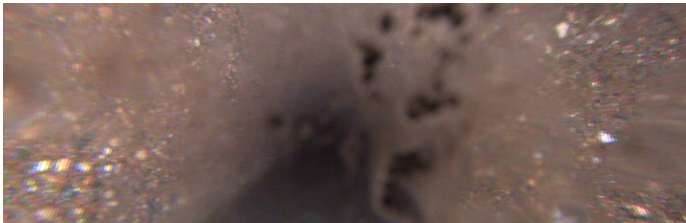
Code: **MSA**
Description: **Abandoned Survey**

Distance (ft): **72.2**
Structural Grade: **0**
O&M Grade: **0**
Clock Start/From:
Clock To:
1st Value:
2nd Value:
Value Percent:
Continuous Index:
Within 8" of Joint: **NO**
Remarks: **camera stopped**
