## Profile/Photo Observation Report

Street:	<b>ALLEY BETWEEN N GUYER ST &amp; N WI</b>	Flow Control:	<b>Not Controlled</b>
City:	<b>Hobart, IN</b>	Year Renewed:	
Location:	<b>Light Highway</b>	Tape/Media #:	
Purpose:	<b>Not Known</b>	Dia/Height:	<b>10"</b>
Use:	<b>Sanitary</b>	Material:	<b>CP</b>
Drain Area:	<b>NA</b>	Lining:	
Category:	<b>NA</b>		
Comment:

Location Details:		Direction of Survey:	<b>Upstream</b>
US MH:	<b>M-504-127</b>	DS MH:	<b>M-504-126</b>
		Total Length Surveyed (ft):	<b>6.7</b>

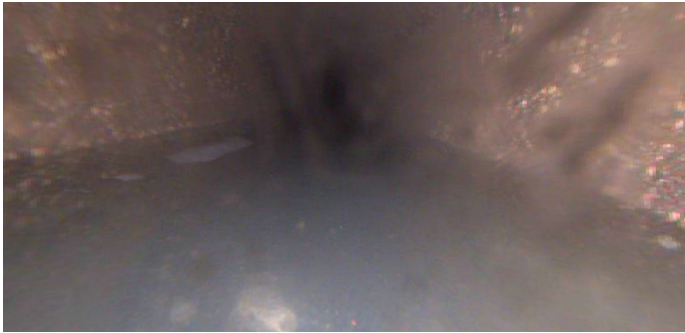
Code:	<b>AMH</b>
Description:	<b>Manhole</b>

Distance (ft):	<b>.0</b>
Structural Grade:	<b>0</b>
O&M Grade:	<b>0</b>
Clock Start/From:	
Clock To:	
1st Value:	
2nd Value:	
Value Percent:	
Continuous Index:	
Within 8" of Joint:	<b>NO</b>
Remarks:	<b>M-504-127</b>

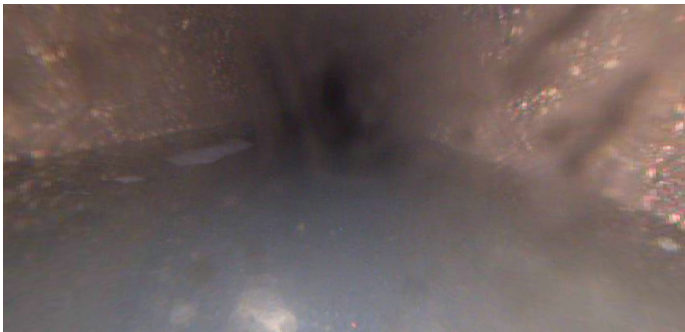
Code:	<b>MWL</b>
Description:	<b>Water Level</b>

Distance (ft):	<b>.0</b>
Structural Grade:	<b>0</b>
O&M Grade:	<b>0</b>
Clock Start/From:	
Clock To:	
1st Value:	
2nd Value:	
Value Percent:	<b>5.000</b>
Continuous Index:	
Within 8" of Joint:	<b>NO</b>
Remarks:

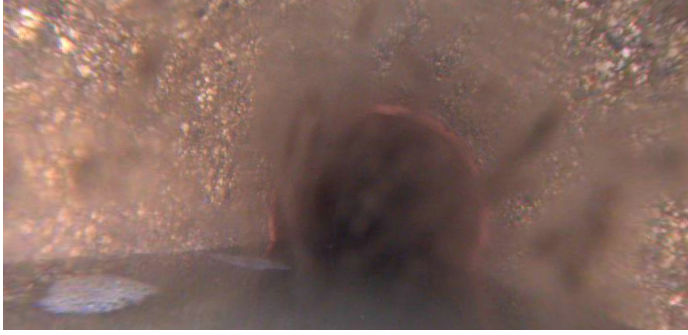
Code: **MMC**  
Description: **Material Change**

Distance (ft): **6.0**  
Structural Grade: **0**  
O&M Grade: **0**  
Clock Start/From:  
Clock To:  
1st Value:  
2nd Value:  
Value Percent:  
Continuous Index:  
Within 8" of Joint: **NO**  
Remarks: **VCP**
