Date:	04/16/2018	Weather:			Coding:	PACP 6.0
Pipe Length (ft):	315.0	Owner:	NA		Pre Clean:	Not Known
P.O.#:		Surveyor:	Selasie Honu		PSR:	P-504-126-127
Customer:		Clean Date:	01/01/1900		Shape:	С
Street:	Summerlin		Flow Control:		Not Controlled	
City:	Hobart, IN		Year Renewed	1		
Location:	Light Highway		Tape/Media #:			
Purpose:	Not Known		Dia/Height:		10"	
Use:	Sanitary		Material:		СР	
Drain Area:	NA		Lining:			
Category:	NA					
Comment:						
Location Details:			Direction of Su	rvey:	Upstream	
US MH:	M-504-127	DS MH:	M-504-126	Total	Length Surveyed (ft)	6.7
D&M Index:	0.00	O&M Quick:	00	000	O&M Rating:	0.00
Structural Index:	3.00	Structural Qu	uick: 31	100	Structural Rating:	3.00
Overall Index:	3.00	Overall Quick	2	00	Overall Rating:	3.00

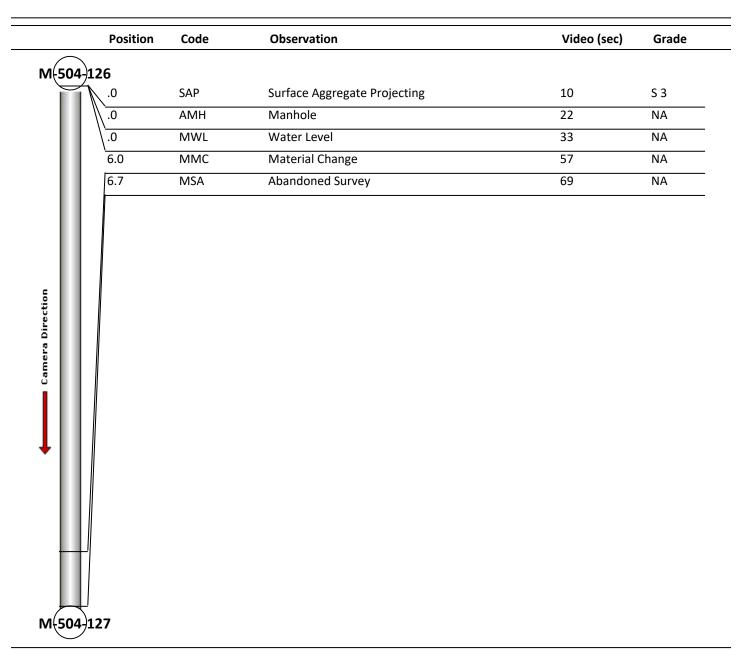
Code: Description:	SAP Surface Aggregate Projecting
Distance (ft): Structural Grade: O&M Grade: Clock Start/From: Clock To: 1st Value: 2nd Value: Value Percent: Continuous Index:	.0 3 0 8 4
Within 8" of Joint: Remarks:
