Profile/Photo Observation Report

Date:	09/02/2021	Weather:		Coding:	PACP 7.0
Pipe Length (ft):	357.6	Owner:	City of Hobart	Pre Clean:	Light Cleaning
P.O.#:	YES502259	Surveyor:	S. Bucklin	PSR:	P-504-126-127
Customer:	City of Hobart	Clean Date:	08/30/2021	Shape:	C

Street:	North Wilson Street	Flow Control:	Not Controlled
City:	Hobart, IN	Year Renewed:	
Location:	Alley	Tape/Media #:	
Purpose:	Routine Assessment	Dia/Height:	10"
Use:	Sanitary Sewage Pipe	Material:	CP
Drain Area:		Lining:	
Category:	NA		
Comment:			
Location Details:		Direction of Survey:	Downstream
US MH:	M-504-127	DS MH:	M-504-126
		Total Length Surveyed (ft):	357.6

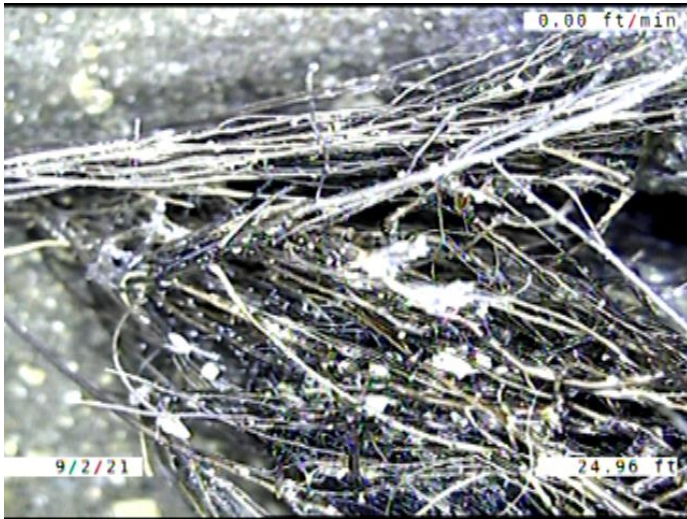
Code: **RMJ**
 Description: **Roots Medium Joint**

Distance (ft): **25.0**
 Structural Grade: **0**
 O&M Grade: **3**
 Clock Start/From: **7**
 Clock To: **5**
 1st Value:
 2nd Value:
 Value Percent: **5.000**
 Continuous Index: **S02**
 Within 8" of Joint: **YES**
 Remarks:

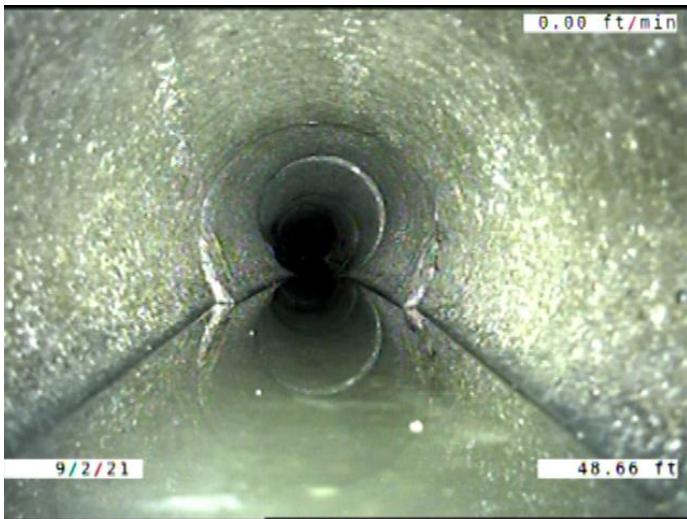
Code: **MWLS**
 Description: **Miscellaneous Water Level Sag**

Distance (ft): **48.7**
 Structural Grade: **2**
 O&M Grade: **0**
 Clock Start/From:
 Clock To:
 1st Value:
 2nd Value:
 Value Percent: **5.000**
 Continuous Index:
 Within 8" of Joint: **NO**
 Remarks:

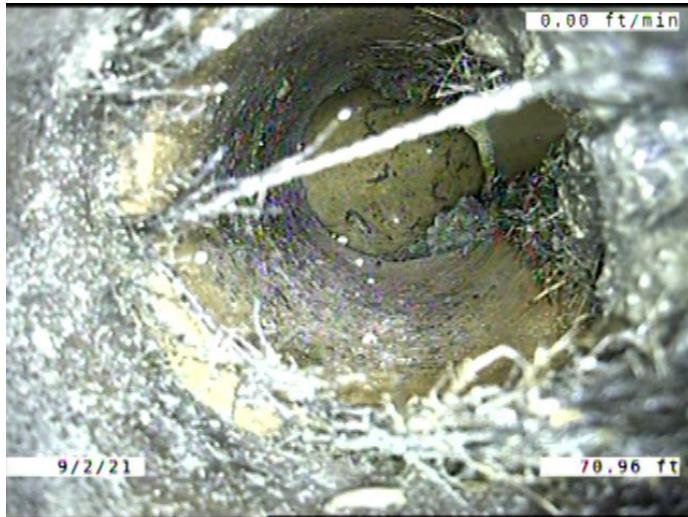
Code: **TF**
Description: **Tap Factory**

Distance (ft): **71.0**
Structural Grade: **0**
O&M Grade: **0**
Clock Start/From: **2**
Clock To:
1st Value: **6.000**
2nd Value:
Value Percent:
Continuous Index:
Within 8" of Joint: **YES**
Remarks: **ROOTS GROWING IN THE TAP**

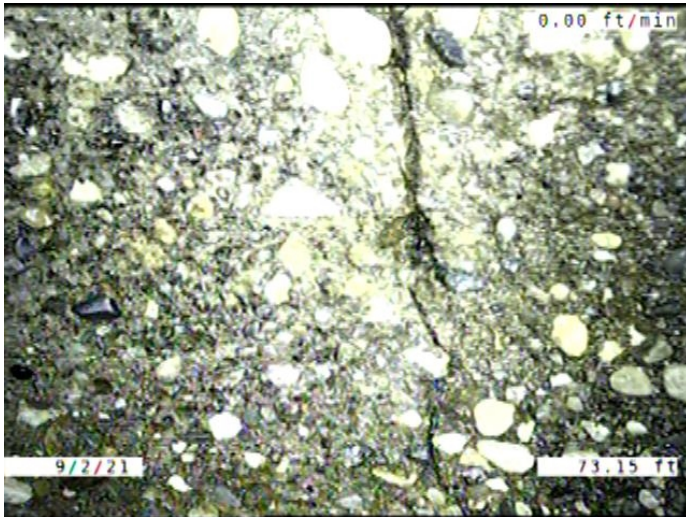
Code: **CM**
 Description: **Crack Multiple**

Distance (ft): **73.1**
 Structural Grade: **3**
 O&M Grade: **0**
 Clock Start/From: **3**
 Clock To: **9**
 1st Value:
 2nd Value:
 Value Percent:
 Continuous Index:
 Within 8" of Joint: **YES**
 Remarks:

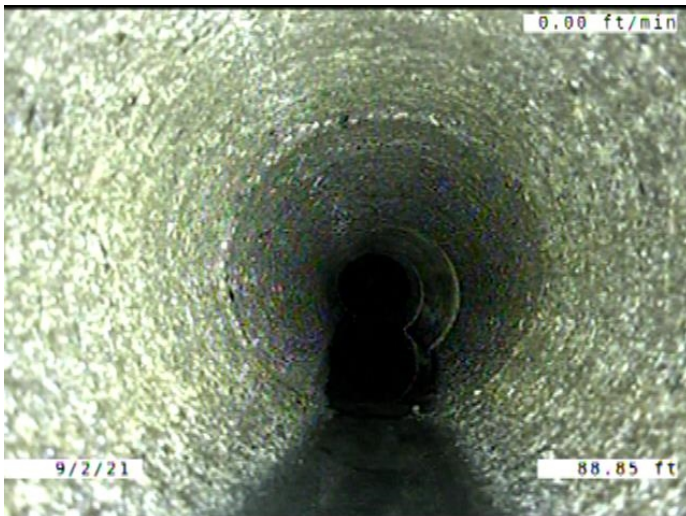
Code: **RMJ**
 Description: **Roots Medium Joint**

Distance (ft): **88.9**
 Structural Grade: **0**
 O&M Grade: **3**
 Clock Start/From: **7**
 Clock To: **5**
 1st Value:
 2nd Value:
 Value Percent: **5.000**
 Continuous Index: **F02**
 Within 8" of Joint: **YES**
 Remarks:

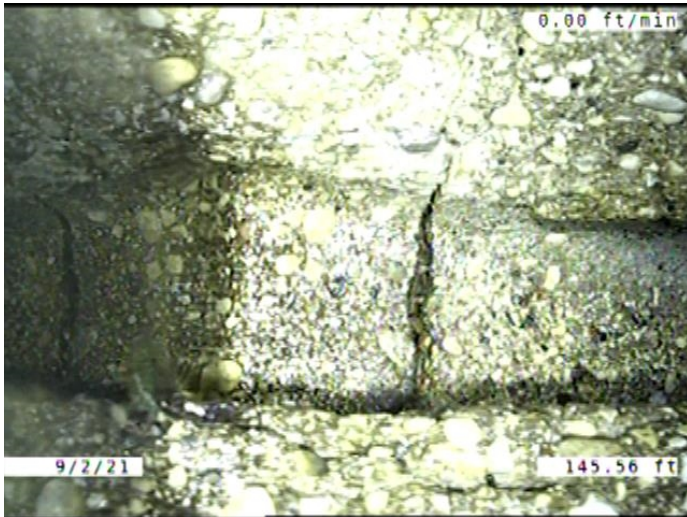
Code: **FL**
Description: **Fracture Longitudinal**

Distance (ft): **145.6**
Structural Grade: **3**
O&M Grade: **0**
Clock Start/From: **3**
Clock To:
1st Value:
2nd Value:
Value Percent:
Continuous Index:
Within 8" of Joint: **YES**
Remarks:

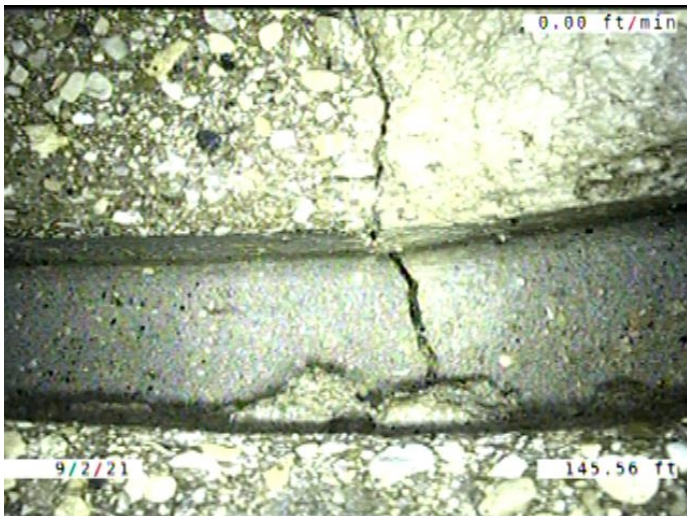
Code: **FL**
Description: **Fracture Longitudinal**

Distance (ft): **145.6**
Structural Grade: **3**
O&M Grade: **0**
Clock Start/From: **10**
Clock To:
1st Value:
2nd Value:
Value Percent:
Continuous Index:
Within 8" of Joint: **YES**
Remarks:

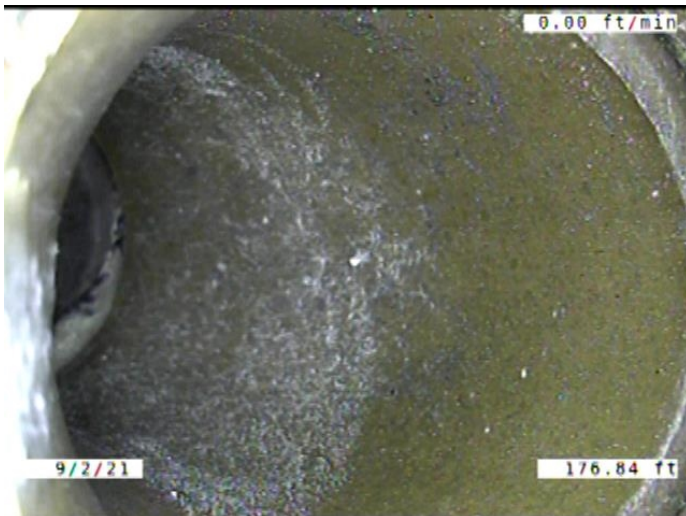
Code: **TBI**
Description: **Tap Break-in Intruding**

Distance (ft): **176.8**
Structural Grade: **0**
O&M Grade: **2**
Clock Start/From: **11**
Clock To:
1st Value: **6.000**
2nd Value: **1.000**
Value Percent:
Continuous Index:
Within 8" of Joint: **NO**
Remarks:

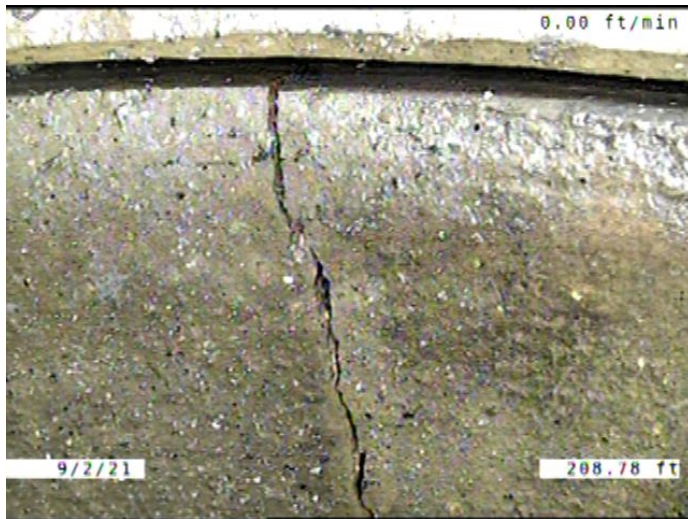
Code: **FS**
 Description: **Fracture Spiral**

Distance (ft): **208.8**
 Structural Grade: **3**
 O&M Grade: **0**
 Clock Start/From: **2**
 Clock To: **3**
 1st Value:
 2nd Value:
 Value Percent:
 Continuous Index:
 Within 8" of Joint: **YES**
 Remarks:

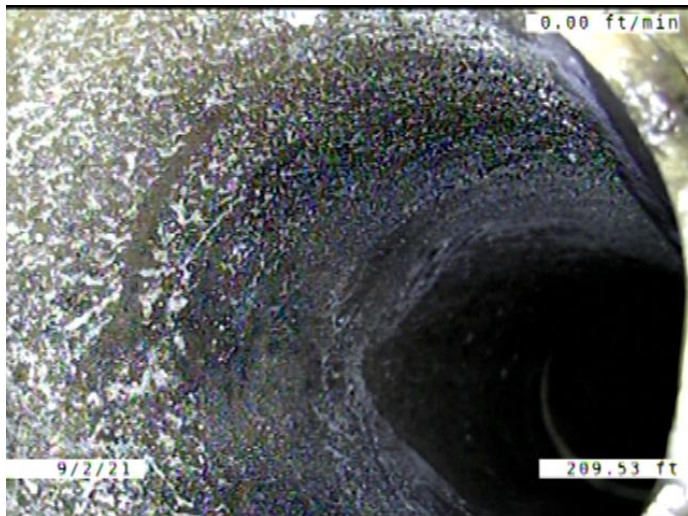
Code: **TFD**
 Description: **Tap Factory Defective**

Distance (ft): **209.5**
 Structural Grade: **0**
 O&M Grade: **3**
 Clock Start/From: **2**
 Clock To:
 1st Value: **6.000**
 2nd Value:
 Value Percent:
 Continuous Index:
 Within 8" of Joint: **YES**
 Remarks: **Debris**

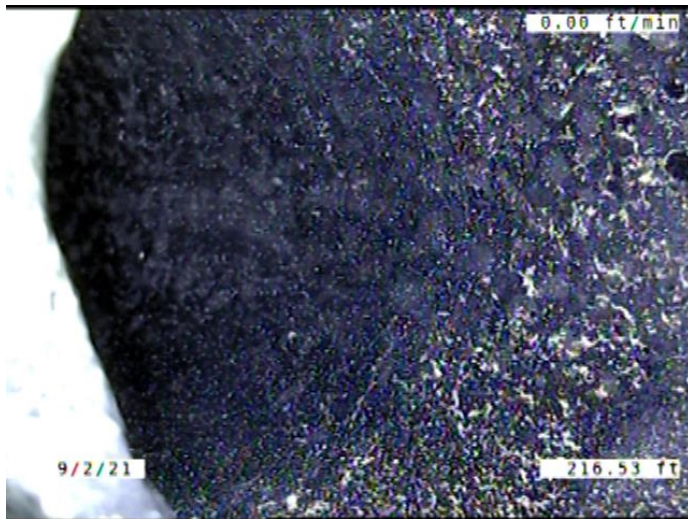
Code: **TBI**
 Description: **Tap Break-in Intruding**

Distance (ft): **216.5**
 Structural Grade: **0**
 O&M Grade: **2**
 Clock Start/From: **11**
 Clock To:
 1st Value: **6.000**
 2nd Value: **1.000**
 Value Percent:
 Continuous Index:
 Within 8" of Joint: **YES**
 Remarks: **ACTIVE**

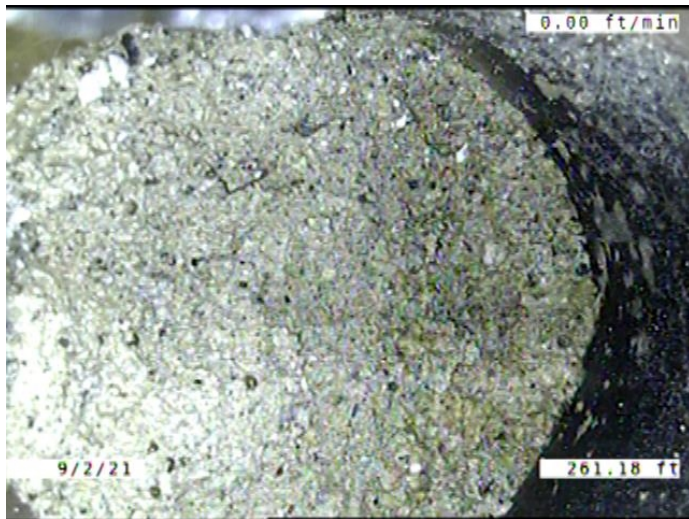
Code: **TFD**
 Description: **Tap Factory Defective**

Distance (ft): **261.2**
 Structural Grade: **0**
 O&M Grade: **3**
 Clock Start/From: **10**
 Clock To:
 1st Value: **6.000**
 2nd Value:
 Value Percent:
 Continuous Index:
 Within 8" of Joint: **YES**
 Remarks: **Debris**

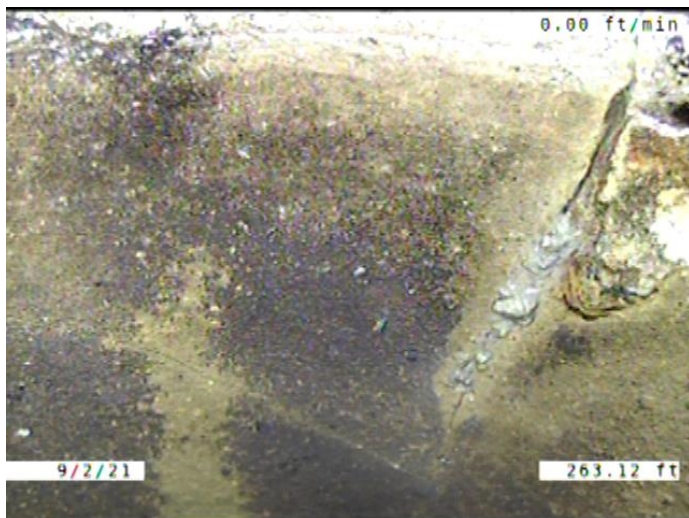
Code: **FM**
 Description: **Fracture Multiple**

Distance (ft): **263.1**
 Structural Grade: **4**
 O&M Grade: **0**
 Clock Start/From: **11**
 Clock To: **1**
 1st Value:
 2nd Value:
 Value Percent:
 Continuous Index:
 Within 8" of Joint: **YES**
 Remarks:

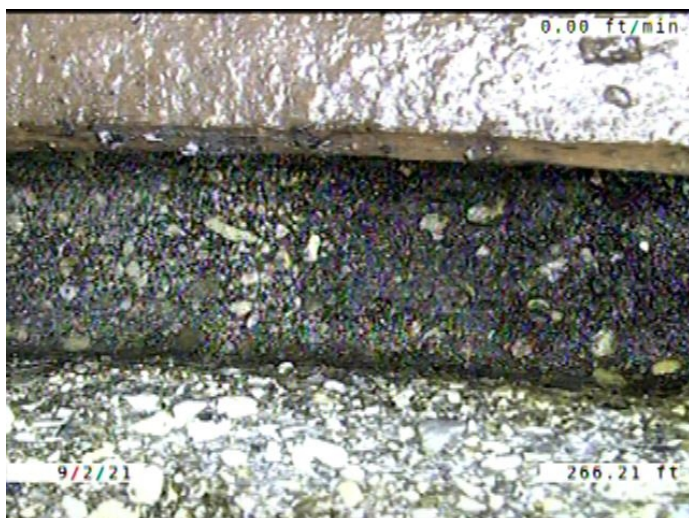
Code: **JAM**
 Description: **Joint Angular Medium**

Distance (ft): **266.2**
 Structural Grade: **3**
 O&M Grade: **0**
 Clock Start/From:
 Clock To:
 1st Value:
 2nd Value:
 Value Percent:
 Continuous Index:
 Within 8" of Joint: **NO**
 Remarks:

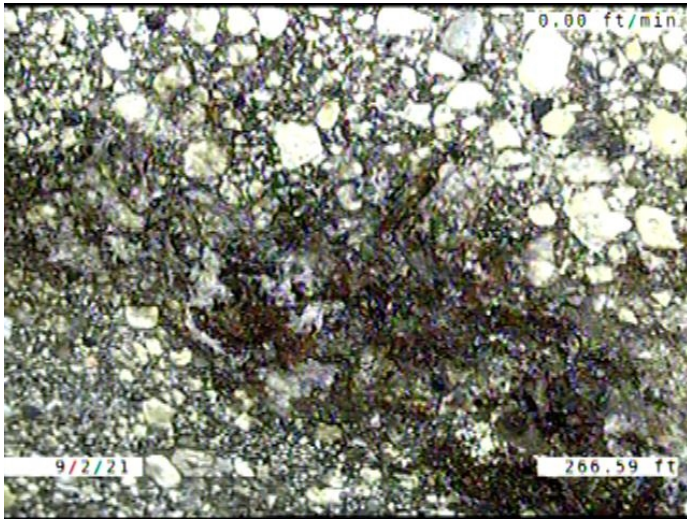
Code: **ISB**
 Description: **Infiltration Stain Barrel**

Distance (ft): **266.6**
 Structural Grade: **0**
 O&M Grade: **1**
 Clock Start/From: **10**
 Clock To: **3**
 1st Value:
 2nd Value:
 Value Percent:
 Continuous Index:
 Within 8" of Joint: **YES**
 Remarks:

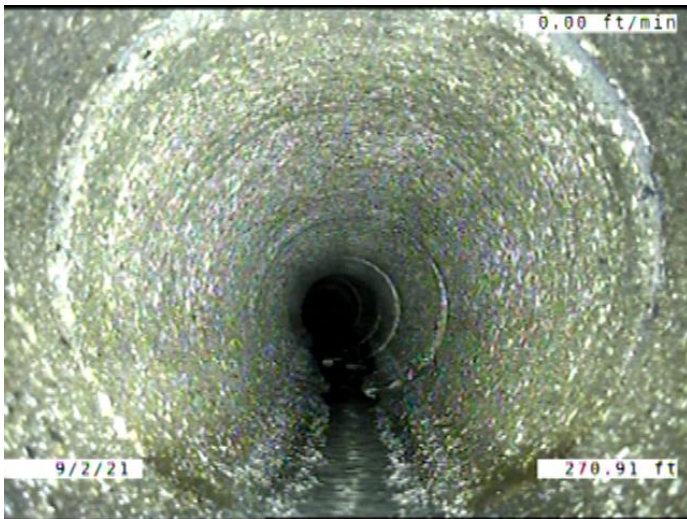
Code: **OBZ**
 Description: **Obstruction Other**

Distance (ft): **270.9**
 Structural Grade: **0**
 O&M Grade: **2**
 Clock Start/From: **4**
 Clock To: **8**
 1st Value:
 2nd Value:
 Value Percent: **10.000**
 Continuous Index: **F05**
 Within 8" of Joint: **YES**
 Remarks: **TP AND RAGS**

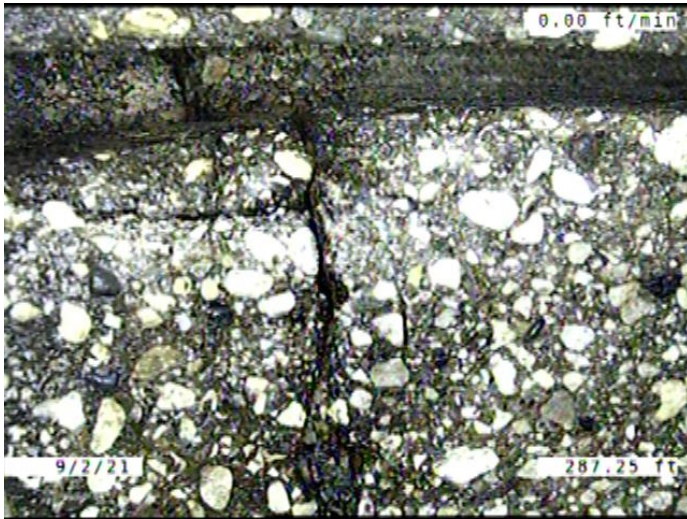
Code: **FM**
 Description: **Fracture Multiple**

Distance (ft): **287.3**
 Structural Grade: **4**
 O&M Grade: **0**
 Clock Start/From: **8**
 Clock To: **9**
 1st Value:
 2nd Value:
 Value Percent:
 Continuous Index:
 Within 8" of Joint: **YES**
 Remarks:

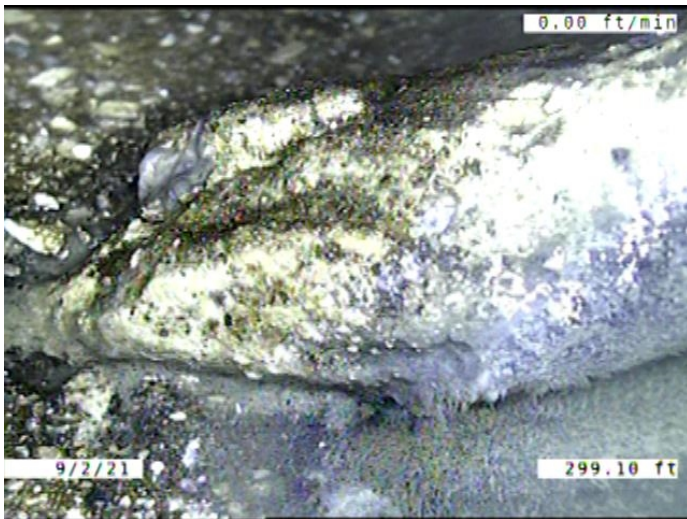
Code: **DAE**
 Description: **Deposits Attached Encrustation**

Distance (ft): **299.1**
 Structural Grade: **0**
 O&M Grade: **2**
 Clock Start/From: **4**
 Clock To: **8**
 1st Value:
 2nd Value:
 Value Percent: **5.000**
 Continuous Index:
 Within 8" of Joint: **YES**
 Remarks:

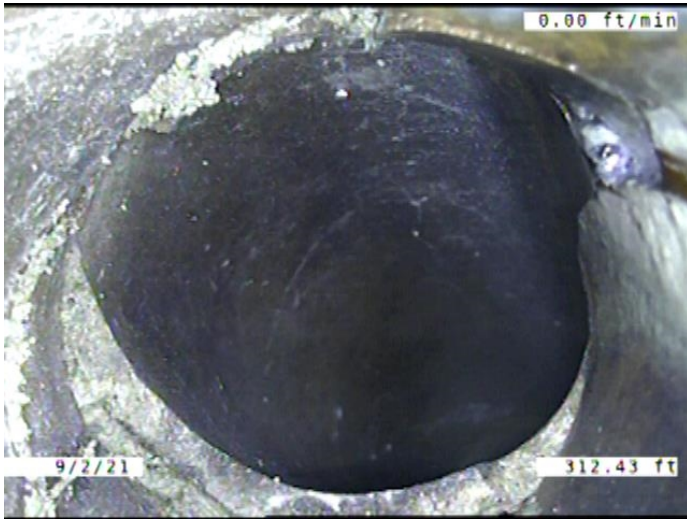
Code: **TFD**
 Description: **Tap Factory Defective**

Distance (ft): **312.4**
 Structural Grade: **0**
 O&M Grade: **3**
 Clock Start/From: **2**
 Clock To:
 1st Value: **6.000**
 2nd Value:
 Value Percent:
 Continuous Index:
 Within 8" of Joint: **YES**
 Remarks: **Debris**

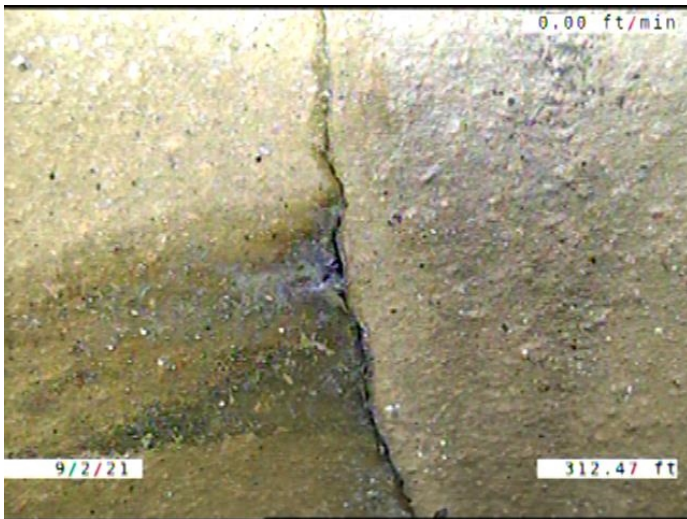
Code: **CS**
 Description: **Crack Spiral**

Distance (ft): **312.5**
 Structural Grade: **2**
 O&M Grade: **0**
 Clock Start/From: **9**
 Clock To: **10**
 1st Value:
 2nd Value:
 Value Percent:
 Continuous Index:
 Within 8" of Joint: **YES**
 Remarks:

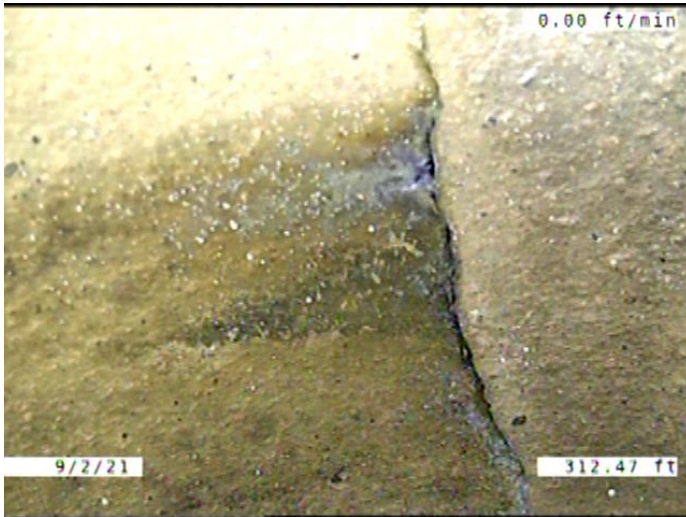
Code: **ISB**
Description: **Infiltration Stain Barrel**

Distance (ft): **312.5**
Structural Grade: **0**
O&M Grade: **1**
Clock Start/From: **7**
Clock To: **10**
1st Value:
2nd Value:
Value Percent:
Continuous Index:
Within 8" of Joint: **YES**
Remarks:

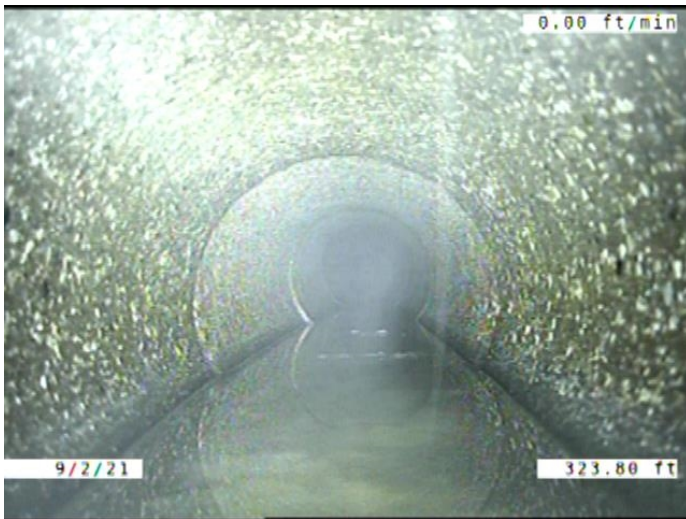
Code: **MWLS**
Description: **Miscellaneous Water Level Sag**

Distance (ft): **323.8**
Structural Grade: **2**
O&M Grade: **0**
Clock Start/From:
Clock To:
1st Value:
2nd Value:
Value Percent: **5.000**
Continuous Index: **S06**
Within 8" of Joint: **NO**
Remarks:

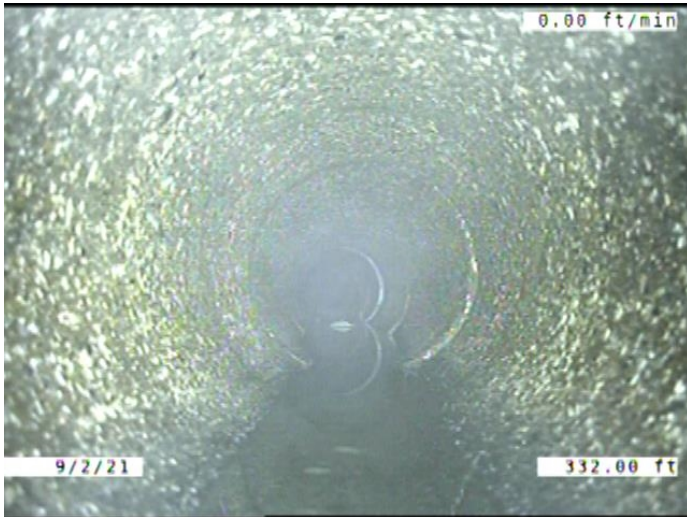
Code: **MWLS**
 Description: **Miscellaneous Water Level Sag**

Distance (ft): **332.0**
 Structural Grade: **2**
 O&M Grade: **0**
 Clock Start/From:
 Clock To:
 1st Value:
 2nd Value:
 Value Percent: **5.000**
 Continuous Index: **F06**
 Within 8" of Joint: **NO**
 Remarks:
