# Profile/Photo Observation Report

Date:	09/02/2021	Weather:		Coding:	PACP 7.0
Pipe Length (ft):	357.6	Owner:	City of Hobart	Pre Clean:	Light Cleaning
P.O.#:	YES502259	Surveyor:	S. Bucklin	PSR:	P-504-126-127
Customer:	City of Hobart	Clean Date:	08/30/2021	Shape:	C

Street:	North Wilson Street	Flow Control:	Not Controlled
City:	Hobart, IN	Year Renewed:	
Location:	Alley	Tape/Media #:	
Purpose:	Routine Assessment	Dia/Height:	10"
Use:	Sanitary Sewage Pipe	Material:	CP
Drain Area:		Lining:	
Category:	NA		
Comment:			
Location Details:		Direction of Survey:	Downstream
US MH:	M-504-127	DS MH:	M-504-126
		Total Length Surveyed (ft):	357.6

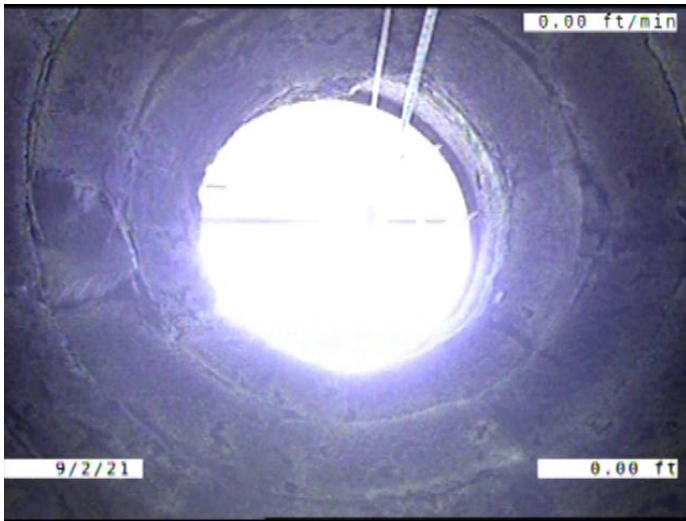
Code: **AMH**  
Description: **Manhole**

Distance (ft): **.0**  
Structural Grade: **0**  
O&M Grade: **0**  
Clock Start/From:  
Clock To:  
1st Value:  
2nd Value:  
Value Percent:  
Continuous Index:  
Within 8" of Joint: **NO**  
Remarks: **M-504-127**

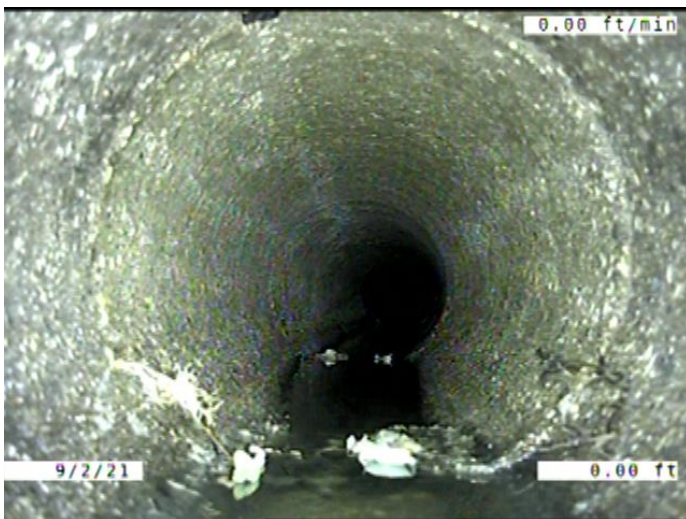
Code: **MWL**  
Description: **Miscellaneous Water Level**

Distance (ft): **.0**  
Structural Grade: **0**  
O&M Grade: **0**  
Clock Start/From:  
Clock To:  
1st Value:  
2nd Value:  
Value Percent: **5.000**  
Continuous Index:  
Within 8" of Joint: **NO**  
Remarks:

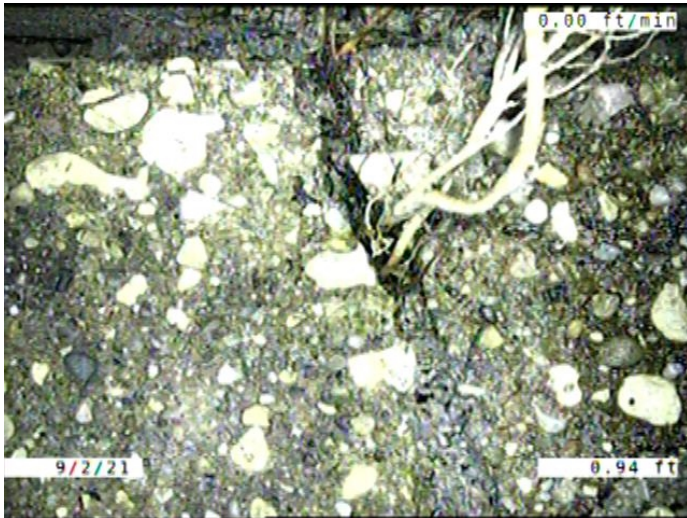
Code: **FS**  
Description: **Fracture Spiral**

Distance (ft): **.9**  
Structural Grade: **3**  
O&M Grade: **0**  
Clock Start/From: **7**  
Clock To: **9**  
1st Value:  
2nd Value:  
Value Percent:  
Continuous Index:  
Within 8" of Joint: **YES**  
Remarks:

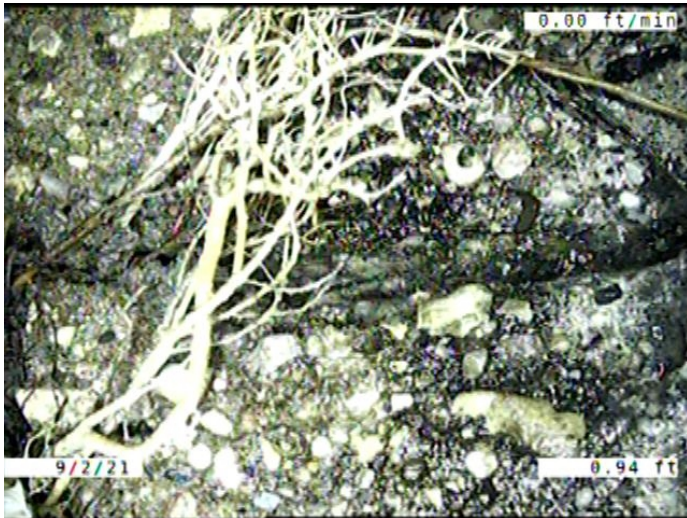
Code: **RFJ**  
Description: **Roots Fine Joint**

Distance (ft): **.9**  
Structural Grade: **0**  
O&M Grade: **1**  
Clock Start/From: **3**  
Clock To: **9**  
1st Value:  
2nd Value:  
Value Percent:  
Continuous Index:  
Within 8" of Joint: **YES**  
Remarks:

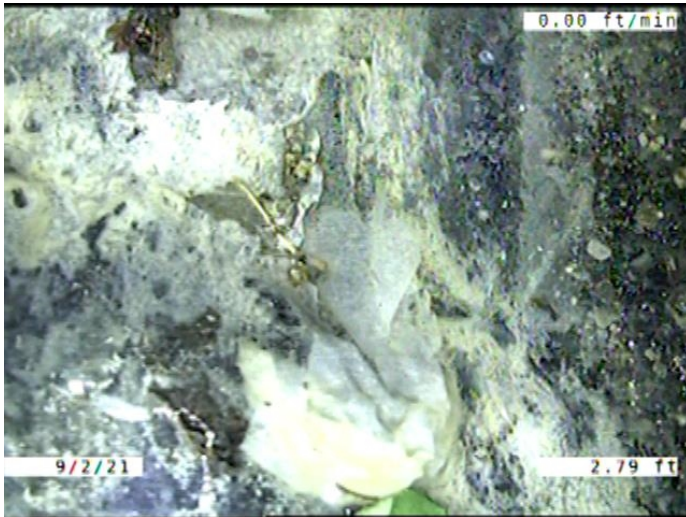
Code: **DSC**  
 Description: **Deposits Settled Hard/Compacted**

Distance (ft): **2.8**  
 Structural Grade: **0**  
 O&M Grade: **2**  
 Clock Start/From: **5**  
 Clock To: **7**  
 1st Value:  
 2nd Value:  
 Value Percent: **5.000**  
 Continuous Index:  
 Within 8" of Joint: **YES**  
 Remarks:

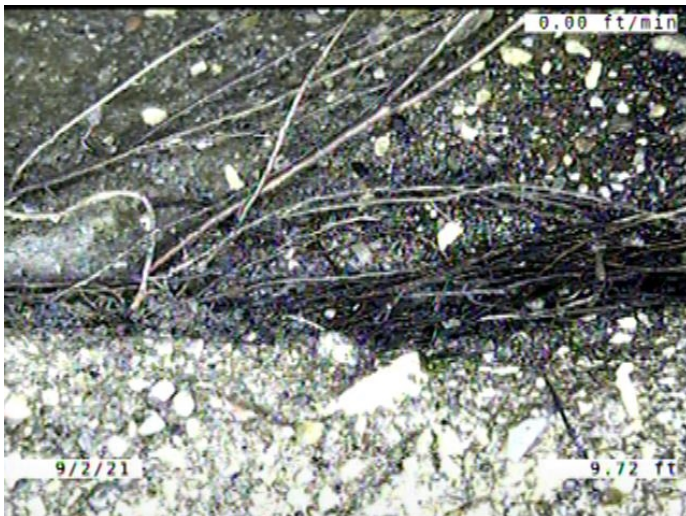
Code: **RFJ**  
 Description: **Roots Fine Joint**

Distance (ft): **9.7**  
 Structural Grade: **0**  
 O&M Grade: **1**  
 Clock Start/From: **3**  
 Clock To: **9**  
 1st Value:  
 2nd Value:  
 Value Percent:  
 Continuous Index: **S01**  
 Within 8" of Joint: **YES**  
 Remarks:

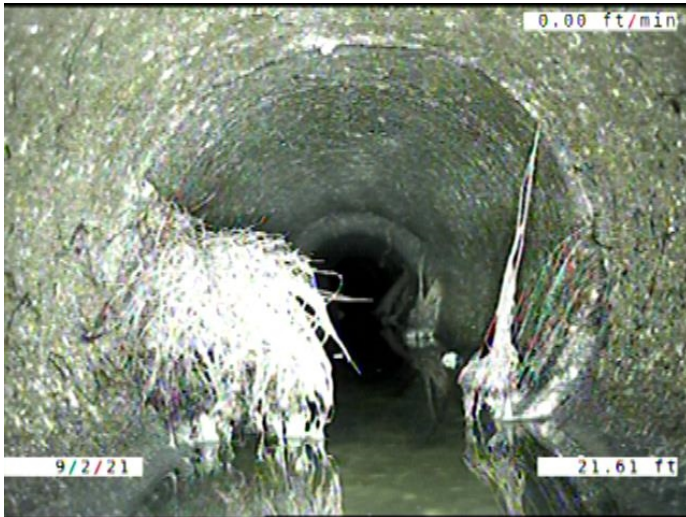
Code: **RMJ**  
 Description: **Roots Medium Joint**

Distance (ft): **21.6**  
 Structural Grade: **0**  
 O&M Grade: **3**  
 Clock Start/From: **2**  
 Clock To: **9**  
 1st Value:  
 2nd Value:  
 Value Percent: **10.000**  
 Continuous Index:  
 Within 8" of Joint: **YES**  
 Remarks:

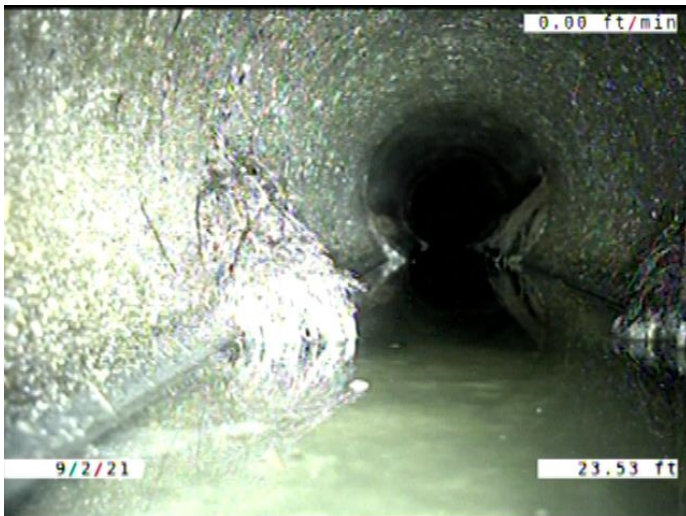
Code: **RFJ**  
 Description: **Roots Fine Joint**

Distance (ft): **23.5**  
 Structural Grade: **0**  
 O&M Grade: **1**  
 Clock Start/From: **3**  
 Clock To: **9**  
 1st Value:  
 2nd Value:  
 Value Percent:  
 Continuous Index: **F01**  
 Within 8" of Joint: **YES**  
 Remarks:

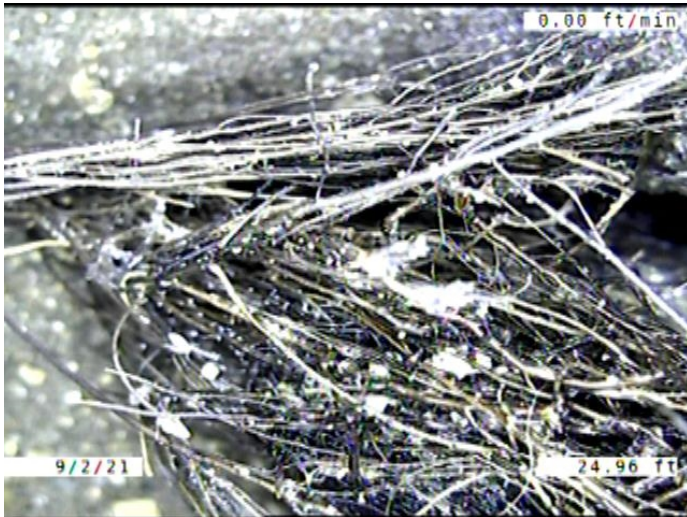
Code: **RMJ**  
 Description: **Roots Medium Joint**

Distance (ft): **25.0**  
 Structural Grade: **0**  
 O&M Grade: **3**  
 Clock Start/From: **7**  
 Clock To: **5**  
 1st Value:  
 2nd Value:  
 Value Percent: **5.000**  
 Continuous Index: **S02**  
 Within 8" of Joint: **YES**  
 Remarks:

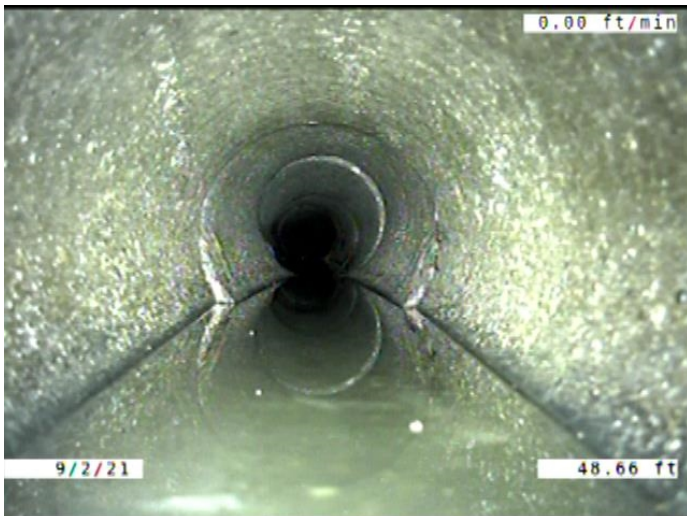
Code: **MWLS**  
 Description: **Miscellaneous Water Level Sag**

Distance (ft): **48.7**  
 Structural Grade: **2**  
 O&M Grade: **0**  
 Clock Start/From:  
 Clock To:  
 1st Value:  
 2nd Value:  
 Value Percent: **5.000**  
 Continuous Index:  
 Within 8" of Joint: **NO**  
 Remarks:

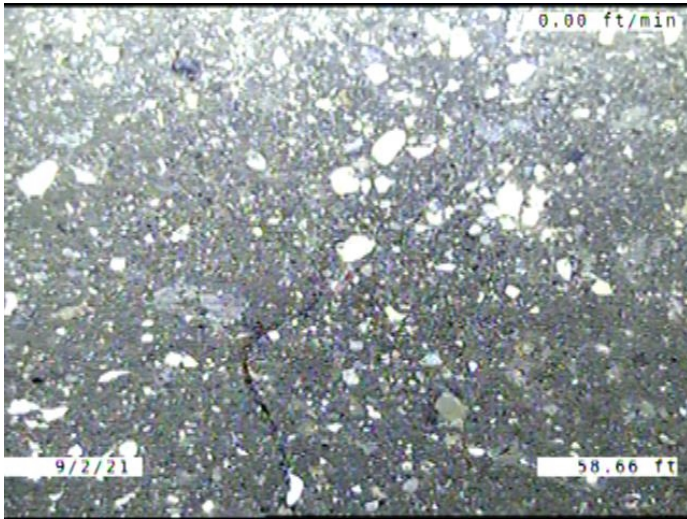
Code: **FM**  
 Description: **Fracture Multiple**

Distance (ft): **58.7**  
 Structural Grade: **4**  
 O&M Grade: **0**  
 Clock Start/From: **7**  
 Clock To: **5**  
 1st Value:  
 2nd Value:  
 Value Percent:  
 Continuous Index: **S03**  
 Within 8" of Joint: **YES**  
 Remarks:

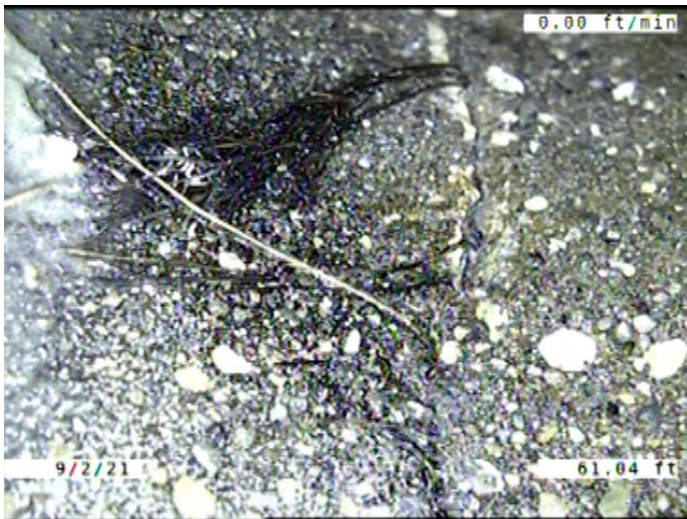
Code: **FL**  
 Description: **Fracture Longitudinal**

Distance (ft): **61.0**  
 Structural Grade: **3**  
 O&M Grade: **0**  
 Clock Start/From: **4**  
 Clock To:  
 1st Value:  
 2nd Value:  
 Value Percent:  
 Continuous Index:  
 Within 8" of Joint: **YES**  
 Remarks:

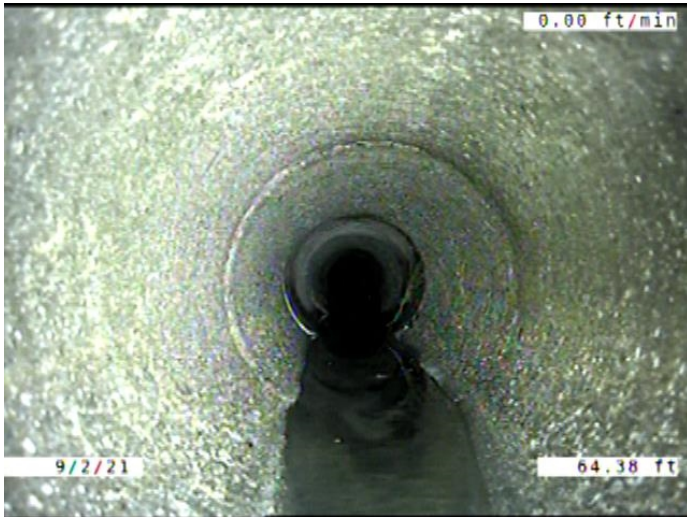
Code: **FM**  
Description: **Fracture Multiple**

Distance (ft): **64.4**  
Structural Grade: **4**  
O&M Grade: **0**  
Clock Start/From: **7**  
Clock To: **5**  
1st Value:  
2nd Value:  
Value Percent:  
Continuous Index: **F03**  
Within 8" of Joint: **YES**  
Remarks:

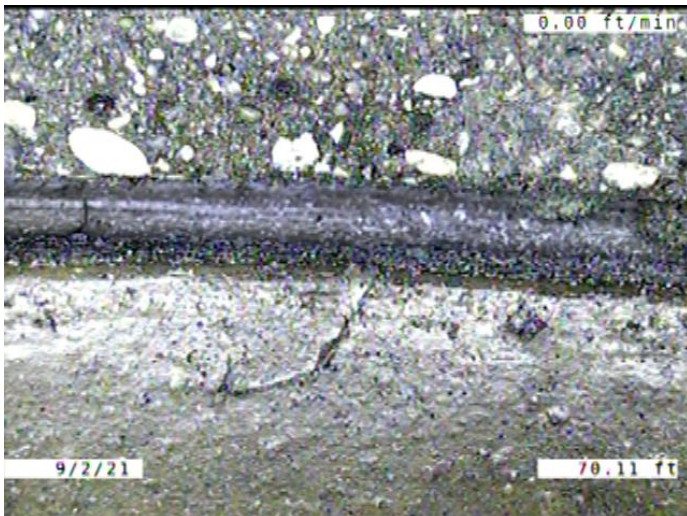
Code: **MMC**  
Description: **Miscellaneous Material Change**

Distance (ft): **70.1**  
Structural Grade: **0**  
O&M Grade: **0**  
Clock Start/From:  
Clock To:  
1st Value:  
2nd Value:  
Value Percent:  
Continuous Index:  
Within 8" of Joint: **NO**  
Remarks: **CONCRETE TO VCP**

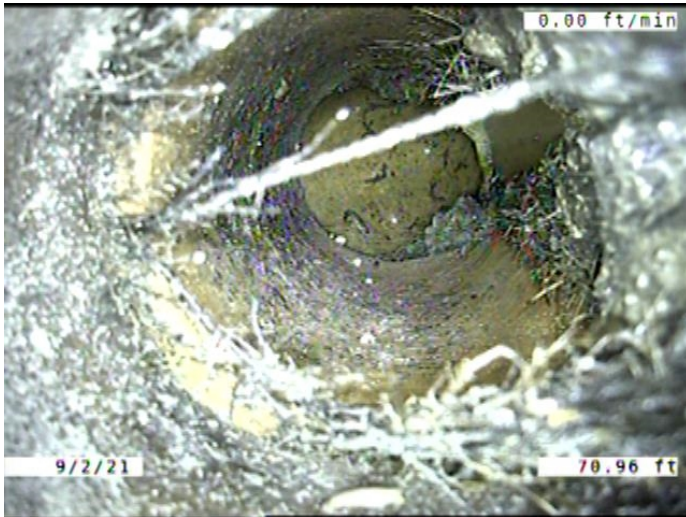
Code: **TF**  
Description: **Tap Factory**

Distance (ft): **71.0**  
Structural Grade: **0**  
O&M Grade: **0**  
Clock Start/From: **2**  
Clock To:  
1st Value: **6.000**  
2nd Value:  
Value Percent:  
Continuous Index:  
Within 8" of Joint: **YES**  
Remarks: **ROOTS GROWING IN THE TAP**

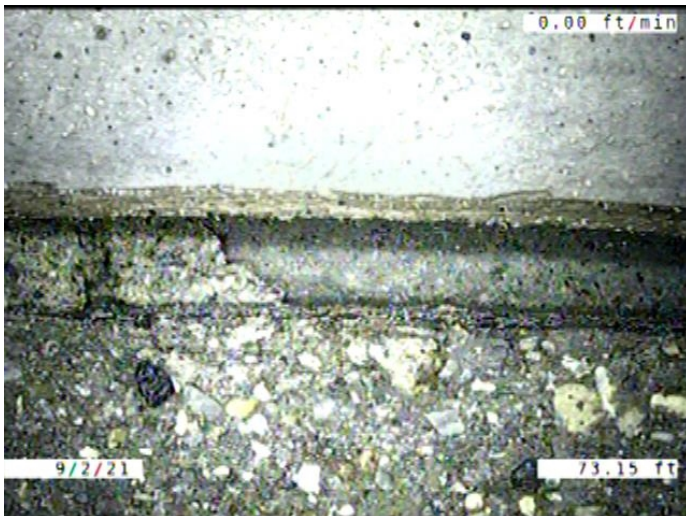
Code: **MMC**  
Description: **Miscellaneous Material Change**

Distance (ft): **73.1**  
Structural Grade: **0**  
O&M Grade: **0**  
Clock Start/From:  
Clock To:  
1st Value:  
2nd Value:  
Value Percent:  
Continuous Index:  
Within 8" of Joint: **NO**  
Remarks: **VCP TO CONCRETE**

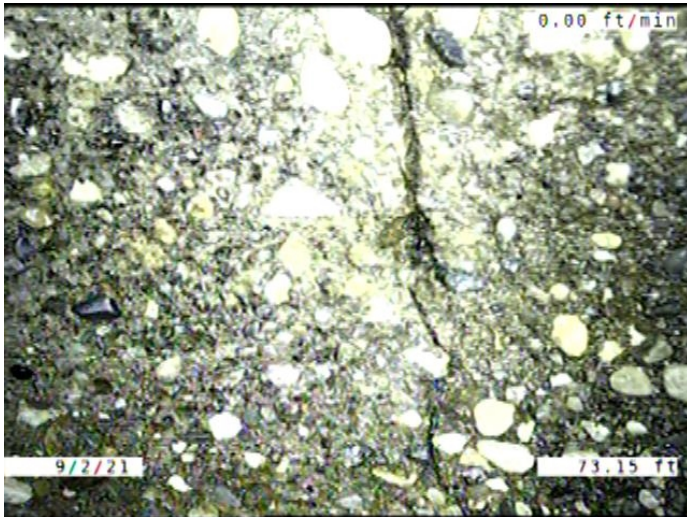
Code: **CM**  
 Description: **Crack Multiple**

Distance (ft): **73.1**  
 Structural Grade: **3**  
 O&M Grade: **0**  
 Clock Start/From: **3**  
 Clock To: **9**  
 1st Value:  
 2nd Value:  
 Value Percent:  
 Continuous Index:  
 Within 8" of Joint: **YES**  
 Remarks:

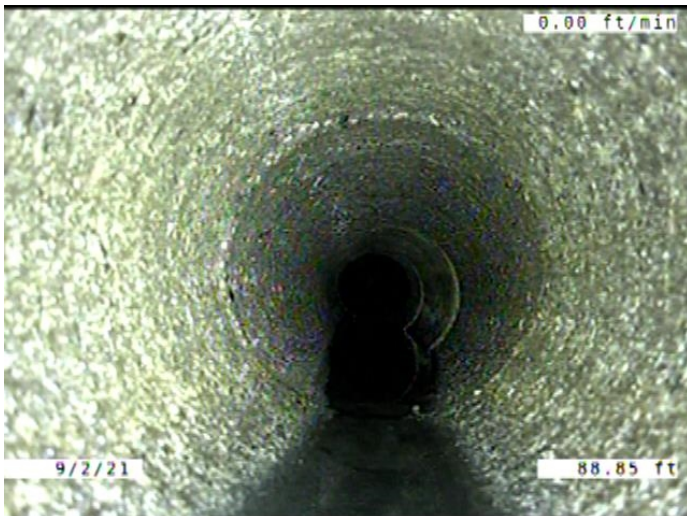
Code: **RMJ**  
 Description: **Roots Medium Joint**

Distance (ft): **88.9**  
 Structural Grade: **0**  
 O&M Grade: **3**  
 Clock Start/From: **7**  
 Clock To: **5**  
 1st Value:  
 2nd Value:  
 Value Percent: **5.000**  
 Continuous Index: **F02**  
 Within 8" of Joint: **YES**  
 Remarks:

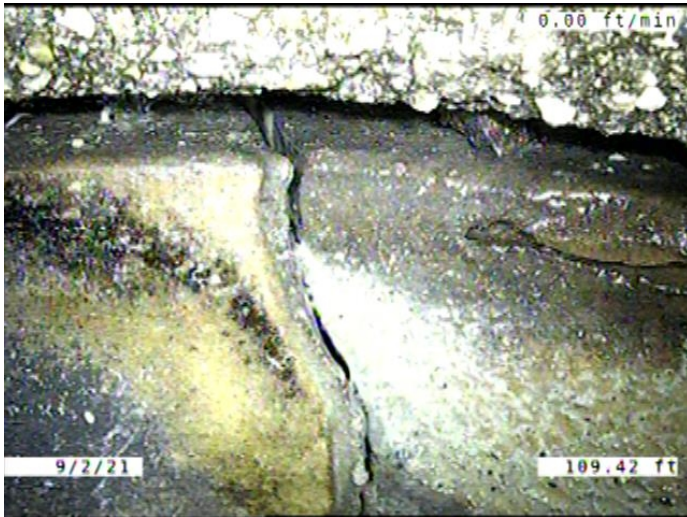
Code: **FM**  
 Description: **Fracture Multiple**

Distance (ft): **109.4**  
 Structural Grade: **4**  
 O&M Grade: **0**  
 Clock Start/From: **7**  
 Clock To: **5**  
 1st Value:  
 2nd Value:  
 Value Percent:  
 Continuous Index:  
 Within 8" of Joint: **YES**  
 Remarks:

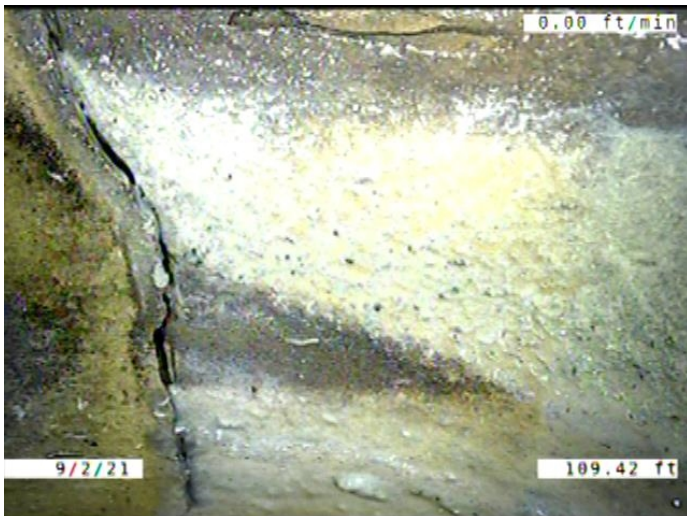
Code: **ISB**  
 Description: **Infiltration Stain Barrel**

Distance (ft): **109.4**  
 Structural Grade: **0**  
 O&M Grade: **1**  
 Clock Start/From: **2**  
 Clock To: **5**  
 1st Value:  
 2nd Value:  
 Value Percent:  
 Continuous Index:  
 Within 8" of Joint: **YES**  
 Remarks:

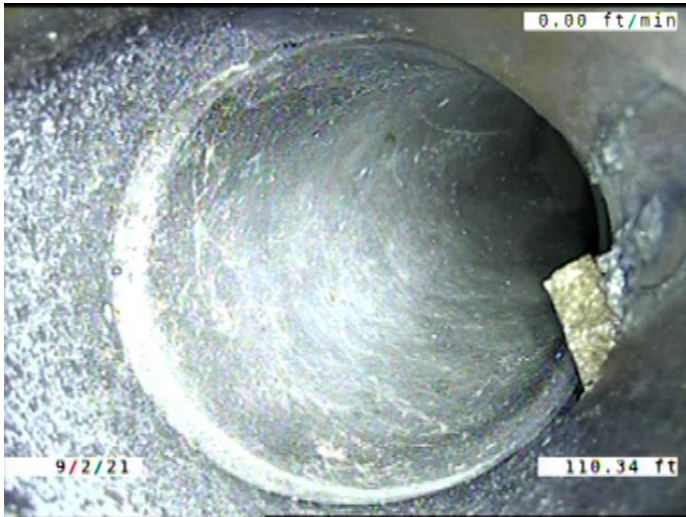
Code: **TFD**  
 Description: **Tap Factory Defective**

Distance (ft): **110.3**  
 Structural Grade: **0**  
 O&M Grade: **3**  
 Clock Start/From: **1**  
 Clock To:  
 1st Value: **6.000**  
 2nd Value:  
 Value Percent:  
 Continuous Index:  
 Within 8" of Joint: **YES**  
 Remarks: **Debris**

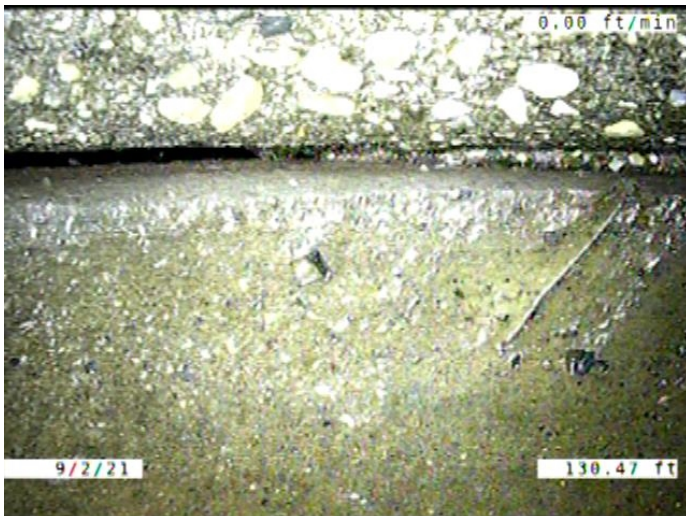
Code: **MMC**  
 Description: **Miscellaneous Material Change**

Distance (ft): **130.5**  
 Structural Grade: **0**  
 O&M Grade: **0**  
 Clock Start/From:  
 Clock To:  
 1st Value:  
 2nd Value:  
 Value Percent:  
 Continuous Index:  
 Within 8" of Joint: **NO**  
 Remarks: **CONCRETE TO VCP**

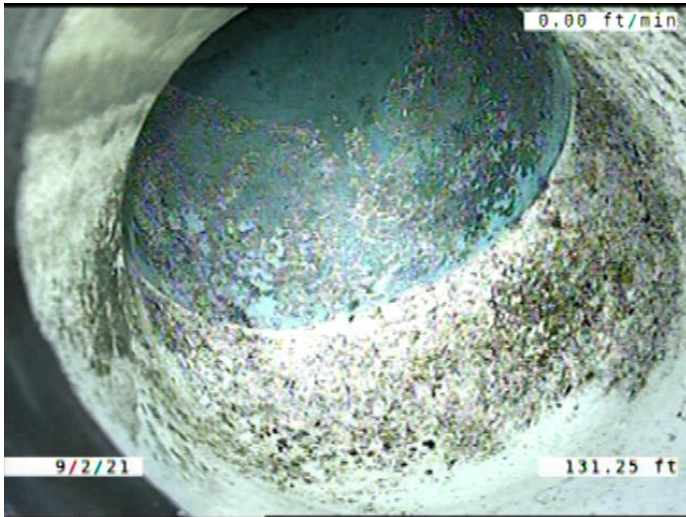
Code: **TF**  
 Description: **Tap Factory**

Distance (ft): **131.3**  
 Structural Grade: **0**  
 O&M Grade: **0**  
 Clock Start/From: **11**  
 Clock To:  
 1st Value: **6.000**  
 2nd Value:  
 Value Percent:  
 Continuous Index:  
 Within 8" of Joint: **YES**  
 Remarks:

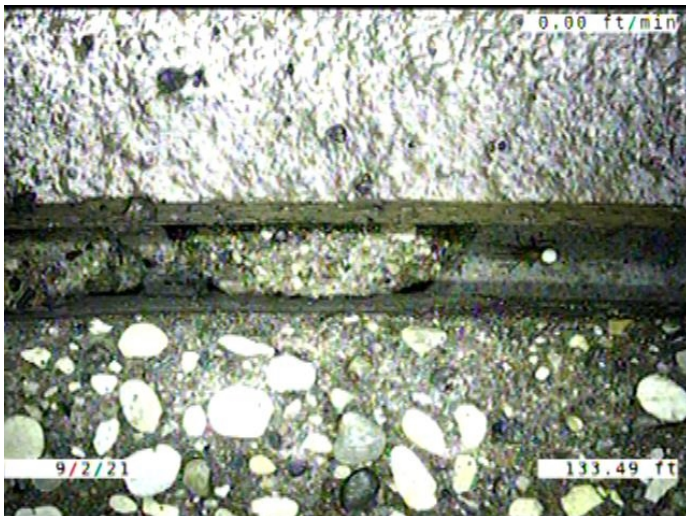
Code: **MMC**  
 Description: **Miscellaneous Material Change**

Distance (ft): **133.5**  
 Structural Grade: **0**  
 O&M Grade: **0**  
 Clock Start/From:  
 Clock To:  
 1st Value:  
 2nd Value:  
 Value Percent:  
 Continuous Index:  
 Within 8" of Joint: **NO**  
 Remarks: **VCP TO CONCRETE**

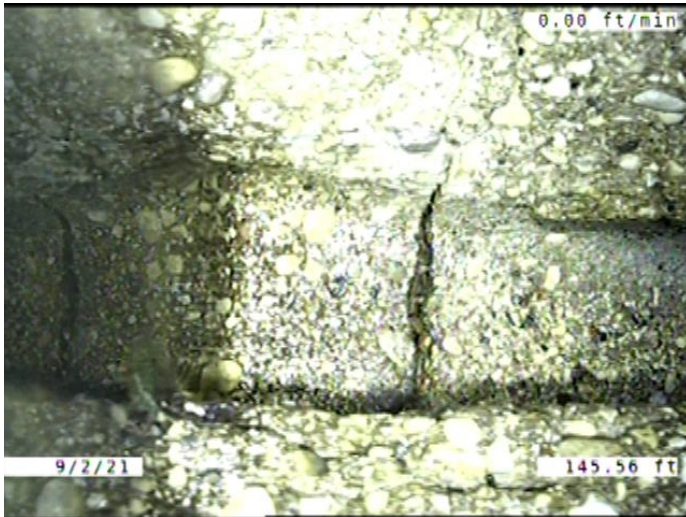
Code: **FL**  
 Description: **Fracture Longitudinal**

Distance (ft): **145.6**  
 Structural Grade: **3**  
 O&M Grade: **0**  
 Clock Start/From: **3**  
 Clock To:  
 1st Value:  
 2nd Value:  
 Value Percent:  
 Continuous Index:  
 Within 8" of Joint: **YES**  
 Remarks:

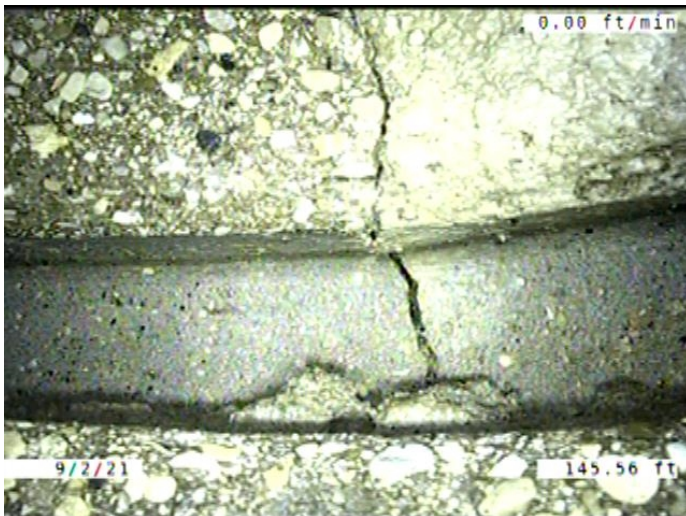
Code: **FL**  
 Description: **Fracture Longitudinal**

Distance (ft): **145.6**  
 Structural Grade: **3**  
 O&M Grade: **0**  
 Clock Start/From: **10**  
 Clock To:  
 1st Value:  
 2nd Value:  
 Value Percent:  
 Continuous Index:  
 Within 8" of Joint: **YES**  
 Remarks:

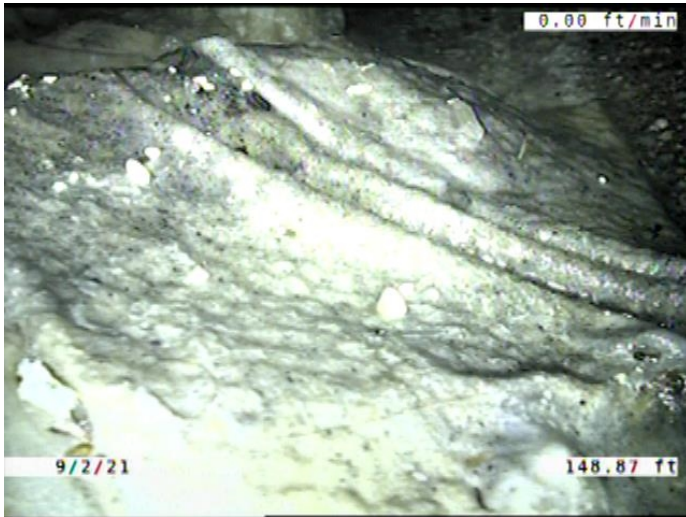
Code: **DAR**  
 Description: **Deposits Attached Ragging**

Distance (ft): **148.9**  
 Structural Grade: **0**  
 O&M Grade: **2**  
 Clock Start/From: **4**  
 Clock To: **7**  
 1st Value:  
 2nd Value:  
 Value Percent: **5.000**  
 Continuous Index:  
 Within 8" of Joint: **YES**  
 Remarks:

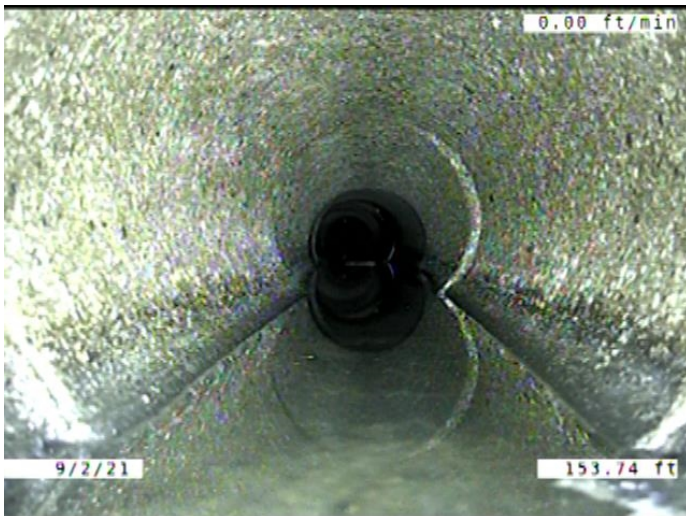
Code: **DSF**  
 Description: **Deposits Settled Fine**

Distance (ft): **153.7**  
 Structural Grade: **0**  
 O&M Grade: **2**  
 Clock Start/From: **5**  
 Clock To: **7**  
 1st Value:  
 2nd Value:  
 Value Percent: **5.000**  
 Continuous Index: **S04**  
 Within 8" of Joint: **YES**  
 Remarks:

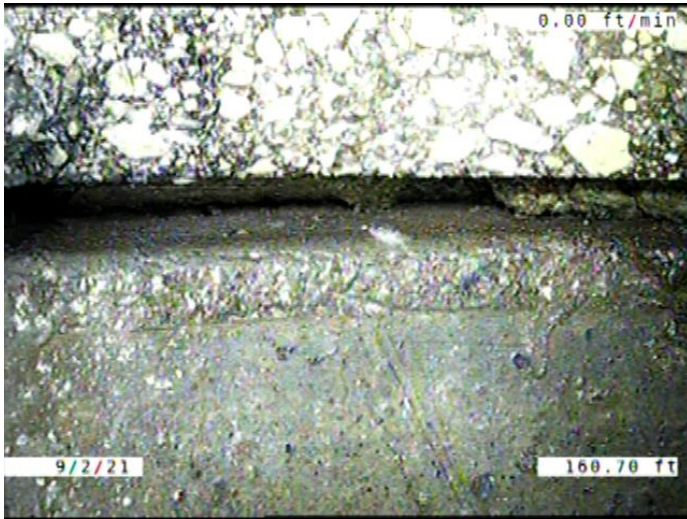
Code: **MMC**  
 Description: **Miscellaneous Material Change**

Distance (ft): **160.7**  
 Structural Grade: **0**  
 O&M Grade: **0**  
 Clock Start/From:  
 Clock To:  
 1st Value:  
 2nd Value:  
 Value Percent:  
 Continuous Index:  
 Within 8" of Joint: **NO**  
 Remarks: **CONCRETE TO VCP**

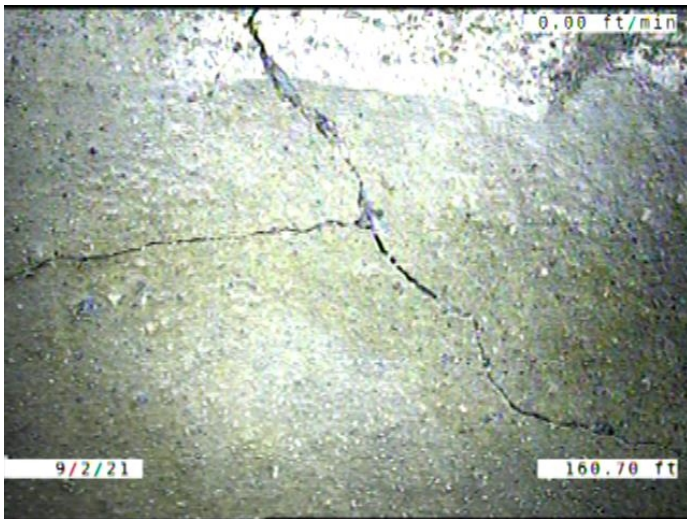
Code: **FM**  
 Description: **Fracture Multiple**

Distance (ft): **160.7**  
 Structural Grade: **4**  
 O&M Grade: **0**  
 Clock Start/From: **11**  
 Clock To: **3**  
 1st Value:  
 2nd Value:  
 Value Percent:  
 Continuous Index:  
 Within 8" of Joint: **YES**  
 Remarks:

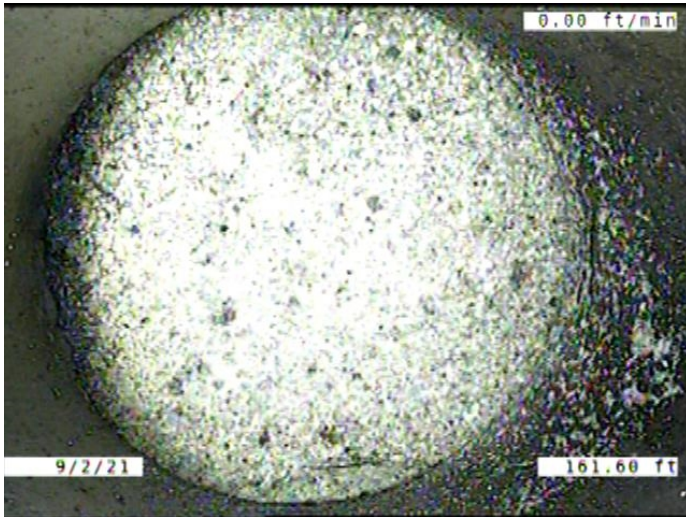
Code: **TFC**  
 Description: **Tap Factory Capped**

Distance (ft): **161.6**  
 Structural Grade: **0**  
 O&M Grade: **0**  
 Clock Start/From: **10**  
 Clock To:  
 1st Value: **6.000**  
 2nd Value:  
 Value Percent:  
 Continuous Index:  
 Within 8" of Joint: **YES**  
 Remarks:

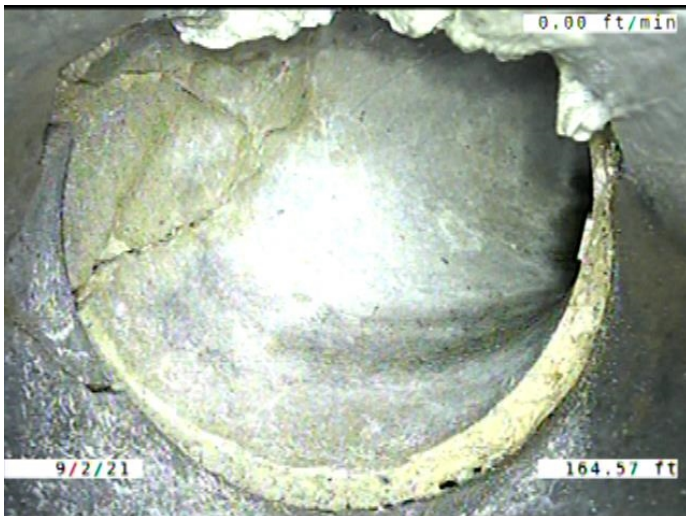
Code: **TFD**  
 Description: **Tap Factory Defective**

Distance (ft): **164.6**  
 Structural Grade: **0**  
 O&M Grade: **3**  
 Clock Start/From: **1**  
 Clock To:  
 1st Value: **6.000**  
 2nd Value:  
 Value Percent:  
 Continuous Index:  
 Within 8" of Joint: **YES**  
 Remarks: **Debris**

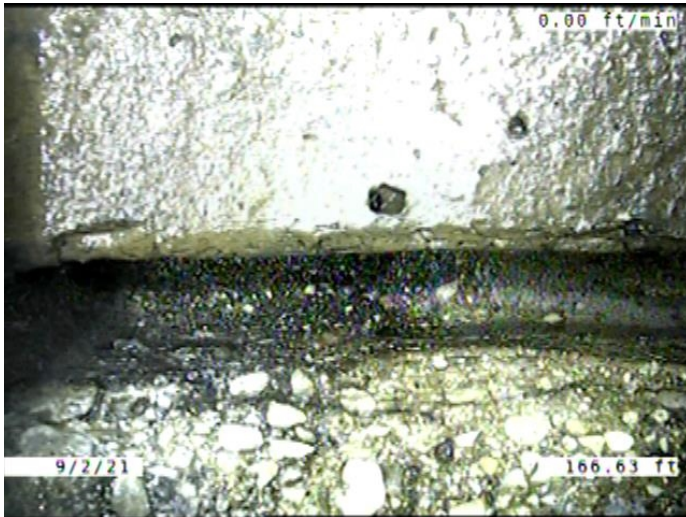
Code: **MMC**  
 Description: **Miscellaneous Material Change**

Distance (ft): **166.6**  
 Structural Grade: **0**  
 O&M Grade: **0**  
 Clock Start/From:  
 Clock To:  
 1st Value:  
 2nd Value:  
 Value Percent:  
 Continuous Index:  
 Within 8" of Joint: **NO**  
 Remarks: **VCP TO CONCRETE**

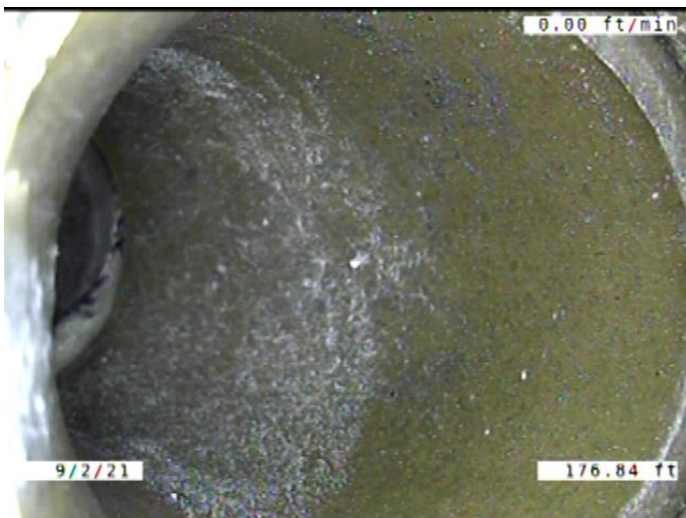
Code: **TBI**  
 Description: **Tap Break-in Intruding**

Distance (ft): **176.8**  
 Structural Grade: **0**  
 O&M Grade: **2**  
 Clock Start/From: **11**  
 Clock To:  
 1st Value: **6.000**  
 2nd Value: **1.000**  
 Value Percent:  
 Continuous Index:  
 Within 8" of Joint: **NO**  
 Remarks:

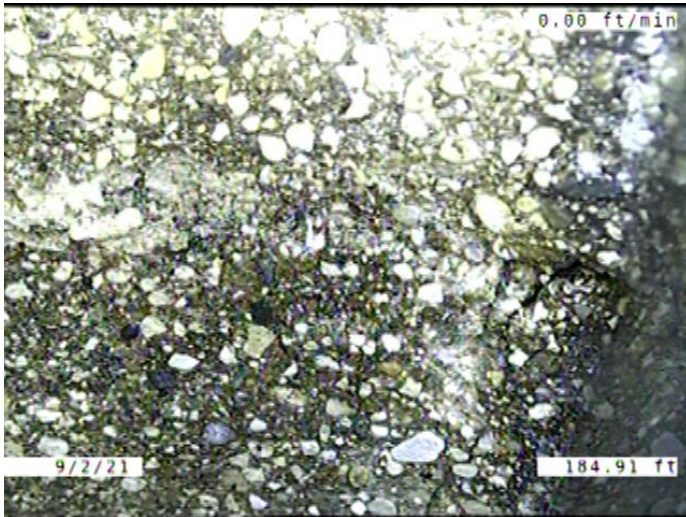
Code: **CM**  
 Description: **Crack Multiple**

Distance (ft): **184.9**  
 Structural Grade: **3**  
 O&M Grade: **0**  
 Clock Start/From: **8**  
 Clock To: **4**  
 1st Value:  
 2nd Value:  
 Value Percent:  
 Continuous Index:  
 Within 8" of Joint: **YES**  
 Remarks:

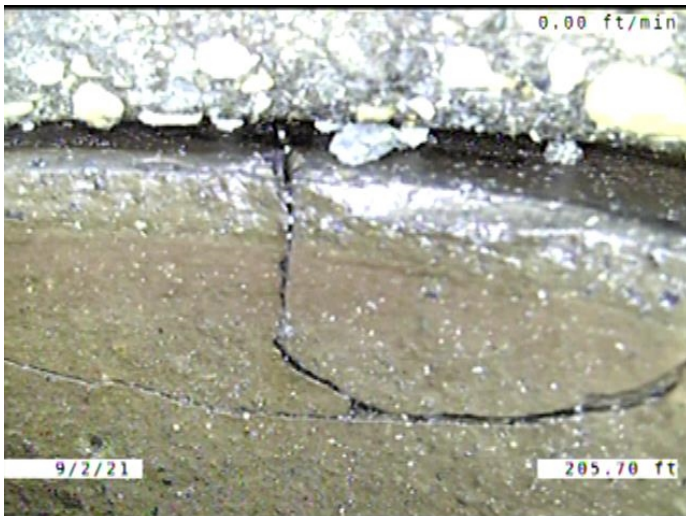
Code: **FM**  
 Description: **Fracture Multiple**

Distance (ft): **205.7**  
 Structural Grade: **4**  
 O&M Grade: **0**  
 Clock Start/From: **1**  
 Clock To: **4**  
 1st Value:  
 2nd Value:  
 Value Percent:  
 Continuous Index:  
 Within 8" of Joint: **YES**  
 Remarks:

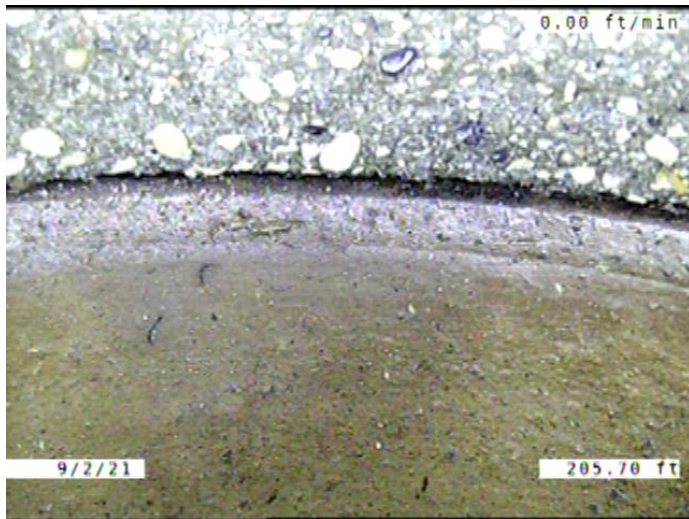
Code: **MMC**  
 Description: **Miscellaneous Material Change**

Distance (ft): **205.7**  
 Structural Grade: **0**  
 O&M Grade: **0**  
 Clock Start/From:  
 Clock To:  
 1st Value:  
 2nd Value:  
 Value Percent:  
 Continuous Index:  
 Within 8" of Joint: **NO**  
 Remarks: **CONCRETE TO VCP**

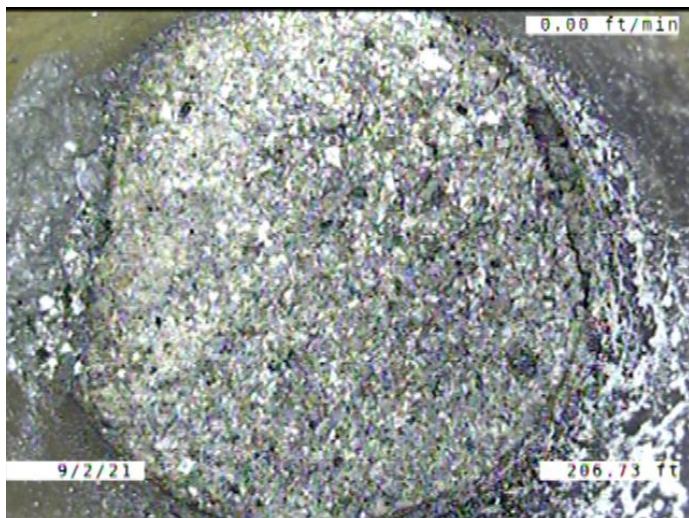
Code: **TFC**  
 Description: **Tap Factory Capped**

Distance (ft): **206.7**  
 Structural Grade: **0**  
 O&M Grade: **0**  
 Clock Start/From: **10**  
 Clock To:  
 1st Value: **6.000**  
 2nd Value:  
 Value Percent:  
 Continuous Index:  
 Within 8" of Joint: **YES**  
 Remarks:

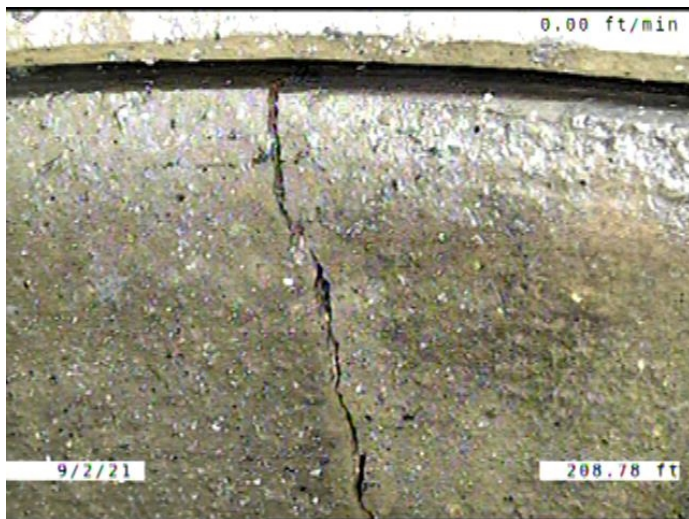
Code: **FS**  
 Description: **Fracture Spiral**

Distance (ft): **208.8**  
 Structural Grade: **3**  
 O&M Grade: **0**  
 Clock Start/From: **2**  
 Clock To: **3**  
 1st Value:  
 2nd Value:  
 Value Percent:  
 Continuous Index:  
 Within 8" of Joint: **YES**  
 Remarks:

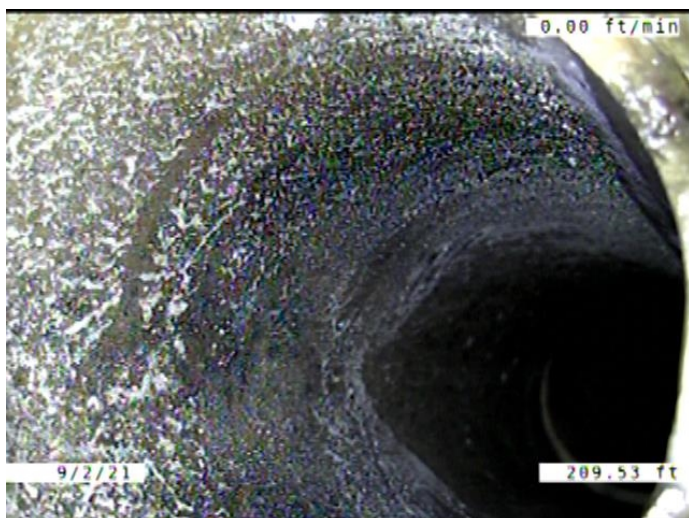
Code: **TFD**  
 Description: **Tap Factory Defective**

Distance (ft): **209.5**  
 Structural Grade: **0**  
 O&M Grade: **3**  
 Clock Start/From: **2**  
 Clock To:  
 1st Value: **6.000**  
 2nd Value:  
 Value Percent:  
 Continuous Index:  
 Within 8" of Joint: **YES**  
 Remarks: **Debris**

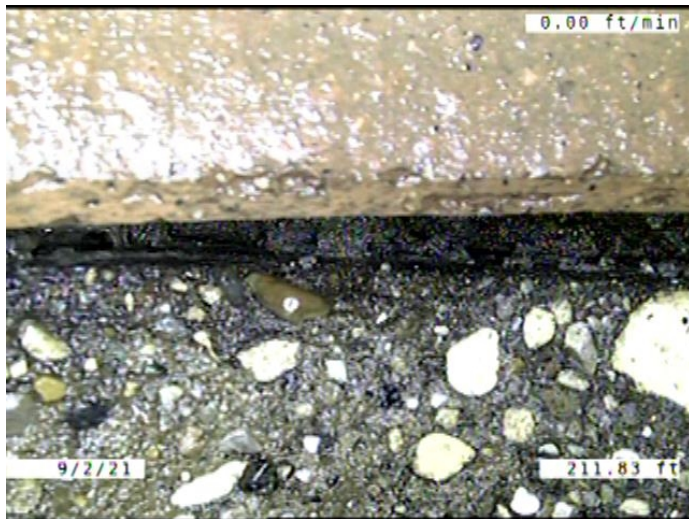
Code: **MMC**  
 Description: **Miscellaneous Material Change**

Distance (ft): **211.8**  
 Structural Grade: **0**  
 O&M Grade: **0**  
 Clock Start/From:  
 Clock To:  
 1st Value:  
 2nd Value:  
 Value Percent:  
 Continuous Index:  
 Within 8" of Joint: **NO**  
 Remarks: **VCP TO CONCRETE**

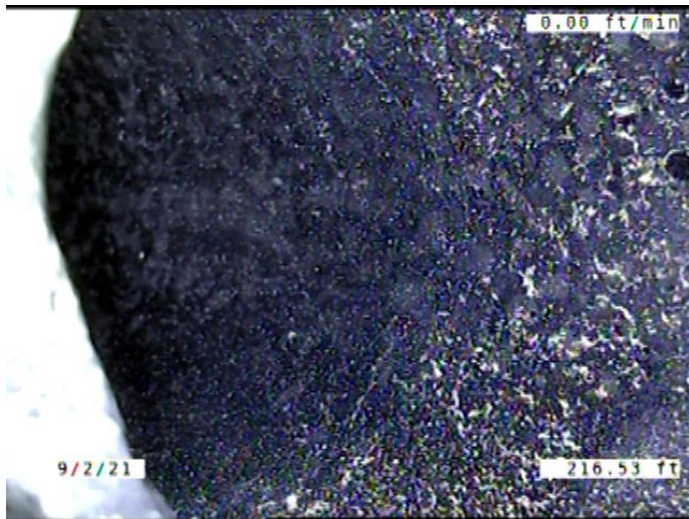
Code: **TBI**  
 Description: **Tap Break-in Intruding**

Distance (ft): **216.5**  
 Structural Grade: **0**  
 O&M Grade: **2**  
 Clock Start/From: **11**  
 Clock To:  
 1st Value: **6.000**  
 2nd Value: **1.000**  
 Value Percent:  
 Continuous Index:  
 Within 8" of Joint: **YES**  
 Remarks: **ACTIVE**

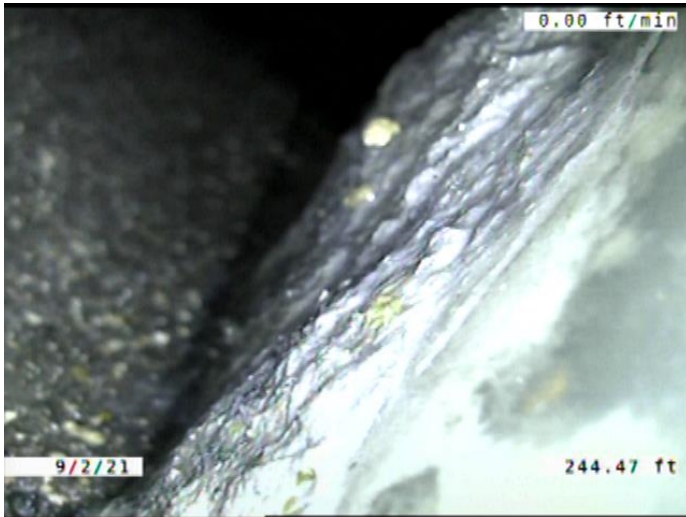
Code: **OBZ**  
 Description: **Obstruction Other**

Distance (ft): **244.5**  
 Structural Grade: **0**  
 O&M Grade: **2**  
 Clock Start/From: **4**  
 Clock To: **8**  
 1st Value:  
 2nd Value:  
 Value Percent: **10.000**  
 Continuous Index: **S05**  
 Within 8" of Joint: **YES**  
 Remarks: **TP AND RAGS**

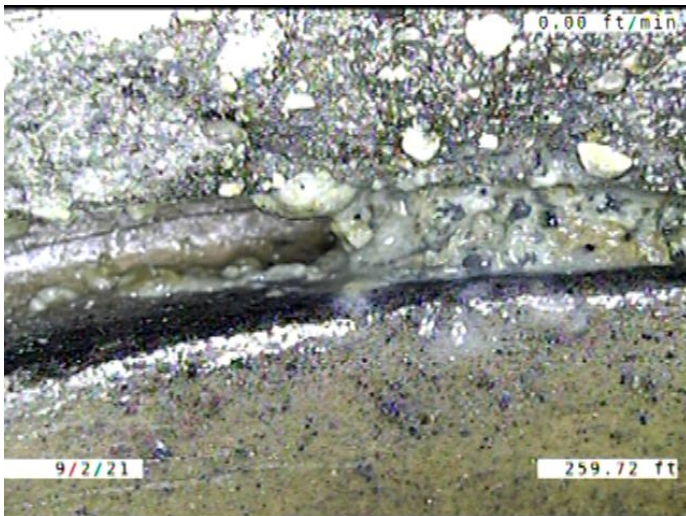
Code: **MMC**  
 Description: **Miscellaneous Material Change**

Distance (ft): **259.7**  
 Structural Grade: **0**  
 O&M Grade: **0**  
 Clock Start/From:  
 Clock To:  
 1st Value:  
 2nd Value:  
 Value Percent:  
 Continuous Index:  
 Within 8" of Joint: **NO**  
 Remarks: **CONCRETE TO VCP**

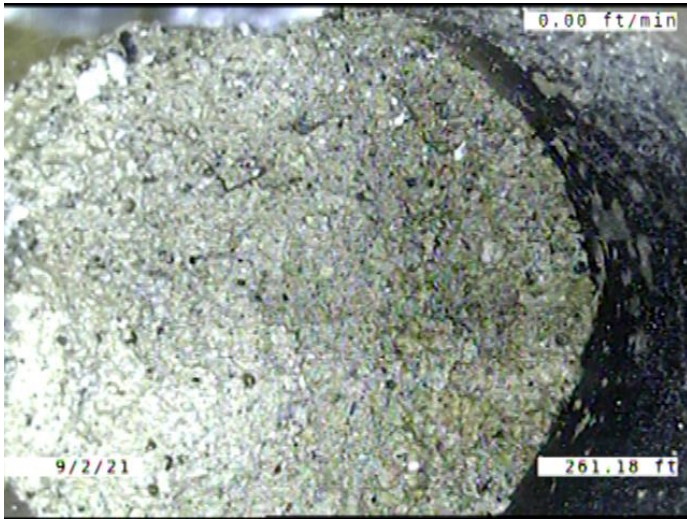
Code: **TFD**  
 Description: **Tap Factory Defective**

Distance (ft): **261.2**  
 Structural Grade: **0**  
 O&M Grade: **3**  
 Clock Start/From: **10**  
 Clock To:  
 1st Value: **6.000**  
 2nd Value:  
 Value Percent:  
 Continuous Index:  
 Within 8" of Joint: **YES**  
 Remarks: **Debris**

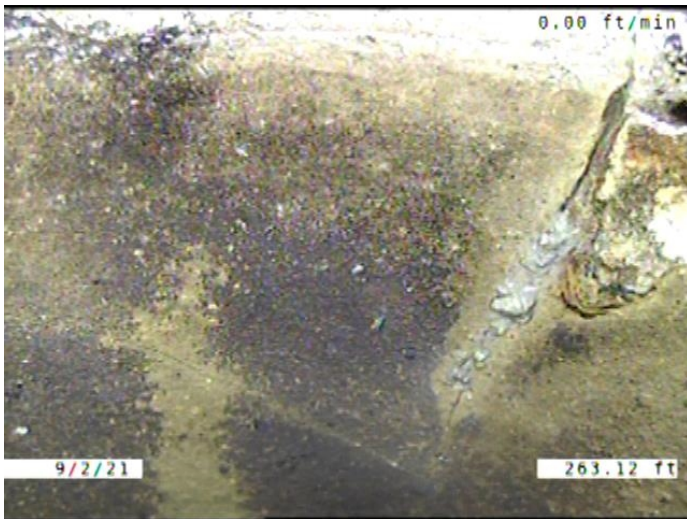
Code: **FM**  
 Description: **Fracture Multiple**

Distance (ft): **263.1**  
 Structural Grade: **4**  
 O&M Grade: **0**  
 Clock Start/From: **11**  
 Clock To: **1**  
 1st Value:  
 2nd Value:  
 Value Percent:  
 Continuous Index:  
 Within 8" of Joint: **YES**  
 Remarks:

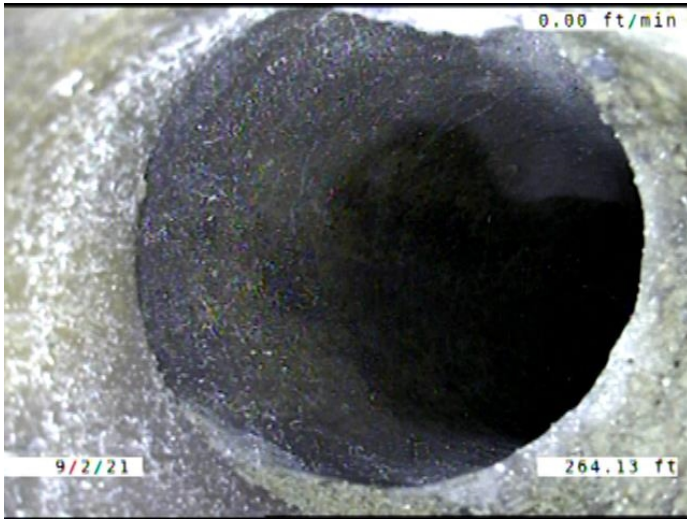
Code: **TF**  
 Description: **Tap Factory**

Distance (ft): **264.1**  
 Structural Grade: **0**  
 O&M Grade: **0**  
 Clock Start/From: **2**  
 Clock To:  
 1st Value: **6.000**  
 2nd Value:  
 Value Percent:  
 Continuous Index:  
 Within 8" of Joint: **YES**  
 Remarks:

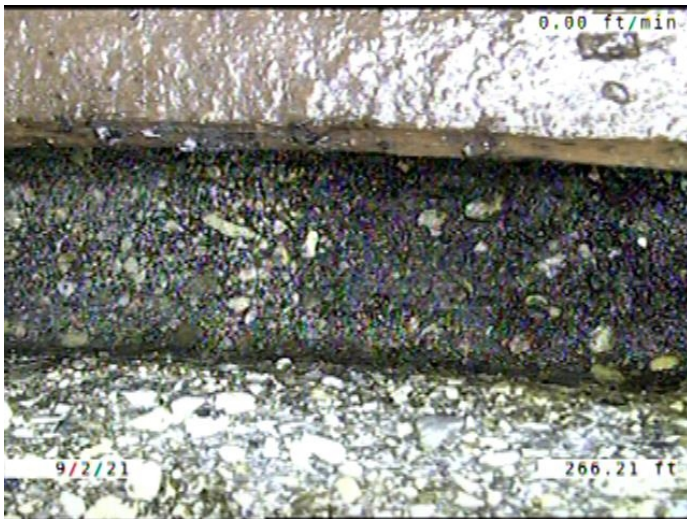
Code: **JAM**  
 Description: **Joint Angular Medium**

Distance (ft): **266.2**  
 Structural Grade: **3**  
 O&M Grade: **0**  
 Clock Start/From:  
 Clock To:  
 1st Value:  
 2nd Value:  
 Value Percent:  
 Continuous Index:  
 Within 8" of Joint: **NO**  
 Remarks:

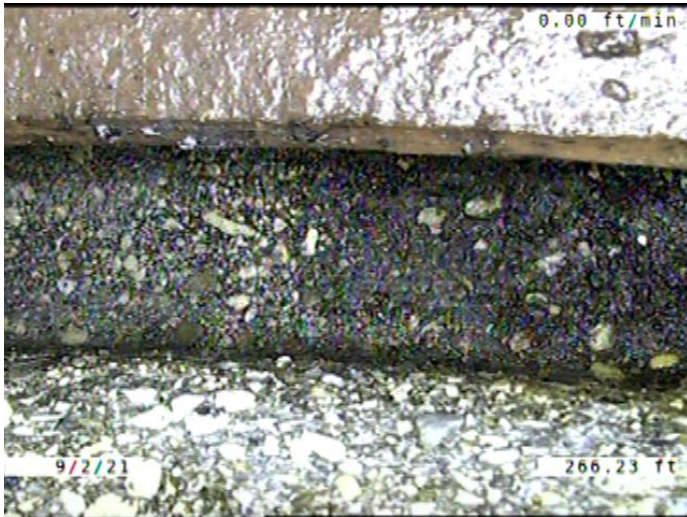
Code: **MMC**  
 Description: **Miscellaneous Material Change**

Distance (ft): **266.2**  
 Structural Grade: **0**  
 O&M Grade: **0**  
 Clock Start/From:  
 Clock To:  
 1st Value:  
 2nd Value:  
 Value Percent:  
 Continuous Index:  
 Within 8" of Joint: **NO**  
 Remarks: **VCP TO CONCRETE**

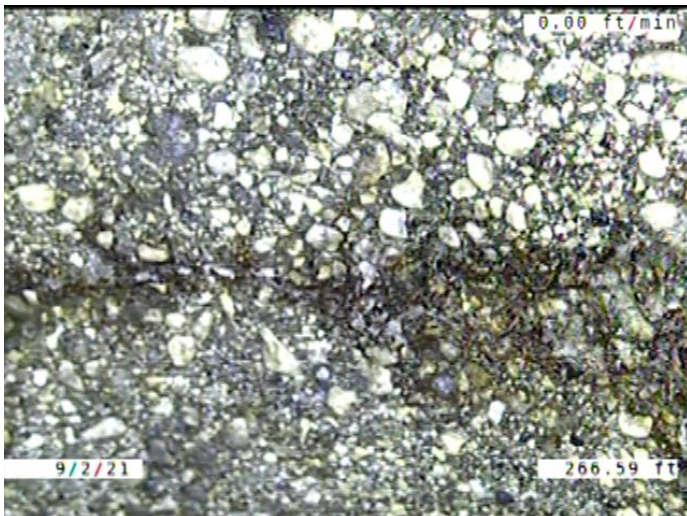
Code: **CM**  
 Description: **Crack Multiple**

Distance (ft): **266.6**  
 Structural Grade: **3**  
 O&M Grade: **0**  
 Clock Start/From: **10**  
 Clock To: **3**  
 1st Value:  
 2nd Value:  
 Value Percent:  
 Continuous Index:  
 Within 8" of Joint: **YES**  
 Remarks:

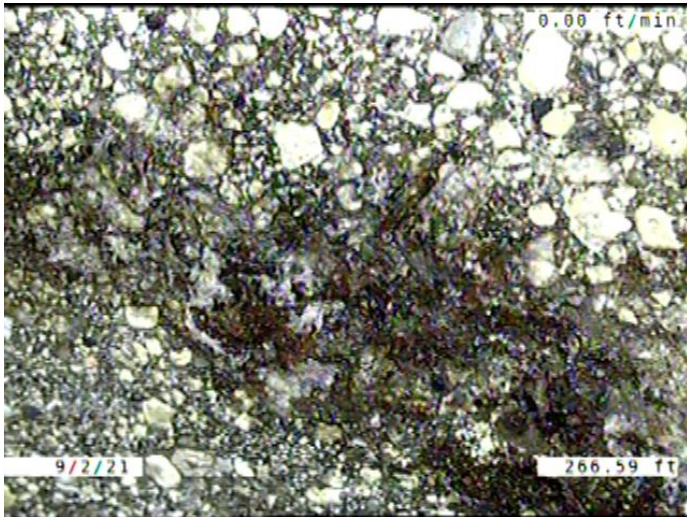
Code: **ISB**  
 Description: **Infiltration Stain Barrel**

Distance (ft): **266.6**  
 Structural Grade: **0**  
 O&M Grade: **1**  
 Clock Start/From: **10**  
 Clock To: **3**  
 1st Value:  
 2nd Value:  
 Value Percent:  
 Continuous Index:  
 Within 8" of Joint: **YES**  
 Remarks:

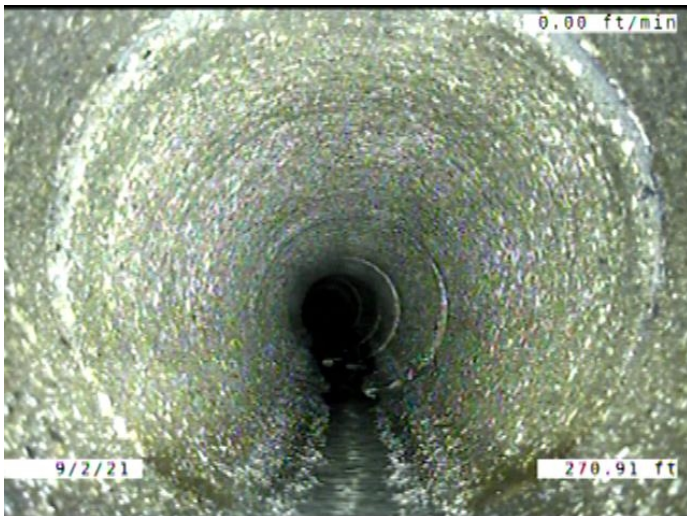
Code: **OBZ**  
 Description: **Obstruction Other**

Distance (ft): **270.9**  
 Structural Grade: **0**  
 O&M Grade: **2**  
 Clock Start/From: **4**  
 Clock To: **8**  
 1st Value:  
 2nd Value:  
 Value Percent: **10.000**  
 Continuous Index: **F05**  
 Within 8" of Joint: **YES**  
 Remarks: **TP AND RAGS**
