# Profile/Photo Observation Report

Date:	09/02/2021	Weather:		Coding:	PACP 7.0
Pipe Length (ft):	357.6	Owner:	City of Hobart	Pre Clean:	Light Cleaning
P.O.#:	YES502259	Surveyor:	S. Bucklin	PSR:	P-504-126-127
Customer:	City of Hobart	Clean Date:	08/30/2021	Shape:	C

Street:	North Wilson Street	Flow Control:	Not Controlled
City:	Hobart, IN	Year Renewed:	
Location:	Alley	Tape/Media #:	
Purpose:	Routine Assessment	Dia/Height:	10"
Use:	Sanitary Sewage Pipe	Material:	CP
Drain Area:		Lining:	
Category:	NA		
Comment:			
Location Details:		Direction of Survey:	Downstream
US MH:	M-504-127	DS MH:	M-504-126
		Total Length Surveyed (ft):	357.6

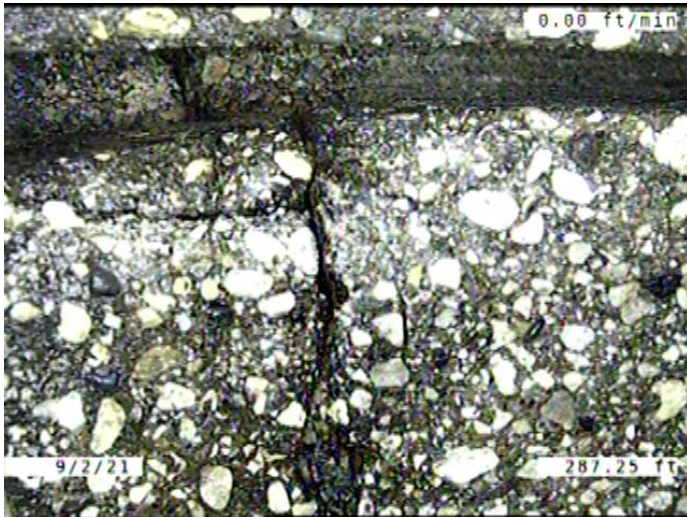
Code: **FM**  
 Description: **Fracture Multiple**

Distance (ft): **287.3**  
 Structural Grade: **4**  
 O&M Grade: **0**  
 Clock Start/From: **8**  
 Clock To: **9**  
 1st Value:  
 2nd Value:  
 Value Percent:  
 Continuous Index:  
 Within 8" of Joint: **YES**  
 Remarks:

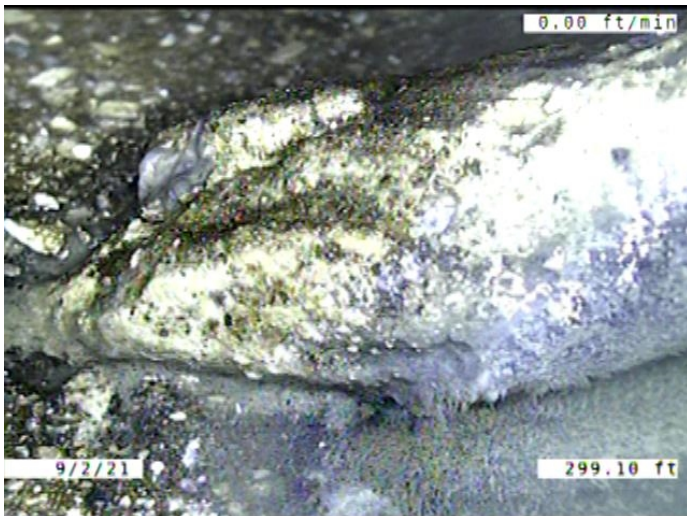
Code: **DAE**  
 Description: **Deposits Attached Encrustation**

Distance (ft): **299.1**  
 Structural Grade: **0**  
 O&M Grade: **2**  
 Clock Start/From: **4**  
 Clock To: **8**  
 1st Value:  
 2nd Value:  
 Value Percent: **5.000**  
 Continuous Index:  
 Within 8" of Joint: **YES**  
 Remarks:

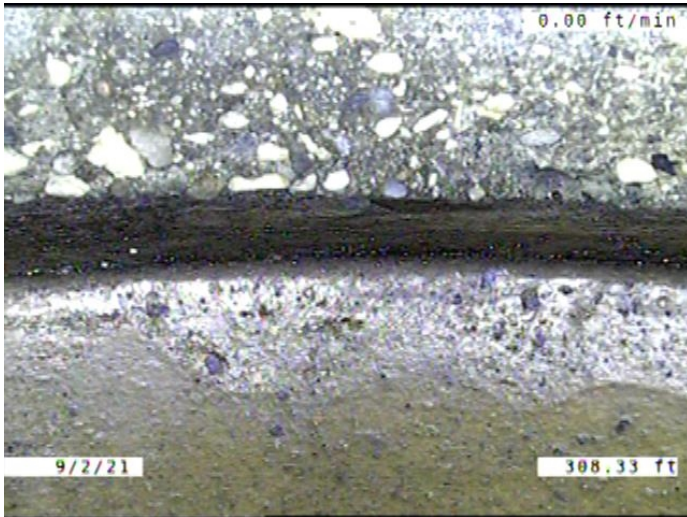
Code: **MMC**  
 Description: **Miscellaneous Material Change**

Distance (ft): **308.3**  
 Structural Grade: **0**  
 O&M Grade: **0**  
 Clock Start/From:  
 Clock To:  
 1st Value:  
 2nd Value:  
 Value Percent:  
 Continuous Index:  
 Within 8" of Joint: **NO**  
 Remarks: **CONCRETE TO VCP**

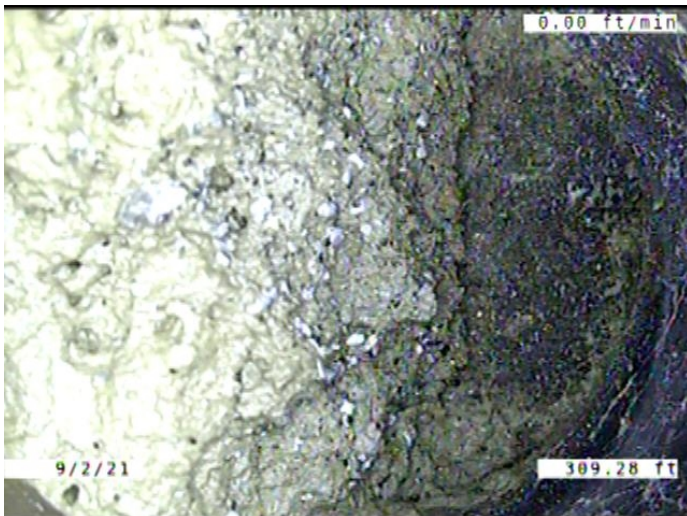
Code: **TFC**  
 Description: **Tap Factory Capped**

Distance (ft): **309.3**  
 Structural Grade: **0**  
 O&M Grade: **0**  
 Clock Start/From: **10**  
 Clock To:  
 1st Value: **6.000**  
 2nd Value:  
 Value Percent:  
 Continuous Index:  
 Within 8" of Joint: **YES**  
 Remarks:

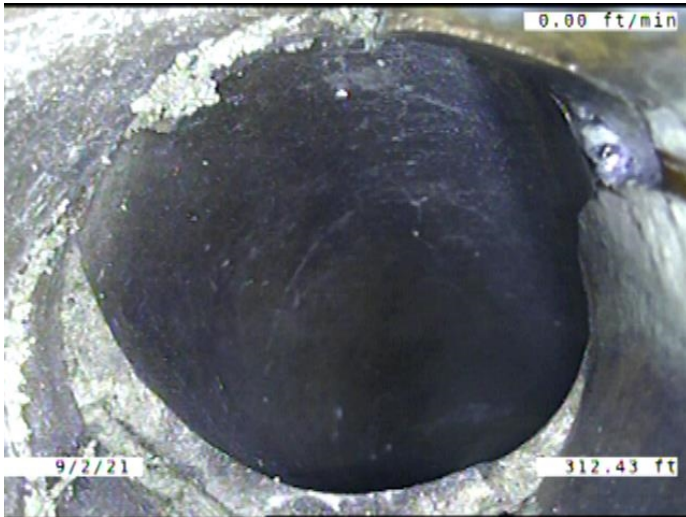
Code: **TFD**  
 Description: **Tap Factory Defective**

Distance (ft): **312.4**  
 Structural Grade: **0**  
 O&M Grade: **3**  
 Clock Start/From: **2**  
 Clock To:  
 1st Value: **6.000**  
 2nd Value:  
 Value Percent:  
 Continuous Index:  
 Within 8" of Joint: **YES**  
 Remarks: **Debris**

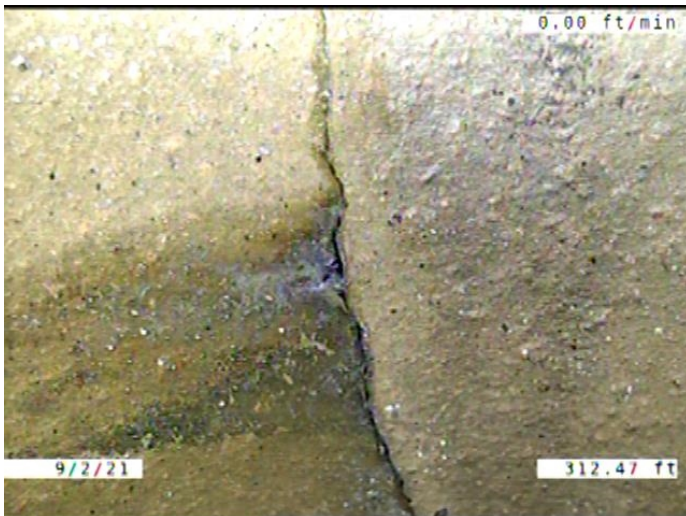
Code: **CS**  
 Description: **Crack Spiral**

Distance (ft): **312.5**  
 Structural Grade: **2**  
 O&M Grade: **0**  
 Clock Start/From: **9**  
 Clock To: **10**  
 1st Value:  
 2nd Value:  
 Value Percent:  
 Continuous Index:  
 Within 8" of Joint: **YES**  
 Remarks:

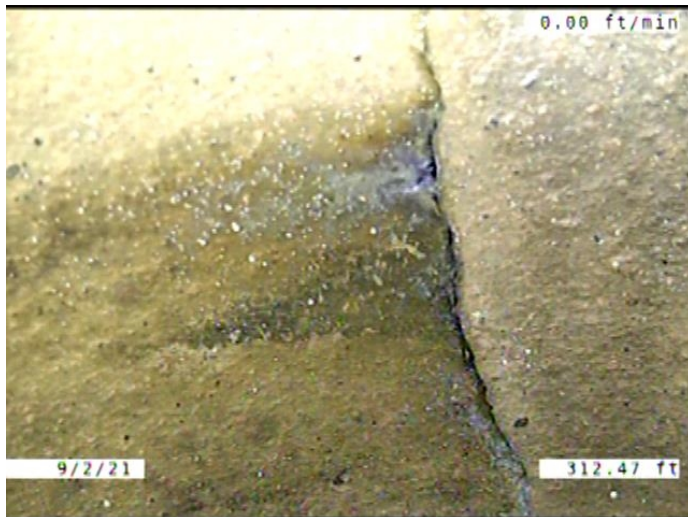
Code: **ISB**  
 Description: **Infiltration Stain Barrel**

Distance (ft): **312.5**  
 Structural Grade: **0**  
 O&M Grade: **1**  
 Clock Start/From: **7**  
 Clock To: **10**  
 1st Value:  
 2nd Value:  
 Value Percent:  
 Continuous Index:  
 Within 8" of Joint: **YES**  
 Remarks:

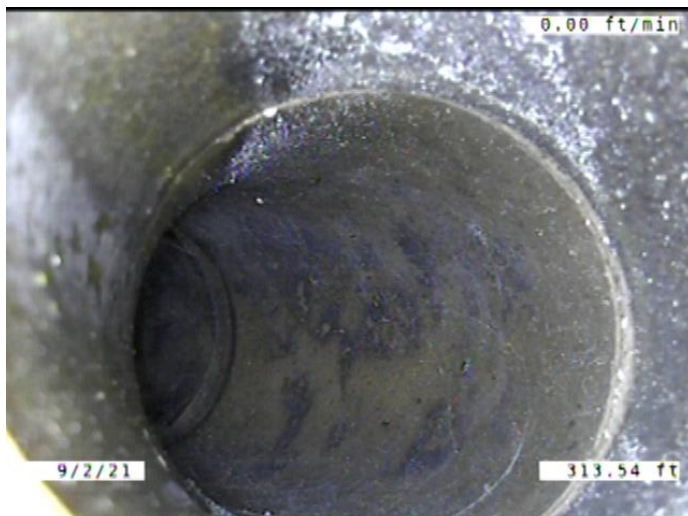
Code: **TB**  
 Description: **Tap Break-in/Hammer**

Distance (ft): **313.5**  
 Structural Grade: **0**  
 O&M Grade: **0**  
 Clock Start/From: **11**  
 Clock To:  
 1st Value: **6.000**  
 2nd Value:  
 Value Percent:  
 Continuous Index:  
 Within 8" of Joint: **YES**  
 Remarks:

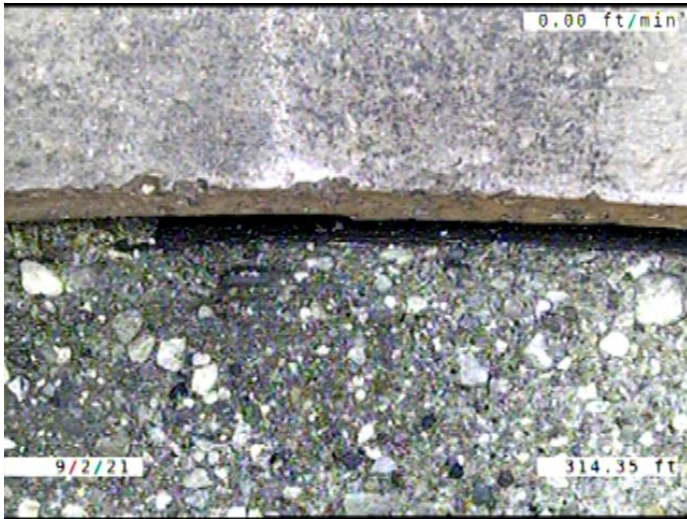
Code: **MMC**  
 Description: **Miscellaneous Material Change**

Distance (ft): **314.4**  
 Structural Grade: **0**  
 O&M Grade: **0**  
 Clock Start/From:  
 Clock To:  
 1st Value:  
 2nd Value:  
 Value Percent:  
 Continuous Index:  
 Within 8" of Joint: **NO**  
 Remarks: **VCP TO CONCRETE**

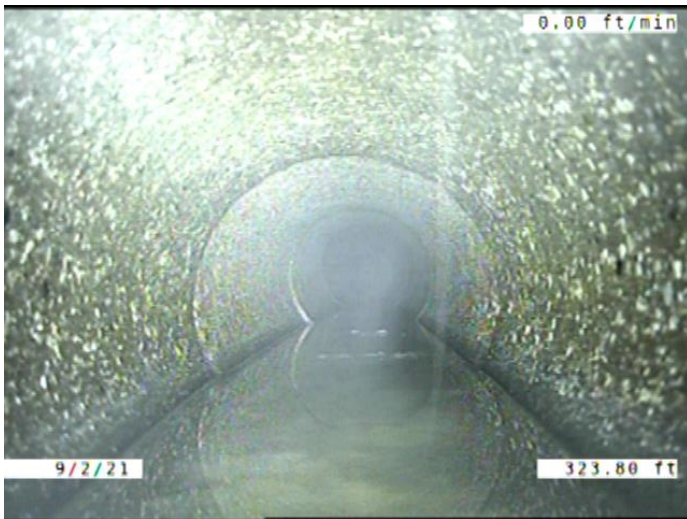
Code: **MWLS**  
 Description: **Miscellaneous Water Level Sag**

Distance (ft): **323.8**  
 Structural Grade: **2**  
 O&M Grade: **0**  
 Clock Start/From:  
 Clock To:  
 1st Value:  
 2nd Value:  
 Value Percent: **5.000**  
 Continuous Index: **S06**  
 Within 8" of Joint: **NO**  
 Remarks:

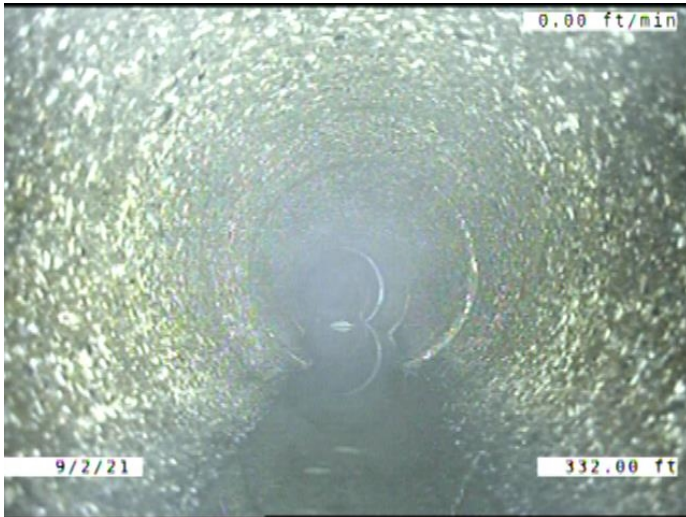
Code: **MWLS**  
 Description: **Miscellaneous Water Level Sag**

Distance (ft): **332.0**  
 Structural Grade: **2**  
 O&M Grade: **0**  
 Clock Start/From:  
 Clock To:  
 1st Value:  
 2nd Value:  
 Value Percent: **5.000**  
 Continuous Index: **F06**  
 Within 8" of Joint: **NO**  
 Remarks:

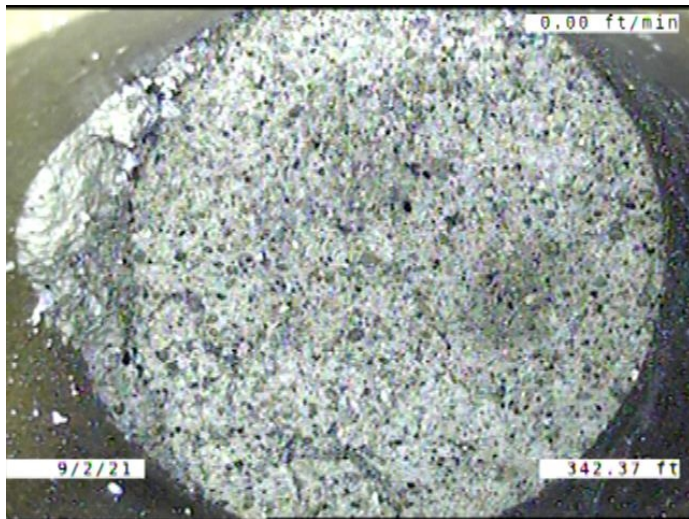
Code: **TFC**  
 Description: **Tap Factory Capped**

Distance (ft): **342.4**  
 Structural Grade: **0**  
 O&M Grade: **0**  
 Clock Start/From: **10**  
 Clock To:  
 1st Value: **4.000**  
 2nd Value:  
 Value Percent:  
 Continuous Index:  
 Within 8" of Joint: **YES**  
 Remarks:

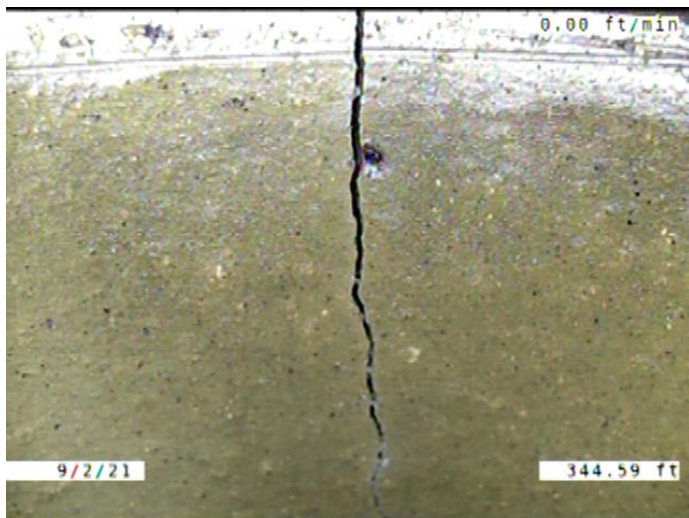
Code: **FM**  
 Description: **Fracture Multiple**

Distance (ft): **344.6**  
 Structural Grade: **4**  
 O&M Grade: **0**  
 Clock Start/From: **10**  
 Clock To: **5**  
 1st Value:  
 2nd Value:  
 Value Percent:  
 Continuous Index:  
 Within 8" of Joint: **YES**  
 Remarks:

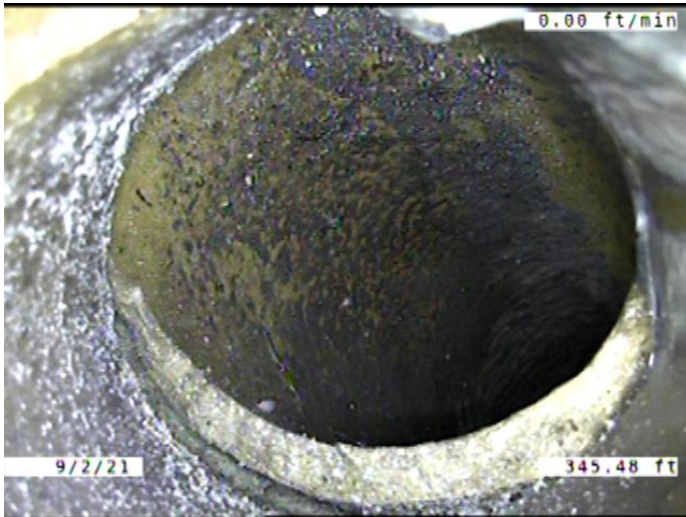
Code: **TFD**  
 Description: **Tap Factory Defective**

Distance (ft): **345.5**  
 Structural Grade: **0**  
 O&M Grade: **3**  
 Clock Start/From: **2**  
 Clock To:  
 1st Value: **6.000**  
 2nd Value:  
 Value Percent:  
 Continuous Index:  
 Within 8" of Joint: **YES**  
 Remarks: **CONSTANTLY RUNNING WATER**

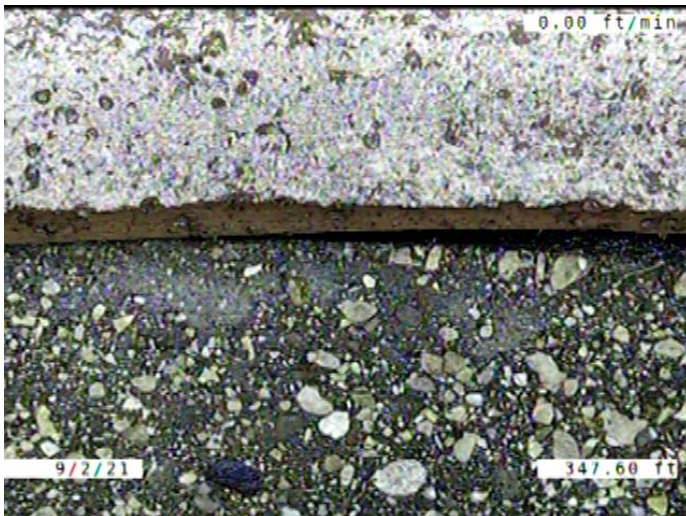
Code: **MMC**  
 Description: **Miscellaneous Material Change**

Distance (ft): **347.6**  
 Structural Grade: **0**  
 O&M Grade: **0**  
 Clock Start/From:  
 Clock To:  
 1st Value:  
 2nd Value:  
 Value Percent:  
 Continuous Index:  
 Within 8" of Joint: **NO**  
 Remarks: **VCP TO CONCRETE**

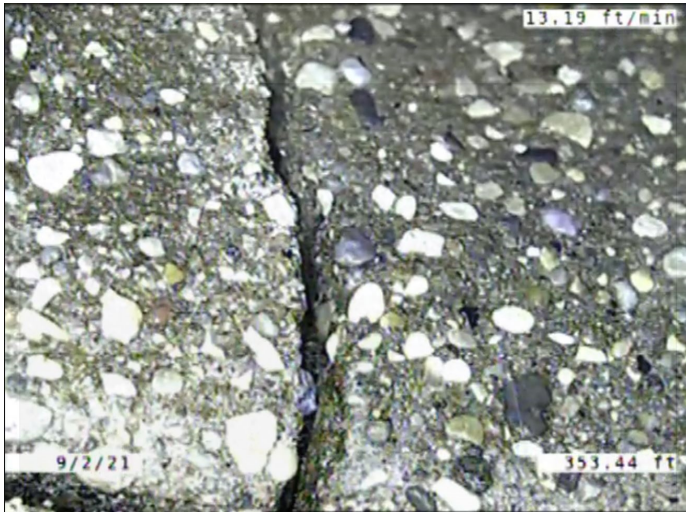
Code: **FS**  
Description: **Fracture Spiral**

Distance (ft): **353.4**  
Structural Grade: **3**  
O&M Grade: **0**  
Clock Start/From: **3**  
Clock To: **4**  
1st Value:  
2nd Value:  
Value Percent:  
Continuous Index:  
Within 8" of Joint: **YES**  
Remarks:

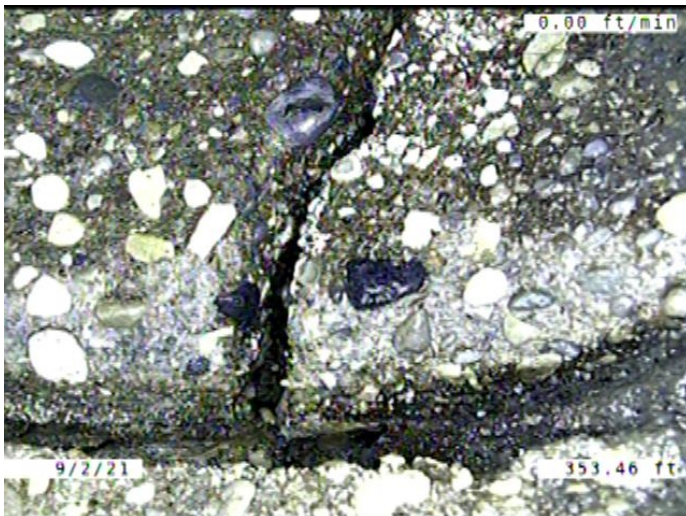
Code: **FS**  
Description: **Fracture Spiral**

Distance (ft): **353.5**  
Structural Grade: **3**  
O&M Grade: **0**  
Clock Start/From: **7**  
Clock To: **9**  
1st Value:  
2nd Value:  
Value Percent:  
Continuous Index:  
Within 8" of Joint: **YES**  
Remarks:

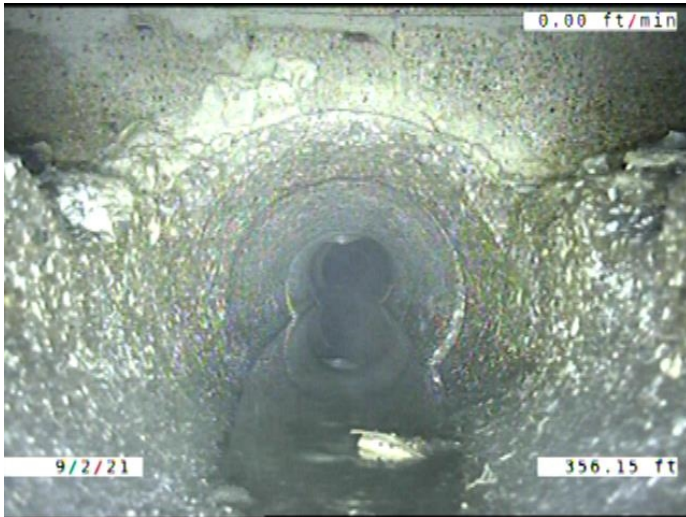
Code: **DSF**  
 Description: **Deposits Settled Fine**

Distance (ft): **356.2**  
 Structural Grade: **0**  
 O&M Grade: **2**  
 Clock Start/From: **5**  
 Clock To: **7**  
 1st Value:  
 2nd Value:  
 Value Percent: **5.000**  
 Continuous Index: **F04**  
 Within 8" of Joint: **YES**  
 Remarks:
