## Profile/Photo Observation Report

Street:	<b>W 41ST AVE</b>	Flow Control:	<b>Not Controlled</b>
City:	<b>Hobart, IN</b>	Year Renewed:	
Location:	<b>Light Highway</b>	Tape/Media #:	
Purpose:	<b>Not Known</b>	Dia/Height:	<b>10"</b>
Use:	<b>Sanitary</b>	Material:	<b>VCP</b>
Drain Area:	<b>NA</b>	Lining:	
Category:	<b>NA</b>		
Comment:

Location Details:		Direction of Survey:	<b>Downstream</b>
US MH:	<b>M-504-128</b>	DS MH:	<b>M-504-127</b>
		Total Length Surveyed (ft):	<b>6.6</b>

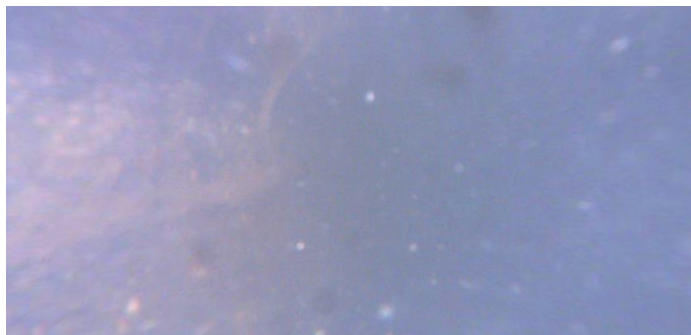
Code: **MCU**  
Description: **Camera Underwater**

Distance (ft): **.0**  
Structural Grade: **0**  
O&M Grade: **4**  
Clock Start/From:  
Clock To:  
1st Value:  
2nd Value:  
Value Percent:  
Continuous Index:  
Within 8" of Joint: **NO**  
Remarks:

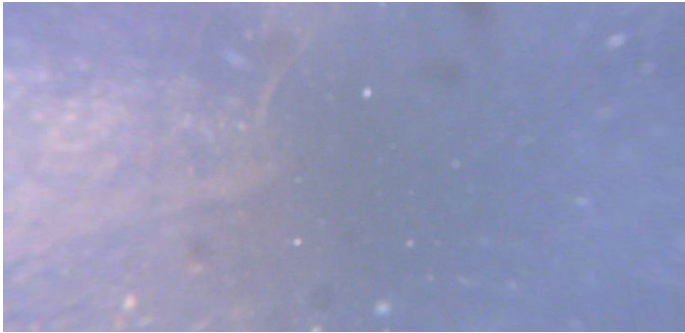
Code:	<b>AMH</b>
Description:	<b>Manhole</b>

Distance (ft):	<b>.0</b>
Structural Grade:	<b>0</b>
O&M Grade:	<b>0</b>
Clock Start/From:	
Clock To:	
1st Value:	
2nd Value:	
Value Percent:	
Continuous Index:	
Within 8" of Joint:	<b>NO</b>
Remarks:	<b>M-504-128</b>

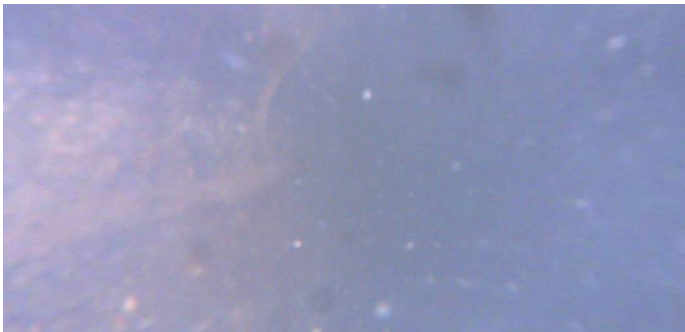
Code:	<b>MWL</b>
Description:	<b>Water Level</b>

Distance (ft):	<b>.0</b>
Structural Grade:	<b>0</b>
O&M Grade:	<b>0</b>
Clock Start/From:	
Clock To:	
1st Value:	
2nd Value:	
Value Percent:	<b>5.000</b>
Continuous Index:	
Within 8" of Joint:	<b>NO</b>
Remarks:
