Profile/Photo Observation Report

Street:	Summerlin	Flow Control:	Not Controlled
City:	Hobart, IN	Year Renewed:	
Location:	Light Highway	Tape/Media #:	
Purpose:	Not Known	Dia/Height:	10"
Use:	Sanitary	Material:	VCP
Drain Area:	NA	Lining:	
Category:	NA		
Comment:

Location Details:		Direction of Survey:	Downstream
US MH:	M-504-128	DS MH:	M-504-127
		Total Length Surveyed (ft):	6.6

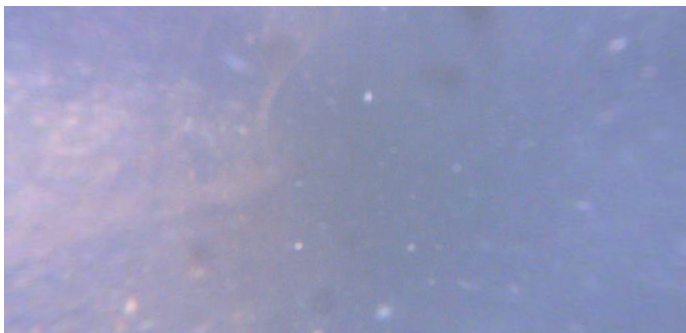
Code: **MCU**
Description: **Camera Underwater**

Distance (ft): **.0**
Structural Grade: **0**
O&M Grade: **4**
Clock Start/From:
Clock To:
1st Value:
2nd Value:
Value Percent:
Continuous Index:
Within 8" of Joint: **NO**
Remarks:

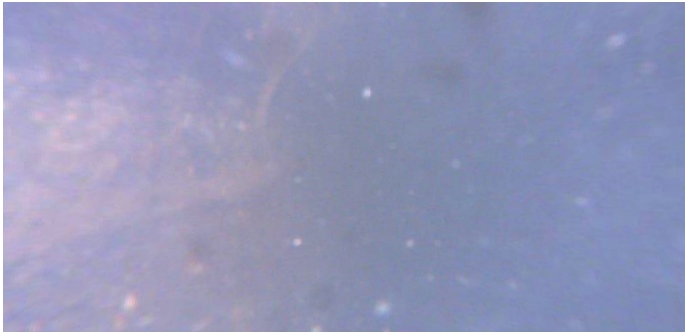
Code:	AMH
Description:	Manhole

Distance (ft):	.0
Structural Grade:	0
O&M Grade:	0
Clock Start/From:	
Clock To:	
1st Value:	
2nd Value:	
Value Percent:	
Continuous Index:	
Within 8" of Joint:	NO
Remarks:	M-504-128

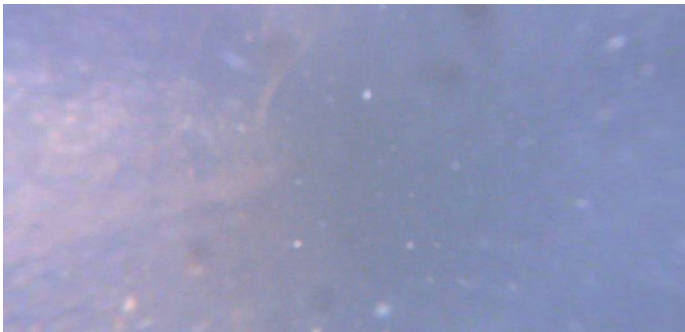
Code:	MWL
Description:	Water Level

Distance (ft):	.0
Structural Grade:	0
O&M Grade:	0
Clock Start/From:	
Clock To:	
1st Value:	
2nd Value:	
Value Percent:	5.000
Continuous Index:	
Within 8" of Joint:	NO
Remarks:
