Profile/Photo Observation Report

Date:	09/02/2021	Weather:		Coding:	PACP 7.0
Pipe Length (ft):	286.3	Owner:	City of Hobart	Pre Clean:	Light Cleaning
P.O.#:	YES502259	Surveyor:	S. Bucklin	PSR:	P-504-127-128
Customer:	City of Hobart	Clean Date:	08/30/2021	Shape:	C

Street:	North Wilson Street	Flow Control:	Not Controlled
City:	Hobart, IN	Year Renewed:	
Location:	Alley	Tape/Media #:	
Purpose:	Routine Assessment	Dia/Height:	10"
Use:	Sanitary Sewage Pipe	Material:	CP
Drain Area:		Lining:	
Category:	NA		
Comment:			
Location Details:		Direction of Survey:	Downstream
US MH:	M-504-128	DS MH:	M-504-127
		Total Length Surveyed (ft):	286.3

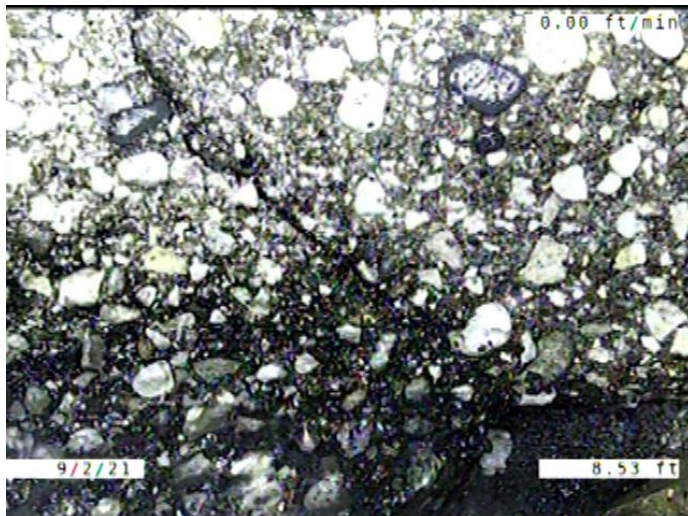
Code: **CM**
 Description: **Crack Multiple**

Distance (ft): **8.5**
 Structural Grade: **3**
 O&M Grade: **0**
 Clock Start/From: **7**
 Clock To: **5**
 1st Value:
 2nd Value:
 Value Percent:
 Continuous Index:
 Within 8" of Joint: **YES**
 Remarks:

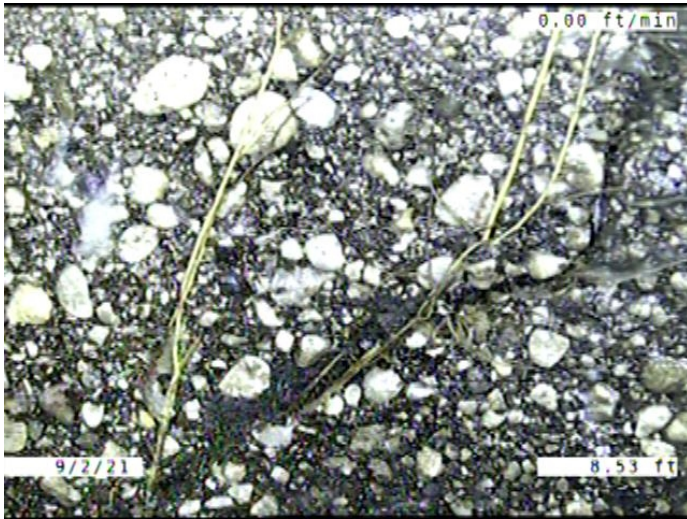
Code: **RFB**
Description: **Roots Fine Barrel**

Distance (ft): **8.5**
Structural Grade: **0**
O&M Grade: **2**
Clock Start/From: **3**
Clock To: **4**
1st Value:
2nd Value:
Value Percent:
Continuous Index:
Within 8" of Joint: **NO**
Remarks:

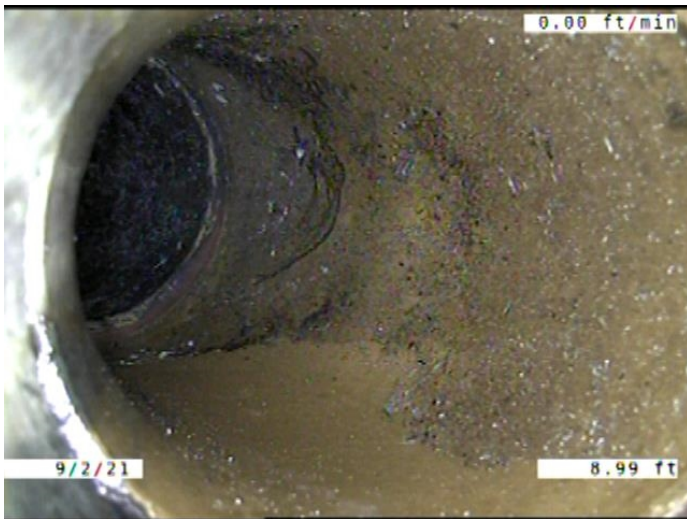
Code: **TBI**
Description: **Tap Break-in Intruding**

Distance (ft): **9.0**
Structural Grade: **0**
O&M Grade: **2**
Clock Start/From: **11**
Clock To:
1st Value: **6.000**
2nd Value: **2.000**
Value Percent:
Continuous Index:
Within 8" of Joint: **NO**
Remarks:

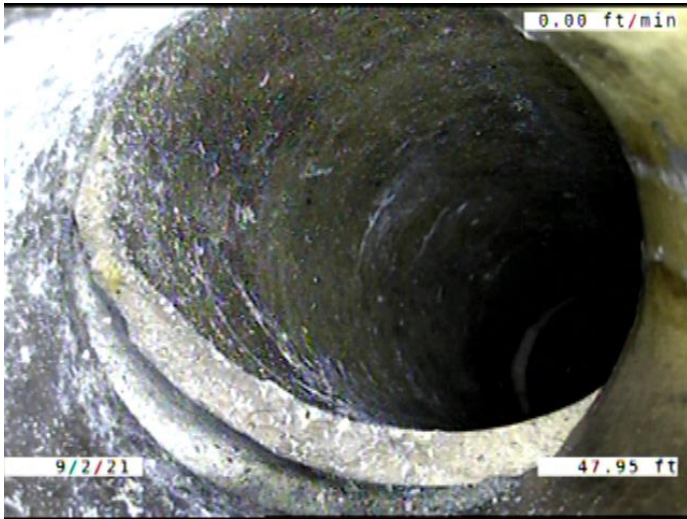
Code: **TFD**
 Description: **Tap Factory Defective**

Distance (ft): **48.0**
 Structural Grade: **0**
 O&M Grade: **3**
 Clock Start/From: **2**
 Clock To:
 1st Value: **4.000**
 2nd Value:
 Value Percent:
 Continuous Index:
 Within 8" of Joint: **YES**
 Remarks: **Debris**

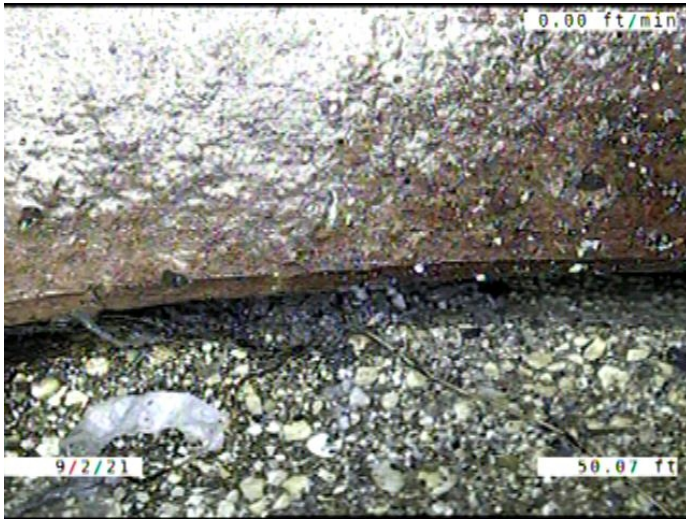
Code: **RFJ**
 Description: **Roots Fine Joint**

Distance (ft): **50.1**
 Structural Grade: **0**
 O&M Grade: **1**
 Clock Start/From: **8**
 Clock To: **9**
 1st Value:
 2nd Value:
 Value Percent:
 Continuous Index:
 Within 8" of Joint: **YES**
 Remarks:

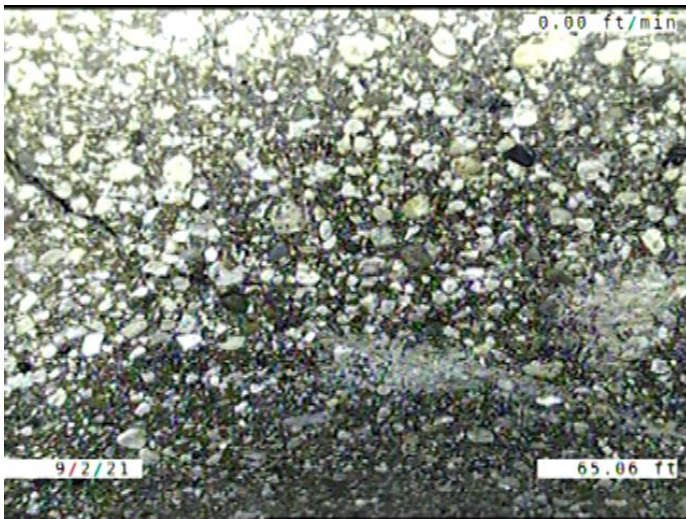
Code: **FM**
 Description: **Fracture Multiple**

Distance (ft): **65.1**
 Structural Grade: **4**
 O&M Grade: **0**
 Clock Start/From: **8**
 Clock To: **4**
 1st Value:
 2nd Value:
 Value Percent:
 Continuous Index:
 Within 8" of Joint: **YES**
 Remarks:

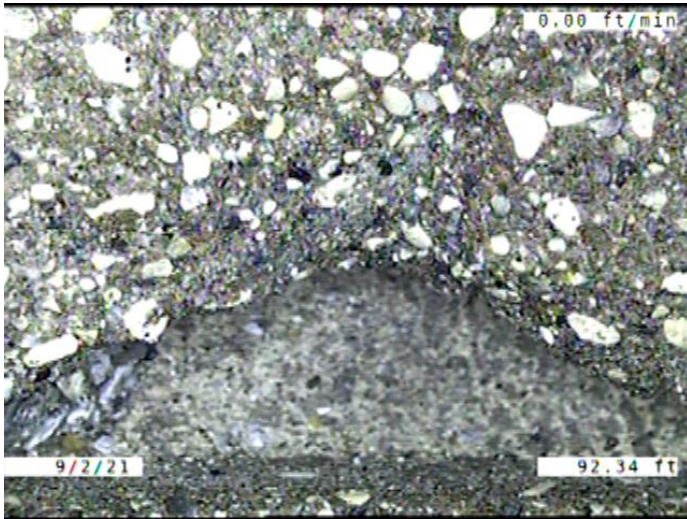
Code: **SMW**
Description: **Surface Damage Missing Wall**

Distance (ft): **92.3**
Structural Grade: **5**
O&M Grade: **0**
Clock Start/From: **9**
Clock To: **10**
1st Value:
2nd Value:
Value Percent:
Continuous Index:
Within 8" of Joint: **YES**
Remarks: **INSIDE OF THE JOINT**

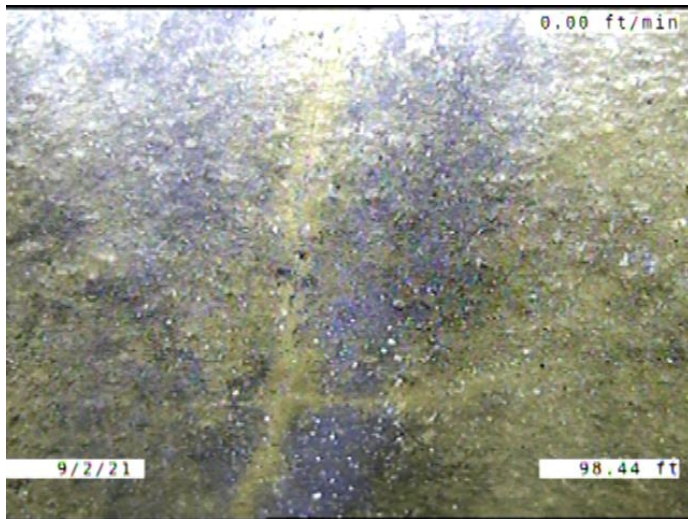
Code: **CM**
 Description: **Crack Multiple**

Distance (ft): **98.4**
 Structural Grade: **3**
 O&M Grade: **0**
 Clock Start/From: **12**
 Clock To: **1**
 1st Value:
 2nd Value:
 Value Percent:
 Continuous Index:
 Within 8" of Joint: **YES**
 Remarks:

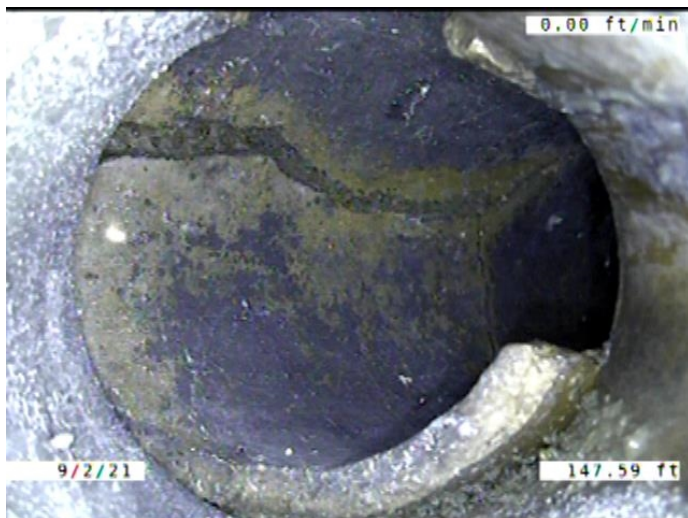
Code: **TFD**
 Description: **Tap Factory Defective**

Distance (ft): **147.6**
 Structural Grade: **0**
 O&M Grade: **3**
 Clock Start/From: **2**
 Clock To:
 1st Value: **6.000**
 2nd Value:
 Value Percent:
 Continuous Index:
 Within 8" of Joint: **YES**
 Remarks: **Debris**

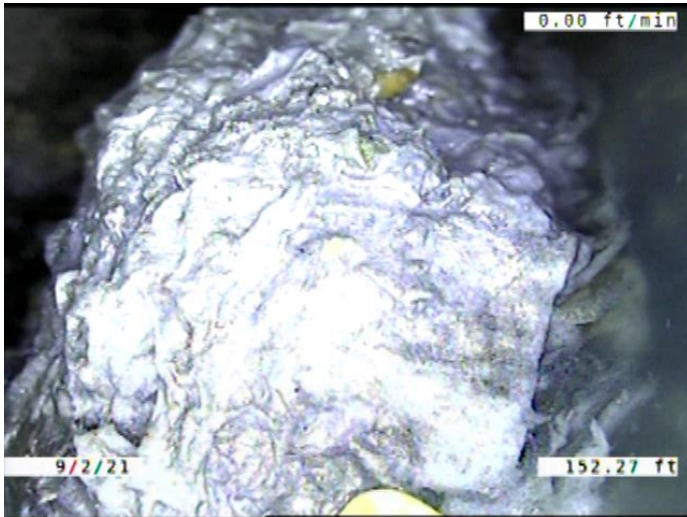
Code: **OBZ**
 Description: **Obstruction Other**

Distance (ft): **152.3**
 Structural Grade: **0**
 O&M Grade: **2**
 Clock Start/From: **6**
 Clock To: **8**
 1st Value:
 2nd Value:
 Value Percent: **5.000**
 Continuous Index:
 Within 8" of Joint: **YES**
 Remarks: **TP AND RAGS**

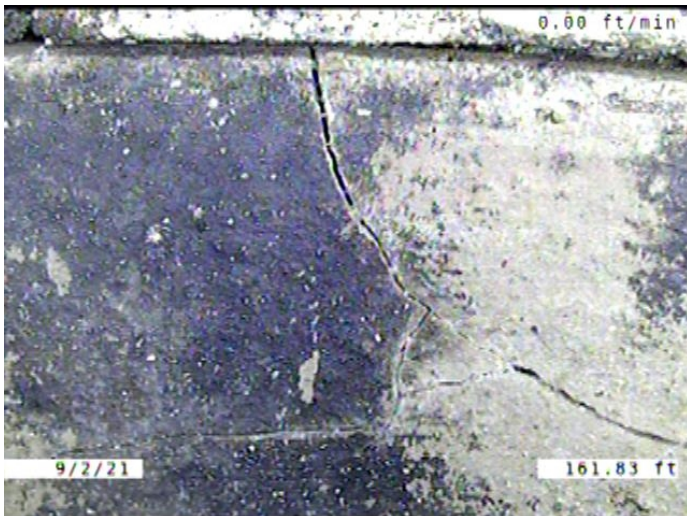
Code: **FM**
 Description: **Fracture Multiple**

Distance (ft): **161.8**
 Structural Grade: **4**
 O&M Grade: **0**
 Clock Start/From: **7**
 Clock To: **12**
 1st Value:
 2nd Value:
 Value Percent:
 Continuous Index:
 Within 8" of Joint: **YES**
 Remarks:

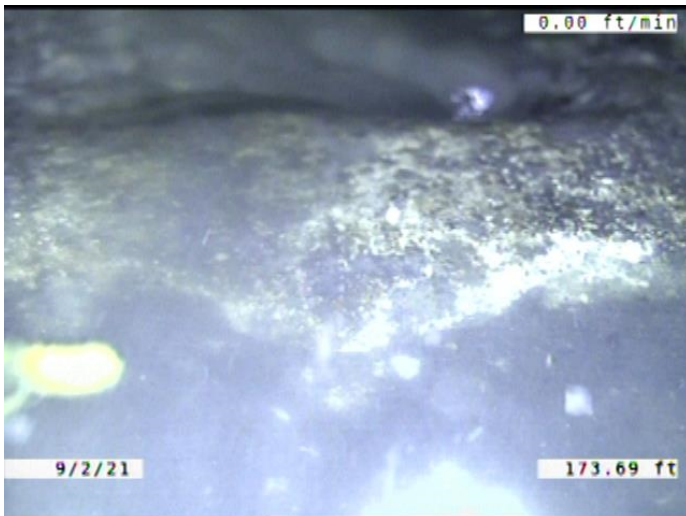
Code: **DAE**
Description: **Deposits Attached Encrustation**

Distance (ft): **173.7**
Structural Grade: **0**
O&M Grade: **2**
Clock Start/From: **4**
Clock To: **8**
1st Value:
2nd Value:
Value Percent: **5.000**
Continuous Index: **S03**
Within 8" of Joint: **YES**
Remarks:

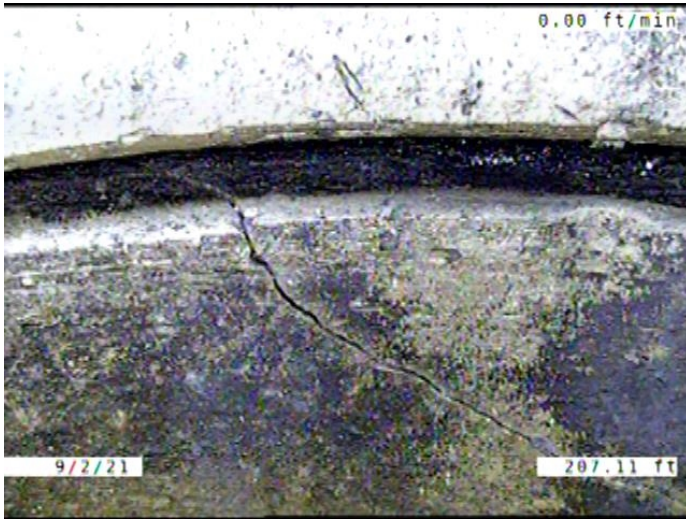
Code: **FM**
Description: **Fracture Multiple**

Distance (ft): **207.1**
Structural Grade: **4**
O&M Grade: **0**
Clock Start/From: **10**
Clock To: **3**
1st Value:
2nd Value:
Value Percent:
Continuous Index:
Within 8" of Joint: **YES**
Remarks:

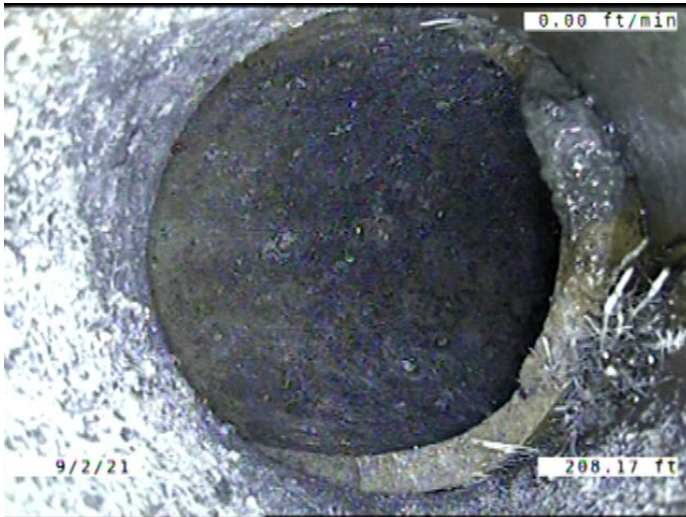
Code: **TFD**
Description: **Tap Factory Defective**

Distance (ft): **208.2**
Structural Grade: **0**
O&M Grade: **3**
Clock Start/From: **1**
Clock To:
1st Value: **6.000**
2nd Value:
Value Percent:
Continuous Index:
Within 8" of Joint: **YES**
Remarks: **Debris**

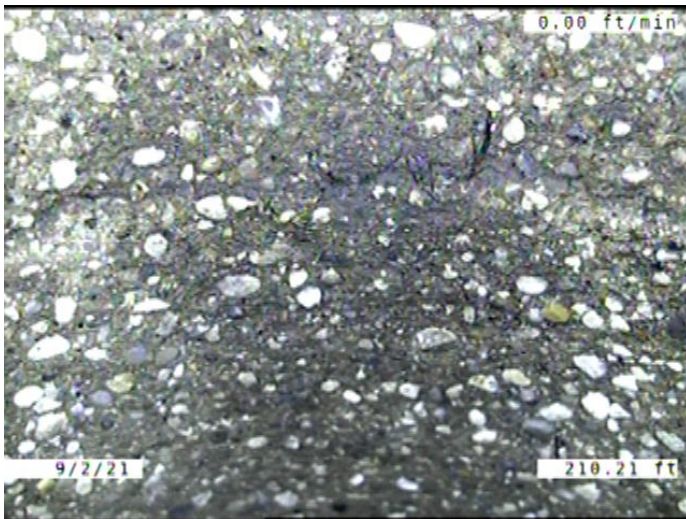
Code: **CM**
 Description: **Crack Multiple**

Distance (ft): **210.2**
 Structural Grade: **3**
 O&M Grade: **0**
 Clock Start/From: **8**
 Clock To: **4**
 1st Value:
 2nd Value:
 Value Percent:
 Continuous Index:
 Within 8" of Joint: **YES**
 Remarks:

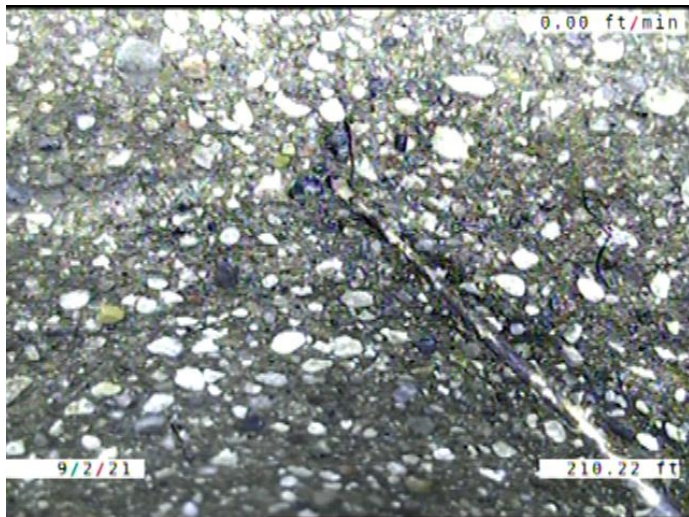
Code: **RFJ**
 Description: **Roots Fine Joint**

Distance (ft): **210.2**
 Structural Grade: **0**
 O&M Grade: **1**
 Clock Start/From: **10**
 Clock To: **2**
 1st Value:
 2nd Value:
 Value Percent:
 Continuous Index:
 Within 8" of Joint: **YES**
 Remarks:

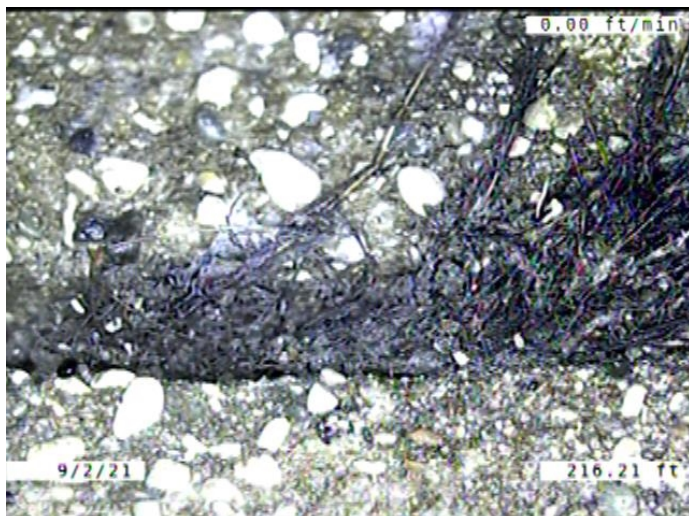
Code: **RFJ**
 Description: **Roots Fine Joint**

Distance (ft): **216.2**
 Structural Grade: **0**
 O&M Grade: **1**
 Clock Start/From: **8**
 Clock To: **9**
 1st Value:
 2nd Value:
 Value Percent:
 Continuous Index:
 Within 8" of Joint: **YES**
 Remarks:

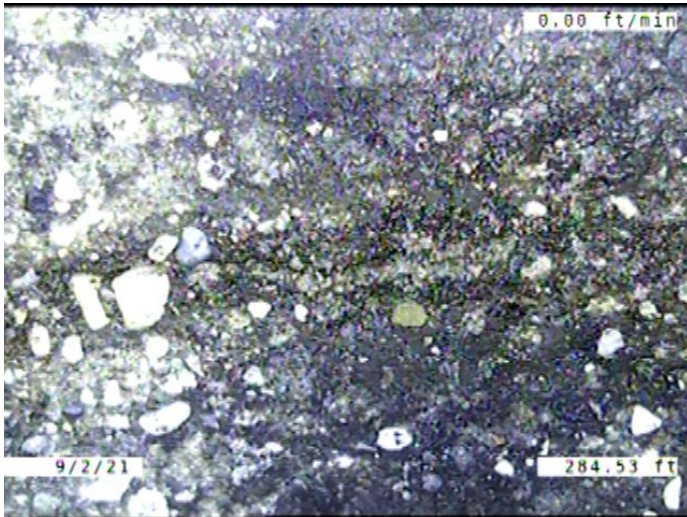
Code: **CC**
Description: **Crack Circumferential**

Distance (ft): **284.5**
Structural Grade: **1**
O&M Grade: **0**
Clock Start/From: **7**
Clock To: **5**
1st Value:
2nd Value:
Value Percent:
Continuous Index:
Within 8" of Joint: **NO**
Remarks:

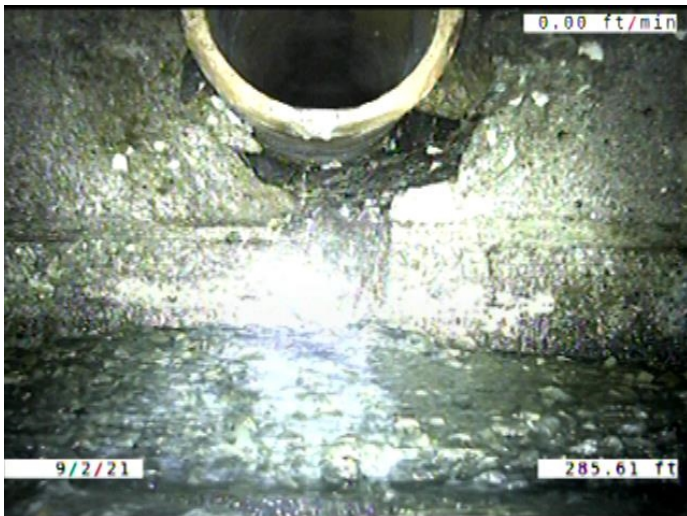
Code: **DSF**
Description: **Deposits Settled Fine**

Distance (ft): **285.6**
Structural Grade: **0**
O&M Grade: **2**
Clock Start/From: **5**
Clock To: **7**
1st Value:
2nd Value:
Value Percent: **5.000**
Continuous Index: **F01**
Within 8" of Joint: **YES**
Remarks:
