Profile/Photo Observation Report

Date:	09/02/2021	Weather:		Coding:	PACP 7.0
Pipe Length (ft):	286.3	Owner:	City of Hobart	Pre Clean:	Light Cleaning
P.O.#:	YES502259	Surveyor:	S. Bucklin	PSR:	P-504-127-128
Customer:	City of Hobart	Clean Date:	08/30/2021	Shape:	C

Street:	North Wilson Street	Flow Control:	Not Controlled
City:	Hobart, IN	Year Renewed:	
Location:	Alley	Tape/Media #:	
Purpose:	Routine Assessment	Dia/Height:	10"
Use:	Sanitary Sewage Pipe	Material:	CP
Drain Area:		Lining:	
Category:	NA		
Comment:			
Location Details:		Direction of Survey:	Downstream
US MH:	M-504-128	DS MH:	M-504-127
		Total Length Surveyed (ft):	286.3

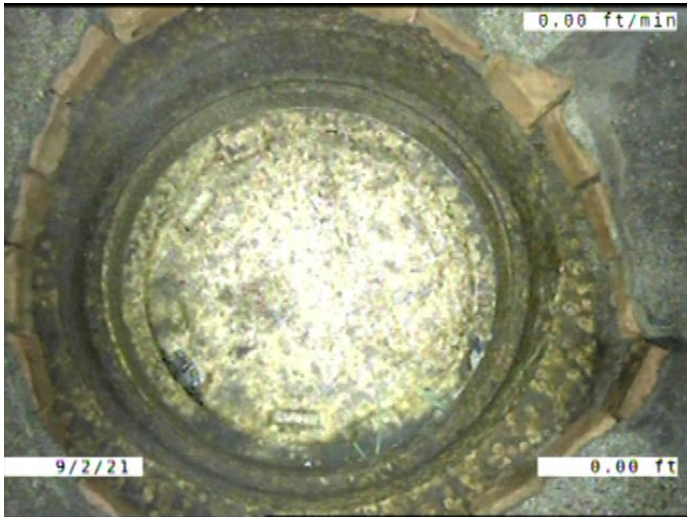
Code: **AMH**
Description: **Manhole**

Distance (ft): **.0**
Structural Grade: **0**
O&M Grade: **0**
Clock Start/From:
Clock To:
1st Value:
2nd Value:
Value Percent:
Continuous Index:
Within 8" of Joint: **NO**
Remarks: **M-504-128**

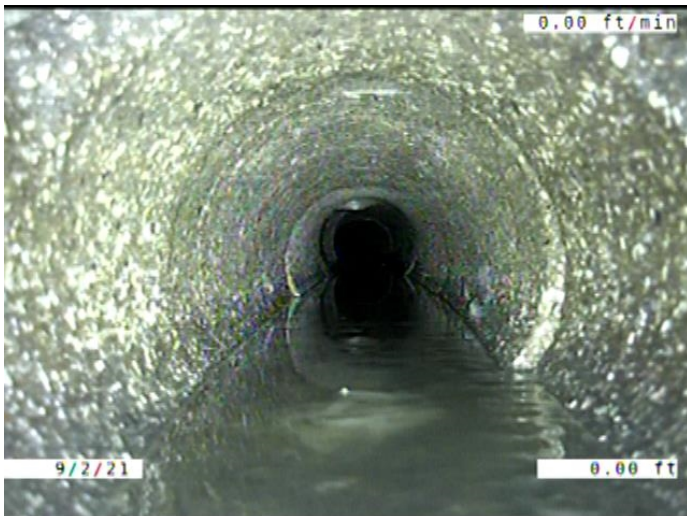
Code: **MWL**
Description: **Miscellaneous Water Level**

Distance (ft): **.0**
Structural Grade: **0**
O&M Grade: **0**
Clock Start/From:
Clock To:
1st Value:
2nd Value:
Value Percent: **5.000**
Continuous Index:
Within 8" of Joint: **NO**
Remarks:

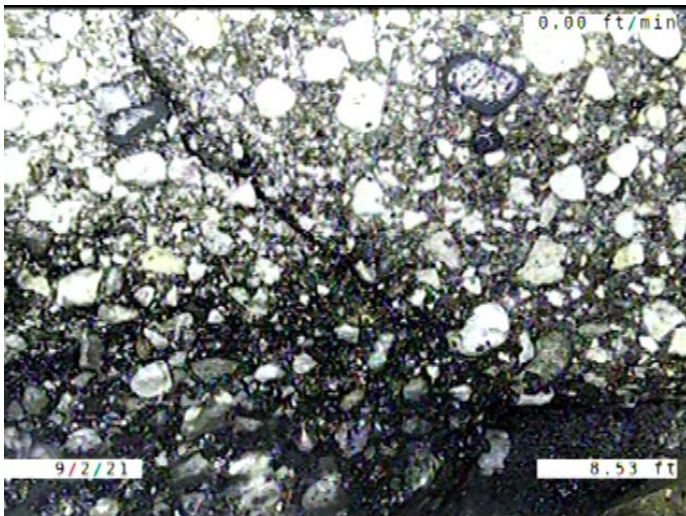
Code: **CM**
 Description: **Crack Multiple**

Distance (ft): **8.5**
 Structural Grade: **3**
 O&M Grade: **0**
 Clock Start/From: **7**
 Clock To: **5**
 1st Value:
 2nd Value:
 Value Percent:
 Continuous Index:
 Within 8" of Joint: **YES**
 Remarks:

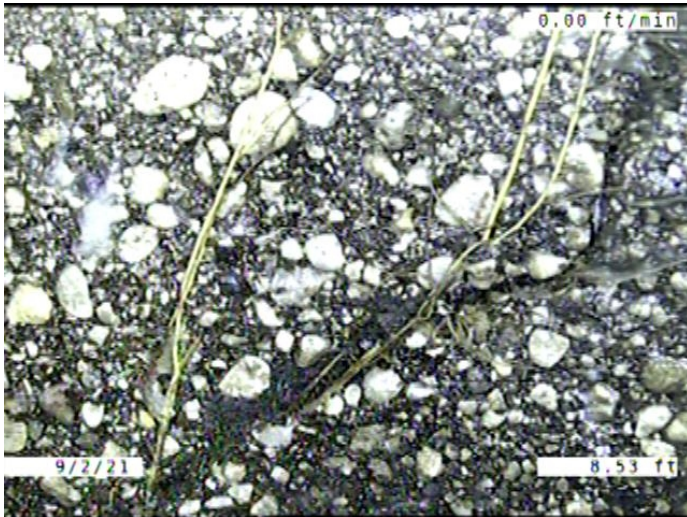
Code: **RFB**
 Description: **Roots Fine Barrel**

Distance (ft): **8.5**
 Structural Grade: **0**
 O&M Grade: **2**
 Clock Start/From: **3**
 Clock To: **4**
 1st Value:
 2nd Value:
 Value Percent:
 Continuous Index:
 Within 8" of Joint: **NO**
 Remarks:

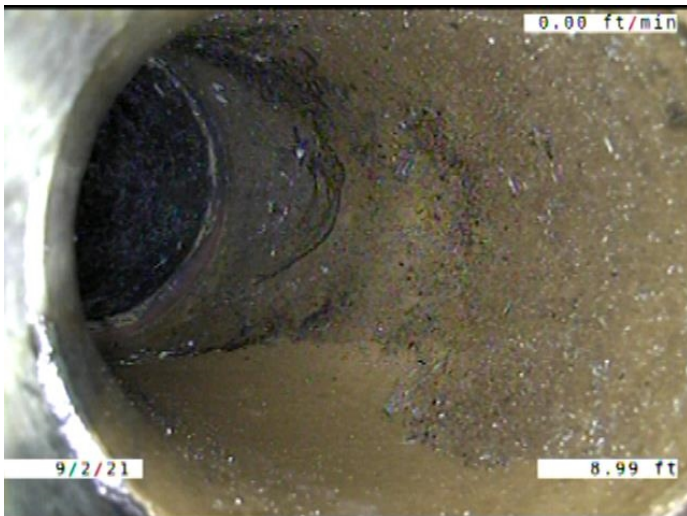
Code: **TBI**
 Description: **Tap Break-in Intruding**

Distance (ft): **9.0**
 Structural Grade: **0**
 O&M Grade: **2**
 Clock Start/From: **11**
 Clock To:
 1st Value: **6.000**
 2nd Value: **2.000**
 Value Percent:
 Continuous Index:
 Within 8" of Joint: **NO**
 Remarks:

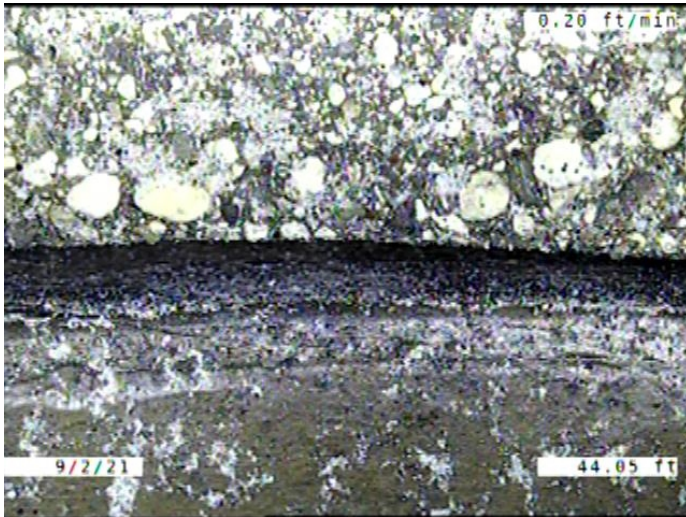
Code: **MMC**
 Description: **Miscellaneous Material Change**

Distance (ft): **44.0**
 Structural Grade: **0**
 O&M Grade: **0**
 Clock Start/From:
 Clock To:
 1st Value:
 2nd Value:
 Value Percent:
 Continuous Index:
 Within 8" of Joint: **NO**
 Remarks: **CONCRETE TO VCP**

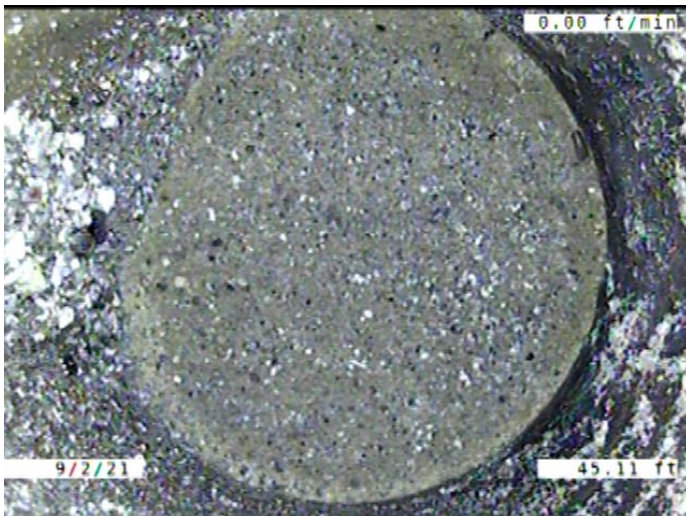
Code: **TFC**
 Description: **Tap Factory Capped**

Distance (ft): **45.1**
 Structural Grade: **0**
 O&M Grade: **0**
 Clock Start/From: **10**
 Clock To:
 1st Value: **6.000**
 2nd Value:
 Value Percent:
 Continuous Index:
 Within 8" of Joint: **YES**
 Remarks:

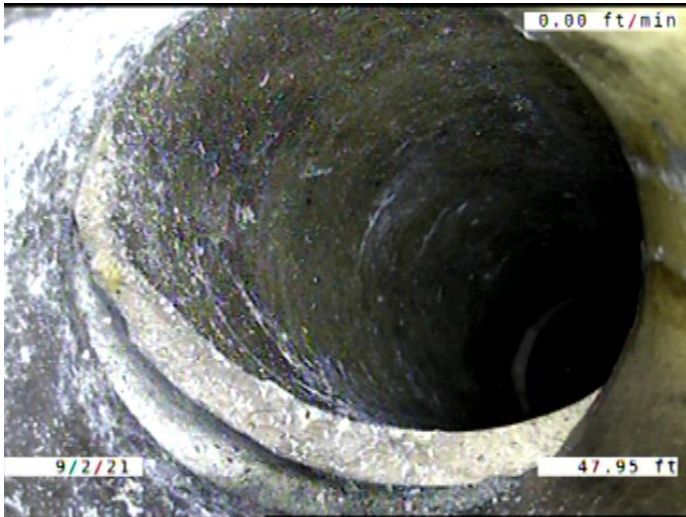
Code: **TFD**
 Description: **Tap Factory Defective**

Distance (ft): **48.0**
 Structural Grade: **0**
 O&M Grade: **3**
 Clock Start/From: **2**
 Clock To:
 1st Value: **4.000**
 2nd Value:
 Value Percent:
 Continuous Index:
 Within 8" of Joint: **YES**
 Remarks: **Debris**

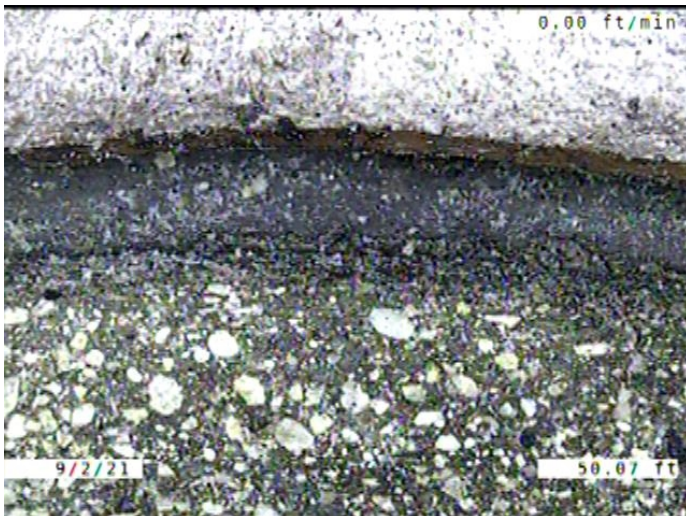
Code: **MMC**
 Description: **Miscellaneous Material Change**

Distance (ft): **50.1**
 Structural Grade: **0**
 O&M Grade: **0**
 Clock Start/From:
 Clock To:
 1st Value:
 2nd Value:
 Value Percent:
 Continuous Index:
 Within 8" of Joint: **NO**
 Remarks: **VCP TO CONCRETE**

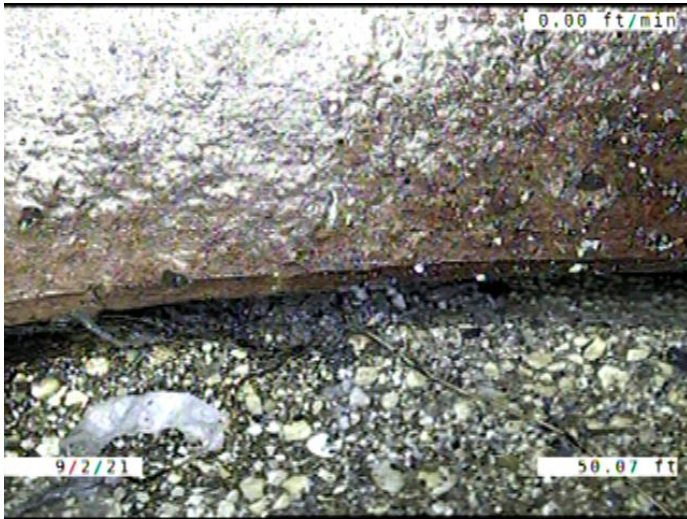
Code: **RFJ**
 Description: **Roots Fine Joint**

Distance (ft): **50.1**
 Structural Grade: **0**
 O&M Grade: **1**
 Clock Start/From: **8**
 Clock To: **9**
 1st Value:
 2nd Value:
 Value Percent:
 Continuous Index:
 Within 8" of Joint: **YES**
 Remarks:

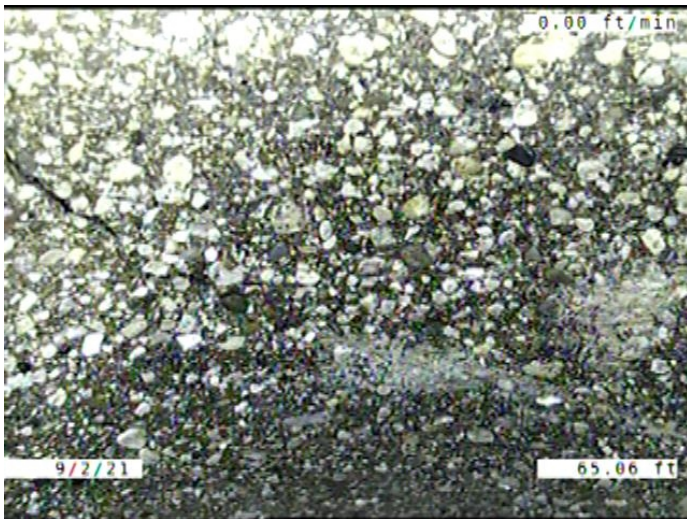
Code: **FM**
 Description: **Fracture Multiple**

Distance (ft): **65.1**
 Structural Grade: **4**
 O&M Grade: **0**
 Clock Start/From: **8**
 Clock To: **4**
 1st Value:
 2nd Value:
 Value Percent:
 Continuous Index:
 Within 8" of Joint: **YES**
 Remarks:

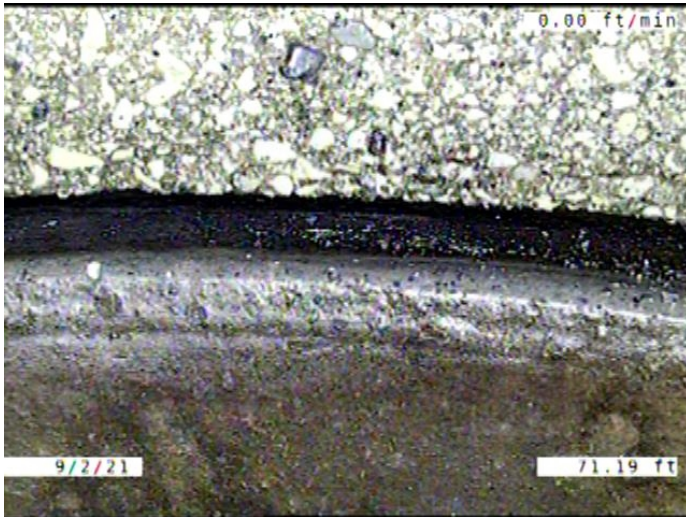
Code: **MMC**
 Description: **Miscellaneous Material Change**

Distance (ft): **71.2**
 Structural Grade: **0**
 O&M Grade: **0**
 Clock Start/From:
 Clock To:
 1st Value:
 2nd Value:
 Value Percent:
 Continuous Index:
 Within 8" of Joint: **NO**
 Remarks: **CONCRETE TO VCP**

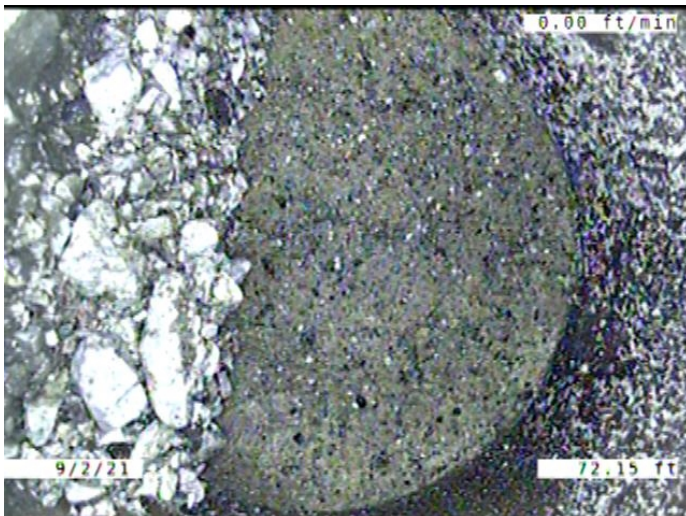
Code: **TFC**
 Description: **Tap Factory Capped**

Distance (ft): **72.2**
 Structural Grade: **0**
 O&M Grade: **0**
 Clock Start/From: **9**
 Clock To:
 1st Value: **6.000**
 2nd Value:
 Value Percent:
 Continuous Index:
 Within 8" of Joint: **YES**
 Remarks:

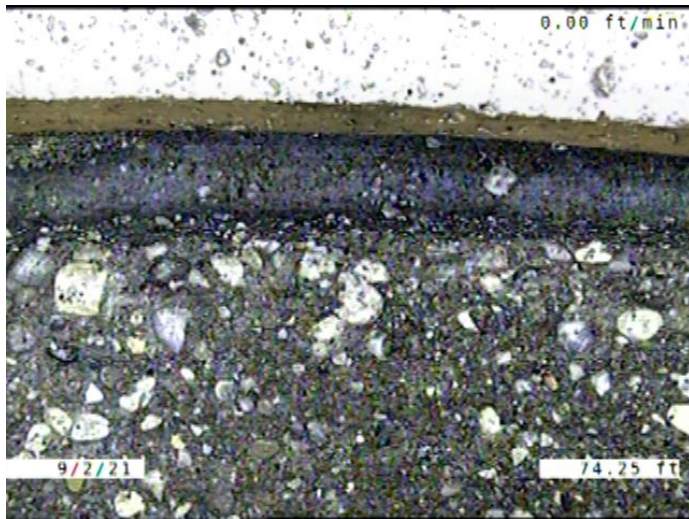
Code: **MMC**
 Description: **Miscellaneous Material Change**

Distance (ft): **74.2**
 Structural Grade: **0**
 O&M Grade: **0**
 Clock Start/From:
 Clock To:
 1st Value:
 2nd Value:
 Value Percent:
 Continuous Index:
 Within 8" of Joint: **NO**
 Remarks: **VCP TO CONCRETE**

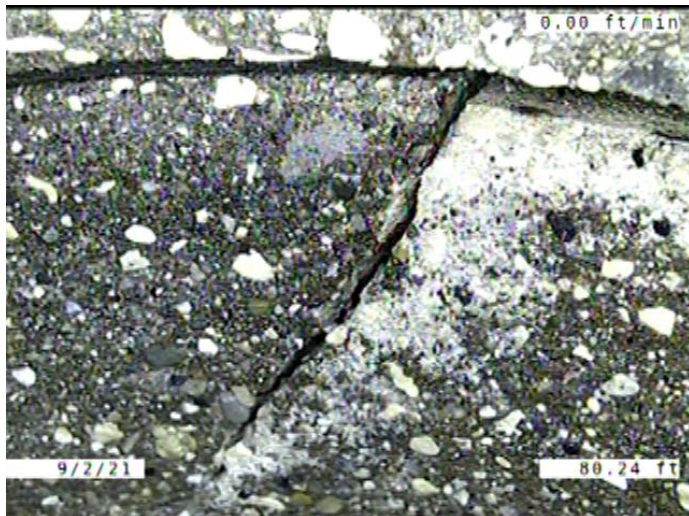
Code: **FM**
 Description: **Fracture Multiple**

Distance (ft): **80.2**
 Structural Grade: **4**
 O&M Grade: **0**
 Clock Start/From: **9**
 Clock To: **2**
 1st Value:
 2nd Value:
 Value Percent:
 Continuous Index:
 Within 8" of Joint: **YES**
 Remarks:

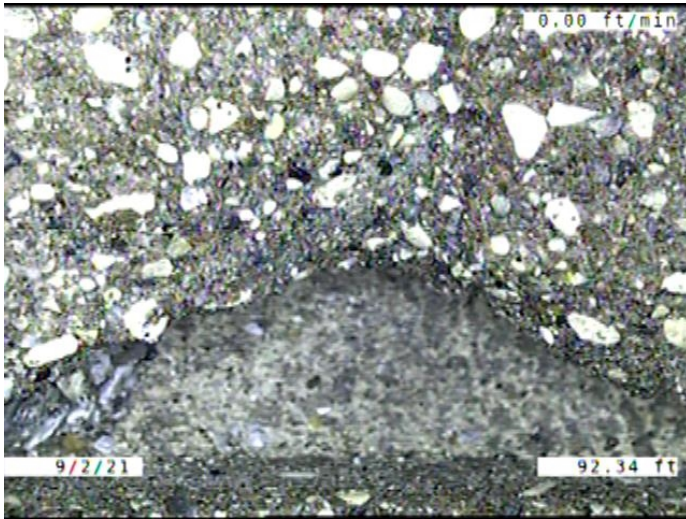
Code: **SMW**
Description: **Surface Damage Missing Wall**

Distance (ft): **92.3**
Structural Grade: **5**
O&M Grade: **0**
Clock Start/From: **9**
Clock To: **10**
1st Value:
2nd Value:
Value Percent:
Continuous Index:
Within 8" of Joint: **YES**
Remarks: **INSIDE OF THE JOINT**

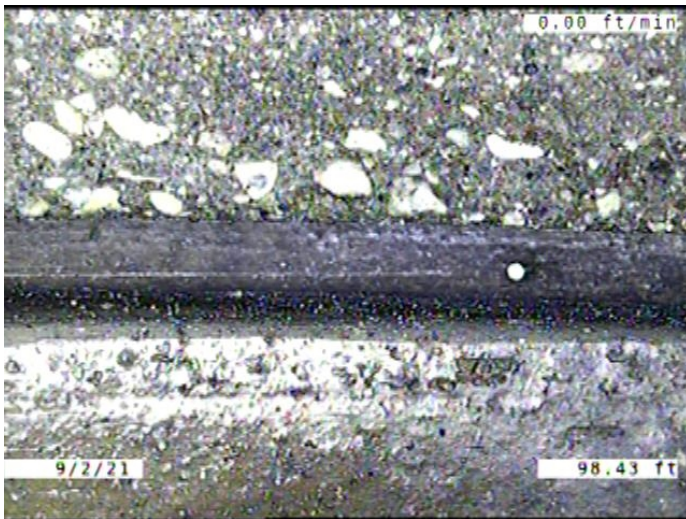
Code: **MMC**
Description: **Miscellaneous Material Change**

Distance (ft): **98.4**
Structural Grade: **0**
O&M Grade: **0**
Clock Start/From:
Clock To:
1st Value:
2nd Value:
Value Percent:
Continuous Index:
Within 8" of Joint: **NO**
Remarks: **CONCRETE TO VCP**

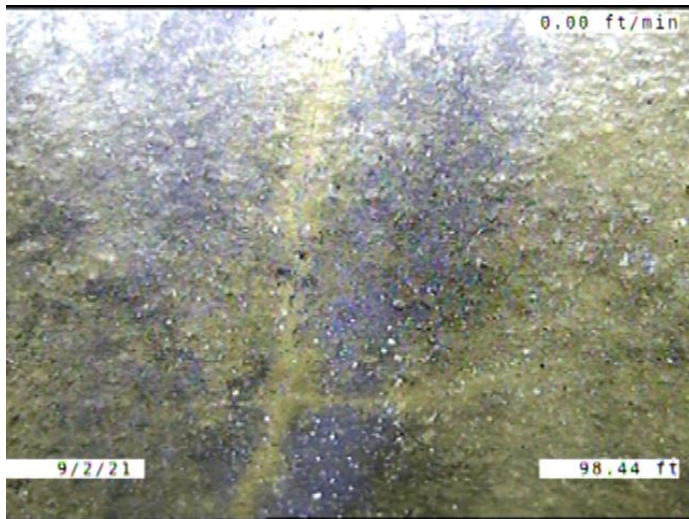
Code: **CM**
 Description: **Crack Multiple**

Distance (ft): **98.4**
 Structural Grade: **3**
 O&M Grade: **0**
 Clock Start/From: **12**
 Clock To: **1**
 1st Value:
 2nd Value:
 Value Percent:
 Continuous Index:
 Within 8" of Joint: **YES**
 Remarks:

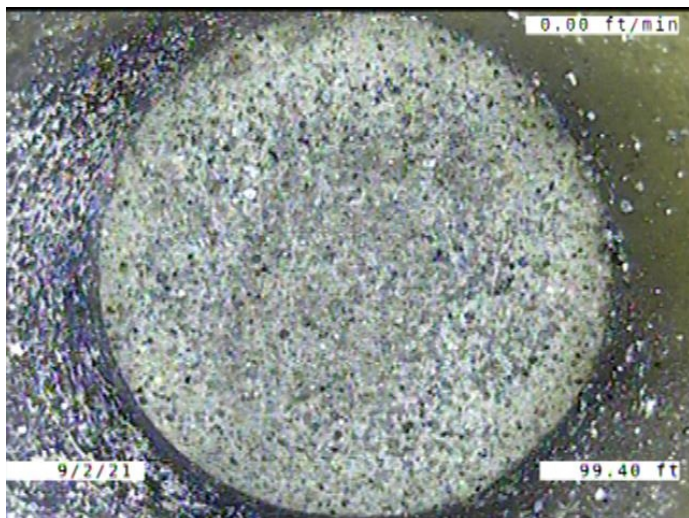
Code: **TFC**
 Description: **Tap Factory Capped**

Distance (ft): **99.4**
 Structural Grade: **0**
 O&M Grade: **0**
 Clock Start/From: **1**
 Clock To:
 1st Value: **6.000**
 2nd Value:
 Value Percent:
 Continuous Index:
 Within 8" of Joint: **YES**
 Remarks:

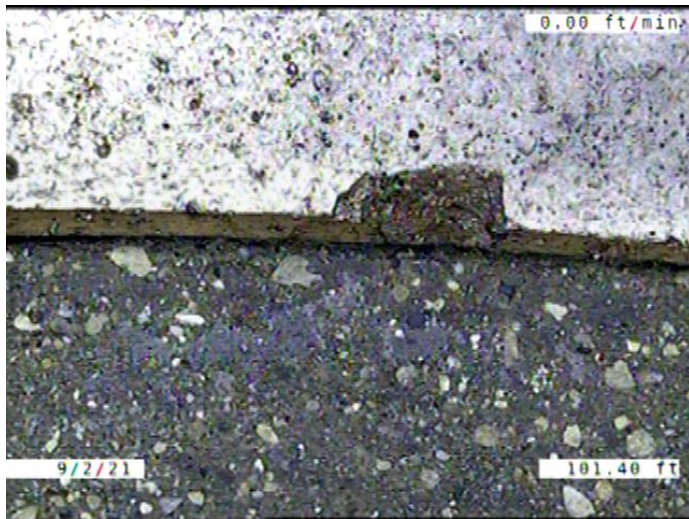
Code: **MMC**
 Description: **Miscellaneous Material Change**

Distance (ft): **101.4**
 Structural Grade: **0**
 O&M Grade: **0**
 Clock Start/From:
 Clock To:
 1st Value:
 2nd Value:
 Value Percent:
 Continuous Index:
 Within 8" of Joint: **NO**
 Remarks: **VCP TO CONCRETE**

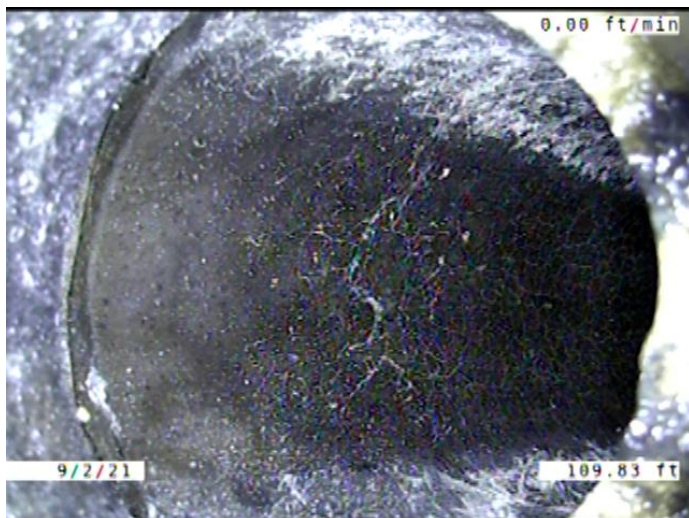
Code: **TBI**
 Description: **Tap Break-in Intruding**

Distance (ft): **109.8**
 Structural Grade: **0**
 O&M Grade: **2**
 Clock Start/From: **2**
 Clock To:
 1st Value: **6.000**
 2nd Value: **2.000**
 Value Percent:
 Continuous Index:
 Within 8" of Joint: **YES**
 Remarks:

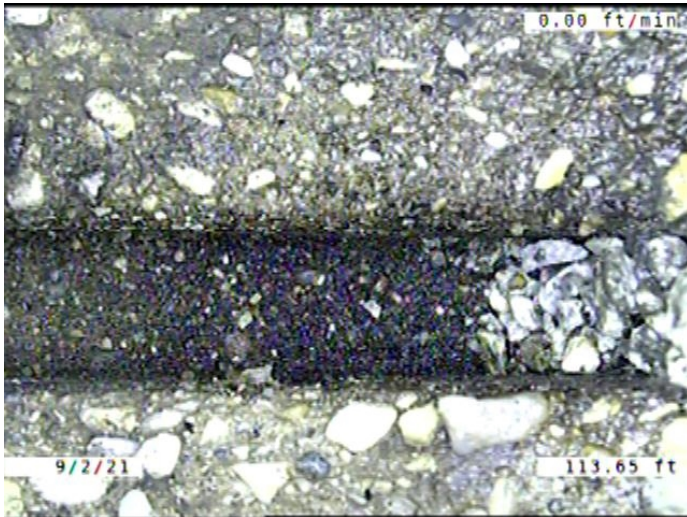
Code: **JAM**
Description: **Joint Angular Medium**

Distance (ft): **113.7**
Structural Grade: **3**
O&M Grade: **0**
Clock Start/From:
Clock To:
1st Value:
2nd Value:
Value Percent:
Continuous Index:
Within 8" of Joint: **NO**
Remarks:

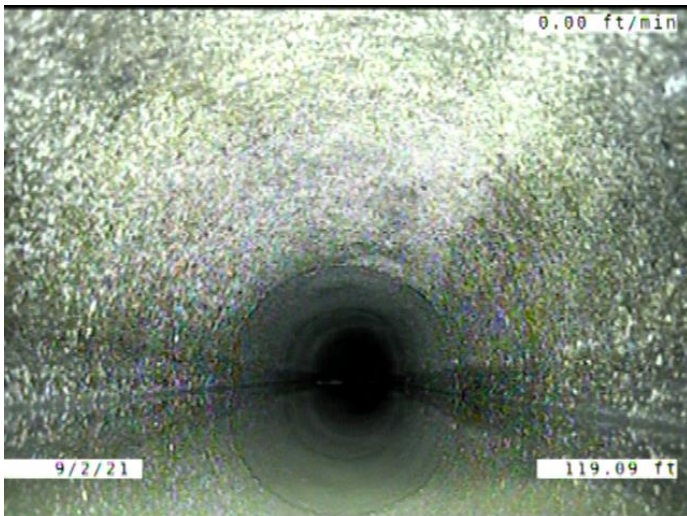
Code: **MWLS**
Description: **Miscellaneous Water Level Sag**

Distance (ft): **119.1**
Structural Grade: **2**
O&M Grade: **0**
Clock Start/From:
Clock To:
1st Value:
2nd Value:
Value Percent: **15.000**
Continuous Index: **S02**
Within 8" of Joint: **NO**
Remarks:

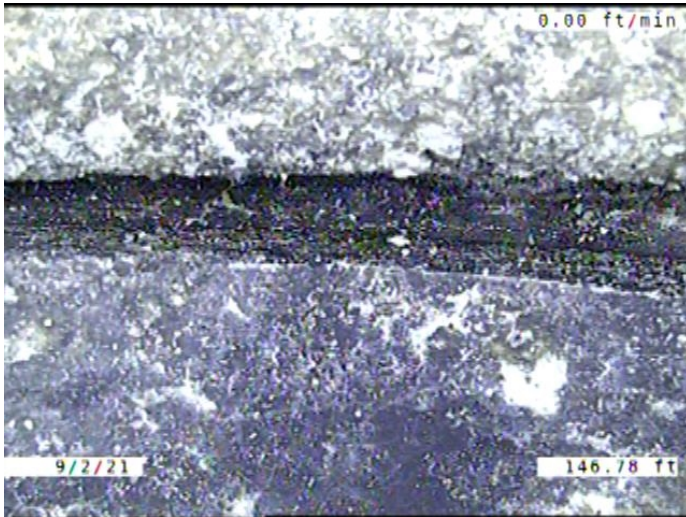
Code: **MMC**
 Description: **Miscellaneous Material Change**

Distance (ft): **146.8**
 Structural Grade: **0**
 O&M Grade: **0**
 Clock Start/From:
 Clock To:
 1st Value:
 2nd Value:
 Value Percent:
 Continuous Index:
 Within 8" of Joint: **NO**
 Remarks: **CONCRETE TO VCP**

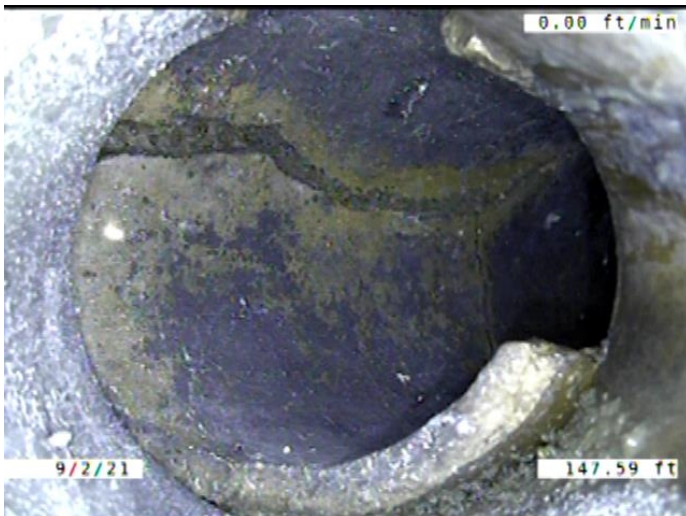
Code: **TFD**
 Description: **Tap Factory Defective**

Distance (ft): **147.6**
 Structural Grade: **0**
 O&M Grade: **3**
 Clock Start/From: **2**
 Clock To:
 1st Value: **6.000**
 2nd Value:
 Value Percent:
 Continuous Index:
 Within 8" of Joint: **YES**
 Remarks: **Debris**

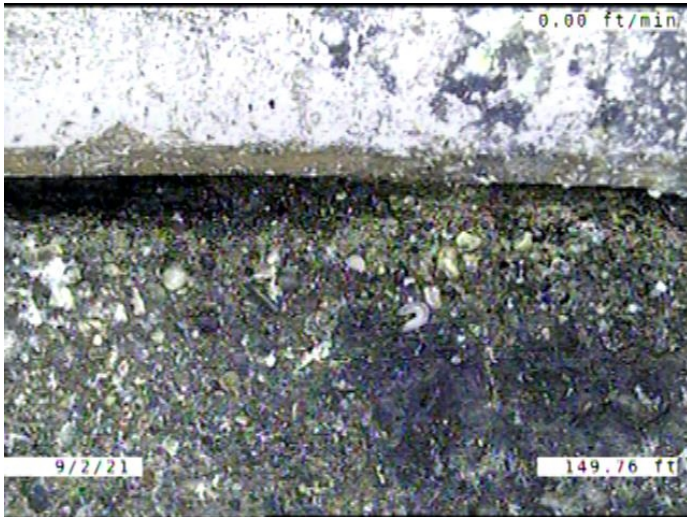
Code: **MMC**
 Description: **Miscellaneous Material Change**

Distance (ft): **149.8**
 Structural Grade: **0**
 O&M Grade: **0**
 Clock Start/From:
 Clock To:
 1st Value:
 2nd Value:
 Value Percent:
 Continuous Index:
 Within 8" of Joint: **NO**
 Remarks: **VCP TO CONCRETE**

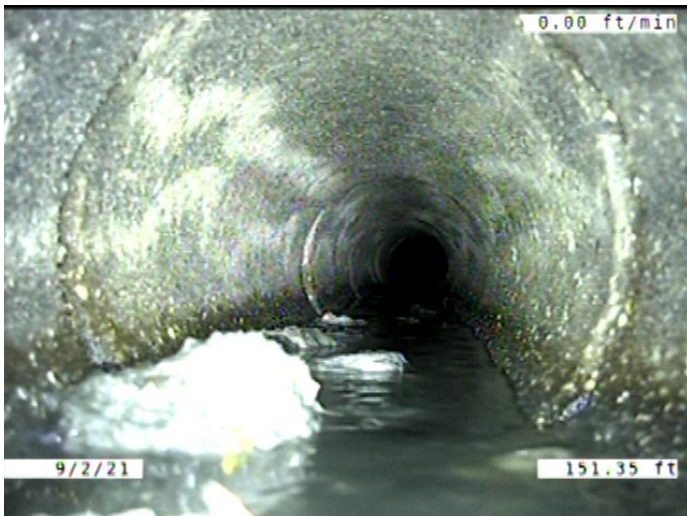
Code: **MWLS**
 Description: **Miscellaneous Water Level Sag**

Distance (ft): **151.3**
 Structural Grade: **2**
 O&M Grade: **0**
 Clock Start/From:
 Clock To:
 1st Value:
 2nd Value:
 Value Percent: **15.000**
 Continuous Index: **F02**
 Within 8" of Joint: **NO**
 Remarks:

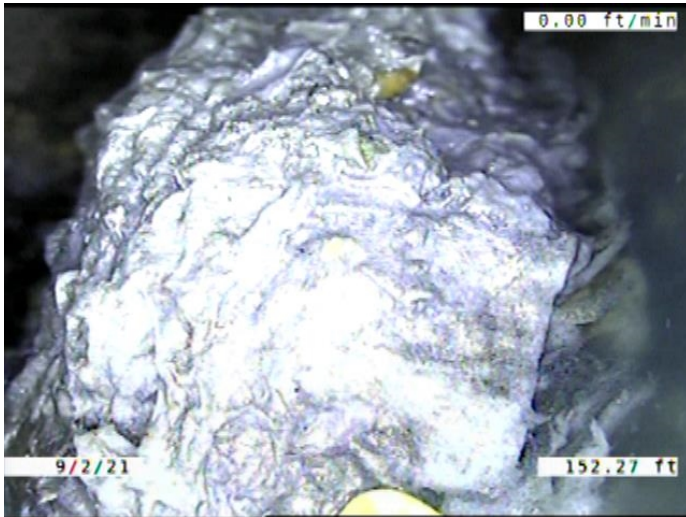
Code: **OBZ**
 Description: **Obstruction Other**

Distance (ft): **152.3**
 Structural Grade: **0**
 O&M Grade: **2**
 Clock Start/From: **6**
 Clock To: **8**
 1st Value:
 2nd Value:
 Value Percent: **5.000**
 Continuous Index:
 Within 8" of Joint: **YES**
 Remarks: **TP AND RAGS**

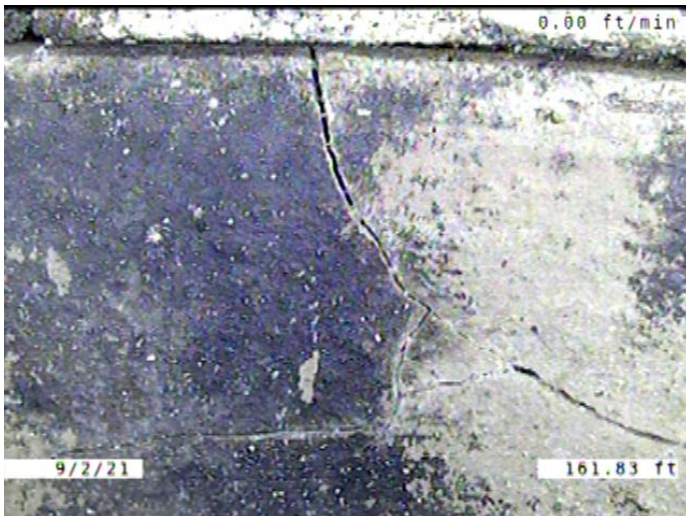
Code: **FM**
 Description: **Fracture Multiple**

Distance (ft): **161.8**
 Structural Grade: **4**
 O&M Grade: **0**
 Clock Start/From: **7**
 Clock To: **12**
 1st Value:
 2nd Value:
 Value Percent:
 Continuous Index:
 Within 8" of Joint: **YES**
 Remarks:

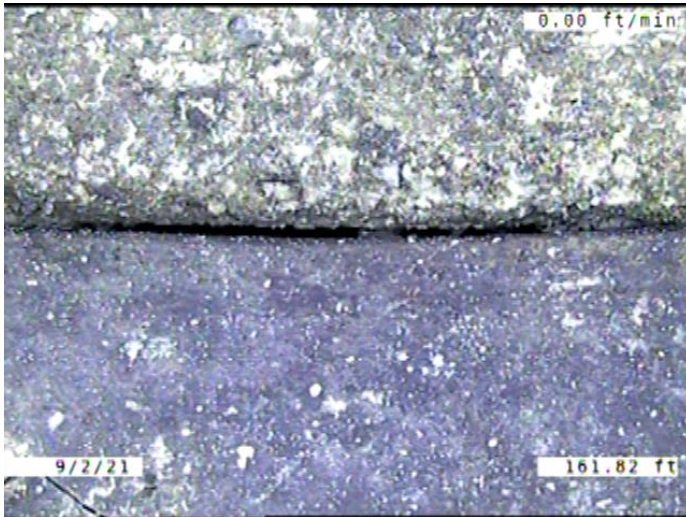
Code: **MMC**
 Description: **Miscellaneous Material Change**

Distance (ft): **161.8**
 Structural Grade: **0**
 O&M Grade: **0**
 Clock Start/From:
 Clock To:
 1st Value:
 2nd Value:
 Value Percent:
 Continuous Index:
 Within 8" of Joint: **NO**
 Remarks: **CONCRETE TO VCP**

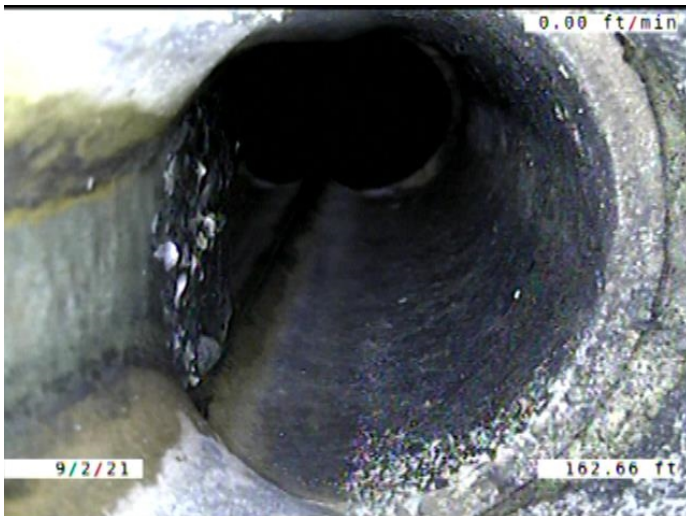
Code: **TFD**
 Description: **Tap Factory Defective**

Distance (ft): **162.7**
 Structural Grade: **0**
 O&M Grade: **3**
 Clock Start/From: **9**
 Clock To:
 1st Value: **6.000**
 2nd Value:
 Value Percent:
 Continuous Index:
 Within 8" of Joint: **YES**
 Remarks: **Debris**

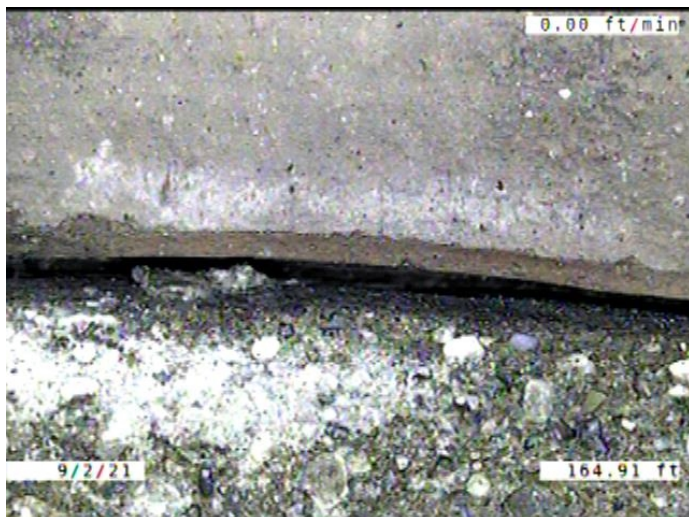
Code: **MMC**
 Description: **Miscellaneous Material Change**

Distance (ft): **164.9**
 Structural Grade: **0**
 O&M Grade: **0**
 Clock Start/From:
 Clock To:
 1st Value:
 2nd Value:
 Value Percent:
 Continuous Index:
 Within 8" of Joint: **NO**
 Remarks: **VCP TO CONCRETE**

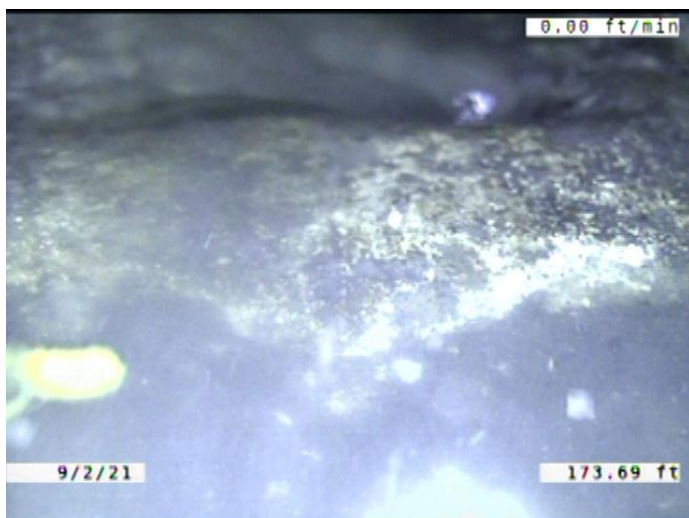
Code: **DAE**
 Description: **Deposits Attached Encrustation**

Distance (ft): **173.7**
 Structural Grade: **0**
 O&M Grade: **2**
 Clock Start/From: **4**
 Clock To: **8**
 1st Value:
 2nd Value:
 Value Percent: **5.000**
 Continuous Index: **S03**
 Within 8" of Joint: **YES**
 Remarks:

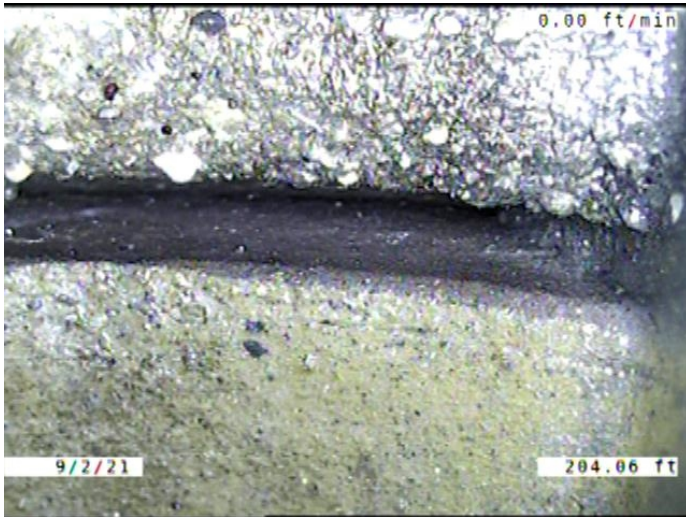
Code: **MMC**
 Description: **Miscellaneous Material Change**

Distance (ft): **204.1**
 Structural Grade: **0**
 O&M Grade: **0**
 Clock Start/From:
 Clock To:
 1st Value:
 2nd Value:
 Value Percent:
 Continuous Index:
 Within 8" of Joint: **NO**
 Remarks: **CONCRETE TO VCP**

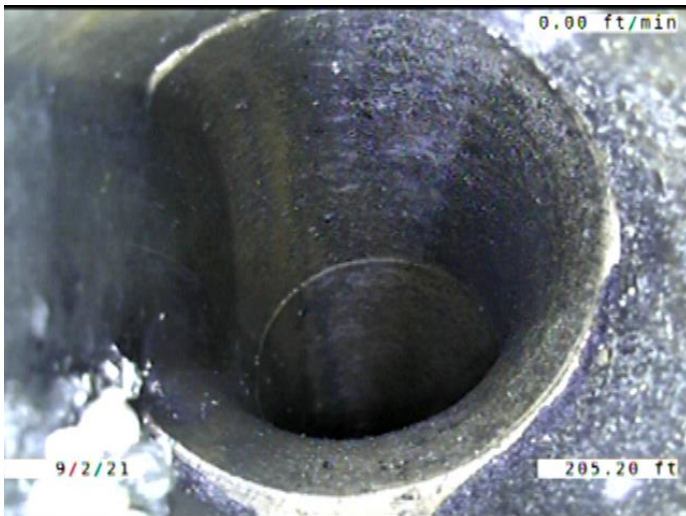
Code: **TF**
 Description: **Tap Factory**

Distance (ft): **205.2**
 Structural Grade: **0**
 O&M Grade: **0**
 Clock Start/From: **9**
 Clock To:
 1st Value: **6.000**
 2nd Value:
 Value Percent:
 Continuous Index:
 Within 8" of Joint: **YES**
 Remarks:

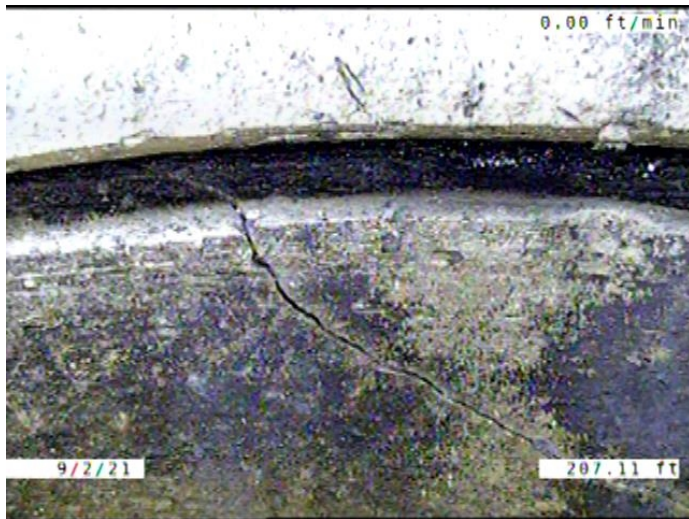
Code: **FM**
 Description: **Fracture Multiple**

Distance (ft): **207.1**
 Structural Grade: **4**
 O&M Grade: **0**
 Clock Start/From: **10**
 Clock To: **3**
 1st Value:
 2nd Value:
 Value Percent:
 Continuous Index:
 Within 8" of Joint: **YES**
 Remarks:

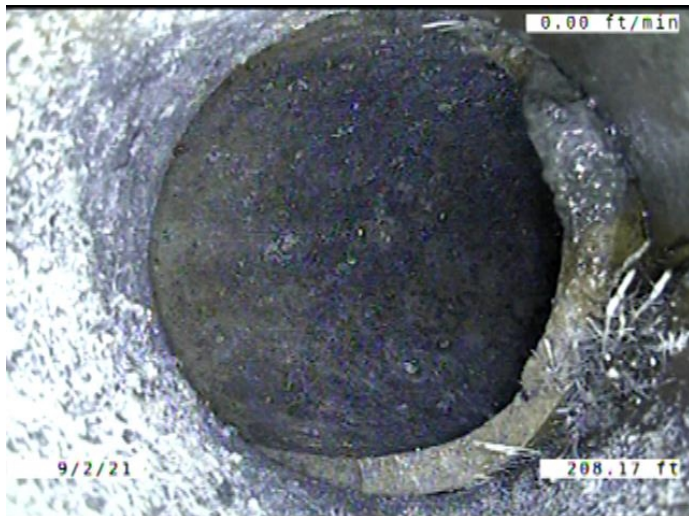
Code: **TFD**
 Description: **Tap Factory Defective**

Distance (ft): **208.2**
 Structural Grade: **0**
 O&M Grade: **3**
 Clock Start/From: **1**
 Clock To:
 1st Value: **6.000**
 2nd Value:
 Value Percent:
 Continuous Index:
 Within 8" of Joint: **YES**
 Remarks: **Debris**

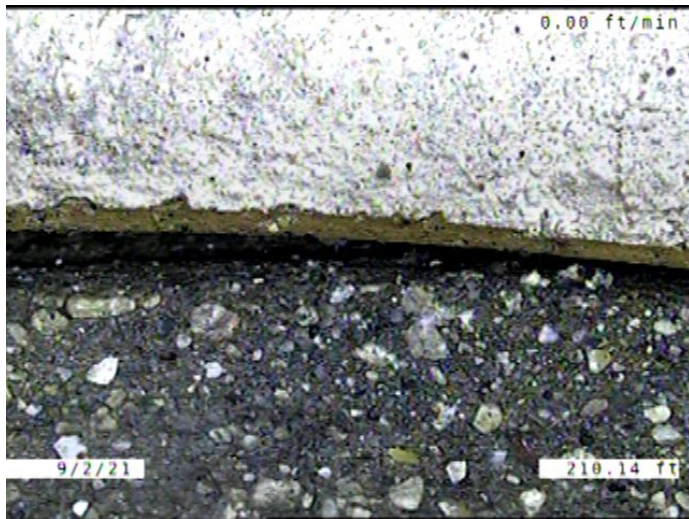
Code: **MMC**
 Description: **Miscellaneous Material Change**

Distance (ft): **210.1**
 Structural Grade: **0**
 O&M Grade: **0**
 Clock Start/From:
 Clock To:
 1st Value:
 2nd Value:
 Value Percent:
 Continuous Index:
 Within 8" of Joint: **NO**
 Remarks: **VCP TO CONCRETE**

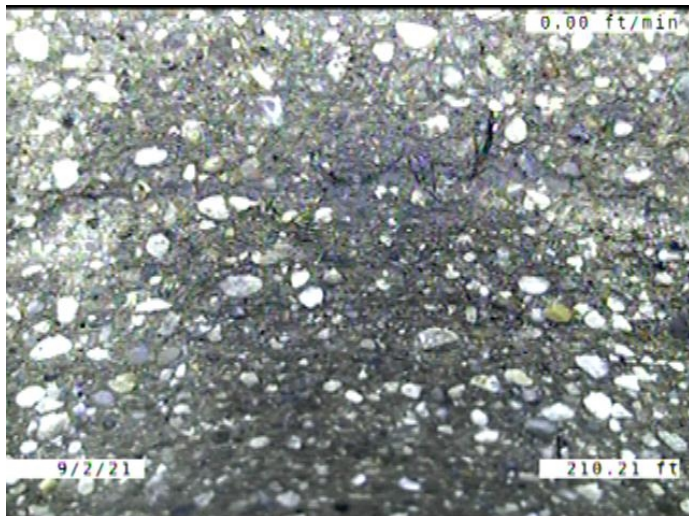
Code: **CM**
 Description: **Crack Multiple**

Distance (ft): **210.2**
 Structural Grade: **3**
 O&M Grade: **0**
 Clock Start/From: **8**
 Clock To: **4**
 1st Value:
 2nd Value:
 Value Percent:
 Continuous Index:
 Within 8" of Joint: **YES**
 Remarks:

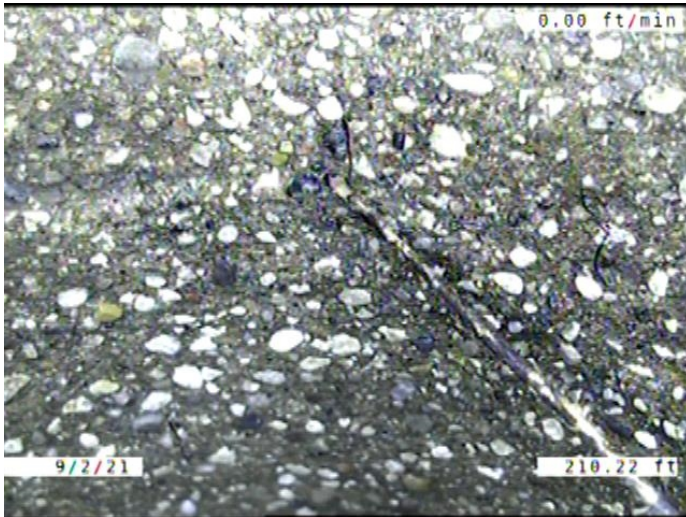
Code: **RFJ**
 Description: **Roots Fine Joint**

Distance (ft): **210.2**
 Structural Grade: **0**
 O&M Grade: **1**
 Clock Start/From: **10**
 Clock To: **2**
 1st Value:
 2nd Value:
 Value Percent:
 Continuous Index:
 Within 8" of Joint: **YES**
 Remarks:

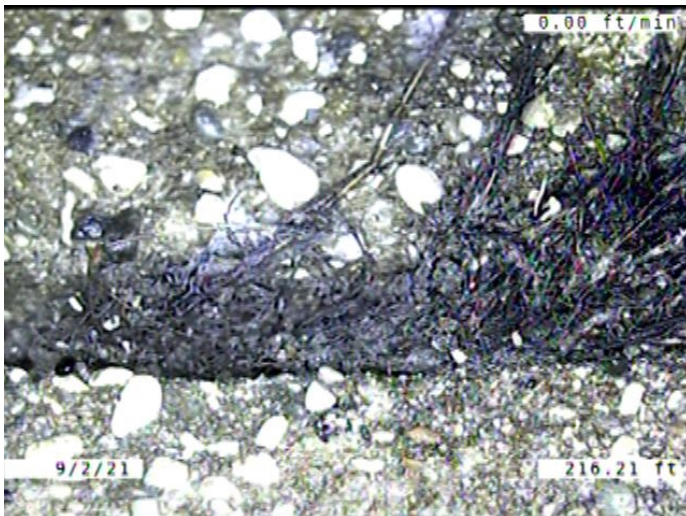
Code: **RFJ**
 Description: **Roots Fine Joint**

Distance (ft): **216.2**
 Structural Grade: **0**
 O&M Grade: **1**
 Clock Start/From: **8**
 Clock To: **9**
 1st Value:
 2nd Value:
 Value Percent:
 Continuous Index:
 Within 8" of Joint: **YES**
 Remarks:

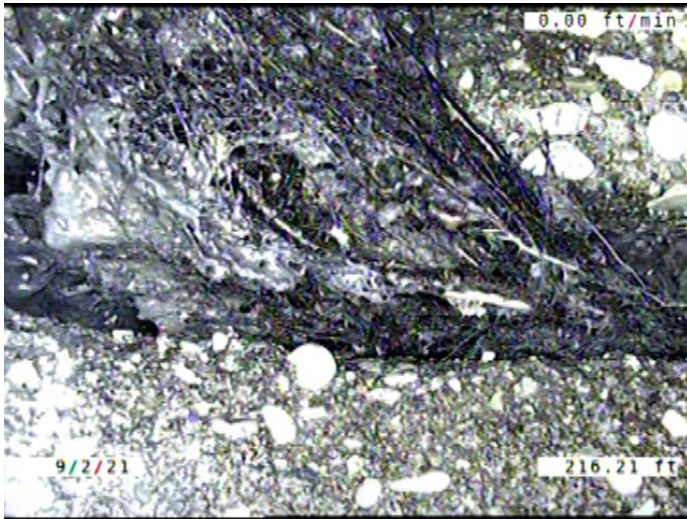
Code: **RFJ**
 Description: **Roots Fine Joint**

Distance (ft): **216.2**
 Structural Grade: **0**
 O&M Grade: **1**
 Clock Start/From: **3**
 Clock To: **4**
 1st Value:
 2nd Value:
 Value Percent:
 Continuous Index:
 Within 8" of Joint: **YES**
 Remarks:

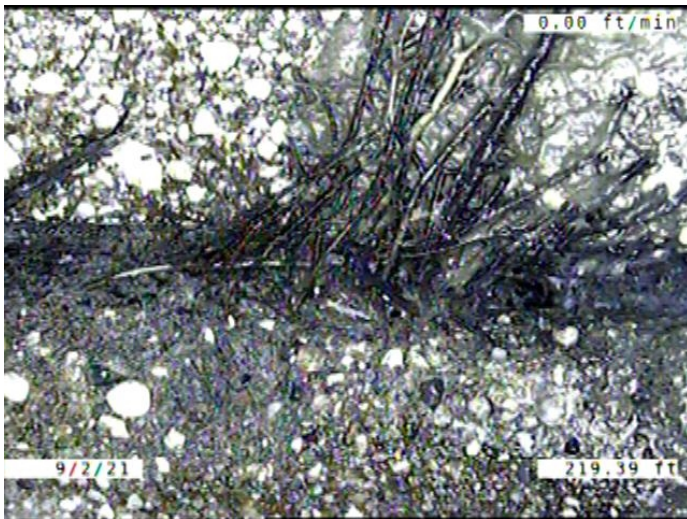
Code: **RFJ**
 Description: **Roots Fine Joint**

Distance (ft): **219.4**
 Structural Grade: **0**
 O&M Grade: **1**
 Clock Start/From: **8**
 Clock To: **4**
 1st Value:
 2nd Value:
 Value Percent:
 Continuous Index:
 Within 8" of Joint: **YES**
 Remarks:

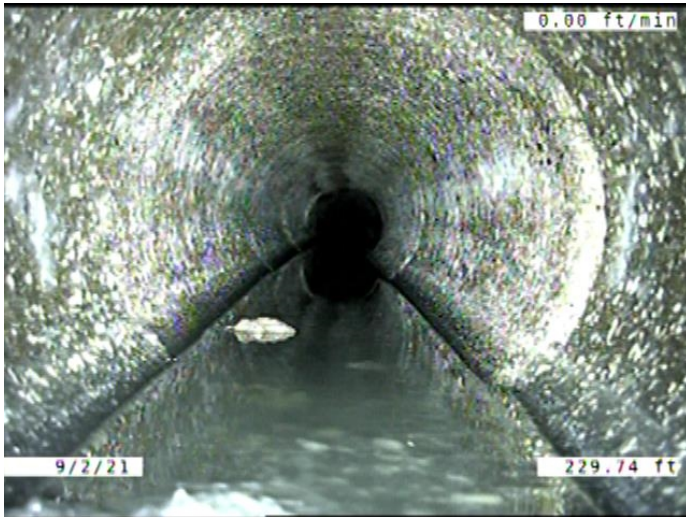
Code: **DAE**
Description: **Deposits Attached Encrustation**

Distance (ft): **229.7**
Structural Grade: **0**
O&M Grade: **2**
Clock Start/From: **4**
Clock To: **8**
1st Value:
2nd Value:
Value Percent: **5.000**
Continuous Index: **F03**
Within 8" of Joint: **YES**
Remarks:

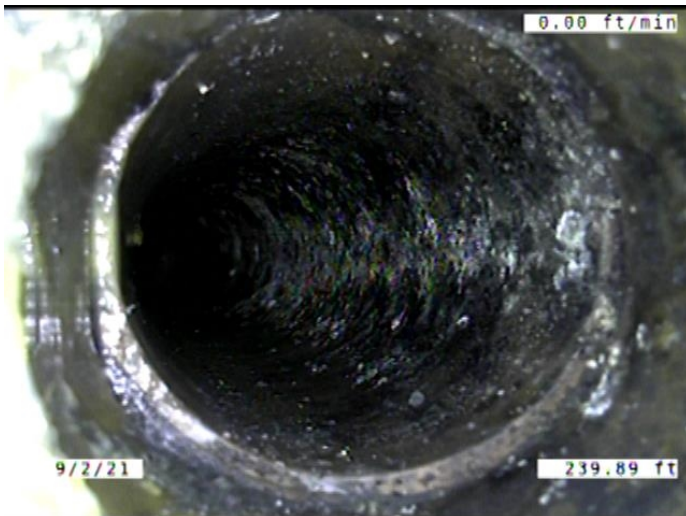
Code: **TB**
Description: **Tap Break-in/Hammer**

Distance (ft): **239.9**
Structural Grade: **0**
O&M Grade: **0**
Clock Start/From: **10**
Clock To:
1st Value: **6.000**
2nd Value:
Value Percent:
Continuous Index:
Within 8" of Joint: **YES**
Remarks:

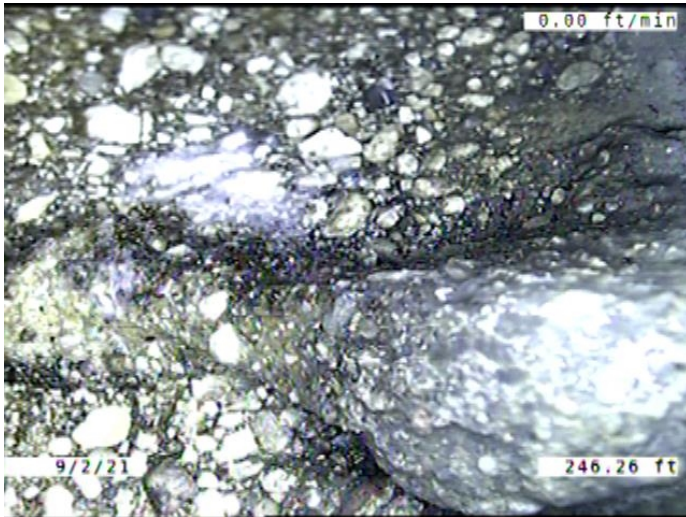
Code: **DAE**
 Description: **Deposits Attached Encrustation**

Distance (ft): **246.3**
 Structural Grade: **0**
 O&M Grade: **2**
 Clock Start/From: **4**
 Clock To: **8**
 1st Value:
 2nd Value:
 Value Percent: **5.000**
 Continuous Index:
 Within 8" of Joint: **YES**
 Remarks:

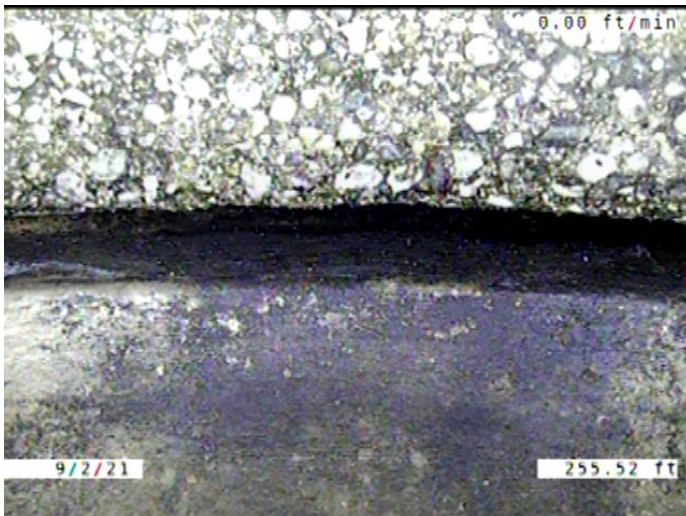
Code: **MMC**
 Description: **Miscellaneous Material Change**

Distance (ft): **255.5**
 Structural Grade: **0**
 O&M Grade: **0**
 Clock Start/From:
 Clock To:
 1st Value:
 2nd Value:
 Value Percent:
 Continuous Index:
 Within 8" of Joint: **NO**
 Remarks: **CONCRETE TO VCP**

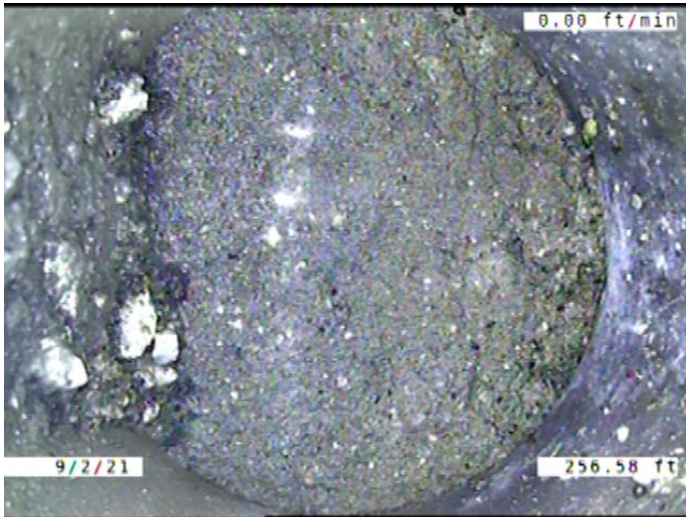
Code: **TFC**
 Description: **Tap Factory Capped**

Distance (ft): **256.6**
 Structural Grade: **0**
 O&M Grade: **0**
 Clock Start/From: **9**
 Clock To:
 1st Value: **6.000**
 2nd Value:
 Value Percent:
 Continuous Index:
 Within 8" of Joint: **YES**
 Remarks:

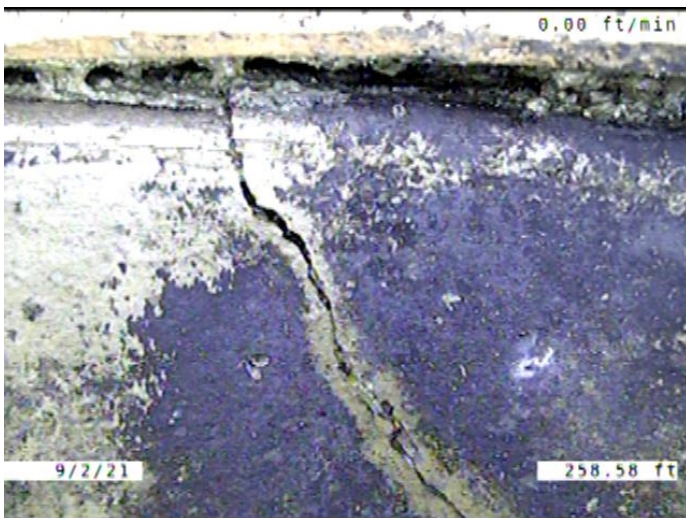
Code: **FM**
 Description: **Fracture Multiple**

Distance (ft): **258.6**
 Structural Grade: **4**
 O&M Grade: **0**
 Clock Start/From: **12**
 Clock To: **2**
 1st Value:
 2nd Value:
 Value Percent:
 Continuous Index:
 Within 8" of Joint: **YES**
 Remarks:

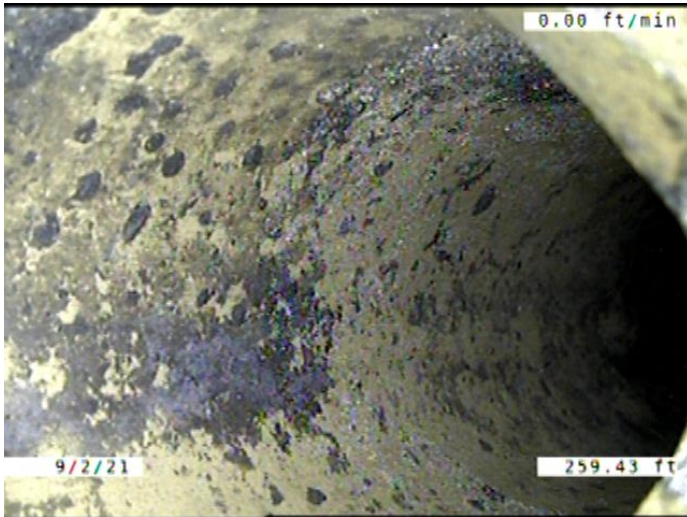
Code: **TFD**
 Description: **Tap Factory Defective**

Distance (ft): **259.4**
 Structural Grade: **0**
 O&M Grade: **3**
 Clock Start/From: **2**
 Clock To:
 1st Value: **6.000**
 2nd Value:
 Value Percent:
 Continuous Index:
 Within 8" of Joint: **YES**
 Remarks: **Debris**

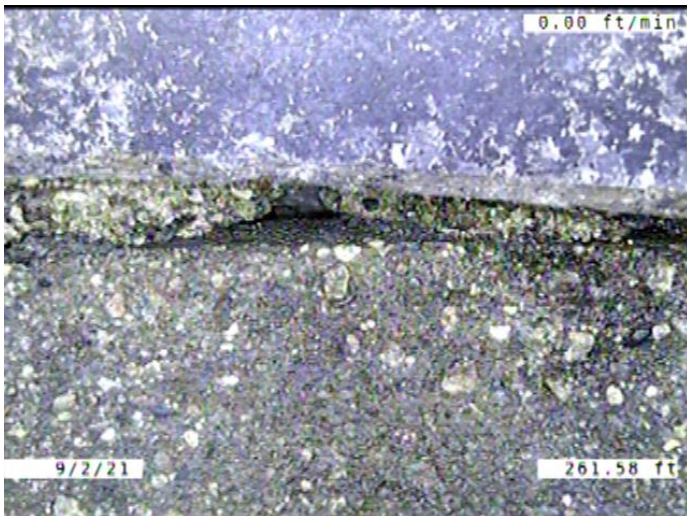
Code: **MMC**
 Description: **Miscellaneous Material Change**

Distance (ft): **261.6**
 Structural Grade: **0**
 O&M Grade: **0**
 Clock Start/From:
 Clock To:
 1st Value:
 2nd Value:
 Value Percent:
 Continuous Index:
 Within 8" of Joint: **NO**
 Remarks: **VCP TO CONCRETE**

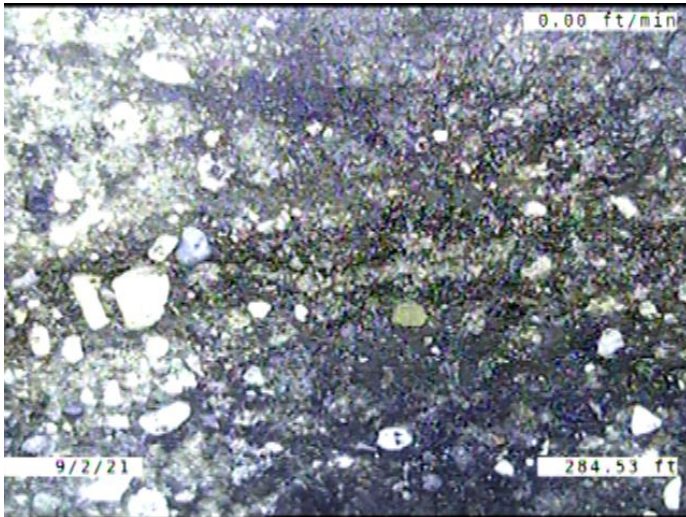
Code: **CC**
 Description: **Crack Circumferential**

Distance (ft): **284.5**
 Structural Grade: **1**
 O&M Grade: **0**
 Clock Start/From: **7**
 Clock To: **5**
 1st Value:
 2nd Value:
 Value Percent:
 Continuous Index:
 Within 8" of Joint: **NO**
 Remarks:

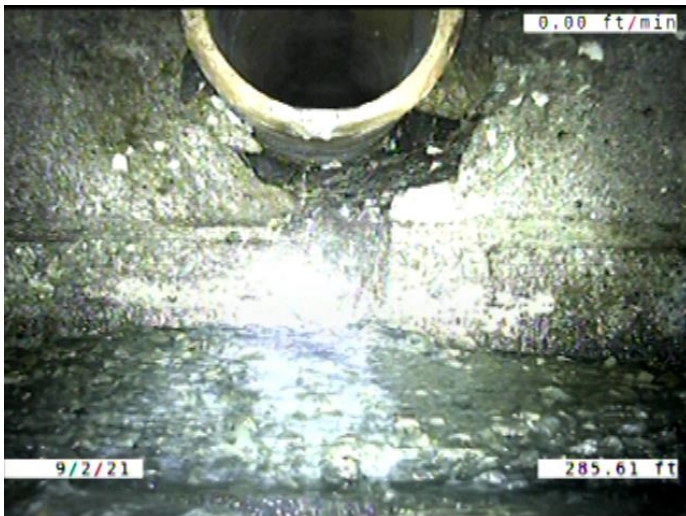
Code: **DSF**
 Description: **Deposits Settled Fine**

Distance (ft): **285.6**
 Structural Grade: **0**
 O&M Grade: **2**
 Clock Start/From: **5**
 Clock To: **7**
 1st Value:
 2nd Value:
 Value Percent: **5.000**
 Continuous Index: **F01**
 Within 8" of Joint: **YES**
 Remarks:
