Profile/Photo Observation Report

Date:	09/02/2021	Weather:		Coding:	PACP 7.0
Pipe Length (ft):	286.3	Owner:	City of Hobart	Pre Clean:	Light Cleaning
P.O.#:	YES502259	Surveyor:	S. Bucklin	PSR:	P-504-127-128
Customer:	City of Hobart	Clean Date:	08/30/2021	Shape:	C

Street:	North Wilson Street	Flow Control:	Not Controlled
City:	Hobart, IN	Year Renewed:	
Location:	Alley	Tape/Media #:	
Purpose:	Routine Assessment	Dia/Height:	10"
Use:	Sanitary Sewage Pipe	Material:	CP
Drain Area:		Lining:	
Category:	NA		
Comment:			
Location Details:		Direction of Survey:	Downstream
US MH:	M-504-128	DS MH:	M-504-127
		Total Length Surveyed (ft):	286.3

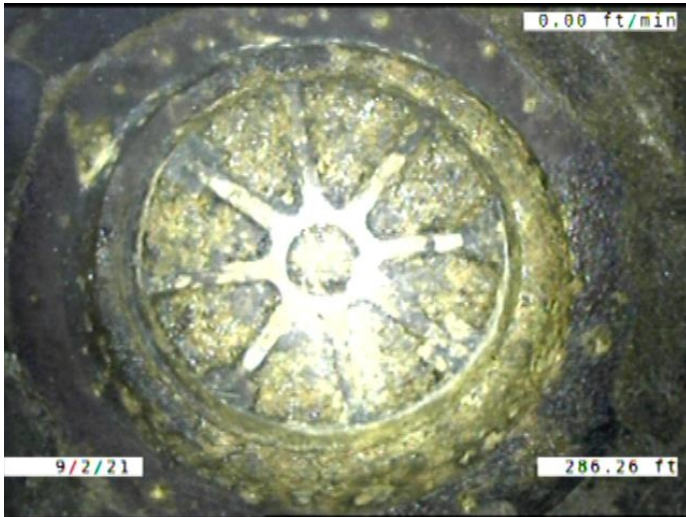
Code:	AMH
Description:	Manhole
Distance (ft):	286.3
Structural Grade:	0
O&M Grade:	0
Clock Start/From:	
Clock To:	
1st Value:	
2nd Value:	
Value Percent:	
Continuous Index:	
Within 8" of Joint:	NO
Remarks:	M-504-127
