# Profile/Photo Observation Report

Date:	09/12/2021	Weather:		Coding:	PACP 7.0
Pipe Length (ft):	167.2	Owner:	City of Hobart	Pre Clean:	Heavy Cleaning
P.O.#:	YES502259	Surveyor:	S. Bucklin	PSR:	P-504-088-130
Customer:	City of Hobart	Clean Date:	08/29/2021	Shape:	C

Street:	West 42nd Avenue	Flow Control:	Not Controlled
City:	Hobart, IN	Year Renewed:	
Location:	Alley	Tape/Media #:	
Purpose:	Routine Assessment	Dia/Height:	12"
Use:	Sanitary Sewage Pipe	Material:	VCP
Drain Area:		Lining:	None
Category:	NA		
Comment:			
Location Details:		Direction of Survey:	Downstream
US MH:	M-504-130	DS MH:	M-504-088
		Total Length Surveyed (ft):	167.2

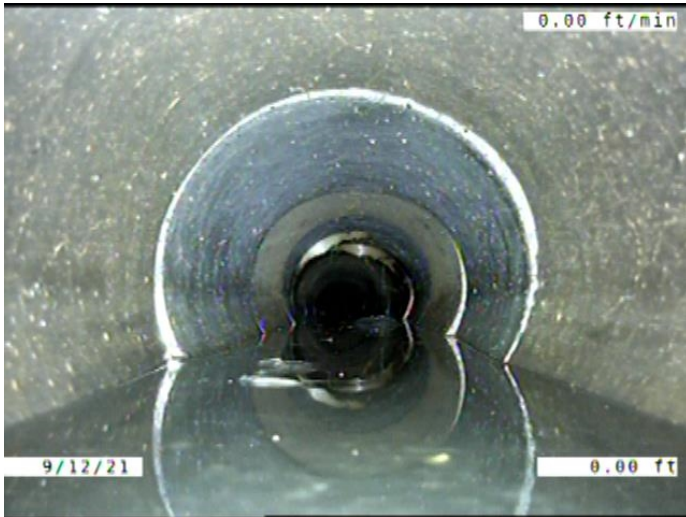
Code: **DSF**  
 Description: **Deposits Settled Fine**

Distance (ft): **.0**  
 Structural Grade: **0**  
 O&M Grade: **2**  
 Clock Start/From: **5**  
 Clock To: **7**  
 1st Value:  
 2nd Value:  
 Value Percent: **5.000**  
 Continuous Index: **S01**  
 Within 8" of Joint: **YES**  
 Remarks:

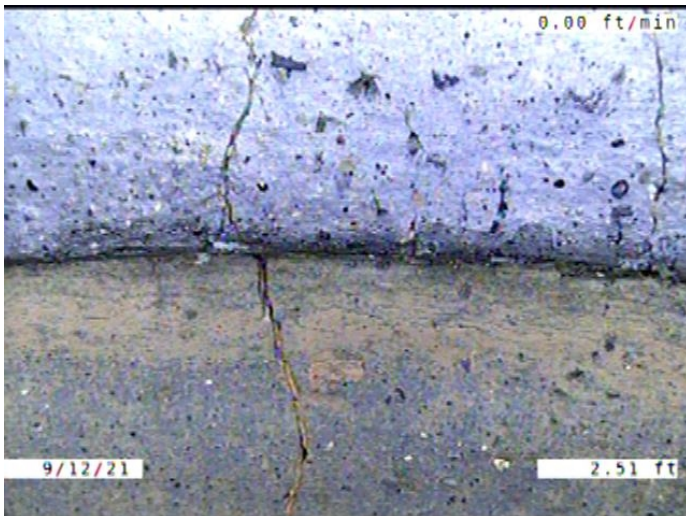
Code: **FM**  
 Description: **Fracture Multiple**

Distance (ft): **2.5**  
 Structural Grade: **4**  
 O&M Grade: **0**  
 Clock Start/From: **8**  
 Clock To: **3**  
 1st Value:  
 2nd Value:  
 Value Percent:  
 Continuous Index: **S02**  
 Within 8" of Joint: **YES**  
 Remarks:

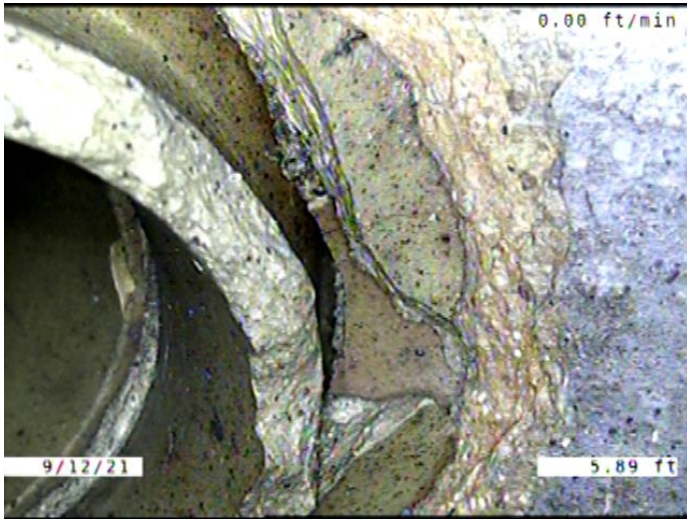
Code: **B**  
Description: **Broken**

Distance (ft): **5.9**  
Structural Grade: **4**  
O&M Grade: **0**  
Clock Start/From: **12**  
Clock To:  
1st Value:  
2nd Value:  
Value Percent:  
Continuous Index:  
Within 8" of Joint: **YES**  
Remarks:

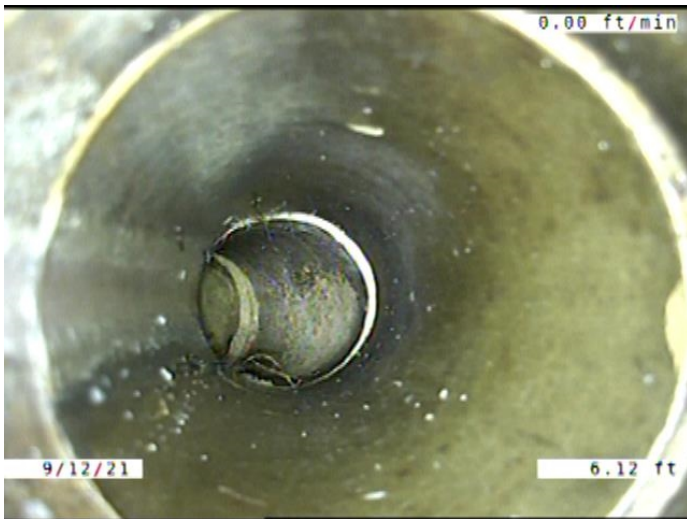
Code: **TB**  
Description: **Tap Break-in/Hammer**

Distance (ft): **6.1**  
Structural Grade: **0**  
O&M Grade: **0**  
Clock Start/From: **11**  
Clock To:  
1st Value: **4.000**  
2nd Value:  
Value Percent:  
Continuous Index:  
Within 8" of Joint: **YES**  
Remarks:

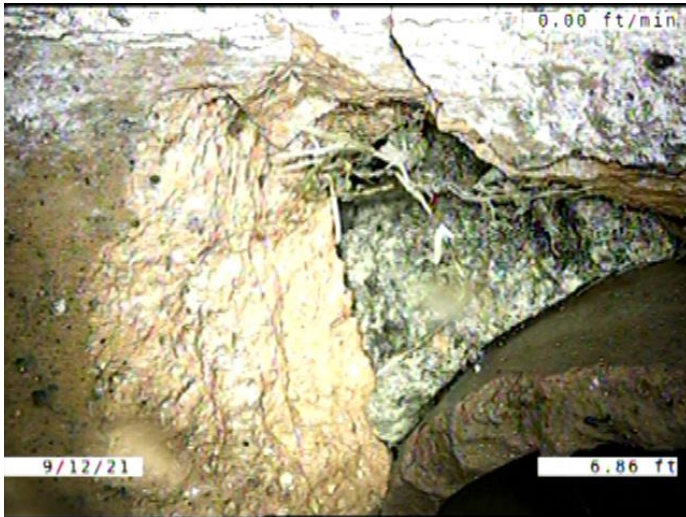
Code: **B**  
 Description: **Broken**

Distance (ft): **6.9**  
 Structural Grade: **4**  
 O&M Grade: **0**  
 Clock Start/From: **11**  
 Clock To: **3**  
 1st Value:  
 2nd Value:  
 Value Percent:  
 Continuous Index:  
 Within 8" of Joint: **YES**  
 Remarks:

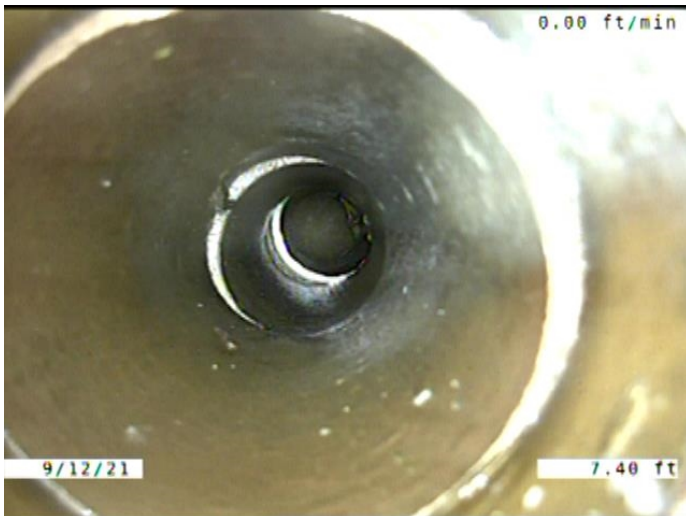
Code: **TBA**  
 Description: **Tap Break-in Activity**

Distance (ft): **7.4**  
 Structural Grade: **0**  
 O&M Grade: **0**  
 Clock Start/From: **1**  
 Clock To:  
 1st Value: **4.000**  
 2nd Value:  
 Value Percent:  
 Continuous Index:  
 Within 8" of Joint: **YES**  
 Remarks: **CONSTANTLY RUNNING WATER**

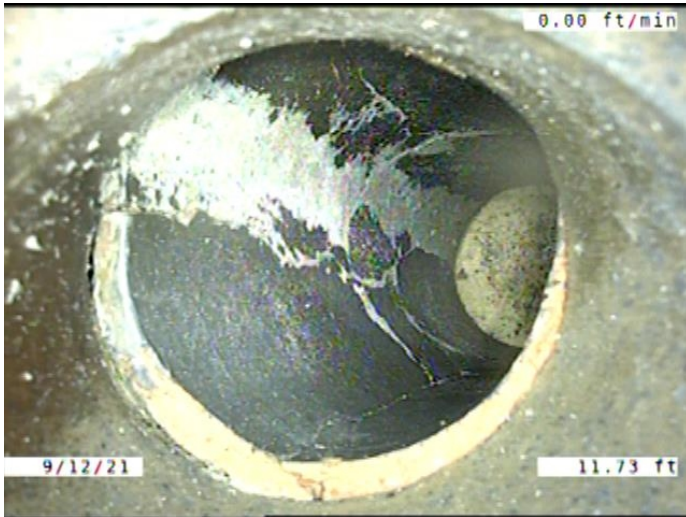
Code: **TFD**  
 Description: **Tap Factory Defective**

Distance (ft): **11.7**  
 Structural Grade: **0**  
 O&M Grade: **3**  
 Clock Start/From: **10**  
 Clock To:  
 1st Value: **4.000**  
 2nd Value:  
 Value Percent:  
 Continuous Index:  
 Within 8" of Joint: **YES**  
 Remarks: **CAPPED**

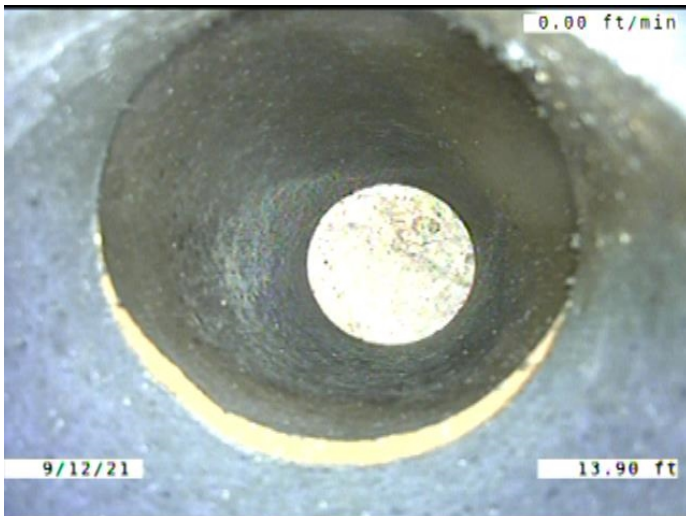
Code: **TFC**  
 Description: **Tap Factory Capped**

Distance (ft): **13.9**  
 Structural Grade: **0**  
 O&M Grade: **0**  
 Clock Start/From: **1**  
 Clock To:  
 1st Value: **4.000**  
 2nd Value:  
 Value Percent:  
 Continuous Index:  
 Within 8" of Joint: **YES**  
 Remarks:

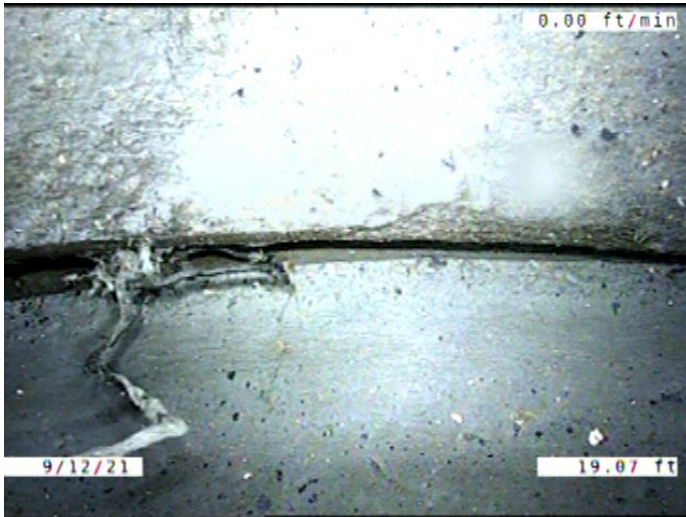
Code: **RFJ**  
 Description: **Roots Fine Joint**

Distance (ft): **19.1**  
 Structural Grade: **0**  
 O&M Grade: **1**  
 Clock Start/From: **10**  
 Clock To:  
 1st Value:  
 2nd Value:  
 Value Percent:  
 Continuous Index:  
 Within 8" of Joint: **YES**  
 Remarks:

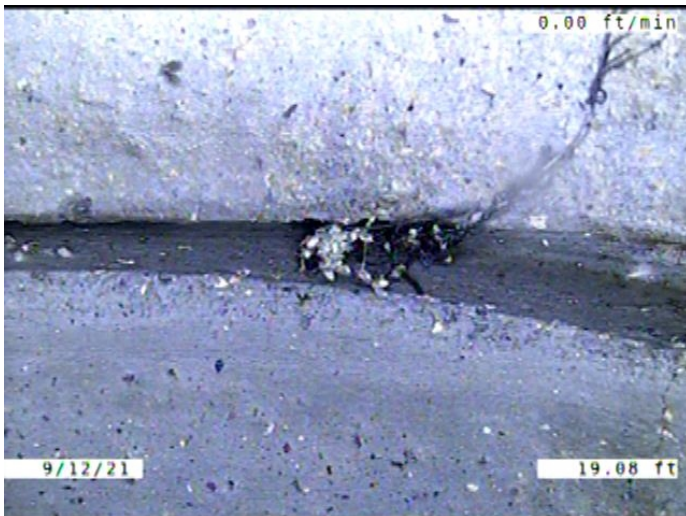
Code: **RFJ**  
 Description: **Roots Fine Joint**

Distance (ft): **19.1**  
 Structural Grade: **0**  
 O&M Grade: **1**  
 Clock Start/From: **1**  
 Clock To: **2**  
 1st Value:  
 2nd Value:  
 Value Percent:  
 Continuous Index:  
 Within 8" of Joint: **YES**  
 Remarks:

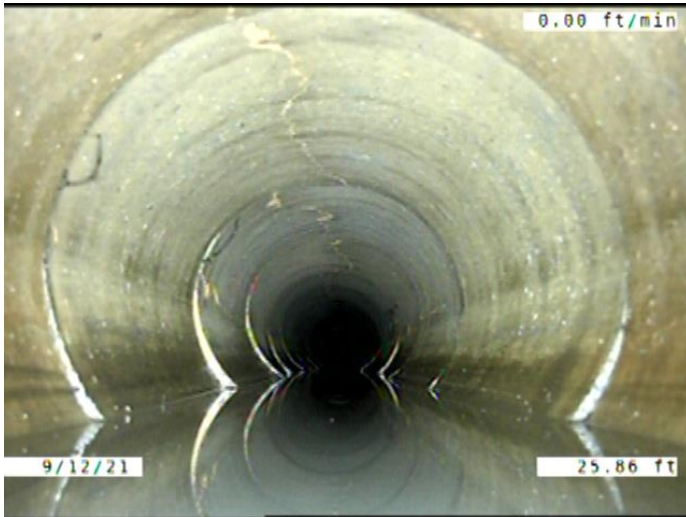
Code: **MWLS**  
 Description: **Miscellaneous Water Level Sag**

Distance (ft): **25.9**  
 Structural Grade: **2**  
 O&M Grade: **0**  
 Clock Start/From:  
 Clock To:  
 1st Value:  
 2nd Value:  
 Value Percent: **10.000**  
 Continuous Index:  
 Within 8" of Joint: **NO**  
 Remarks:

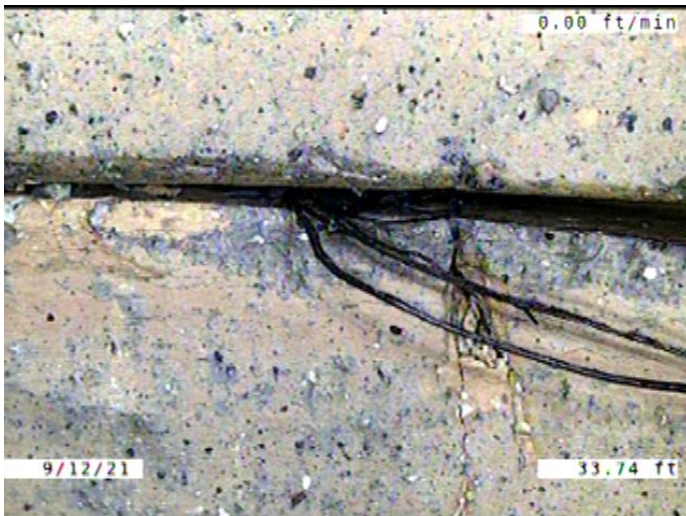
Code: **RFJ**  
 Description: **Roots Fine Joint**

Distance (ft): **33.7**  
 Structural Grade: **0**  
 O&M Grade: **1**  
 Clock Start/From: **2**  
 Clock To:  
 1st Value:  
 2nd Value:  
 Value Percent:  
 Continuous Index:  
 Within 8" of Joint: **YES**  
 Remarks:

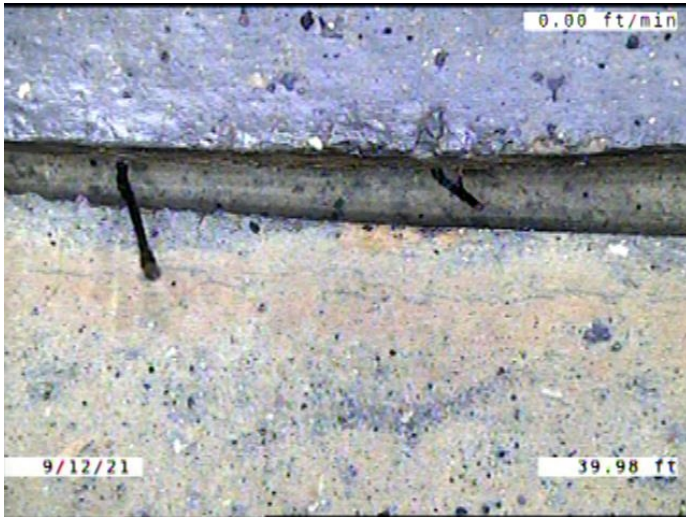
Code: **RFJ**  
Description: **Roots Fine Joint**

Distance (ft): **40.0**  
Structural Grade: **0**  
O&M Grade: **1**  
Clock Start/From: **12**  
Clock To: **1**  
1st Value:  
2nd Value:  
Value Percent:  
Continuous Index:  
Within 8" of Joint: **YES**  
Remarks:

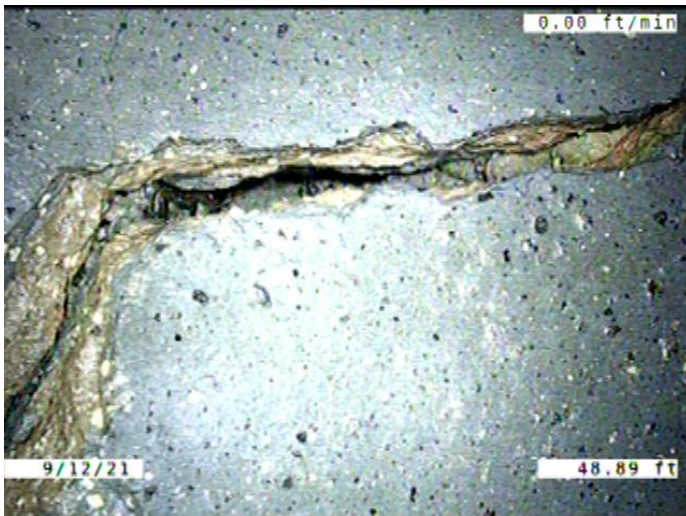
Code: **B**  
Description: **Broken**

Distance (ft): **47.8**  
Structural Grade: **4**  
O&M Grade: **0**  
Clock Start/From: **12**  
Clock To: **12**  
1st Value:  
2nd Value:  
Value Percent:  
Continuous Index:  
Within 8" of Joint: **YES**  
Remarks:

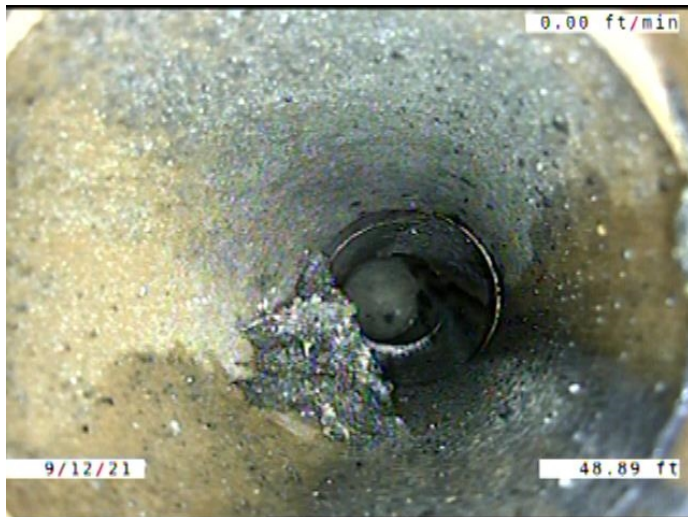
Code: **TBI**  
 Description: **Tap Break-in Intruding**

Distance (ft): **48.9**  
 Structural Grade: **0**  
 O&M Grade: **2**  
 Clock Start/From: **12**  
 Clock To:  
 1st Value: **4.000**  
 2nd Value: **1.000**  
 Value Percent:  
 Continuous Index:  
 Within 8" of Joint: **YES**  
 Remarks:

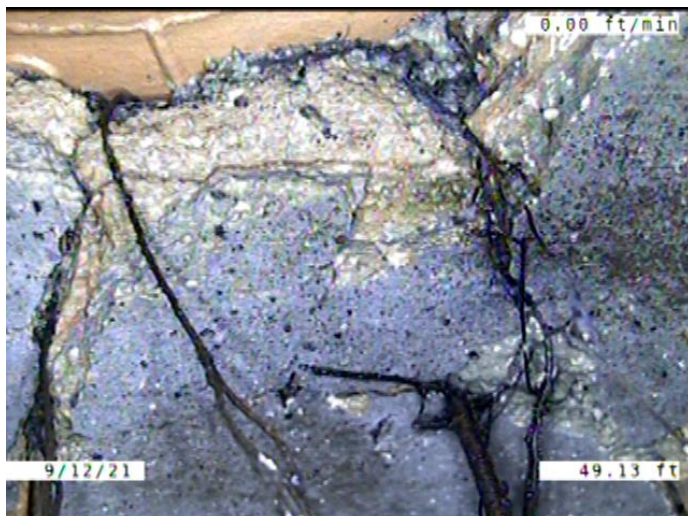
Code: **RFB**  
 Description: **Roots Fine Barrel**

Distance (ft): **49.1**  
 Structural Grade: **0**  
 O&M Grade: **2**  
 Clock Start/From: **11**  
 Clock To: **1**  
 1st Value:  
 2nd Value:  
 Value Percent:  
 Continuous Index:  
 Within 8" of Joint: **NO**  
 Remarks:

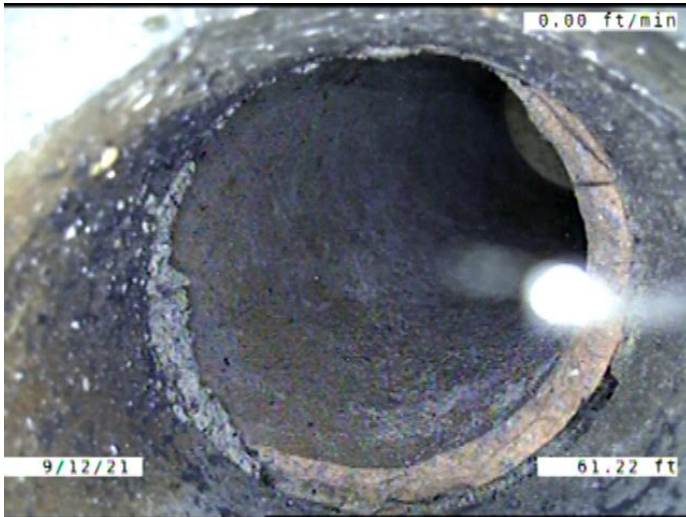
Code: **TFD**  
 Description: **Tap Factory Defective**

Distance (ft): **61.2**  
 Structural Grade: **0**  
 O&M Grade: **3**  
 Clock Start/From: **10**  
 Clock To:  
 1st Value: **4.000**  
 2nd Value:  
 Value Percent:  
 Continuous Index:  
 Within 8" of Joint: **YES**  
 Remarks: **Defective**

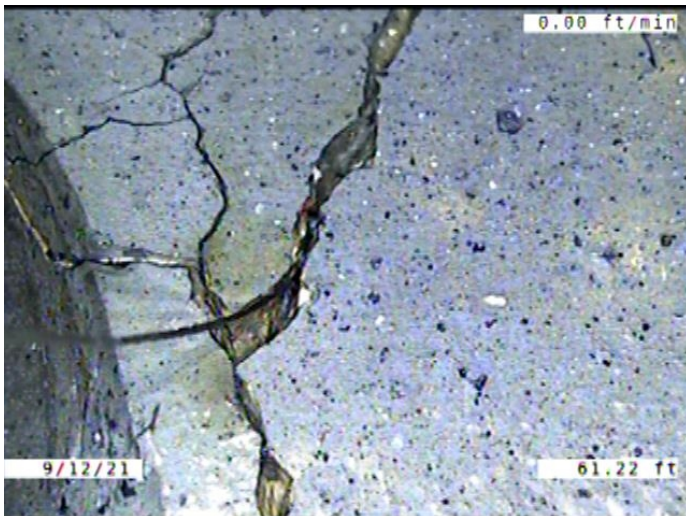
Code: **RFB**  
 Description: **Roots Fine Barrel**

Distance (ft): **61.2**  
 Structural Grade: **0**  
 O&M Grade: **2**  
 Clock Start/From: **12**  
 Clock To:  
 1st Value:  
 2nd Value:  
 Value Percent:  
 Continuous Index:  
 Within 8" of Joint: **NO**  
 Remarks:

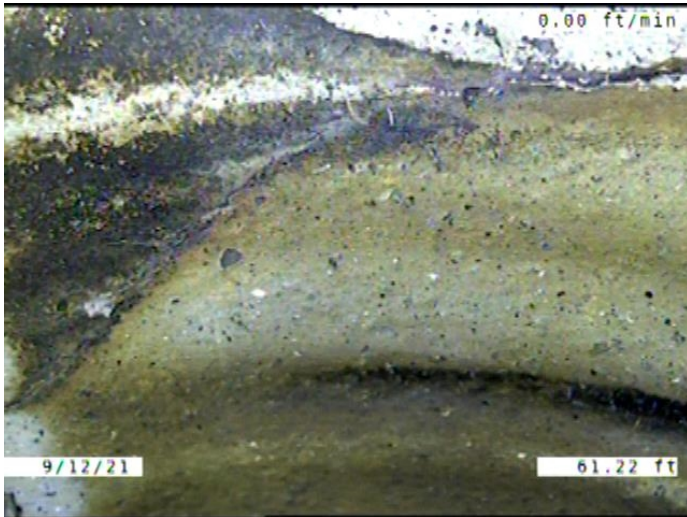
Code: **ISB**  
 Description: **Infiltration Stain Barrel**

Distance (ft): **61.2**  
 Structural Grade: **0**  
 O&M Grade: **1**  
 Clock Start/From: **9**  
 Clock To: **3**  
 1st Value:  
 2nd Value:  
 Value Percent:  
 Continuous Index: **S03**  
 Within 8" of Joint: **YES**  
 Remarks:

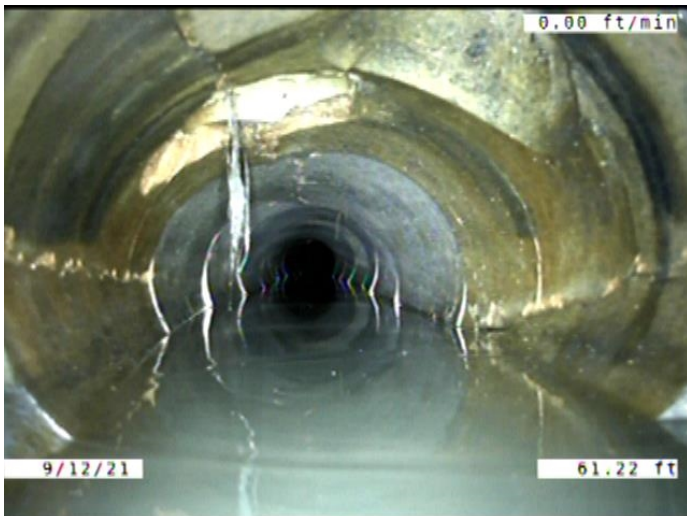
Code: **MWLS**  
 Description: **Miscellaneous Water Level Sag**

Distance (ft): **61.2**  
 Structural Grade: **2**  
 O&M Grade: **0**  
 Clock Start/From:  
 Clock To:  
 1st Value:  
 2nd Value:  
 Value Percent: **10.000**  
 Continuous Index: **S04**  
 Within 8" of Joint: **NO**  
 Remarks:

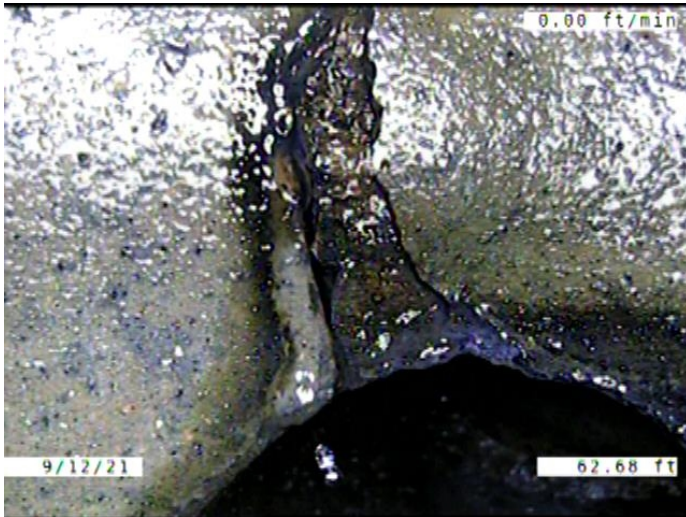
Code: **IWB**  
 Description: **Infiltration Weeper Barrel**

Distance (ft): **62.7**  
 Structural Grade: **0**  
 O&M Grade: **2**  
 Clock Start/From: **12**  
 Clock To: **1**  
 1st Value:  
 2nd Value:  
 Value Percent:  
 Continuous Index:  
 Within 8" of Joint: **YES**  
 Remarks:

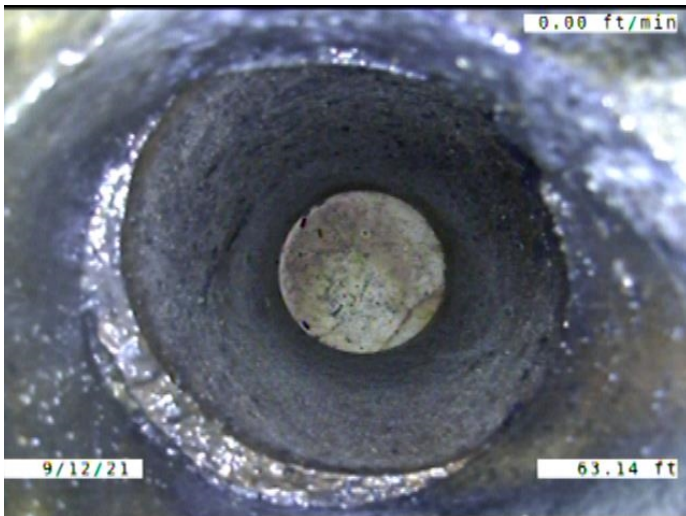
Code: **TFD**  
 Description: **Tap Factory Defective**

Distance (ft): **63.1**  
 Structural Grade: **0**  
 O&M Grade: **3**  
 Clock Start/From: **1**  
 Clock To:  
 1st Value: **4.000**  
 2nd Value:  
 Value Percent:  
 Continuous Index:  
 Within 8" of Joint: **YES**  
 Remarks: **CAPPED**

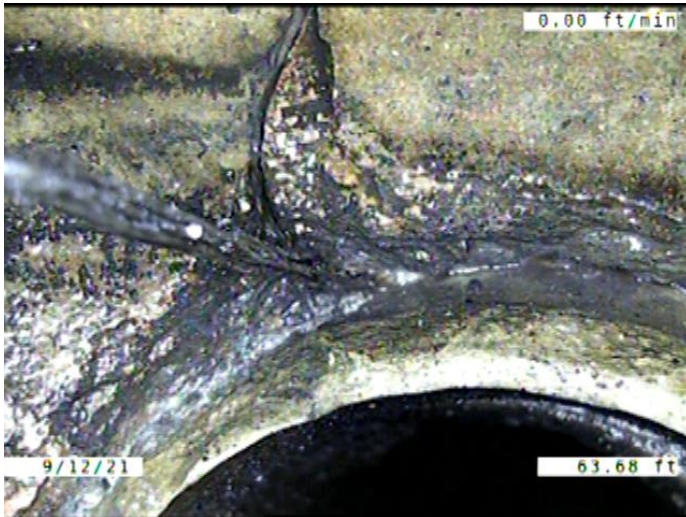
Code: **RFL**  
 Description: **Roots Fine Lateral**

Distance (ft): **63.7**  
 Structural Grade: **0**  
 O&M Grade: **1**  
 Clock Start/From: **11**  
 Clock To: **12**  
 1st Value:  
 2nd Value:  
 Value Percent:  
 Continuous Index:  
 Within 8" of Joint: **NO**  
 Remarks:

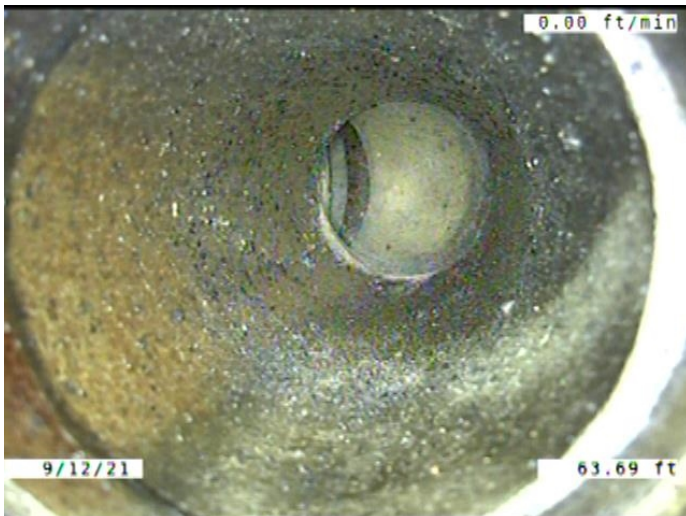
Code: **TBD**  
 Description: **Tap Break-in/Hammer Defective**

Distance (ft): **63.7**  
 Structural Grade: **0**  
 O&M Grade: **3**  
 Clock Start/From: **11**  
 Clock To:  
 1st Value: **4.000**  
 2nd Value:  
 Value Percent:  
 Continuous Index:  
 Within 8" of Joint: **YES**  
 Remarks: **Defective**

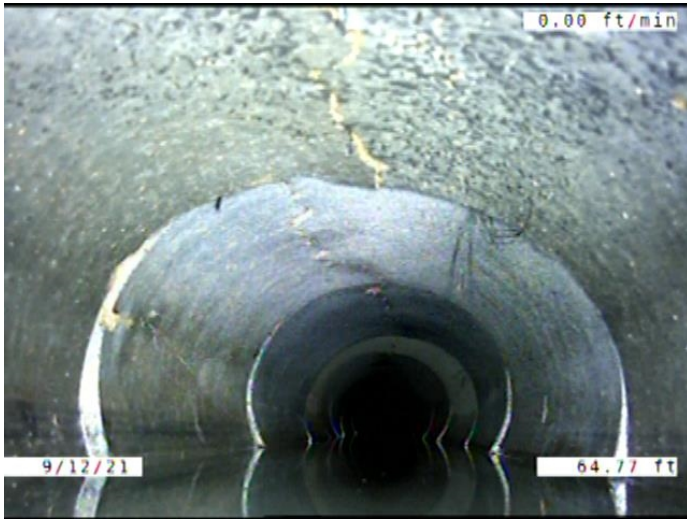
Code: **ISB**  
 Description: **Infiltration Stain Barrel**

Distance (ft): **64.8**  
 Structural Grade: **0**  
 O&M Grade: **1**  
 Clock Start/From: **9**  
 Clock To: **3**  
 1st Value:  
 2nd Value:  
 Value Percent:  
 Continuous Index: **F03**  
 Within 8" of Joint: **YES**  
 Remarks:

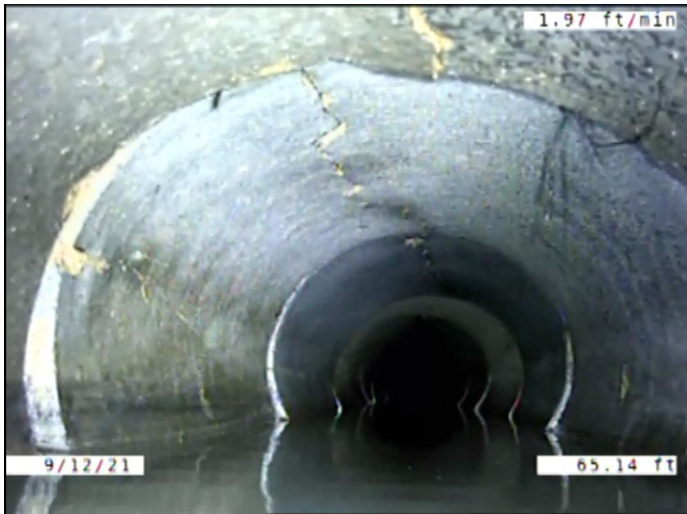
Code: **B**  
 Description: **Broken**

Distance (ft): **65.1**  
 Structural Grade: **4**  
 O&M Grade: **0**  
 Clock Start/From: **9**  
 Clock To: **4**  
 1st Value:  
 2nd Value:  
 Value Percent:  
 Continuous Index:  
 Within 8" of Joint: **YES**  
 Remarks:

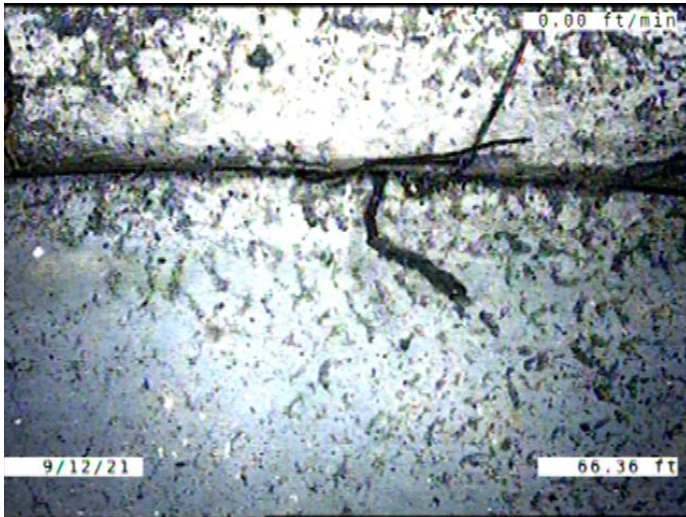
Code: **RFJ**  
 Description: **Roots Fine Joint**

Distance (ft): **66.4**  
 Structural Grade: **0**  
 O&M Grade: **1**  
 Clock Start/From: **11**  
 Clock To: **1**  
 1st Value:  
 2nd Value:  
 Value Percent:  
 Continuous Index:  
 Within 8" of Joint: **YES**  
 Remarks:

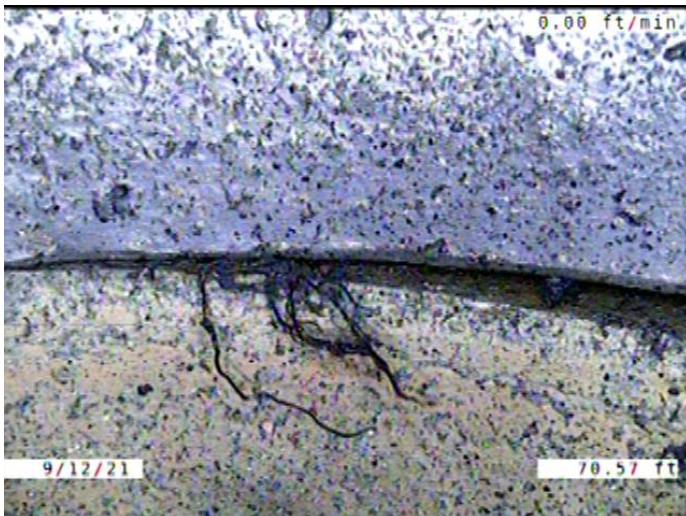
Code: **RFJ**  
 Description: **Roots Fine Joint**

Distance (ft): **70.6**  
 Structural Grade: **0**  
 O&M Grade: **1**  
 Clock Start/From: **2**  
 Clock To:  
 1st Value:  
 2nd Value:  
 Value Percent:  
 Continuous Index:  
 Within 8" of Joint: **YES**  
 Remarks:

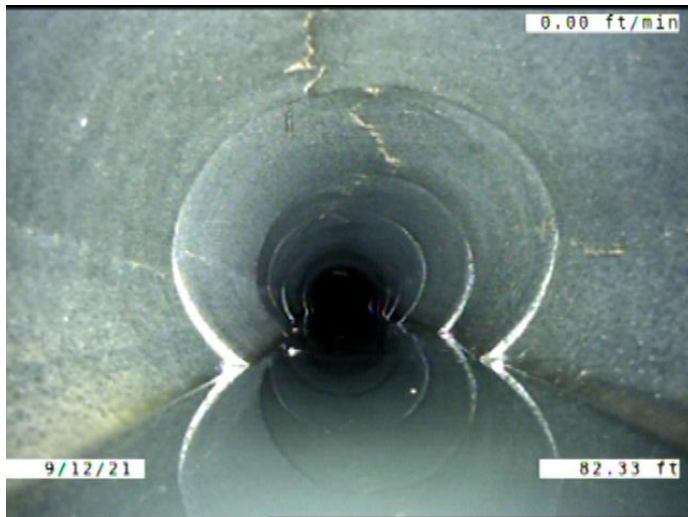
Code: **MWLS**  
 Description: **Miscellaneous Water Level Sag**

Distance (ft): **82.3**  
 Structural Grade: **2**  
 O&M Grade: **0**  
 Clock Start/From:  
 Clock To:  
 1st Value:  
 2nd Value:  
 Value Percent: **10.000**  
 Continuous Index: **F04**  
 Within 8" of Joint: **NO**  
 Remarks:

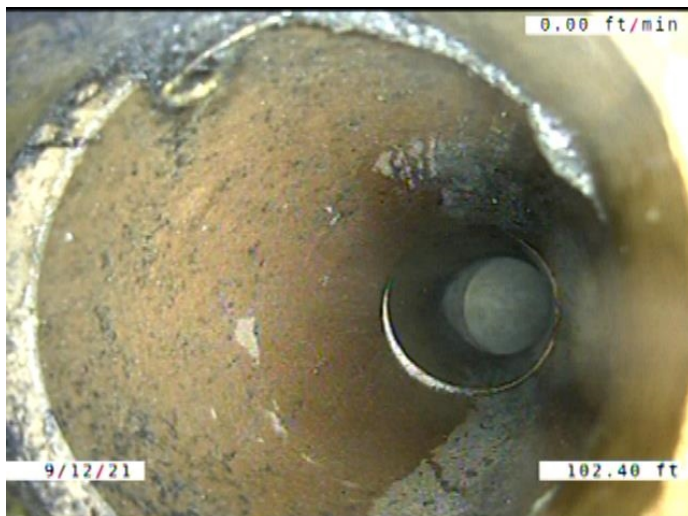
Code: **TBI**  
 Description: **Tap Break-in Intruding**

Distance (ft): **102.4**  
 Structural Grade: **0**  
 O&M Grade: **2**  
 Clock Start/From: **1**  
 Clock To:  
 1st Value: **4.000**  
 2nd Value: **1.000**  
 Value Percent:  
 Continuous Index:  
 Within 8" of Joint: **YES**  
 Remarks: **ACTIVITY**

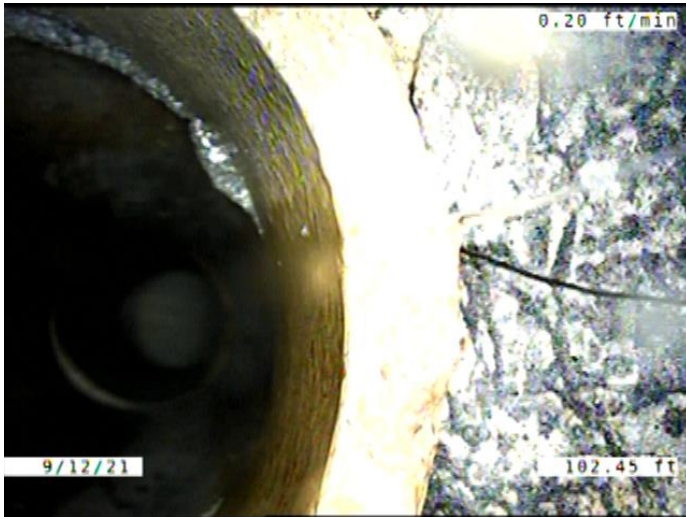
Code: **RFL**  
 Description: **Roots Fine Lateral**

Distance (ft): **102.4**  
 Structural Grade: **0**  
 O&M Grade: **1**  
 Clock Start/From: **1**  
 Clock To:  
 1st Value:  
 2nd Value:  
 Value Percent:  
 Continuous Index:  
 Within 8" of Joint: **NO**  
 Remarks:

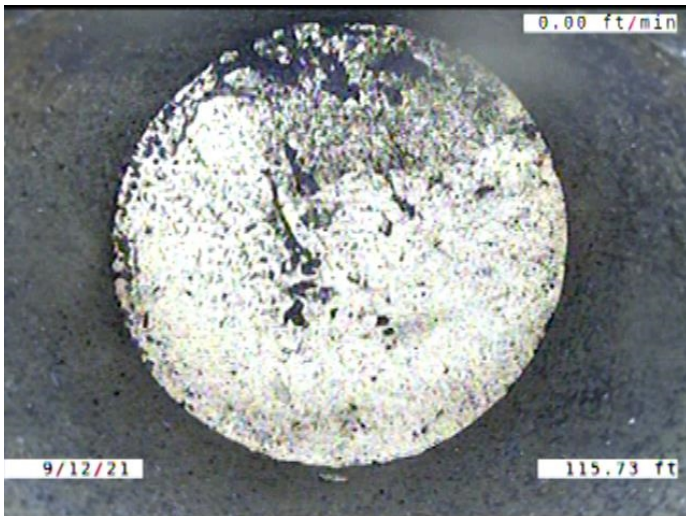
Code: **TFC**  
 Description: **Tap Factory Capped**

Distance (ft): **115.7**  
 Structural Grade: **0**  
 O&M Grade: **0**  
 Clock Start/From: **11**  
 Clock To:  
 1st Value: **4.000**  
 2nd Value:  
 Value Percent:  
 Continuous Index:  
 Within 8" of Joint: **YES**  
 Remarks:

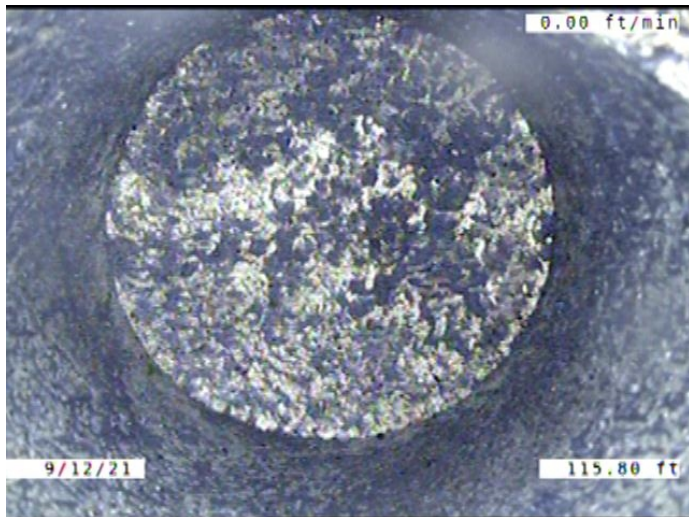
Code: **TFC**  
 Description: **Tap Factory Capped**

Distance (ft): **115.8**  
 Structural Grade: **0**  
 O&M Grade: **0**  
 Clock Start/From: **1**  
 Clock To:  
 1st Value: **4.000**  
 2nd Value:  
 Value Percent:  
 Continuous Index:  
 Within 8" of Joint: **YES**  
 Remarks:

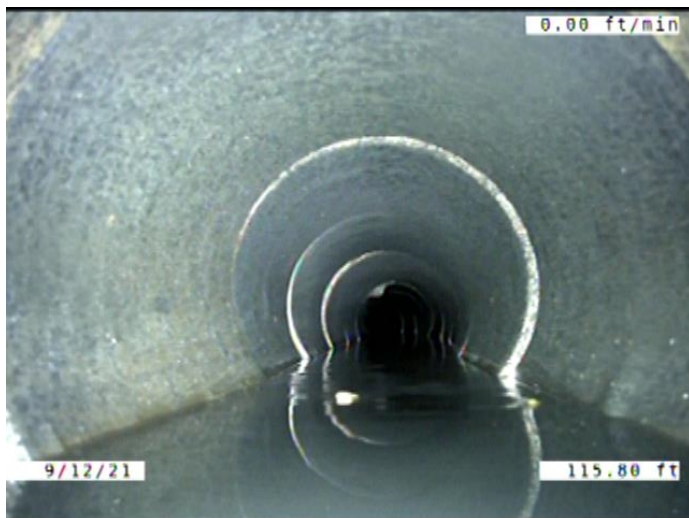
Code: **FM**  
 Description: **Fracture Multiple**

Distance (ft): **115.8**  
 Structural Grade: **4**  
 O&M Grade: **0**  
 Clock Start/From: **8**  
 Clock To: **3**  
 1st Value:  
 2nd Value:  
 Value Percent:  
 Continuous Index: **F02**  
 Within 8" of Joint: **YES**  
 Remarks:

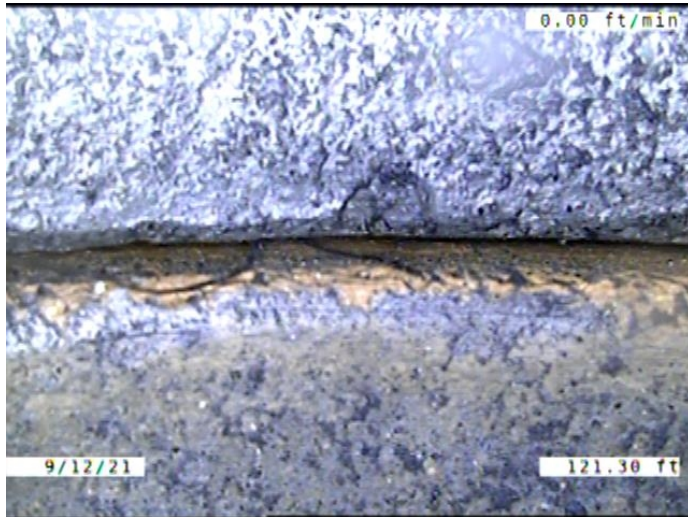
Code: **RFJ**  
 Description: **Roots Fine Joint**

Distance (ft): **121.3**  
 Structural Grade: **0**  
 O&M Grade: **1**  
 Clock Start/From: **10**  
 Clock To: **11**  
 1st Value:  
 2nd Value:  
 Value Percent:  
 Continuous Index:  
 Within 8" of Joint: **YES**  
 Remarks:

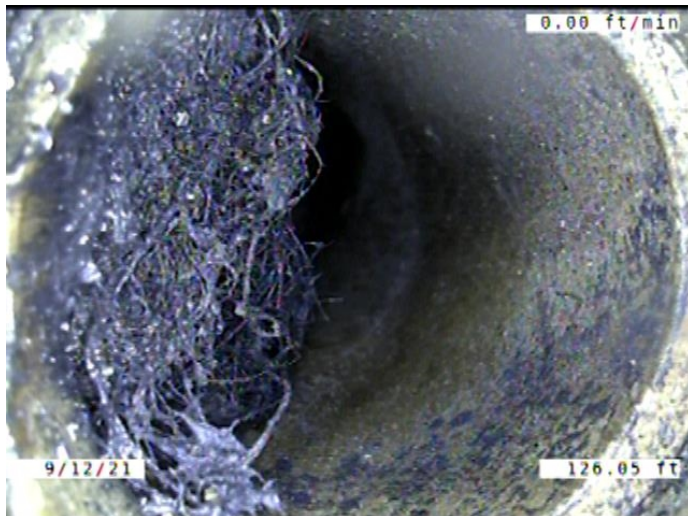
Code: **TBD**  
 Description: **Tap Break-in/Hammer Defective**

Distance (ft): **126.1**  
 Structural Grade: **0**  
 O&M Grade: **3**  
 Clock Start/From: **11**  
 Clock To:  
 1st Value: **4.000**  
 2nd Value:  
 Value Percent:  
 Continuous Index:  
 Within 8" of Joint: **YES**  
 Remarks: **Defective**

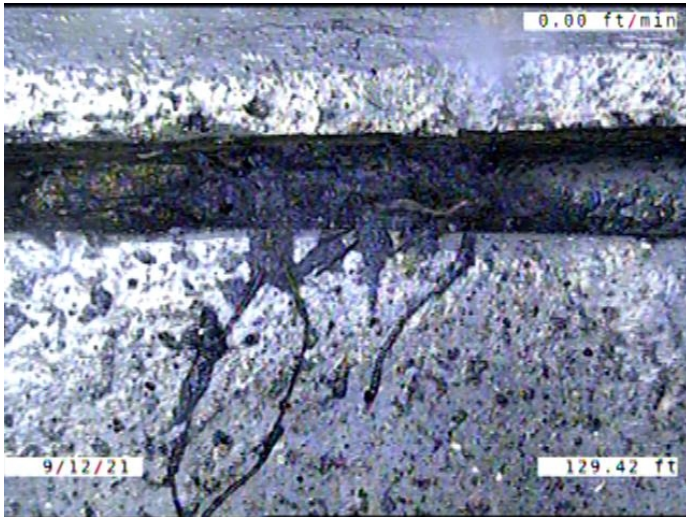
Code: **RFJ**  
 Description: **Roots Fine Joint**

Distance (ft): **129.4**  
 Structural Grade: **0**  
 O&M Grade: **1**  
 Clock Start/From: **3**  
 Clock To:  
 1st Value:  
 2nd Value:  
 Value Percent:  
 Continuous Index:  
 Within 8" of Joint: **YES**  
 Remarks:

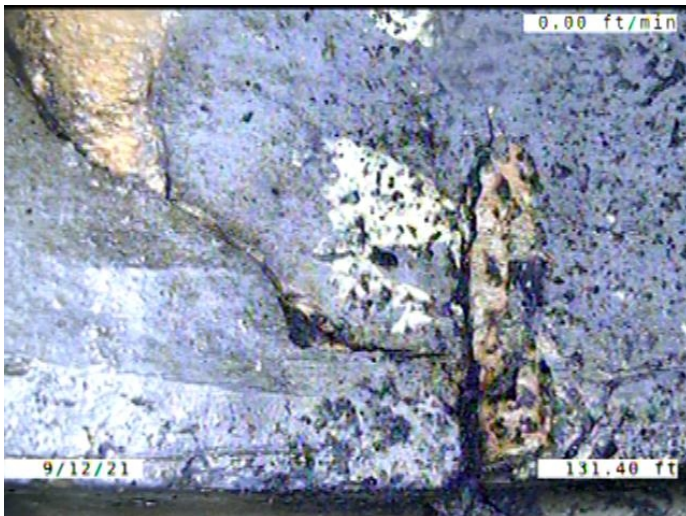
Code: **B**  
 Description: **Broken**

Distance (ft): **131.4**  
 Structural Grade: **4**  
 O&M Grade: **0**  
 Clock Start/From: **4**  
 Clock To: **5**  
 1st Value:  
 2nd Value:  
 Value Percent:  
 Continuous Index:  
 Within 8" of Joint: **YES**  
 Remarks:

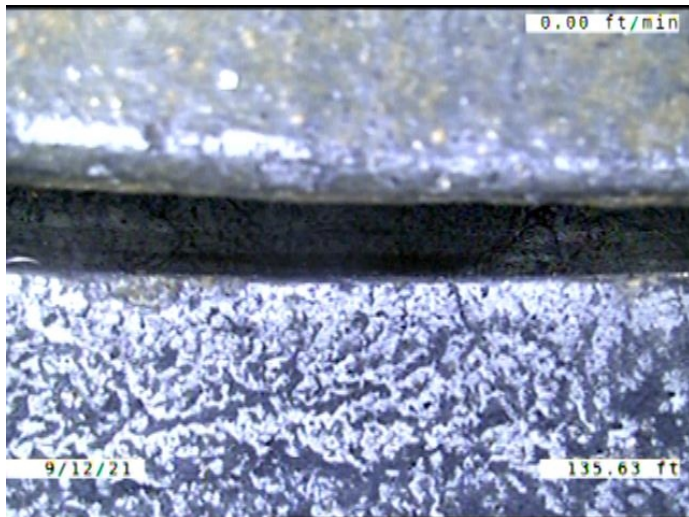
Code: **JSL**  
 Description: **Joint Separated Large**

Distance (ft): **135.6**  
 Structural Grade: **4**  
 O&M Grade: **0**  
 Clock Start/From:  
 Clock To:  
 1st Value:  
 2nd Value:  
 Value Percent:  
 Continuous Index:  
 Within 8" of Joint: **NO**  
 Remarks: **SOIL VISIBLE**

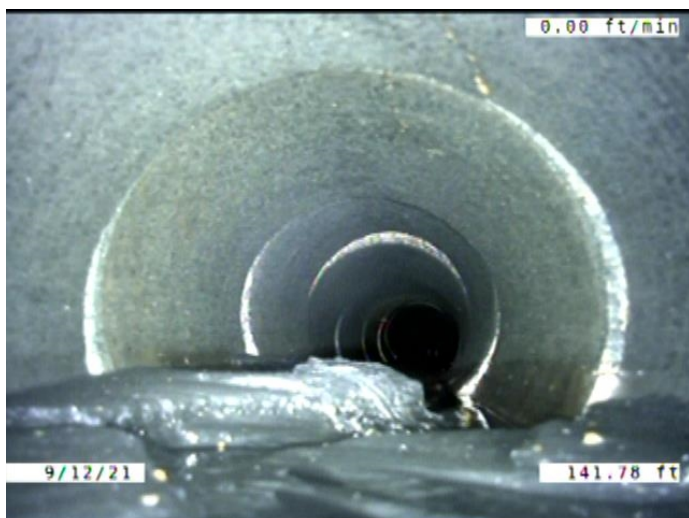
Code: **DSF**  
 Description: **Deposits Settled Fine**

Distance (ft): **141.8**  
 Structural Grade: **0**  
 O&M Grade: **3**  
 Clock Start/From: **4**  
 Clock To: **8**  
 1st Value:  
 2nd Value:  
 Value Percent: **15.000**  
 Continuous Index:  
 Within 8" of Joint: **YES**  
 Remarks:

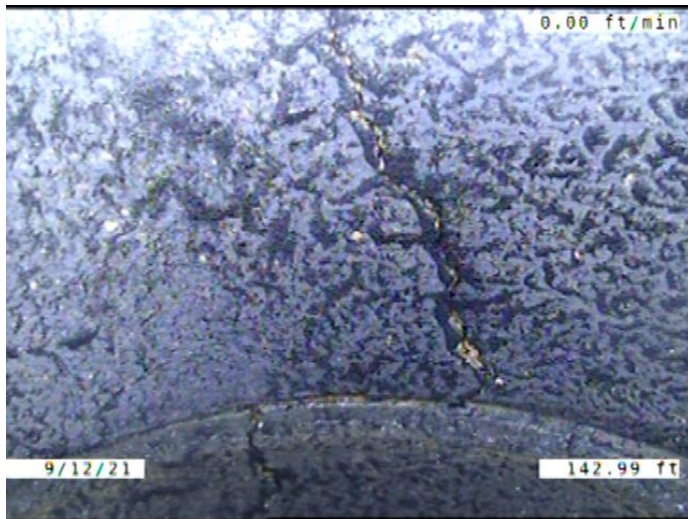
Code: **FM**  
 Description: **Fracture Multiple**

Distance (ft): **143.0**  
 Structural Grade: **4**  
 O&M Grade: **0**  
 Clock Start/From: **11**  
 Clock To: **1**  
 1st Value:  
 2nd Value:  
 Value Percent:  
 Continuous Index:  
 Within 8" of Joint: **YES**  
 Remarks:

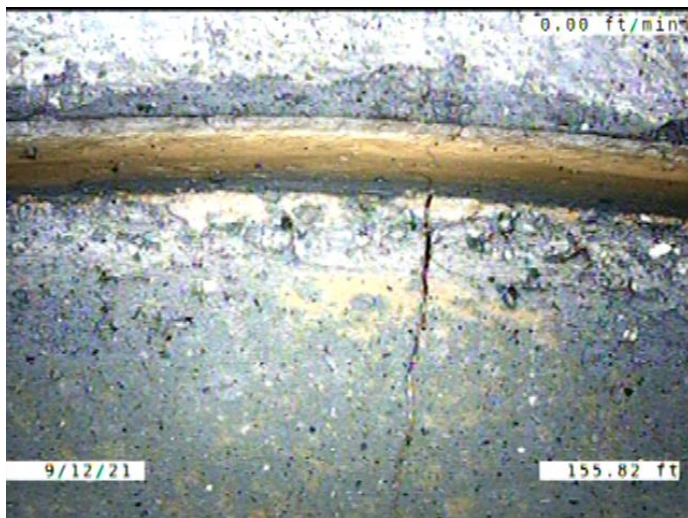
Code: **CM**  
 Description: **Crack Multiple**

Distance (ft): **155.8**  
 Structural Grade: **3**  
 O&M Grade: **0**  
 Clock Start/From: **12**  
 Clock To: **1**  
 1st Value:  
 2nd Value:  
 Value Percent:  
 Continuous Index: **S06**  
 Within 8" of Joint: **YES**  
 Remarks:

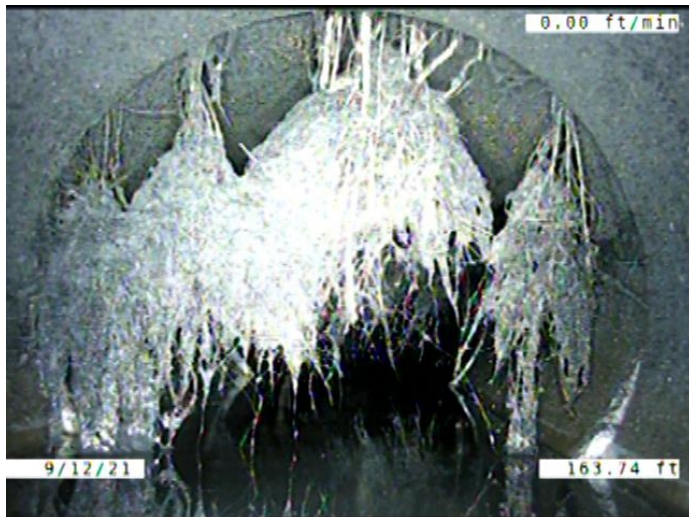
Code: **RMJ**  
 Description: **Roots Medium Joint**

Distance (ft): **163.7**  
 Structural Grade: **0**  
 O&M Grade: **3**  
 Clock Start/From: **9**  
 Clock To: **3**  
 1st Value:  
 2nd Value:  
 Value Percent: **35.000**  
 Continuous Index:  
 Within 8" of Joint: **YES**  
 Remarks:

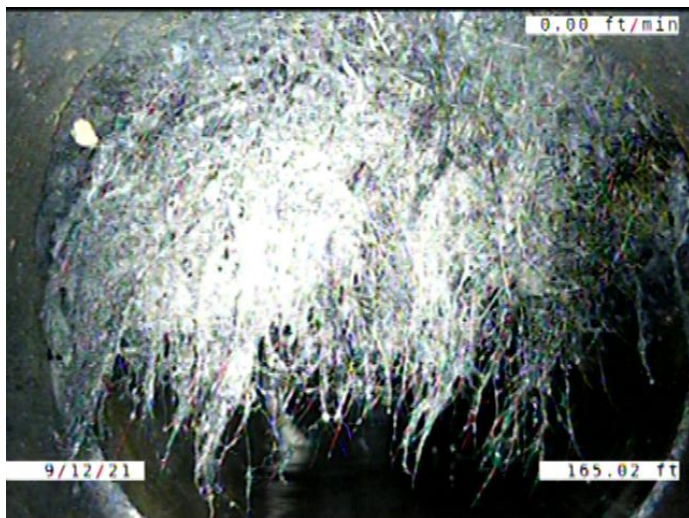
Code: **RBJ**  
 Description: **Roots Ball Joint**

Distance (ft): **165.0**  
 Structural Grade: **0**  
 O&M Grade: **4**  
 Clock Start/From: **9**  
 Clock To: **3**  
 1st Value:  
 2nd Value:  
 Value Percent: **60.000**  
 Continuous Index:  
 Within 8" of Joint: **YES**  
 Remarks:

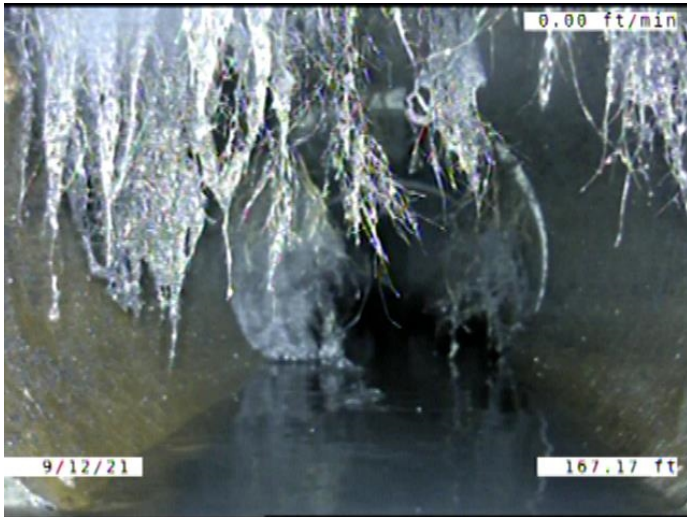
Code: **DSF**  
 Description: **Deposits Settled Fine**

Distance (ft): **167.2**  
 Structural Grade: **0**  
 O&M Grade: **2**  
 Clock Start/From: **5**  
 Clock To: **7**  
 1st Value:  
 2nd Value:  
 Value Percent: **5.000**  
 Continuous Index: **F01**  
 Within 8" of Joint: **YES**  
 Remarks:

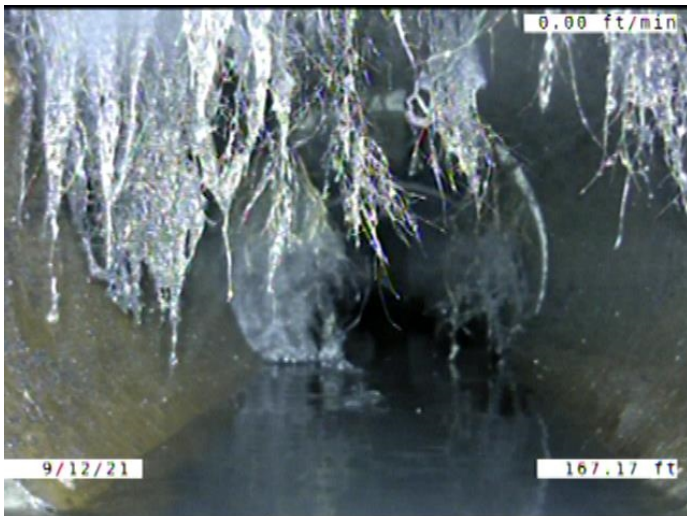
Code: **CM**  
 Description: **Crack Multiple**

Distance (ft): **167.2**  
 Structural Grade: **3**  
 O&M Grade: **0**  
 Clock Start/From: **12**  
 Clock To: **1**  
 1st Value:  
 2nd Value:  
 Value Percent:  
 Continuous Index: **F06**  
 Within 8" of Joint: **YES**  
 Remarks:
