## Profile/Photo Observation Report

Street:	<b>Summerlin</b>	Flow Control:	<b>Not Controlled</b>
City:	<b>Hobart, IN</b>	Year Renewed:	
Location:	<b>Light Highway</b>	Tape/Media #:	
Purpose:	<b>Not Known</b>	Dia/Height:	<b>10"</b>
Use:	<b>Sanitary</b>	Material:	<b>CP</b>
Drain Area:	<b>NA</b>	Lining:	
Category:	<b>NA</b>		
Comment:

Location Details:		Direction of Survey:	<b>Downstream</b>
US MH:	<b>M-504-130</b>	DS MH:	<b>M-504-105</b>
		Total Length Surveyed (ft):	<b>3.5</b>

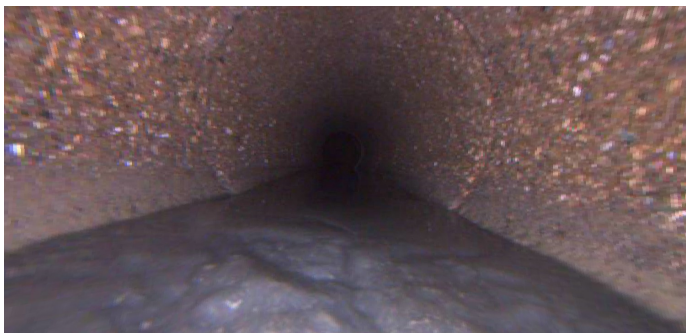
Code: **SAP**  
Description: **Surface Aggregate Projecting**

Distance (ft): **.0**  
Structural Grade: **3**  
O&M Grade: **0**  
Clock Start/From: **7**  
Clock To: **5**  
1st Value:  
2nd Value:  
Value Percent:  
Continuous Index:  
Within 8" of Joint:  
Remarks:

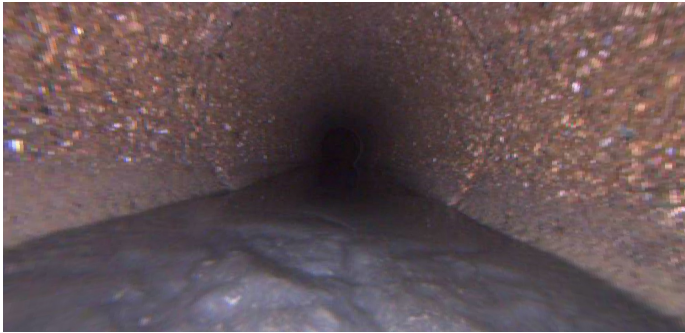
Code:	<b>AMH</b>
Description:	<b>Manhole</b>

Distance (ft):	<b>.0</b>
Structural Grade:	<b>0</b>
O&M Grade:	<b>0</b>
Clock Start/From:	
Clock To:	
1st Value:	
2nd Value:	
Value Percent:	
Continuous Index:	
Within 8" of Joint:	<b>NO</b>
Remarks:	<b>M-504-130</b>

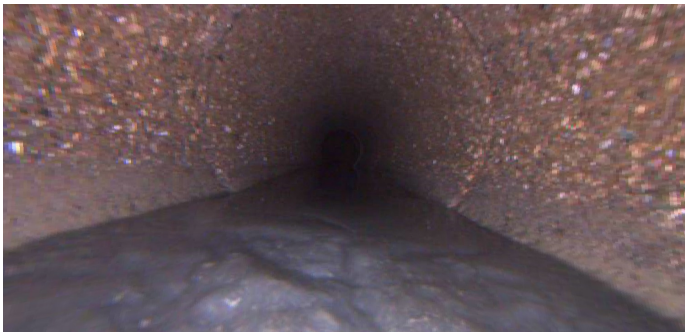
Code:	<b>MWL</b>
Description:	<b>Water Level</b>

Distance (ft):	<b>.0</b>
Structural Grade:	<b>0</b>
O&M Grade:	<b>0</b>
Clock Start/From:	
Clock To:	
1st Value:	
2nd Value:	
Value Percent:	<b>5.000</b>
Continuous Index:	
Within 8" of Joint:	<b>NO</b>
Remarks:

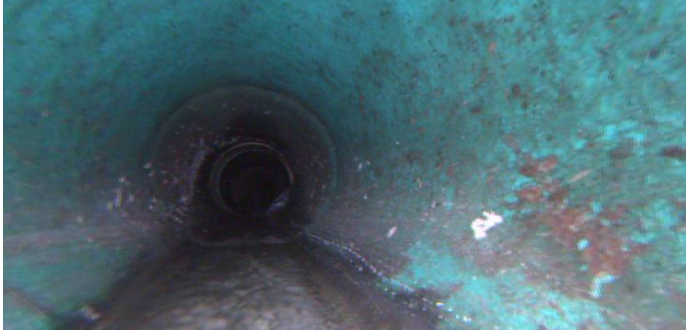
Code: **MMC**  
Description: **Material Change**

Distance (ft): **3.5**  
Structural Grade: **0**  
O&M Grade: **0**  
Clock Start/From:  
Clock To:  
1st Value:  
2nd Value:  
Value Percent:  
Continuous Index:  
Within 8" of Joint: **NO**  
Remarks: **camera glitch material change to pvc  
exact footage of change unknown**

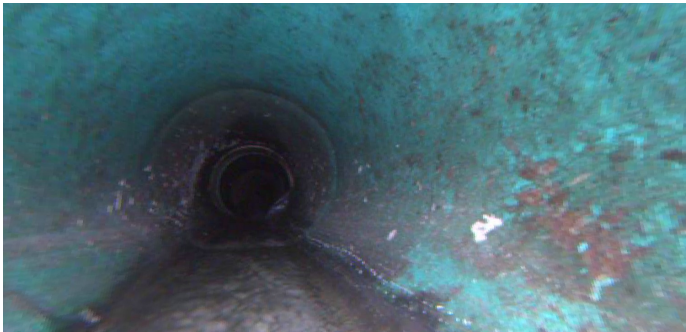
Code: **MSA**  
Description: **Abandoned Survey**

Distance (ft): **3.5**  
Structural Grade: **0**  
O&M Grade: **0**  
Clock Start/From:  
Clock To:  
1st Value:  
2nd Value:  
Value Percent:  
Continuous Index:  
Within 8" of Joint: **NO**  
Remarks: **no blockage**
