Profile/Photo Observation Report

Date:	04/18/2018	Weather:		Coding:	PACP 6.0
Pipe Length (ft):	281.7	Owner:	NA	Pre Clean:	Not Known
P.O.#:		Surveyor:	Byrd Fitzgerald	PSR:	P-504-105-130
Customer:		Clean Date:	01/01/1900	Shape:	C

Street:	Summerlin	Flow Control:	Not Controlled
City:	Hobart, IN	Year Renewed:	
Location:	Light Highway	Tape/Media #:	
Purpose:	Not Known	Dia/Height:	12"
Use:	Sanitary	Material:	PVC
Drain Area:	NA	Lining:	
Category:	NA		
Comment:

Location Details:		Direction of Survey:	Downstream
US MH:	M-504-130	DS MH:	M-504-105
		Total Length Surveyed (ft):	182.0

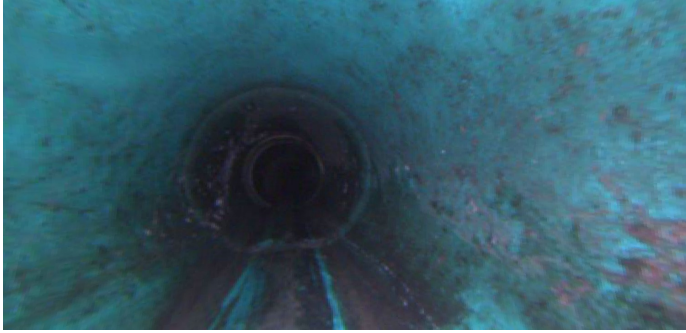
Code: **AMH**
Description: **Manhole**

Distance (ft): **.0**
Structural Grade: **0**
O&M Grade: **0**
Clock Start/From:
Clock To:
1st Value:
2nd Value:
Value Percent:
Continuous Index:
Within 8" of Joint: **NO**
Remarks: **M-504-130**

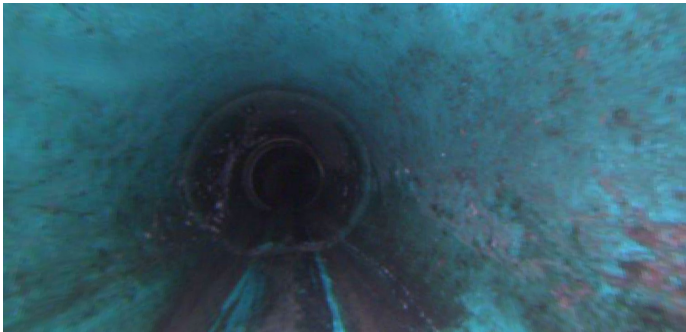
Code: **MWL**
Description: **Water Level**

Distance (ft): **.0**
Structural Grade: **0**
O&M Grade: **0**
Clock Start/From:
Clock To:
1st Value:
2nd Value:
Value Percent: **5.000**
Continuous Index:
Within 8" of Joint: **NO**
Remarks:

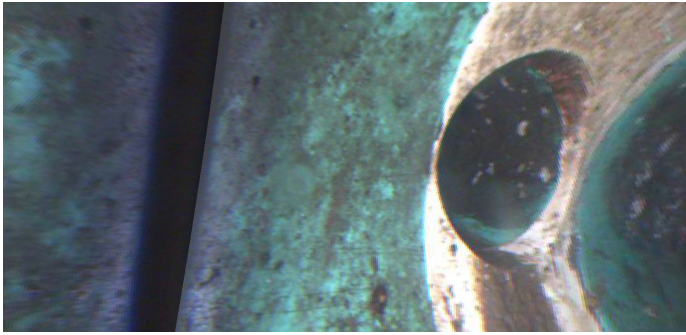
Code: **TF**
Description: **Tap Factory**

Distance (ft): **5.5**
Structural Grade: **0**
O&M Grade: **0**
Clock Start/From: **2**
Clock To:
1st Value: **4.000**
2nd Value:
Value Percent:
Continuous Index:
Within 8" of Joint: **YES**
Remarks:

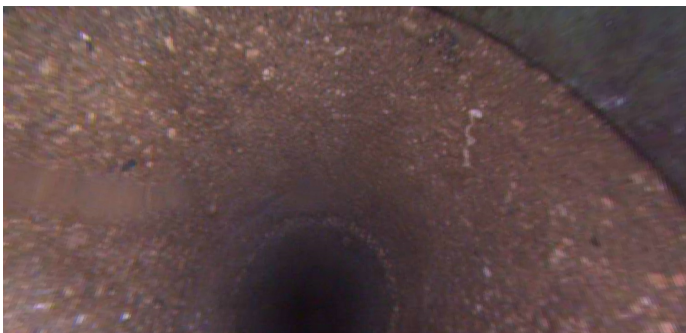
Code: **SAP**
Description: **Surface Aggregate Projecting**

Distance (ft): **6.8**
Structural Grade: **3**
O&M Grade: **0**
Clock Start/From: **7**
Clock To: **5**
1st Value:
2nd Value:
Value Percent:
Continuous Index: **S01**
Within 8" of Joint:
Remarks:

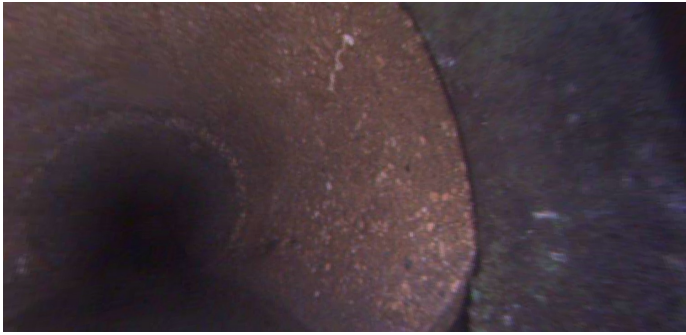
Code: **MMC**
Description: **Material Change**

Distance (ft): **6.8**
Structural Grade: **0**
O&M Grade: **0**
Clock Start/From:
Clock To:
1st Value:
2nd Value:
Value Percent:
Continuous Index:
Within 8" of Joint: **NO**
Remarks: **concrete**

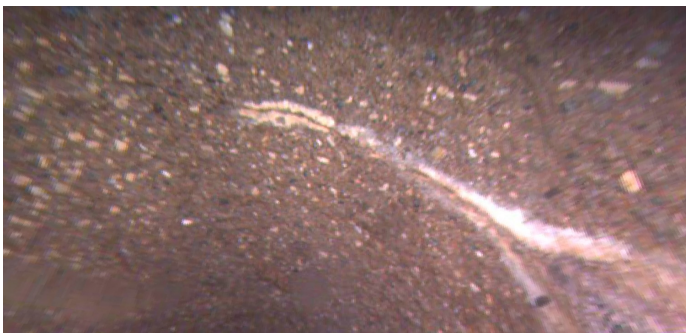
Code: **CC**
Description: **Crack Circumferential**

Distance (ft): **27.0**
Structural Grade: **1**
O&M Grade: **0**
Clock Start/From: **7**
Clock To: **5**
1st Value:
2nd Value:
Value Percent:
Continuous Index:
Within 8" of Joint:
Remarks:

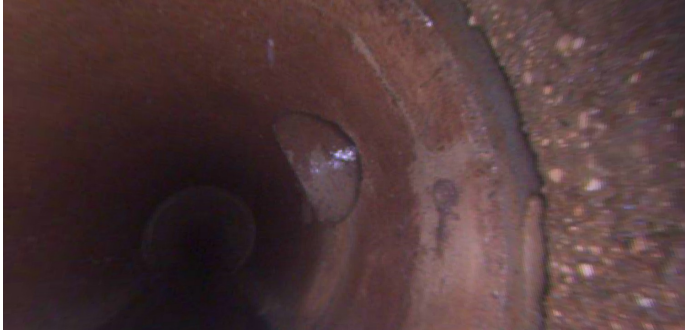
Code: **SAP**
Description: **Surface Aggregate Projecting**

Distance (ft): **29.4**
Structural Grade: **3**
O&M Grade: **0**
Clock Start/From: **7**
Clock To: **5**
1st Value:
2nd Value:
Value Percent:
Continuous Index: **F01**
Within 8" of Joint:
Remarks:

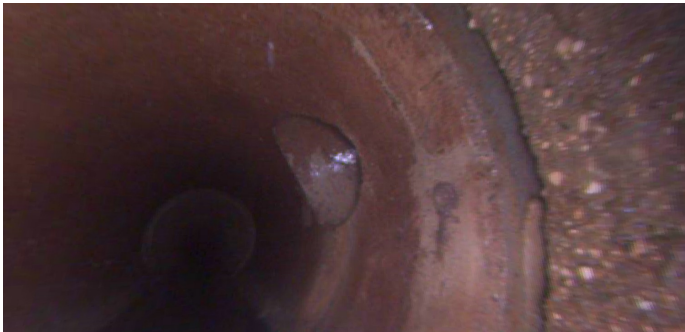
Code: **MMC**
Description: **Material Change**

Distance (ft): **29.4**
Structural Grade: **0**
O&M Grade: **0**
Clock Start/From:
Clock To:
1st Value:
2nd Value:
Value Percent:
Continuous Index:
Within 8" of Joint: **NO**
Remarks: **vcp**

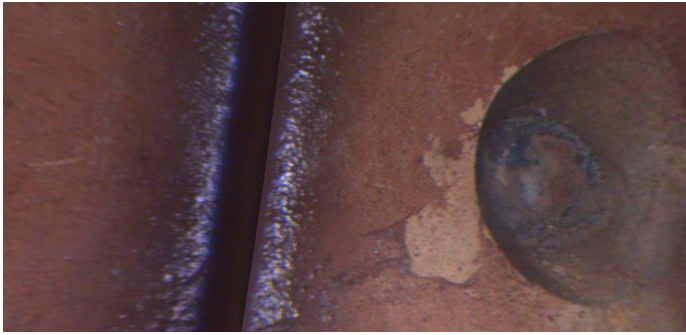
Code: **TFC**
Description: **Tap Factory Capped**

Distance (ft): **31.1**
Structural Grade: **0**
O&M Grade: **0**
Clock Start/From: **2**
Clock To:
1st Value: **4.000**
2nd Value:
Value Percent:
Continuous Index:
Within 8" of Joint: **YES**
Remarks:

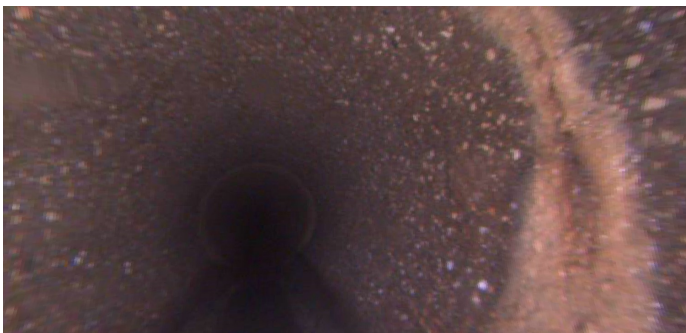
Code: **SAP**
Description: **Surface Aggregate Projecting**

Distance (ft): **32.8**
Structural Grade: **3**
O&M Grade: **0**
Clock Start/From: **7**
Clock To: **5**
1st Value:
2nd Value:
Value Percent:
Continuous Index: **S02**
Within 8" of Joint:
Remarks:

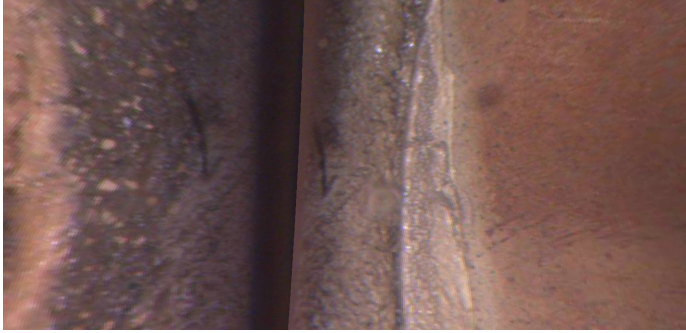
Code: **MMC**
Description: **Material Change**

Distance (ft): **32.8**
Structural Grade: **0**
O&M Grade: **0**
Clock Start/From:
Clock To:
1st Value:
2nd Value:
Value Percent:
Continuous Index:
Within 8" of Joint: **NO**
Remarks: **concrete**

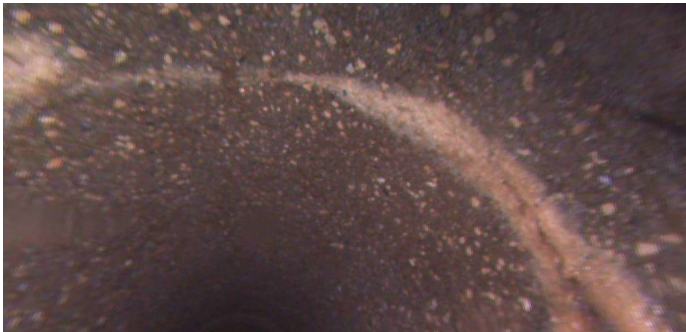
Code: **CC**
Description: **Crack Circumferential**

Distance (ft): **32.8**
Structural Grade: **1**
O&M Grade: **0**
Clock Start/From: **7**
Clock To: **5**
1st Value:
2nd Value:
Value Percent:
Continuous Index:
Within 8" of Joint:
Remarks:

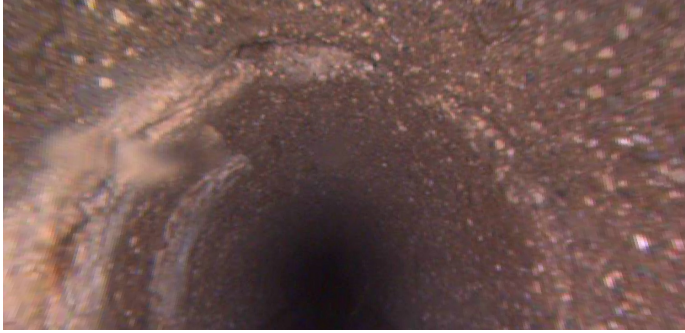
Code: **CL**
Description: **Crack Longitudinal**

Distance (ft): **38.0**
Structural Grade: **2**
O&M Grade: **0**
Clock Start/From: **11**
Clock To:
1st Value:
2nd Value:
Value Percent:
Continuous Index:
Within 8" of Joint: **YES**
Remarks:

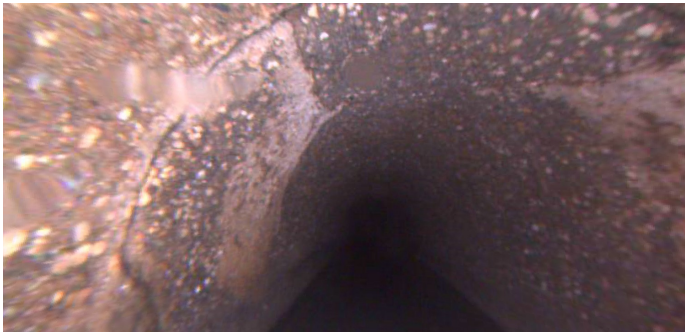
Code: **FM**
Description: **Fracture Multiple**

Distance (ft): **62.2**
Structural Grade: **4**
O&M Grade: **0**
Clock Start/From: **8**
Clock To: **4**
1st Value:
2nd Value:
Value Percent:
Continuous Index:
Within 8" of Joint: **YES**
Remarks:

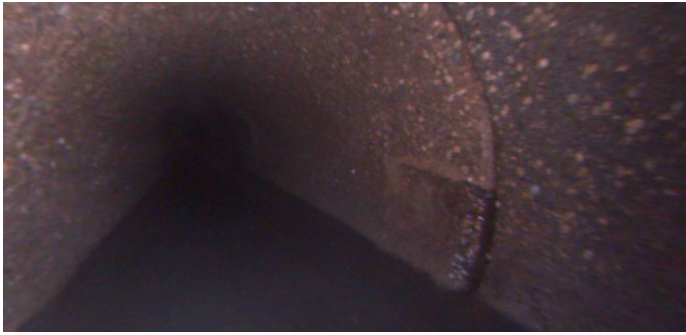
Code: **FL**
Description: **Fracture Longitudinal**

Distance (ft): **65.2**
Structural Grade: **3**
O&M Grade: **0**
Clock Start/From: **3**
Clock To:
1st Value:
2nd Value:
Value Percent:
Continuous Index:
Within 8" of Joint: **YES**
Remarks:

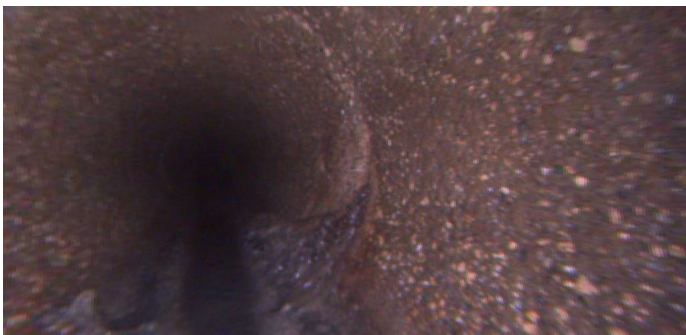
Code: **RFJ**
Description: **Roots Fine Joint**

Distance (ft): **109.6**
Structural Grade: **0**
O&M Grade: **1**
Clock Start/From: **4**
Clock To:
1st Value:
2nd Value:
Value Percent:
Continuous Index:
Within 8" of Joint: **YES**
Remarks:

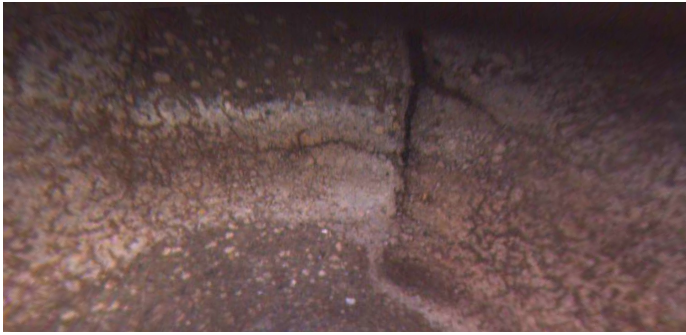
Code: **FM**
Description: **Fracture Multiple**

Distance (ft): **140.6**
Structural Grade: **4**
O&M Grade: **0**
Clock Start/From: **11**
Clock To: **1**
1st Value:
2nd Value:
Value Percent:
Continuous Index:
Within 8" of Joint: **YES**
Remarks:

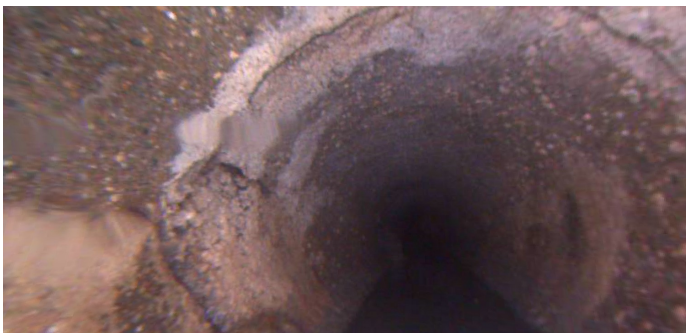
Code: **FM**
Description: **Fracture Multiple**

Distance (ft): **148.6**
Structural Grade: **4**
O&M Grade: **0**
Clock Start/From: **8**
Clock To: **12**
1st Value:
2nd Value:
Value Percent:
Continuous Index:
Within 8" of Joint: **YES**
Remarks:

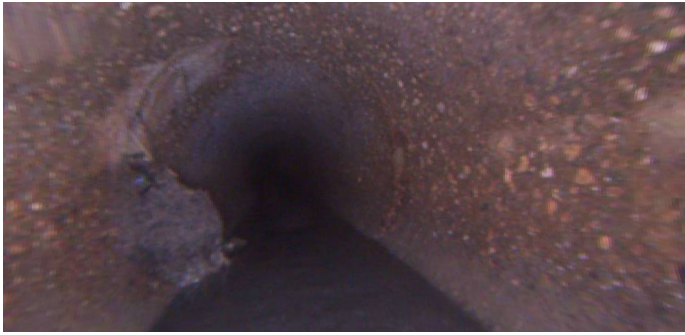
Code: **RMJ**
Description: **Roots Medium Joint**

Distance (ft): **151.1**
Structural Grade: **0**
O&M Grade: **3**
Clock Start/From: **7**
Clock To: **8**
1st Value:
2nd Value:
Value Percent: **5.000**
Continuous Index:
Within 8" of Joint: **YES**
Remarks:

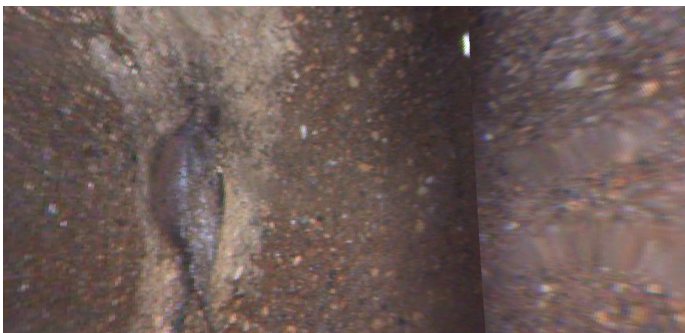
Code: **DAZ**
Description: **Deposits Attached Other**

Distance (ft): **161.8**
Structural Grade: **0**
O&M Grade: **2**
Clock Start/From: **9**
Clock To:
1st Value:
2nd Value:
Value Percent: **5.000**
Continuous Index:
Within 8" of Joint: **YES**
Remarks: **overlay of material**

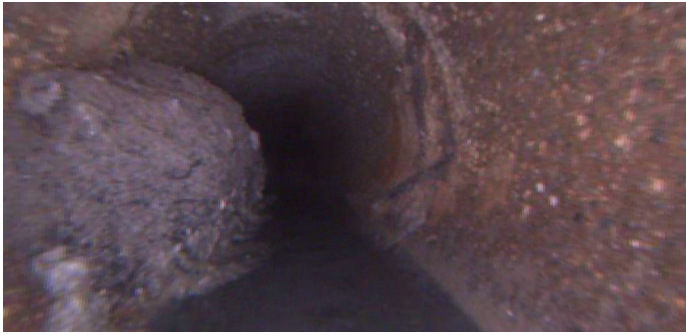
Code: **RMJ**
Description: **Roots Medium Joint**

Distance (ft): **163.3**
Structural Grade: **0**
O&M Grade: **3**
Clock Start/From: **7**
Clock To: **10**
1st Value:
2nd Value:
Value Percent: **25.000**
Continuous Index:
Within 8" of Joint: **YES**
Remarks:

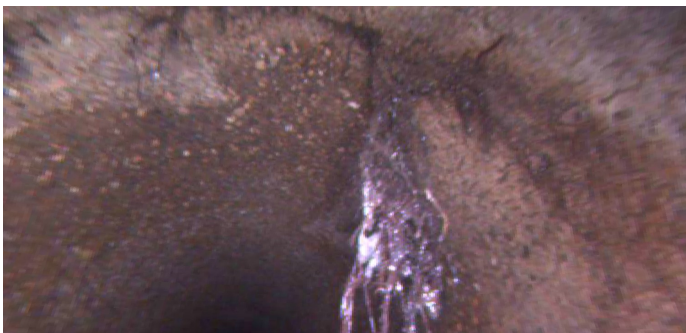
Code: **RMJ**
Description: **Roots Medium Joint**

Distance (ft): **172.3**
Structural Grade: **0**
O&M Grade: **3**
Clock Start/From: **7**
Clock To: **5**
1st Value:
2nd Value:
Value Percent: **5.000**
Continuous Index:
Within 8" of Joint: **YES**
Remarks:

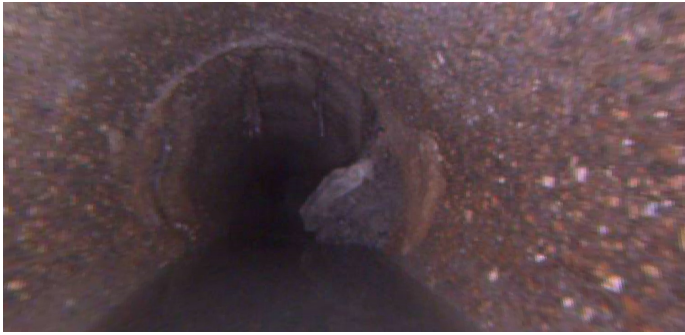
Code: **RFJ**
Description: **Roots Fine Joint**

Distance (ft): **180.2**
Structural Grade: **0**
O&M Grade: **1**
Clock Start/From: **7**
Clock To: **1**
1st Value:
2nd Value:
Value Percent:
Continuous Index:
Within 8" of Joint: **YES**
Remarks:

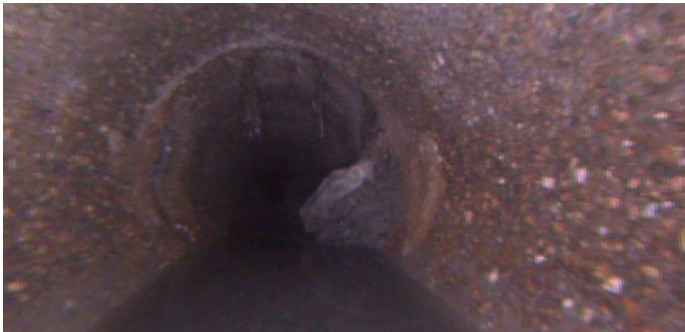
Code: **RMJ**
Description: **Roots Medium Joint**

Distance (ft): **180.2**
Structural Grade: **0**
O&M Grade: **3**
Clock Start/From: **3**
Clock To: **5**
1st Value:
2nd Value:
Value Percent: **5.000**
Continuous Index:
Within 8" of Joint: **YES**
Remarks:

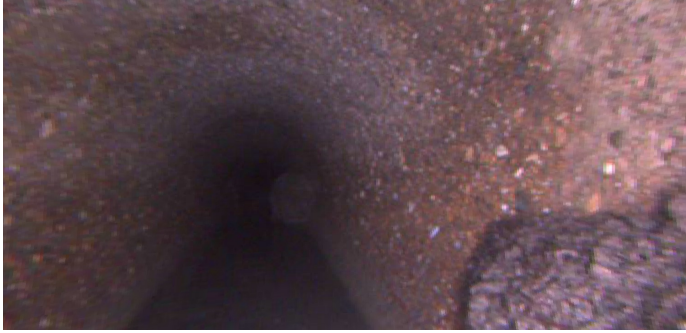
Code: **SAP**
Description: **Surface Aggregate Projecting**

Distance (ft): **182.0**
Structural Grade: **3**
O&M Grade: **0**
Clock Start/From: **7**
Clock To: **5**
1st Value:
2nd Value:
Value Percent:
Continuous Index: **F02**
Within 8" of Joint:
Remarks:

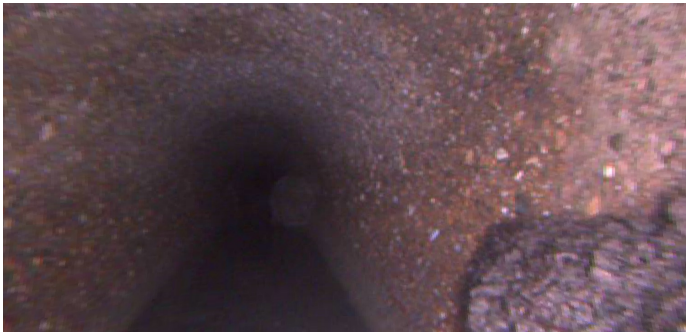
Code: **MSA**
Description: **Abandoned Survey**

Distance (ft): **182.0**
Structural Grade: **0**
O&M Grade: **0**
Clock Start/From:
Clock To:
1st Value:
2nd Value:
Value Percent:
Continuous Index:
Within 8" of Joint: **NO**
Remarks: **rmj**
