Profile/Photo Observation Report

Date:	09/12/2021	Weather:		Coding:	PACP 7.0
Pipe Length (ft):	255.7	Owner:	City of Hobart	Pre Clean:	Heavy Cleaning
P.O.#:	YES502259	Surveyor:	S. Bucklin	PSR:	P-504-105-130
Customer:	City of Hobart	Clean Date:	08/28/2021	Shape:	C

Street:	North Virginia Street	Flow Control:	Not Controlled
City:	Hobart, IN	Year Renewed:	
Location:	Alley	Tape/Media #:	
Purpose:	Routine Assessment	Dia/Height:	12"
Use:	Sanitary Sewage Pipe	Material:	CP
Drain Area:		Lining:	None
Category:	NA		
Comment:			
Location Details:		Direction of Survey:	Downstream
US MH:	M-504-130	DS MH:	M-504-105
		Total Length Surveyed (ft):	255.7

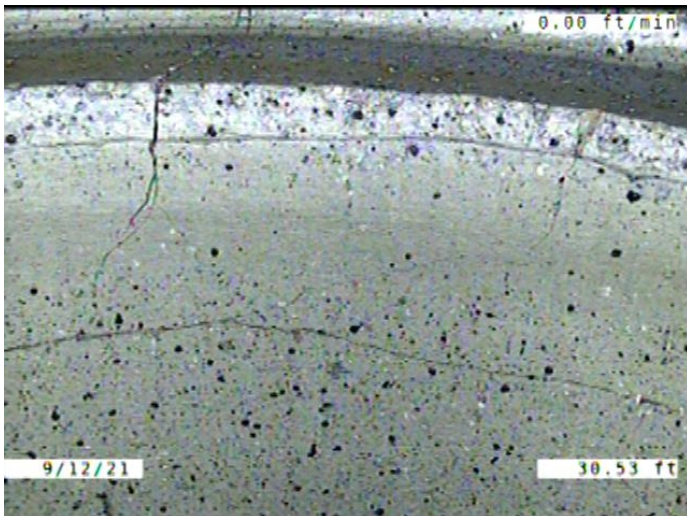
Code: **CM**
Description: **Crack Multiple**

Distance (ft): **30.5**
Structural Grade: **3**
O&M Grade: **0**
Clock Start/From: **9**
Clock To: **2**
1st Value:
2nd Value:
Value Percent:
Continuous Index:
Within 8" of Joint: **YES**
Remarks:

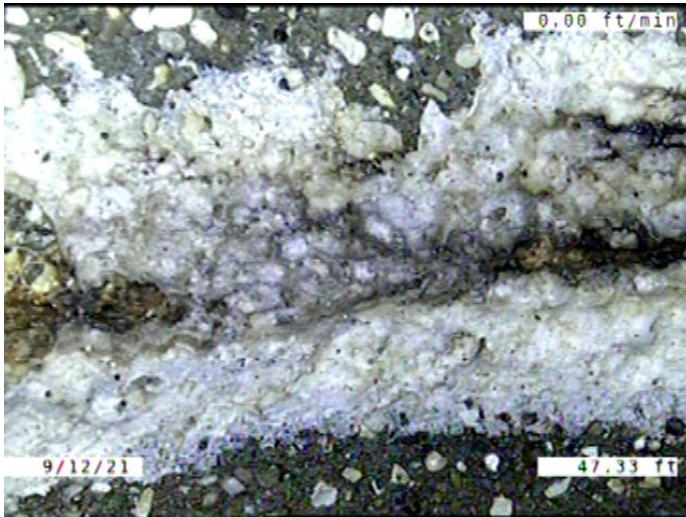
Code: **DAE**
 Description: **Deposits Attached Encrustation**

Distance (ft): **47.3**
 Structural Grade: **0**
 O&M Grade: **2**
 Clock Start/From: **7**
 Clock To: **3**
 1st Value:
 2nd Value:
 Value Percent: **5.000**
 Continuous Index:
 Within 8" of Joint: **YES**
 Remarks:

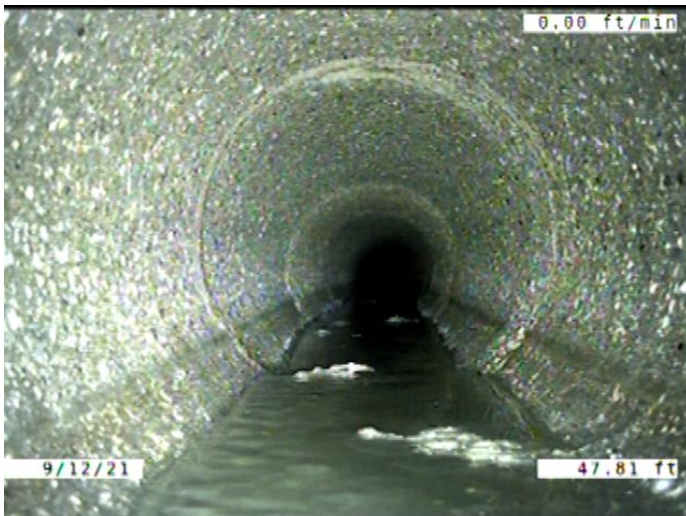
Code: **DSF**
 Description: **Deposits Settled Fine**

Distance (ft): **47.8**
 Structural Grade: **0**
 O&M Grade: **2**
 Clock Start/From: **5**
 Clock To: **7**
 1st Value:
 2nd Value:
 Value Percent: **5.000**
 Continuous Index: **S01**
 Within 8" of Joint: **YES**
 Remarks:

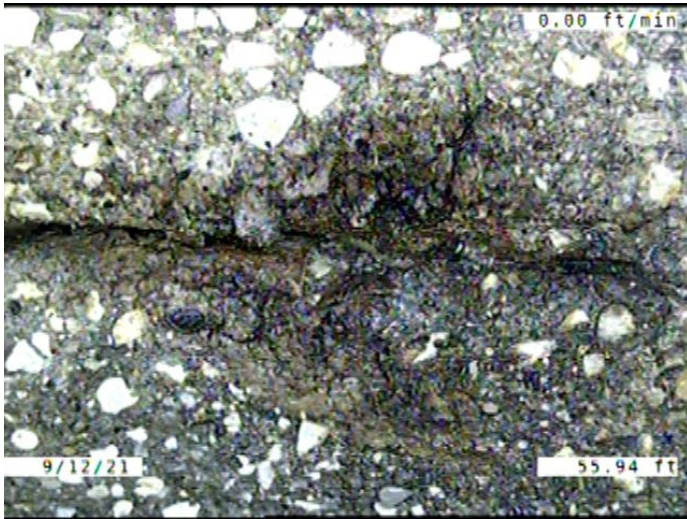
Code: **DAE**
 Description: **Deposits Attached Encrustation**

Distance (ft): **55.9**
 Structural Grade: **0**
 O&M Grade: **2**
 Clock Start/From: **2**
 Clock To: **3**
 1st Value:
 2nd Value:
 Value Percent: **5.000**
 Continuous Index:
 Within 8" of Joint: **YES**
 Remarks:

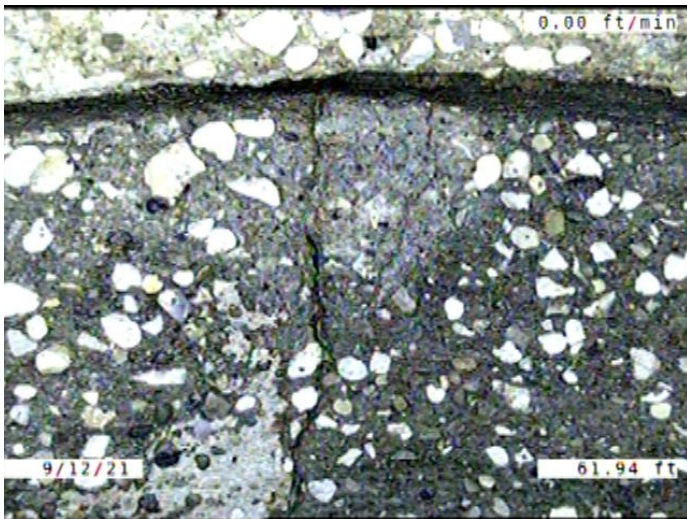
Code: **DAE**
 Description: **Deposits Attached Encrustation**

Distance (ft): **61.9**
 Structural Grade: **0**
 O&M Grade: **2**
 Clock Start/From: **8**
 Clock To: **11**
 1st Value:
 2nd Value:
 Value Percent: **5.000**
 Continuous Index:
 Within 8" of Joint: **YES**
 Remarks:

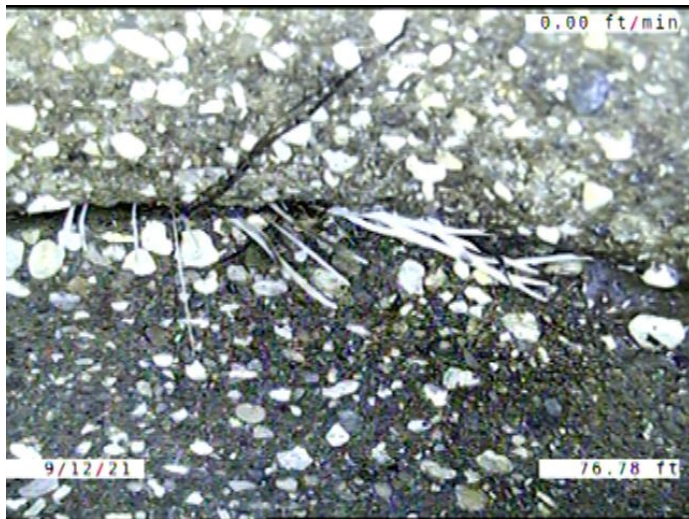
Code: **DAE**
 Description: **Deposits Attached Encrustation**

Distance (ft): **76.8**
 Structural Grade: **0**
 O&M Grade: **2**
 Clock Start/From: **3**
 Clock To: **4**
 1st Value:
 2nd Value:
 Value Percent: **5.000**
 Continuous Index:
 Within 8" of Joint: **YES**
 Remarks:

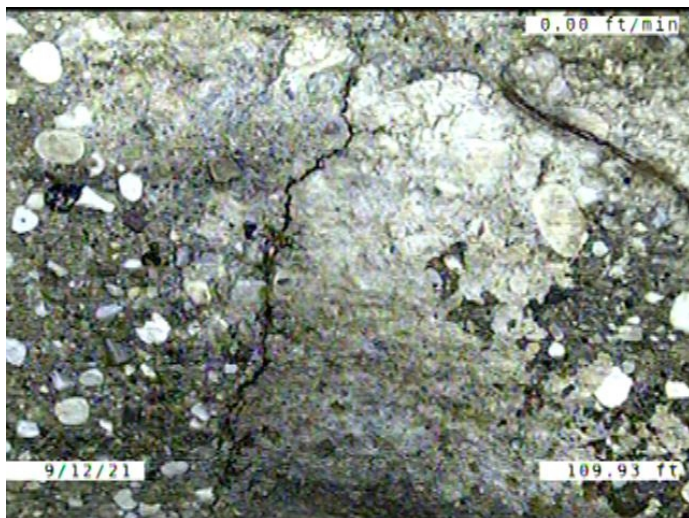
Code: **CM**
 Description: **Crack Multiple**

Distance (ft): **109.9**
 Structural Grade: **3**
 O&M Grade: **0**
 Clock Start/From: **2**
 Clock To: **3**
 1st Value:
 2nd Value:
 Value Percent:
 Continuous Index:
 Within 8" of Joint: **YES**
 Remarks:

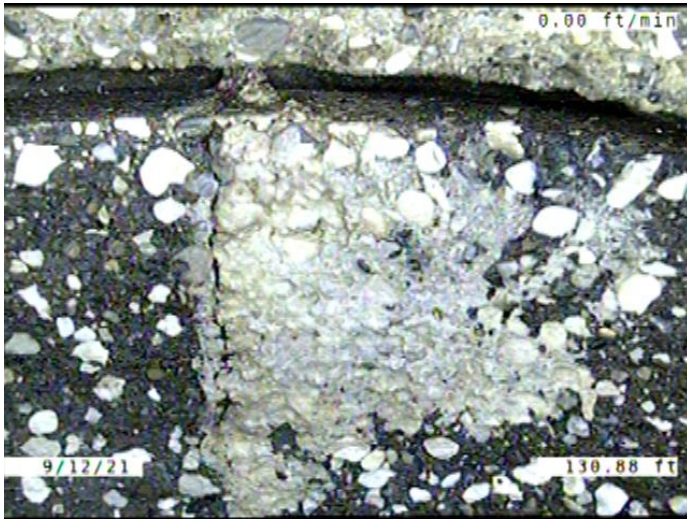
Code: **DAE**
 Description: **Deposits Attached Encrustation**

Distance (ft): **130.9**
 Structural Grade: **0**
 O&M Grade: **2**
 Clock Start/From: **2**
 Clock To: **3**
 1st Value:
 2nd Value:
 Value Percent: **5.000**
 Continuous Index:
 Within 8" of Joint: **YES**
 Remarks:

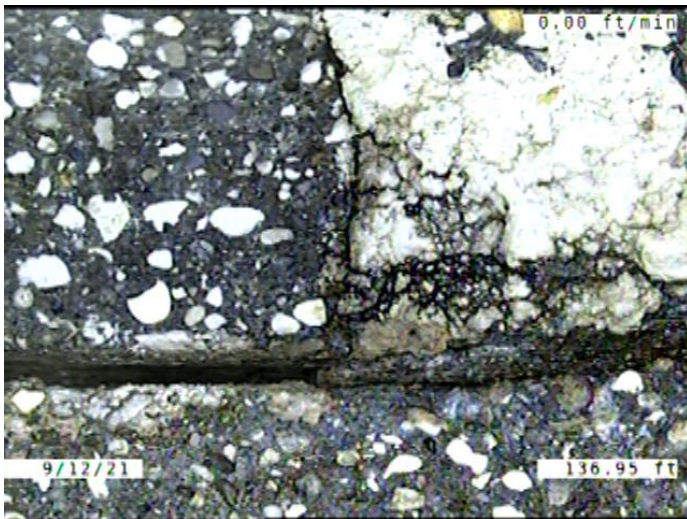
Code: **CL**
 Description: **Crack Longitudinal**

Distance (ft): **136.9**
 Structural Grade: **2**
 O&M Grade: **0**
 Clock Start/From: **9**
 Clock To:
 1st Value:
 2nd Value:
 Value Percent:
 Continuous Index:
 Within 8" of Joint: **YES**
 Remarks:

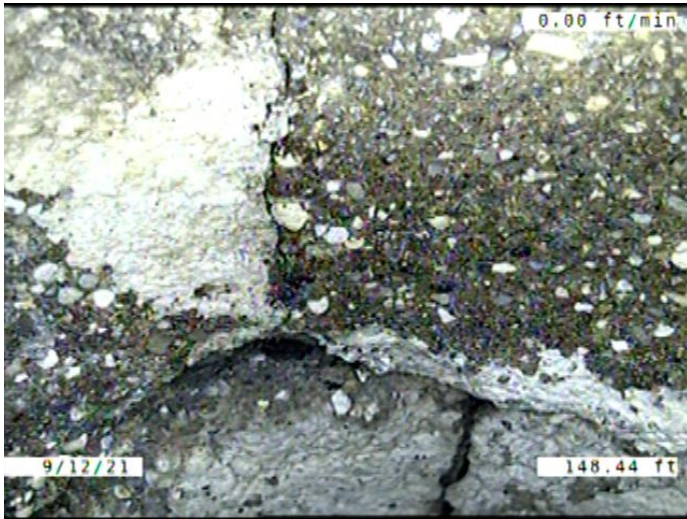
Code: **DAE**
 Description: **Deposits Attached Encrustation**

Distance (ft): **148.4**
 Structural Grade: **0**
 O&M Grade: **2**
 Clock Start/From: **8**
 Clock To: **3**
 1st Value:
 2nd Value:
 Value Percent: **5.000**
 Continuous Index:
 Within 8" of Joint: **YES**
 Remarks:

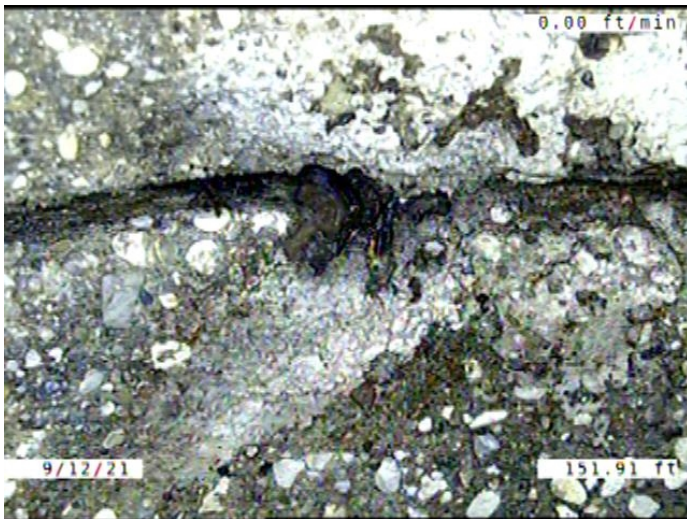
Code: **RFJ**
 Description: **Roots Fine Joint**

Distance (ft): **151.9**
 Structural Grade: **0**
 O&M Grade: **1**
 Clock Start/From: **10**
 Clock To:
 1st Value:
 2nd Value:
 Value Percent:
 Continuous Index:
 Within 8" of Joint: **YES**
 Remarks:

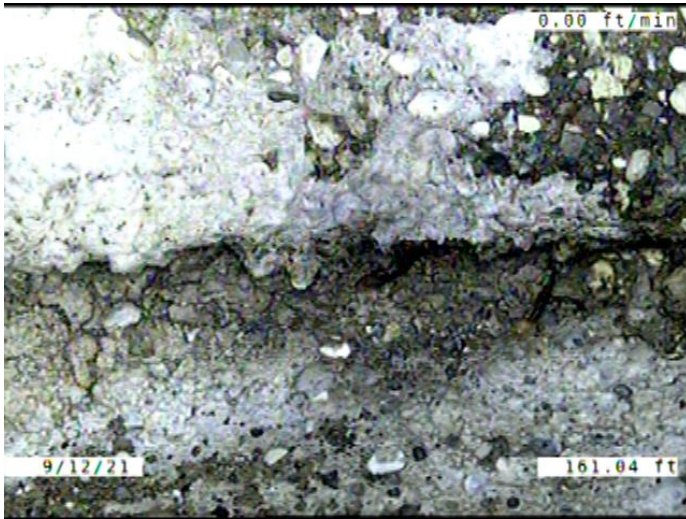
Code: **DAE**
Description: **Deposits Attached Encrustation**

Distance (ft): **161.0**
Structural Grade: **0**
O&M Grade: **2**
Clock Start/From: **9**
Clock To: **3**
1st Value:
2nd Value:
Value Percent: **5.000**
Continuous Index: **S02**
Within 8" of Joint: **YES**
Remarks:

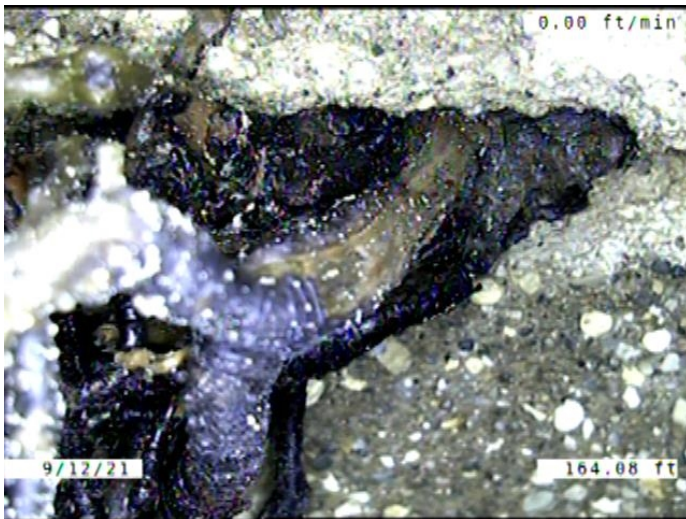
Code: **RMJ**
Description: **Roots Medium Joint**

Distance (ft): **164.1**
Structural Grade: **0**
O&M Grade: **3**
Clock Start/From: **8**
Clock To: **10**
1st Value:
2nd Value:
Value Percent: **5.000**
Continuous Index:
Within 8" of Joint: **YES**
Remarks:

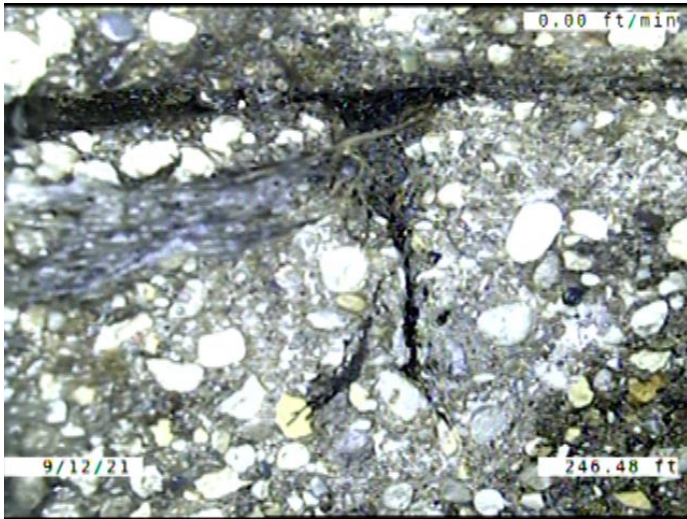
Code: **RFJ**
Description: **Roots Fine Joint**

Distance (ft): **246.5**
Structural Grade: **0**
O&M Grade: **1**
Clock Start/From: **9**
Clock To:
1st Value:
2nd Value:
Value Percent:
Continuous Index:
Within 8" of Joint: **YES**
Remarks:

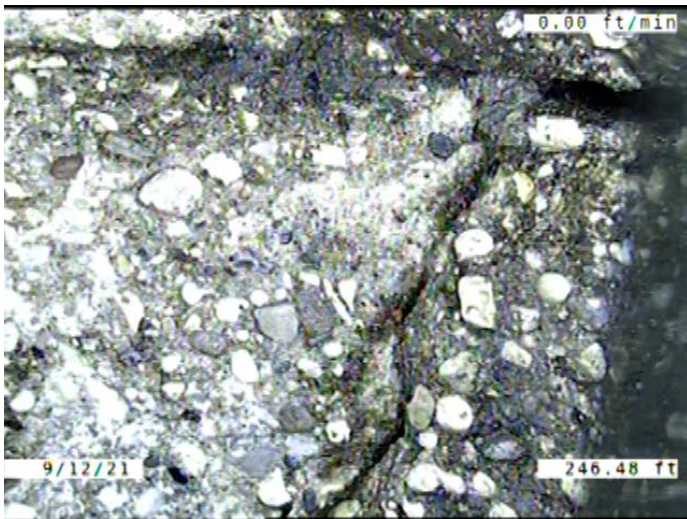
Code: **FS**
Description: **Fracture Spiral**

Distance (ft): **246.5**
Structural Grade: **3**
O&M Grade: **0**
Clock Start/From: **3**
Clock To: **4**
1st Value:
2nd Value:
Value Percent:
Continuous Index:
Within 8" of Joint: **YES**
Remarks:
