Profile/Photo Observation Report

Date:	09/12/2021	Weather:		Coding:	PACP 7.0
Pipe Length (ft):	255.7	Owner:	City of Hobart	Pre Clean:	Heavy Cleaning
P.O.#:	YES502259	Surveyor:	S. Bucklin	PSR:	P-504-105-130
Customer:	City of Hobart	Clean Date:	08/28/2021	Shape:	C

Street:	North Virginia Street	Flow Control:	Not Controlled
City:	Hobart, IN	Year Renewed:	
Location:	Alley	Tape/Media #:	
Purpose:	Routine Assessment	Dia/Height:	12"
Use:	Sanitary Sewage Pipe	Material:	CP
Drain Area:		Lining:	None
Category:	NA		
Comment:			
Location Details:		Direction of Survey:	Downstream
US MH:	M-504-130	DS MH:	M-504-105
		Total Length Surveyed (ft):	255.7

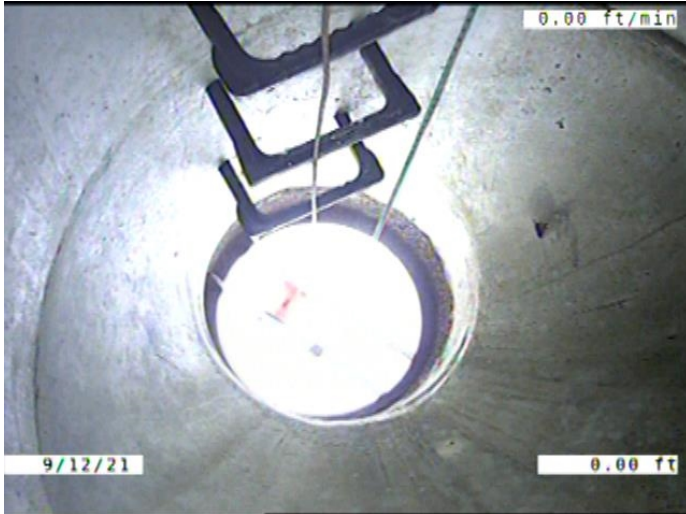
Code: **AMH**
 Description: **Manhole**

Distance (ft): **.0**
 Structural Grade: **0**
 O&M Grade: **0**
 Clock Start/From:
 Clock To:
 1st Value:
 2nd Value:
 Value Percent:
 Continuous Index:
 Within 8" of Joint: **NO**
 Remarks: **M-504-130**

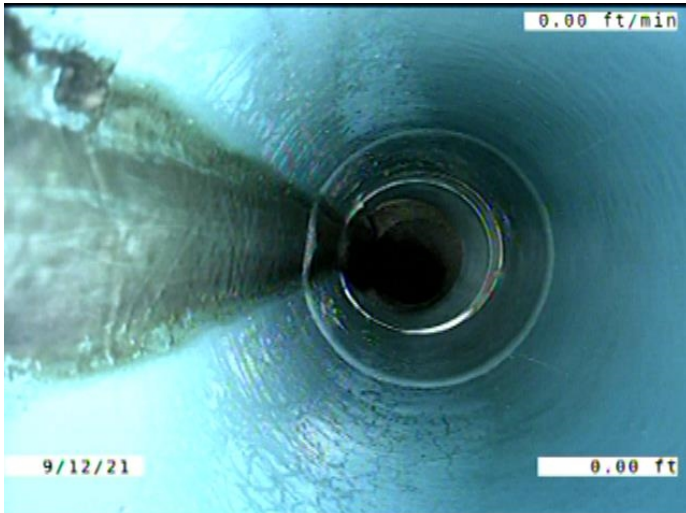
Code: **MWL**
 Description: **Miscellaneous Water Level**

Distance (ft): **.0**
 Structural Grade: **0**
 O&M Grade: **0**
 Clock Start/From:
 Clock To:
 1st Value:
 2nd Value:
 Value Percent: **5.000**
 Continuous Index:
 Within 8" of Joint: **NO**
 Remarks:

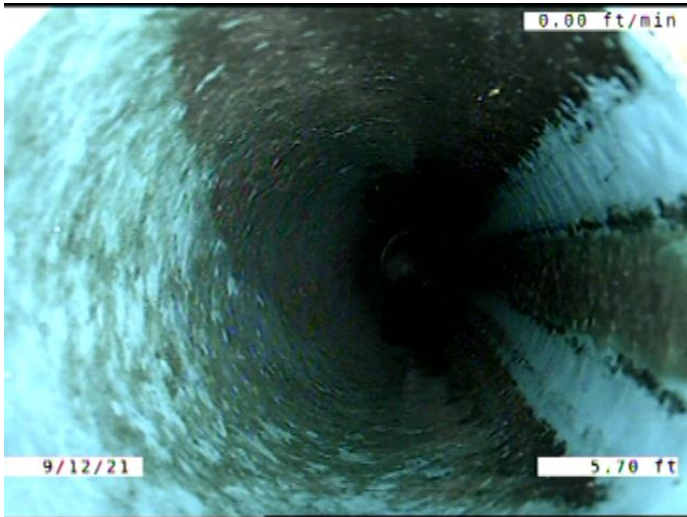
Code: **TF**
 Description: **Tap Factory**

Distance (ft): **5.7**
 Structural Grade: **0**
 O&M Grade: **0**
 Clock Start/From: **2**
 Clock To:
 1st Value: **6.000**
 2nd Value:
 Value Percent:
 Continuous Index:
 Within 8" of Joint: **YES**
 Remarks:

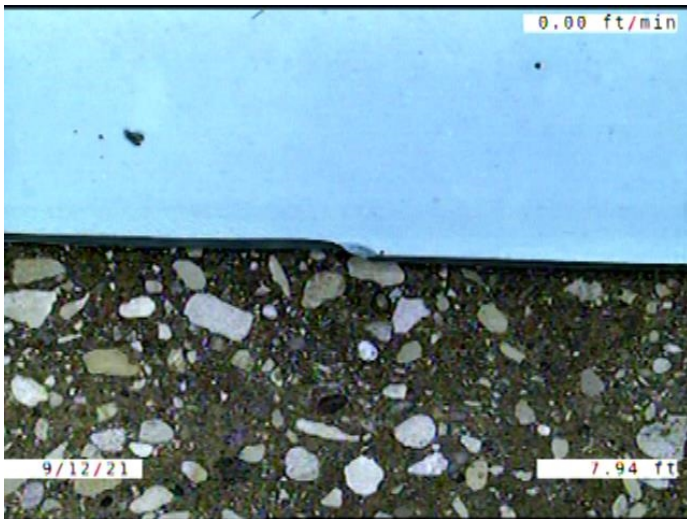
Code: **MMC**
 Description: **Miscellaneous Material Change**

Distance (ft): **7.9**
 Structural Grade: **0**
 O&M Grade: **0**
 Clock Start/From:
 Clock To:
 1st Value:
 2nd Value:
 Value Percent:
 Continuous Index:
 Within 8" of Joint: **NO**
 Remarks: **PVC TO CONCRETE**

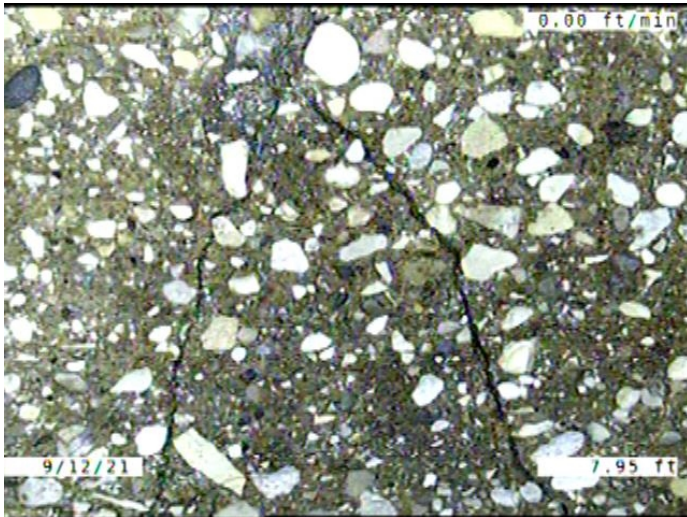
Code: **FM**
 Description: **Fracture Multiple**

Distance (ft): **7.9**
 Structural Grade: **4**
 O&M Grade: **0**
 Clock Start/From: **10**
 Clock To: **1**
 1st Value:
 2nd Value:
 Value Percent:
 Continuous Index:
 Within 8" of Joint: **YES**
 Remarks:

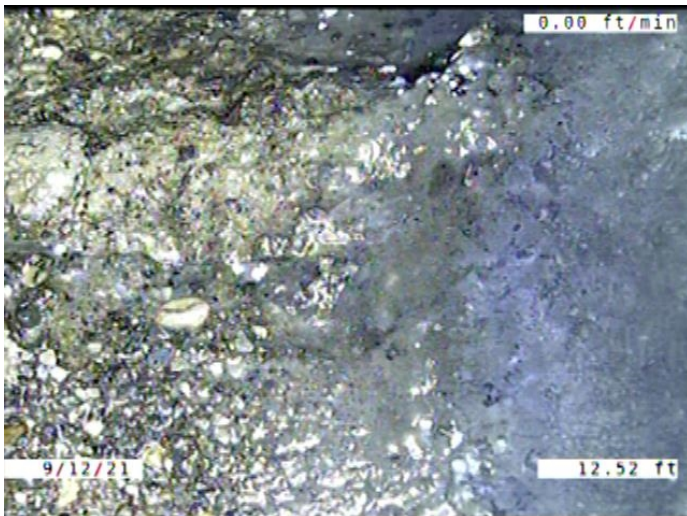
Code: **DAE**
 Description: **Deposits Attached Encrustation**

Distance (ft): **12.5**
 Structural Grade: **0**
 O&M Grade: **2**
 Clock Start/From: **7**
 Clock To: **8**
 1st Value:
 2nd Value:
 Value Percent: **5.000**
 Continuous Index:
 Within 8" of Joint: **YES**
 Remarks:

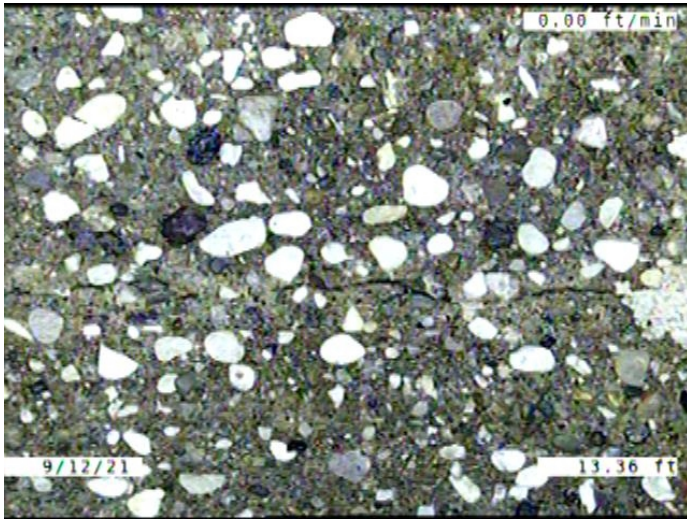
Code: **FS**
 Description: **Fracture Spiral**

Distance (ft): **13.4**
 Structural Grade: **3**
 O&M Grade: **0**
 Clock Start/From: **7**
 Clock To: **1**
 1st Value:
 2nd Value:
 Value Percent:
 Continuous Index:
 Within 8" of Joint: **YES**
 Remarks:

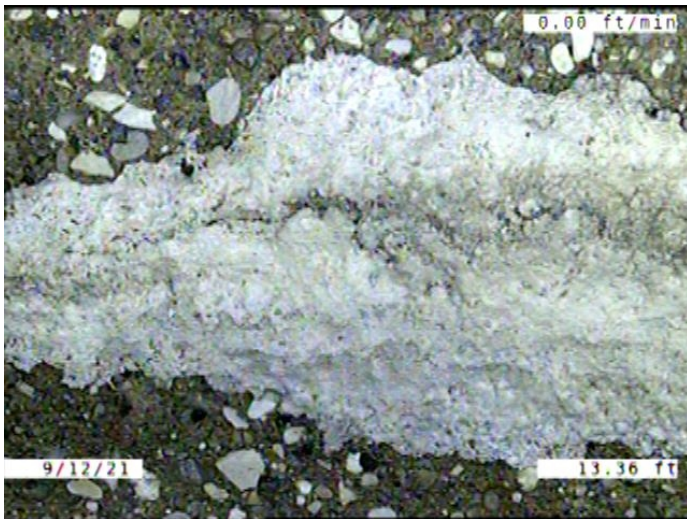
Code: **DAE**
 Description: **Deposits Attached Encrustation**

Distance (ft): **13.4**
 Structural Grade: **0**
 O&M Grade: **2**
 Clock Start/From: **1**
 Clock To: **5**
 1st Value:
 2nd Value:
 Value Percent: **5.000**
 Continuous Index:
 Within 8" of Joint: **YES**
 Remarks:

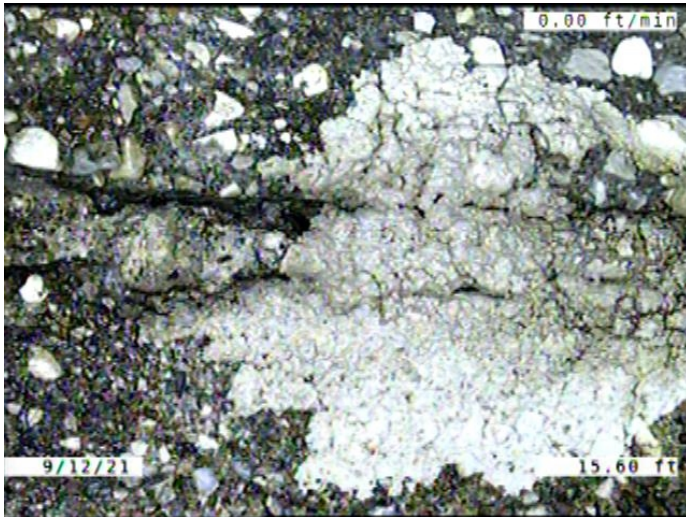
Code: **DAE**
 Description: **Deposits Attached Encrustation**

Distance (ft): **15.6**
 Structural Grade: **0**
 O&M Grade: **2**
 Clock Start/From: **3**
 Clock To: **4**
 1st Value:
 2nd Value:
 Value Percent: **5.000**
 Continuous Index:
 Within 8" of Joint: **YES**
 Remarks:

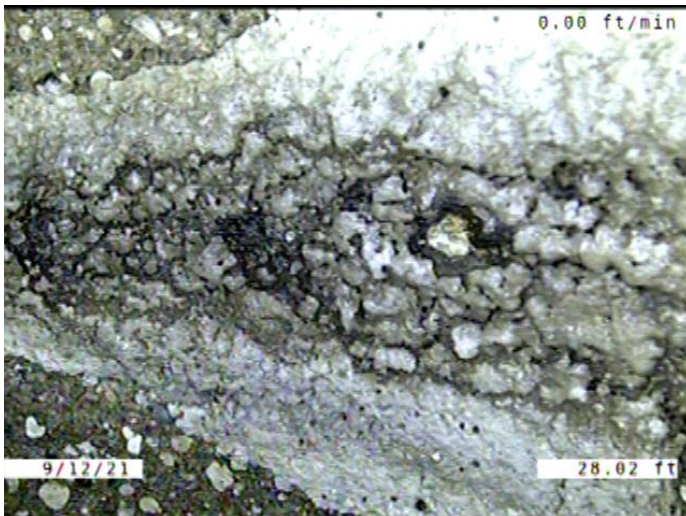
Code: **DAE**
 Description: **Deposits Attached Encrustation**

Distance (ft): **28.0**
 Structural Grade: **0**
 O&M Grade: **2**
 Clock Start/From: **1**
 Clock To: **5**
 1st Value:
 2nd Value:
 Value Percent: **5.000**
 Continuous Index:
 Within 8" of Joint: **YES**
 Remarks:

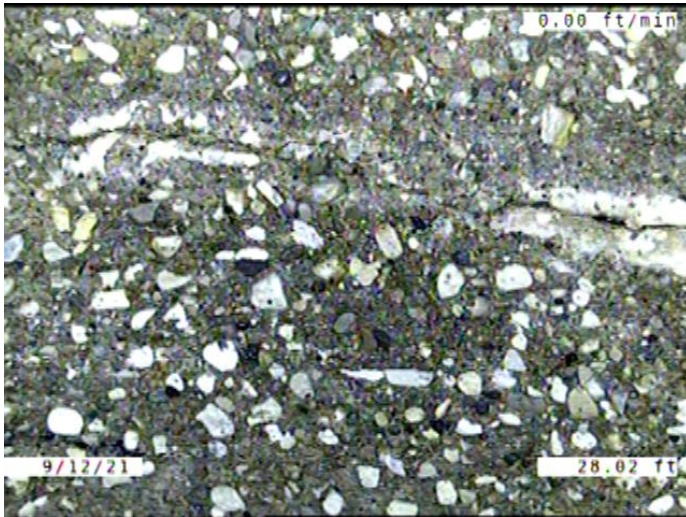
Code: **CS**
Description: **Crack Spiral**

Distance (ft): **28.0**
Structural Grade: **2**
O&M Grade: **0**
Clock Start/From: **12**
Clock To: **12**
1st Value:
2nd Value:
Value Percent:
Continuous Index:
Within 8" of Joint: **YES**
Remarks:

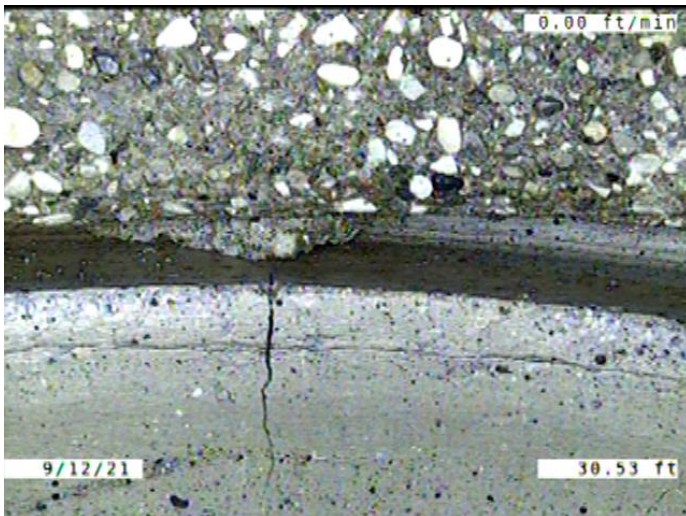
Code: **MMC**
Description: **Miscellaneous Material Change**

Distance (ft): **30.5**
Structural Grade: **0**
O&M Grade: **0**
Clock Start/From:
Clock To:
1st Value:
2nd Value:
Value Percent:
Continuous Index:
Within 8" of Joint: **NO**
Remarks: **CONCRETE TO VCP**

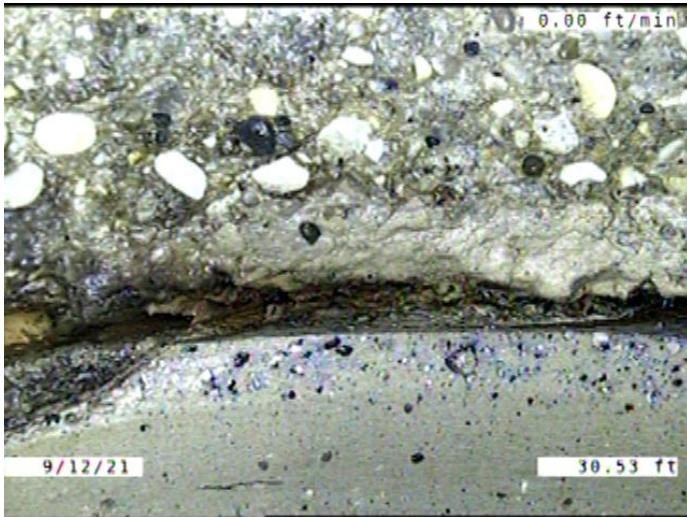
Code: **DAE**
 Description: **Deposits Attached Encrustation**

Distance (ft): **30.5**
 Structural Grade: **0**
 O&M Grade: **2**
 Clock Start/From: **8**
 Clock To: **9**
 1st Value:
 2nd Value:
 Value Percent: **5.000**
 Continuous Index:
 Within 8" of Joint: **YES**
 Remarks:

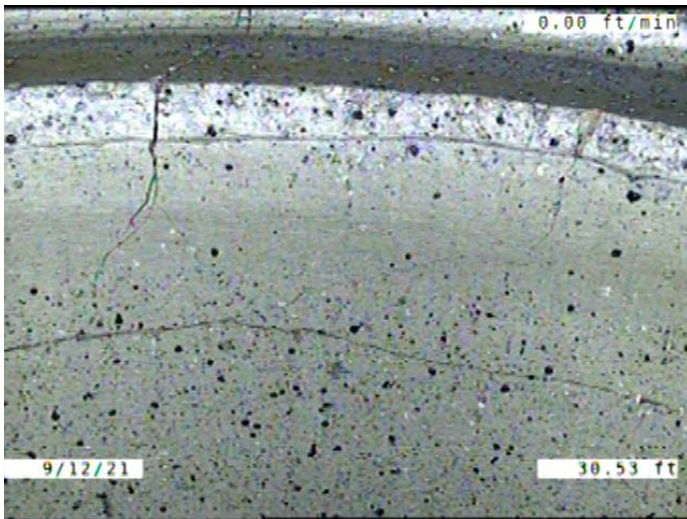
Code: **CM**
 Description: **Crack Multiple**

Distance (ft): **30.5**
 Structural Grade: **3**
 O&M Grade: **0**
 Clock Start/From: **9**
 Clock To: **2**
 1st Value:
 2nd Value:
 Value Percent:
 Continuous Index:
 Within 8" of Joint: **YES**
 Remarks:

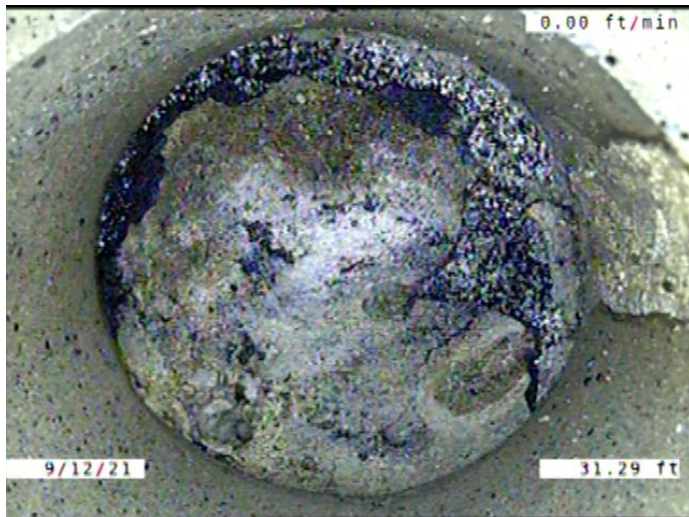
Code: **TFC**
 Description: **Tap Factory Capped**

Distance (ft): **31.3**
 Structural Grade: **0**
 O&M Grade: **0**
 Clock Start/From: **2**
 Clock To:
 1st Value: **4.000**
 2nd Value:
 Value Percent:
 Continuous Index:
 Within 8" of Joint: **YES**
 Remarks:

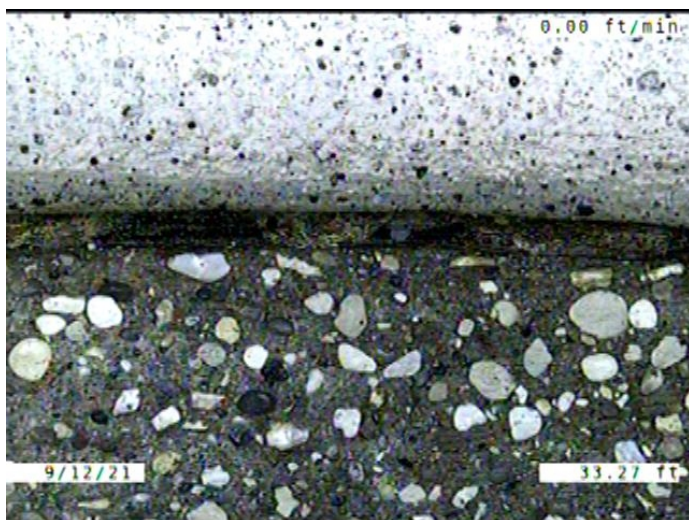
Code: **MMC**
 Description: **Miscellaneous Material Change**

Distance (ft): **33.3**
 Structural Grade: **0**
 O&M Grade: **0**
 Clock Start/From:
 Clock To:
 1st Value:
 2nd Value:
 Value Percent:
 Continuous Index:
 Within 8" of Joint: **NO**
 Remarks: **VCP TO CONCRETE**

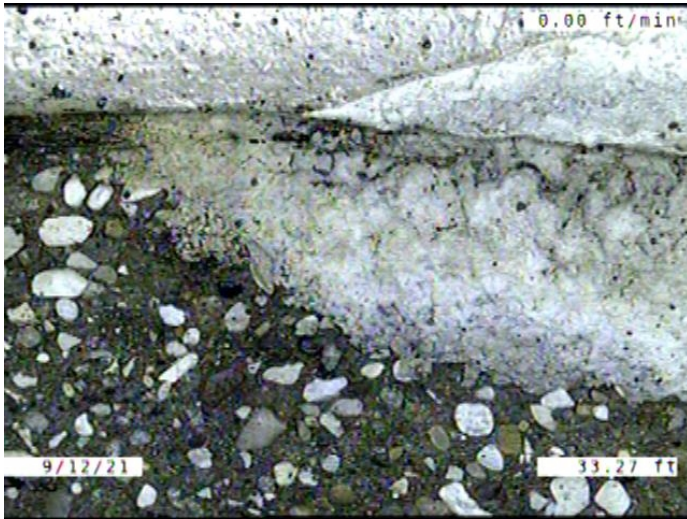
Code: **DAE**
 Description: **Deposits Attached Encrustation**

Distance (ft): **33.3**
 Structural Grade: **0**
 O&M Grade: **2**
 Clock Start/From: **1**
 Clock To: **4**
 1st Value:
 2nd Value:
 Value Percent: **5.000**
 Continuous Index:
 Within 8" of Joint: **YES**
 Remarks:

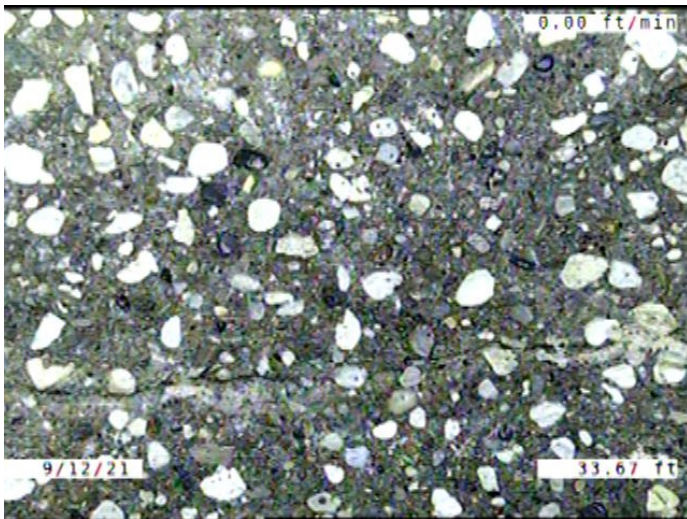
Code: **FS**
 Description: **Fracture Spiral**

Distance (ft): **33.7**
 Structural Grade: **3**
 O&M Grade: **0**
 Clock Start/From: **12**
 Clock To: **12**
 1st Value:
 2nd Value:
 Value Percent:
 Continuous Index:
 Within 8" of Joint: **YES**
 Remarks:

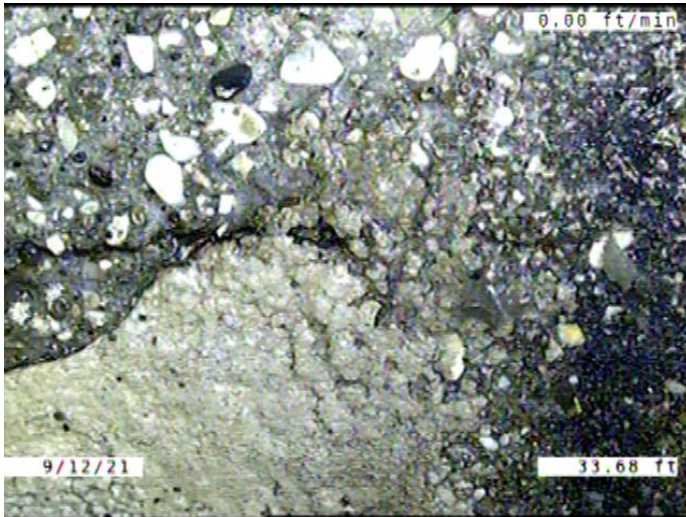
Code: **DAE**
 Description: **Deposits Attached Encrustation**

Distance (ft): **33.7**
 Structural Grade: **0**
 O&M Grade: **2**
 Clock Start/From: **12**
 Clock To: **4**
 1st Value:
 2nd Value:
 Value Percent: **5.000**
 Continuous Index:
 Within 8" of Joint: **YES**
 Remarks:

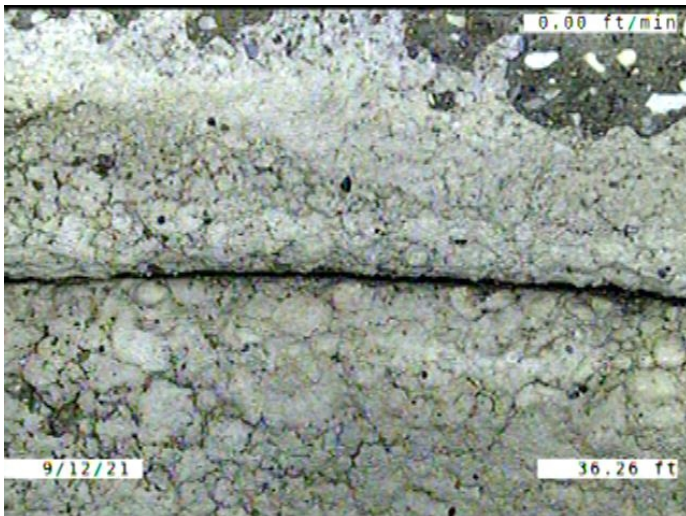
Code: **DAE**
 Description: **Deposits Attached Encrustation**

Distance (ft): **36.3**
 Structural Grade: **0**
 O&M Grade: **2**
 Clock Start/From: **8**
 Clock To: **3**
 1st Value:
 2nd Value:
 Value Percent: **5.000**
 Continuous Index:
 Within 8" of Joint: **YES**
 Remarks:

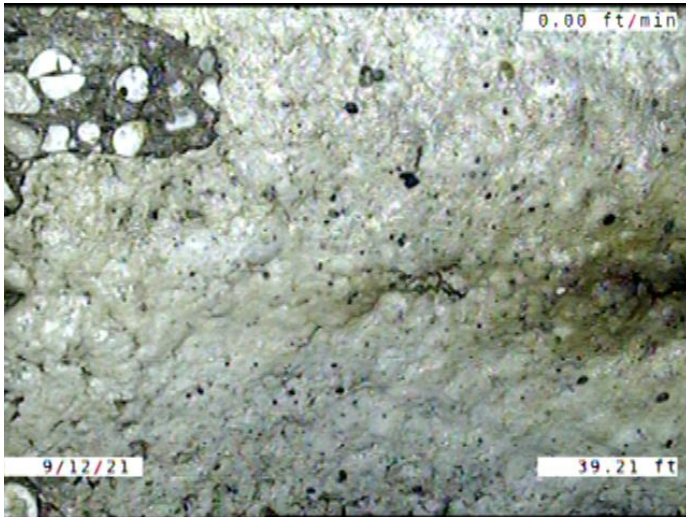
Code: **DAE**
 Description: **Deposits Attached Encrustation**

Distance (ft): **39.2**
 Structural Grade: **0**
 O&M Grade: **2**
 Clock Start/From: **8**
 Clock To: **12**
 1st Value:
 2nd Value:
 Value Percent: **5.000**
 Continuous Index:
 Within 8" of Joint: **YES**
 Remarks:

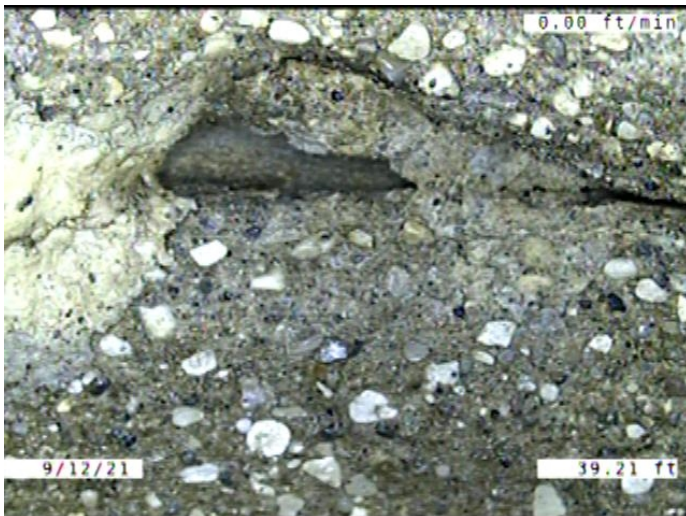
Code: **SZ**
 Description: **Surface Damage Other**

Distance (ft): **39.2**
 Structural Grade: **0**
 O&M Grade: **0**
 Clock Start/From: **12**
 Clock To:
 1st Value:
 2nd Value:
 Value Percent:
 Continuous Index:
 Within 8" of Joint: **YES**
 Remarks: **A PIECE CHIPPED AWAY FROM THE JOINT**

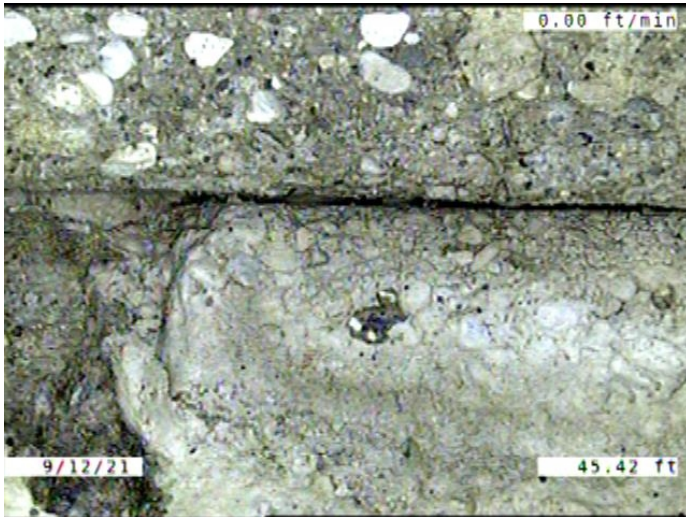
Code: **DAE**
 Description: **Deposits Attached Encrustation**

Distance (ft): **45.4**
 Structural Grade: **0**
 O&M Grade: **2**
 Clock Start/From: **7**
 Clock To: **5**
 1st Value:
 2nd Value:
 Value Percent: **5.000**
 Continuous Index:
 Within 8" of Joint: **YES**
 Remarks:

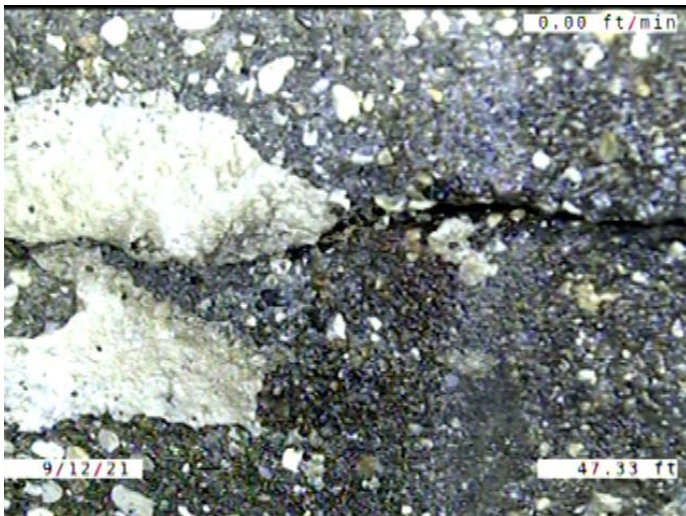
Code: **FM**
 Description: **Fracture Multiple**

Distance (ft): **47.3**
 Structural Grade: **4**
 O&M Grade: **0**
 Clock Start/From: **7**
 Clock To: **5**
 1st Value:
 2nd Value:
 Value Percent:
 Continuous Index:
 Within 8" of Joint: **YES**
 Remarks:

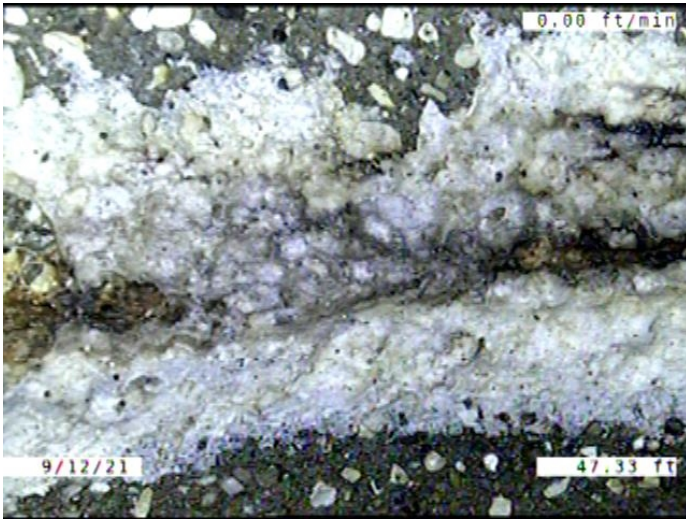
Code: **DAE**
 Description: **Deposits Attached Encrustation**

Distance (ft): **47.3**
 Structural Grade: **0**
 O&M Grade: **2**
 Clock Start/From: **7**
 Clock To: **3**
 1st Value:
 2nd Value:
 Value Percent: **5.000**
 Continuous Index:
 Within 8" of Joint: **YES**
 Remarks:

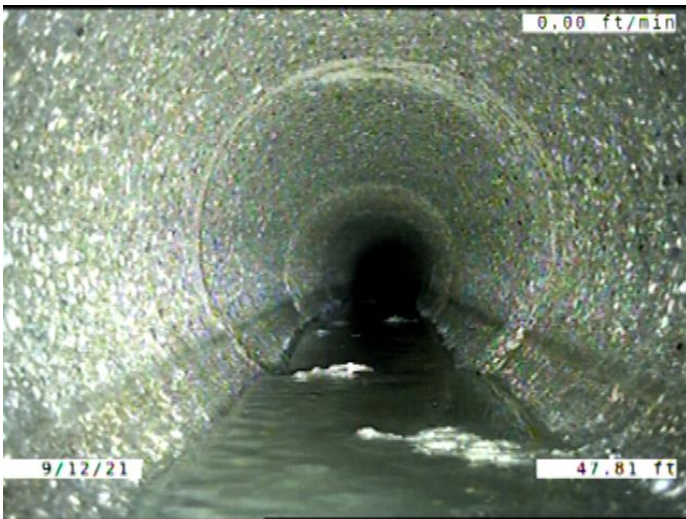
Code: **DSF**
 Description: **Deposits Settled Fine**

Distance (ft): **47.8**
 Structural Grade: **0**
 O&M Grade: **2**
 Clock Start/From: **5**
 Clock To: **7**
 1st Value:
 2nd Value:
 Value Percent: **5.000**
 Continuous Index: **S01**
 Within 8" of Joint: **YES**
 Remarks:

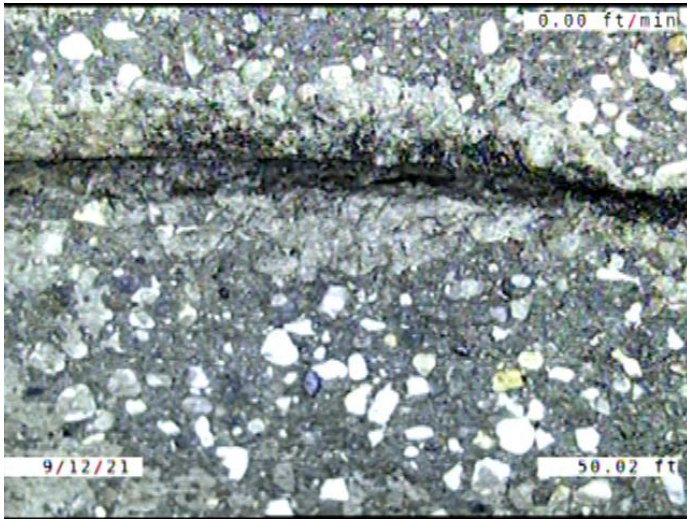
Code:	DAE
Description:	Deposits Attached Encrustation
Distance (ft):	50.0
Structural Grade:	0
O&M Grade:	2
Clock Start/From:	8
Clock To:	4
1st Value:	
2nd Value:	
Value Percent:	5.000
Continuous Index:	
Within 8" of Joint:	YES
Remarks:

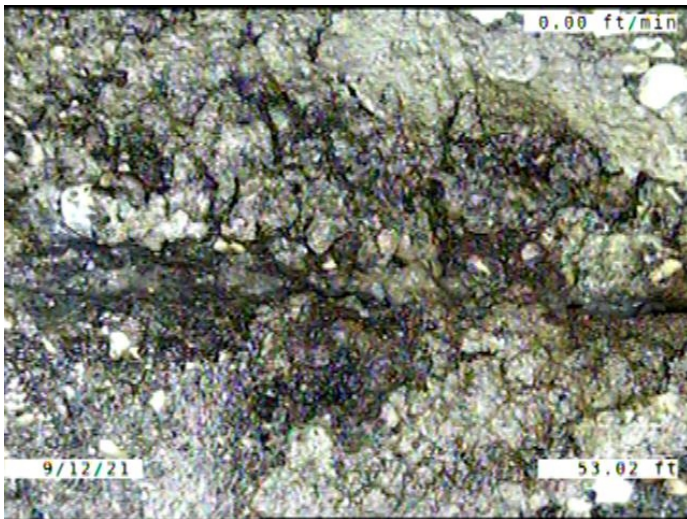
Code:	DAE
Description:	Deposits Attached Encrustation
Distance (ft):	53.0
Structural Grade:	0
O&M Grade:	2
Clock Start/From:	1
Clock To:	3
1st Value:	
2nd Value:	
Value Percent:	5.000
Continuous Index:	
Within 8" of Joint:	YES
Remarks:

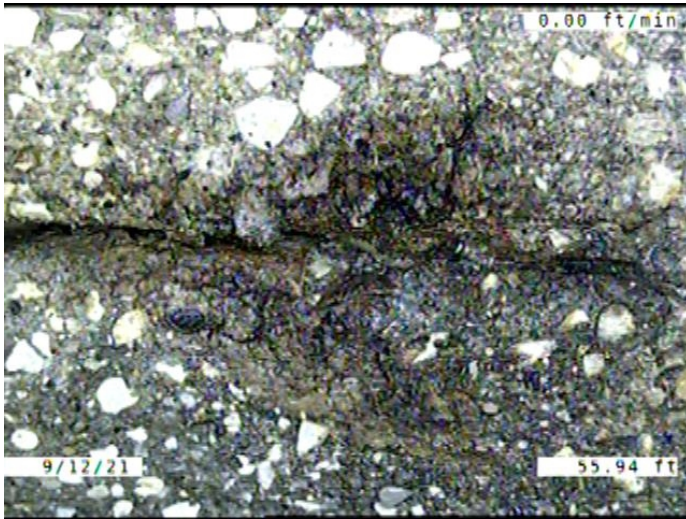
Code: **DAE**
 Description: **Deposits Attached Encrustation**

Distance (ft): **55.9**
 Structural Grade: **0**
 O&M Grade: **2**
 Clock Start/From: **2**
 Clock To: **3**
 1st Value:
 2nd Value:
 Value Percent: **5.000**
 Continuous Index:
 Within 8" of Joint: **YES**
 Remarks:

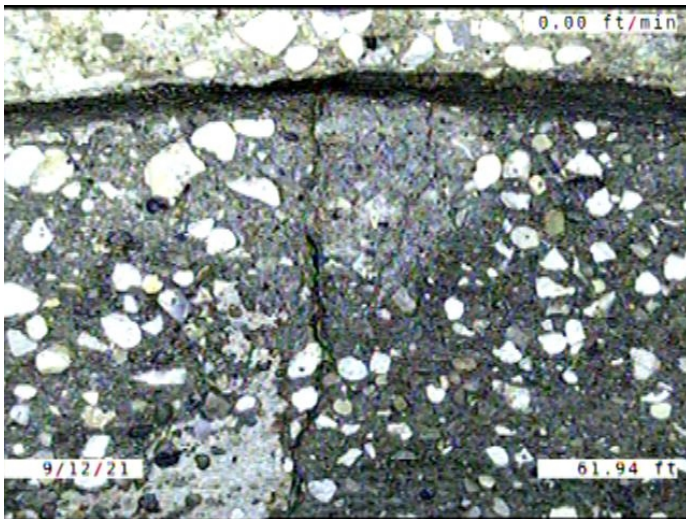
Code: **DAE**
 Description: **Deposits Attached Encrustation**

Distance (ft): **61.9**
 Structural Grade: **0**
 O&M Grade: **2**
 Clock Start/From: **8**
 Clock To: **11**
 1st Value:
 2nd Value:
 Value Percent: **5.000**
 Continuous Index:
 Within 8" of Joint: **YES**
 Remarks:

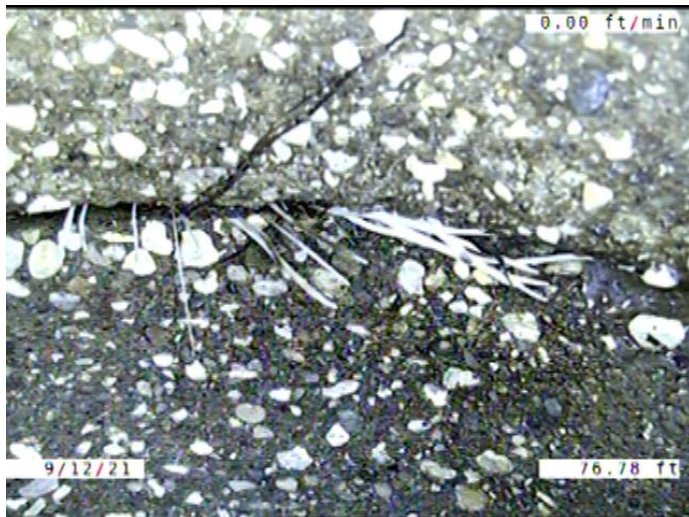
Code: **DAE**
 Description: **Deposits Attached Encrustation**

Distance (ft): **76.8**
 Structural Grade: **0**
 O&M Grade: **2**
 Clock Start/From: **3**
 Clock To: **4**
 1st Value:
 2nd Value:
 Value Percent: **5.000**
 Continuous Index:
 Within 8" of Joint: **YES**
 Remarks:

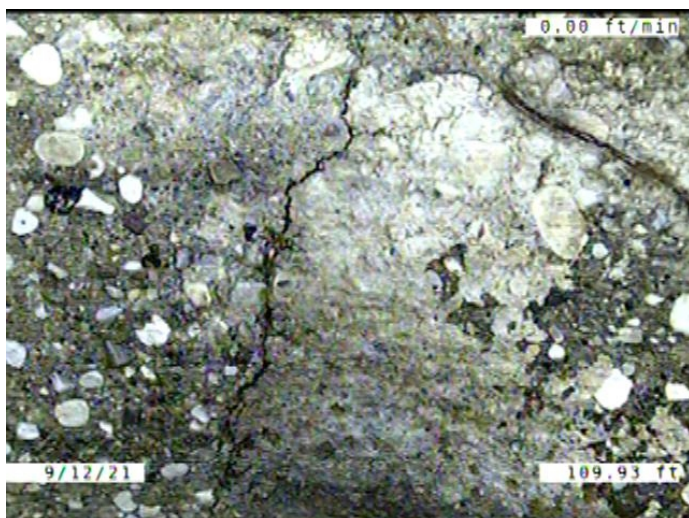
Code: **CM**
 Description: **Crack Multiple**

Distance (ft): **109.9**
 Structural Grade: **3**
 O&M Grade: **0**
 Clock Start/From: **2**
 Clock To: **3**
 1st Value:
 2nd Value:
 Value Percent:
 Continuous Index:
 Within 8" of Joint: **YES**
 Remarks:

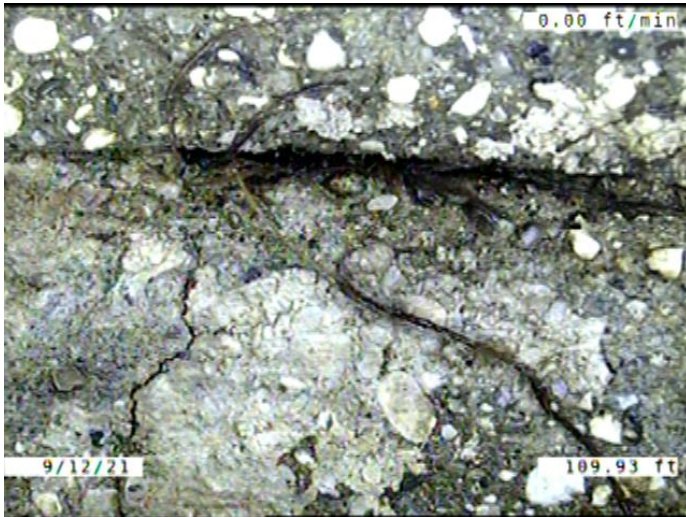
Code: **RFJ**
 Description: **Roots Fine Joint**

Distance (ft): **109.9**
 Structural Grade: **0**
 O&M Grade: **1**
 Clock Start/From: **3**
 Clock To:
 1st Value:
 2nd Value:
 Value Percent:
 Continuous Index:
 Within 8" of Joint: **YES**
 Remarks:

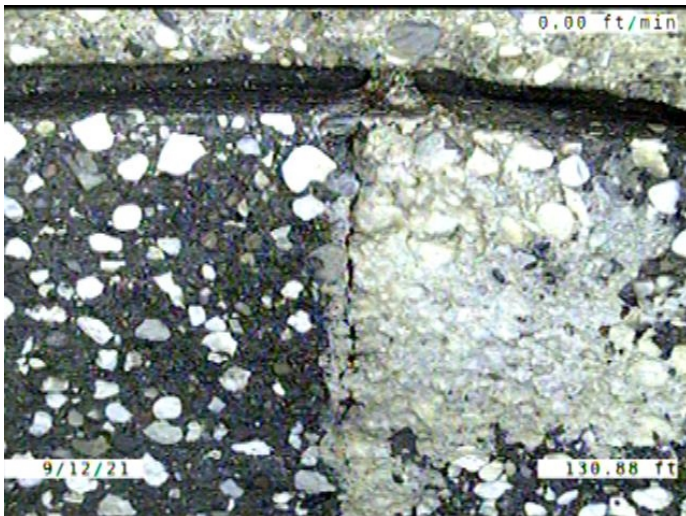
Code: **CL**
 Description: **Crack Longitudinal**

Distance (ft): **130.9**
 Structural Grade: **2**
 O&M Grade: **0**
 Clock Start/From: **2**
 Clock To:
 1st Value:
 2nd Value:
 Value Percent:
 Continuous Index:
 Within 8" of Joint: **YES**
 Remarks:

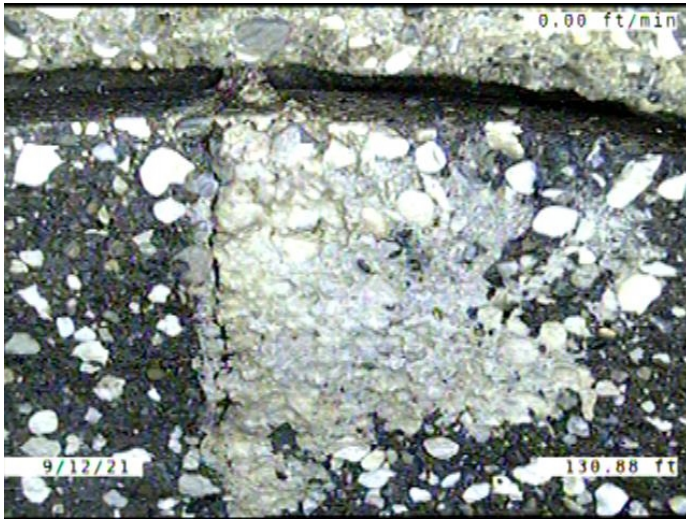
Code: **DAE**
 Description: **Deposits Attached Encrustation**

Distance (ft): **130.9**
 Structural Grade: **0**
 O&M Grade: **2**
 Clock Start/From: **2**
 Clock To: **3**
 1st Value:
 2nd Value:
 Value Percent: **5.000**
 Continuous Index:
 Within 8" of Joint: **YES**
 Remarks:

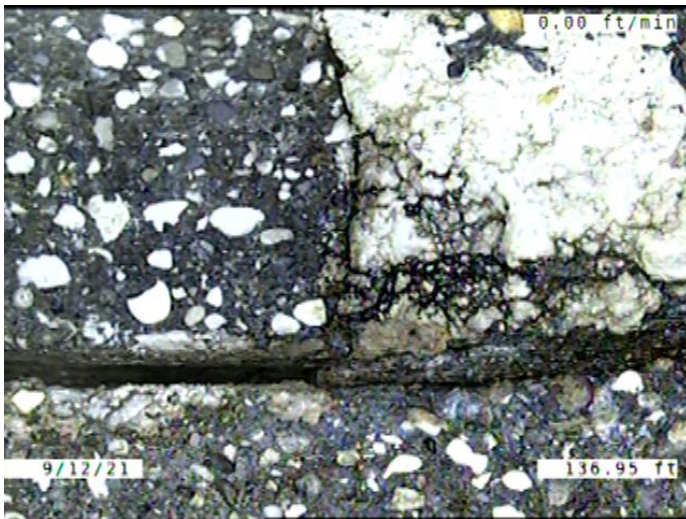
Code: **CL**
 Description: **Crack Longitudinal**

Distance (ft): **136.9**
 Structural Grade: **2**
 O&M Grade: **0**
 Clock Start/From: **9**
 Clock To:
 1st Value:
 2nd Value:
 Value Percent:
 Continuous Index:
 Within 8" of Joint: **YES**
 Remarks:

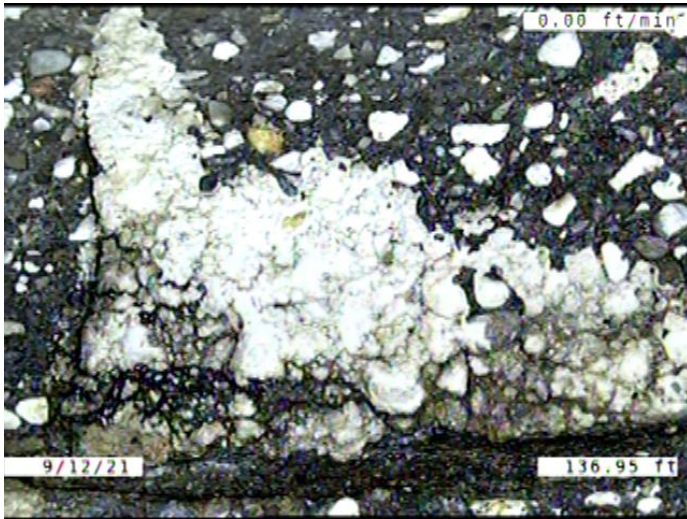
Code: **DAE**
 Description: **Deposits Attached Encrustation**

Distance (ft): **136.9**
 Structural Grade: **0**
 O&M Grade: **2**
 Clock Start/From: **8**
 Clock To: **9**
 1st Value:
 2nd Value:
 Value Percent: **5.000**
 Continuous Index:
 Within 8" of Joint: **YES**
 Remarks:

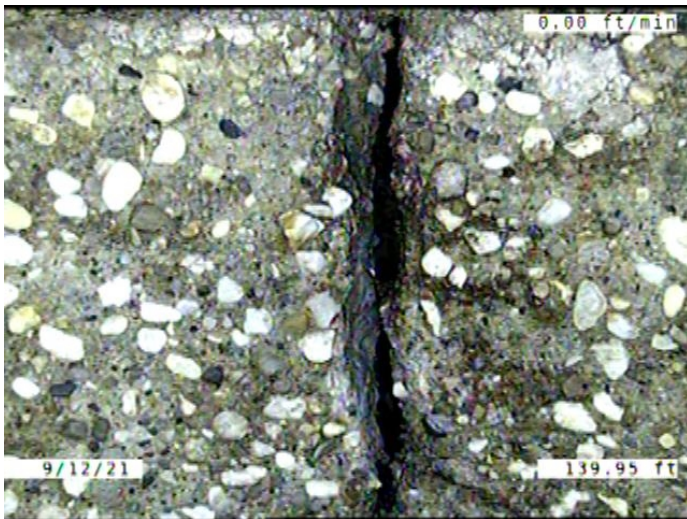
Code: **FM**
 Description: **Fracture Multiple**

Distance (ft): **140.0**
 Structural Grade: **4**
 O&M Grade: **0**
 Clock Start/From: **7**
 Clock To: **5**
 1st Value:
 2nd Value:
 Value Percent:
 Continuous Index:
 Within 8" of Joint: **YES**
 Remarks:

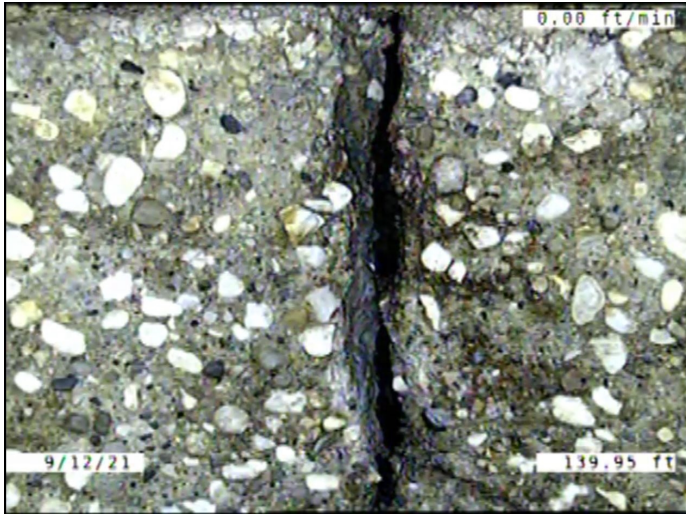
Code: **HVV**
Description: **Hole Void Visible**

Distance (ft): **140.0**
Structural Grade: **5**
O&M Grade: **0**
Clock Start/From: **12**
Clock To:
1st Value:
2nd Value:
Value Percent:
Continuous Index:
Within 8" of Joint: **NO**
Remarks:

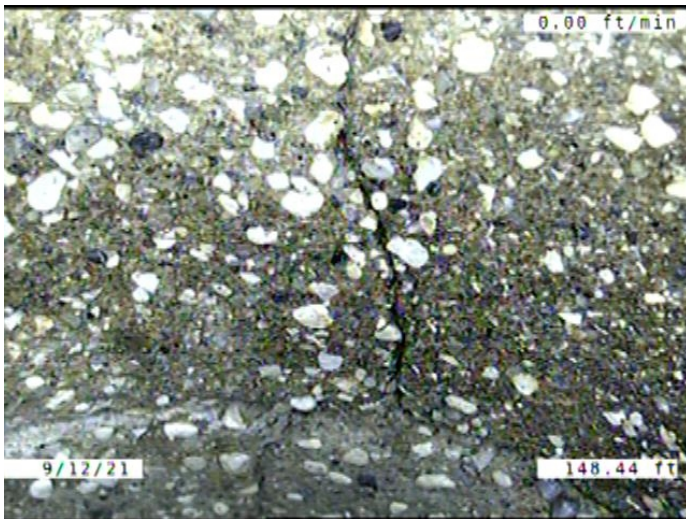
Code: **FM**
Description: **Fracture Multiple**

Distance (ft): **148.4**
Structural Grade: **4**
O&M Grade: **0**
Clock Start/From: **9**
Clock To: **3**
1st Value:
2nd Value:
Value Percent:
Continuous Index:
Within 8" of Joint: **YES**
Remarks:

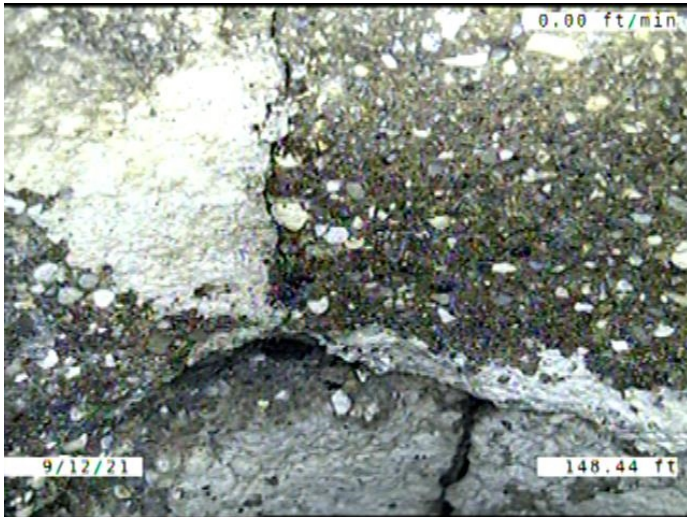
Code: **DAE**
 Description: **Deposits Attached Encrustation**

Distance (ft): **148.4**
 Structural Grade: **0**
 O&M Grade: **2**
 Clock Start/From: **8**
 Clock To: **3**
 1st Value:
 2nd Value:
 Value Percent: **5.000**
 Continuous Index:
 Within 8" of Joint: **YES**
 Remarks:

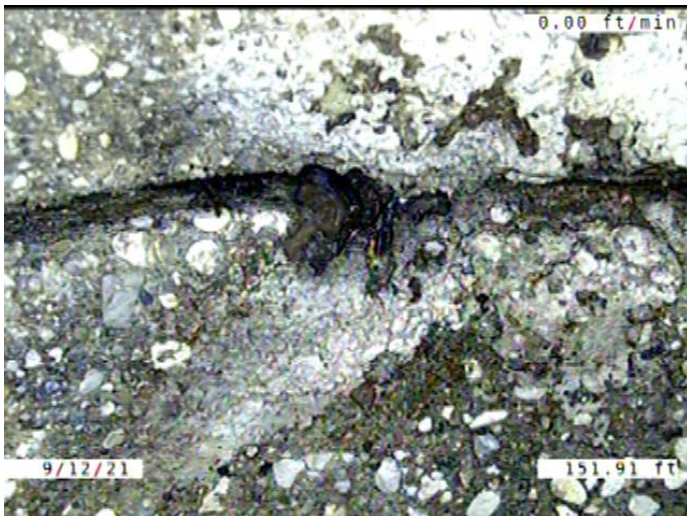
Code: **RFJ**
 Description: **Roots Fine Joint**

Distance (ft): **151.9**
 Structural Grade: **0**
 O&M Grade: **1**
 Clock Start/From: **10**
 Clock To:
 1st Value:
 2nd Value:
 Value Percent:
 Continuous Index:
 Within 8" of Joint: **YES**
 Remarks:

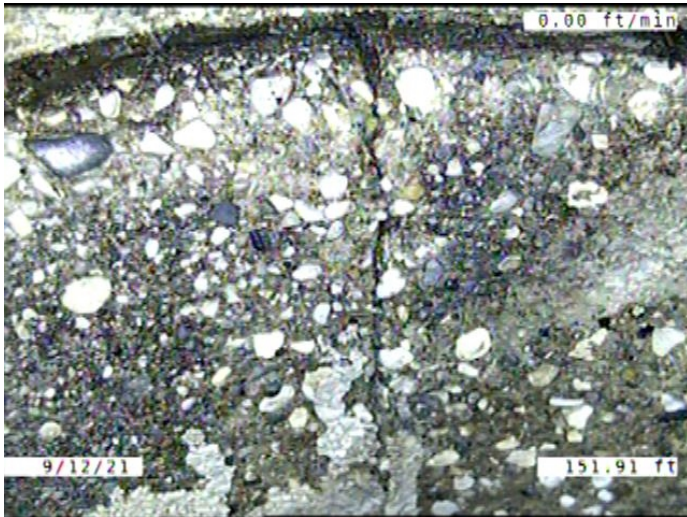
Code: **FL**
 Description: **Fracture Longitudinal**

Distance (ft): **151.9**
 Structural Grade: **3**
 O&M Grade: **0**
 Clock Start/From: **9**
 Clock To:
 1st Value:
 2nd Value:
 Value Percent:
 Continuous Index:
 Within 8" of Joint: **YES**
 Remarks:

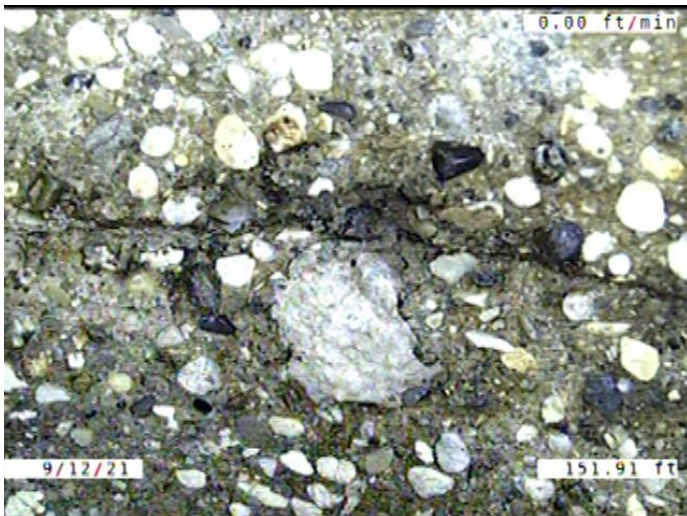
Code: **DAE**
 Description: **Deposits Attached Encrustation**

Distance (ft): **151.9**
 Structural Grade: **0**
 O&M Grade: **2**
 Clock Start/From: **8**
 Clock To: **3**
 1st Value:
 2nd Value:
 Value Percent: **5.000**
 Continuous Index:
 Within 8" of Joint: **YES**
 Remarks:

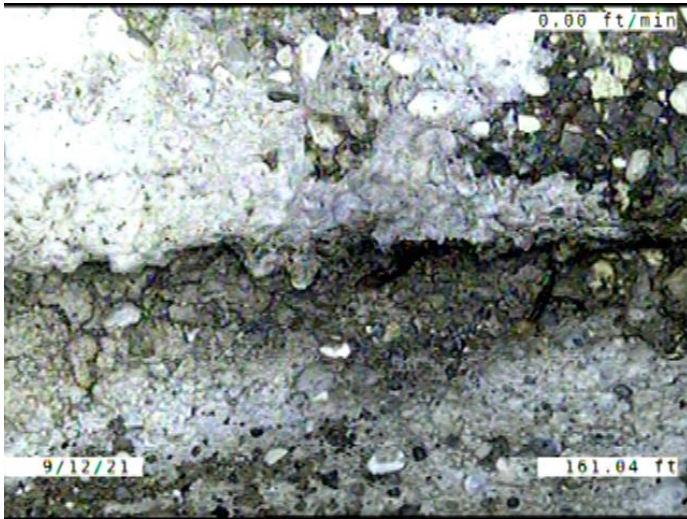
Code: **DAE**
 Description: **Deposits Attached Encrustation**

Distance (ft): **161.0**
 Structural Grade: **0**
 O&M Grade: **2**
 Clock Start/From: **9**
 Clock To: **3**
 1st Value:
 2nd Value:
 Value Percent: **5.000**
 Continuous Index: **S02**
 Within 8" of Joint: **YES**
 Remarks:

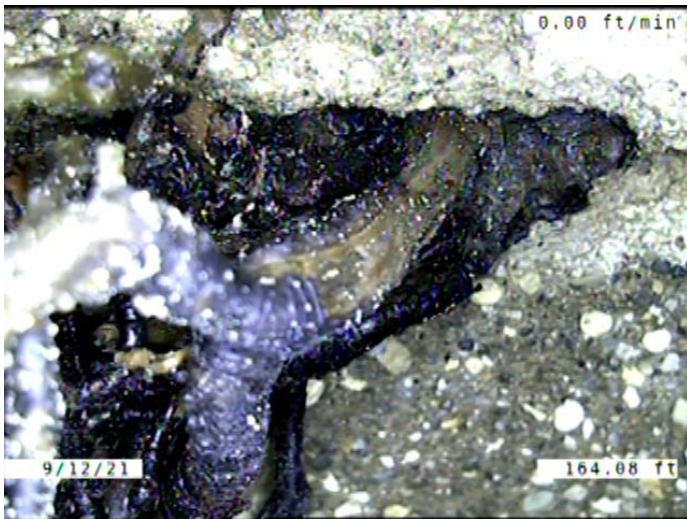
Code: **RMJ**
 Description: **Roots Medium Joint**

Distance (ft): **164.1**
 Structural Grade: **0**
 O&M Grade: **3**
 Clock Start/From: **8**
 Clock To: **10**
 1st Value:
 2nd Value:
 Value Percent: **5.000**
 Continuous Index:
 Within 8" of Joint: **YES**
 Remarks:

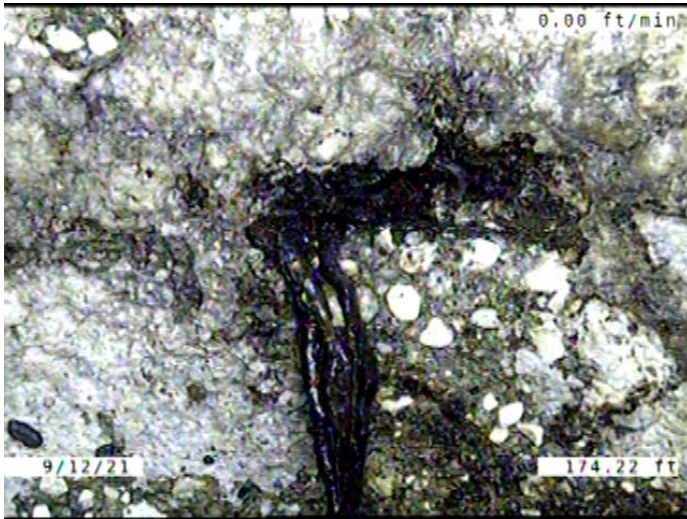
Code: **RFJ**
 Description: **Roots Fine Joint**

Distance (ft): **174.2**
 Structural Grade: **0**
 O&M Grade: **1**
 Clock Start/From: **3**
 Clock To:
 1st Value:
 2nd Value:
 Value Percent:
 Continuous Index:
 Within 8" of Joint: **YES**
 Remarks:

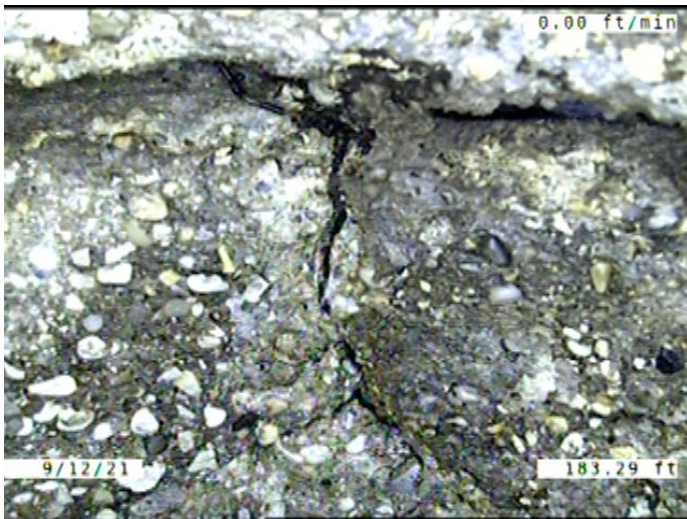
Code: **RFJ**
 Description: **Roots Fine Joint**

Distance (ft): **183.3**
 Structural Grade: **0**
 O&M Grade: **1**
 Clock Start/From: **1**
 Clock To: **4**
 1st Value:
 2nd Value:
 Value Percent:
 Continuous Index:
 Within 8" of Joint: **YES**
 Remarks:

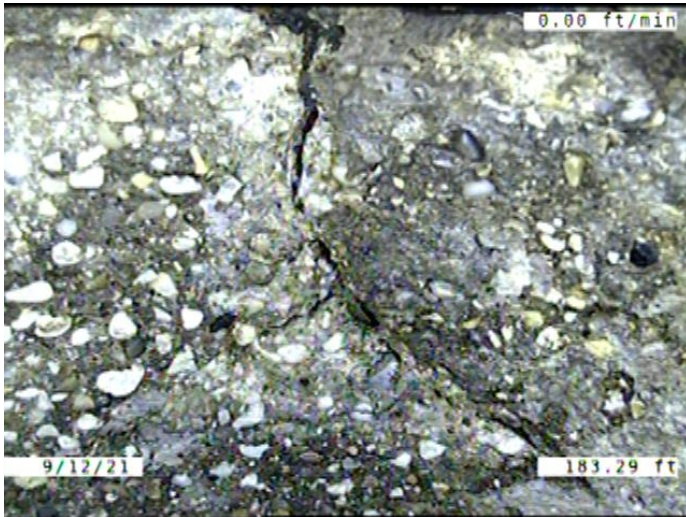
Code: **FM**
 Description: **Fracture Multiple**

Distance (ft): **183.3**
 Structural Grade: **4**
 O&M Grade: **0**
 Clock Start/From: **9**
 Clock To: **2**
 1st Value:
 2nd Value:
 Value Percent:
 Continuous Index:
 Within 8" of Joint: **YES**
 Remarks:

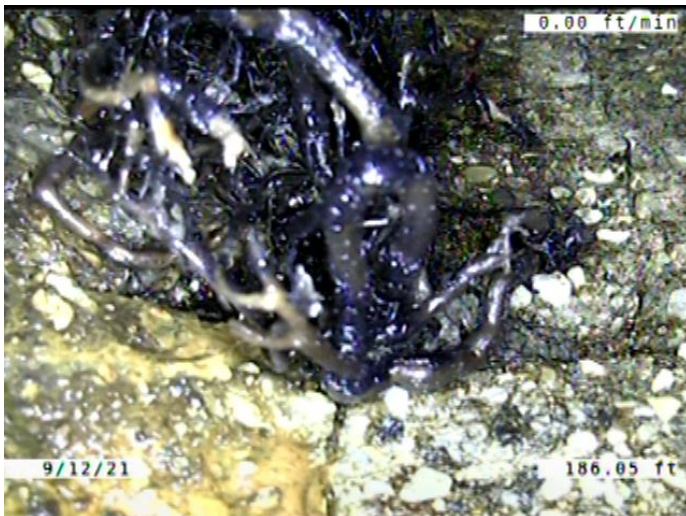
Code: **RMJ**
 Description: **Roots Medium Joint**

Distance (ft): **186.0**
 Structural Grade: **0**
 O&M Grade: **3**
 Clock Start/From: **3**
 Clock To: **4**
 1st Value:
 2nd Value:
 Value Percent: **5.000**
 Continuous Index:
 Within 8" of Joint: **YES**
 Remarks:

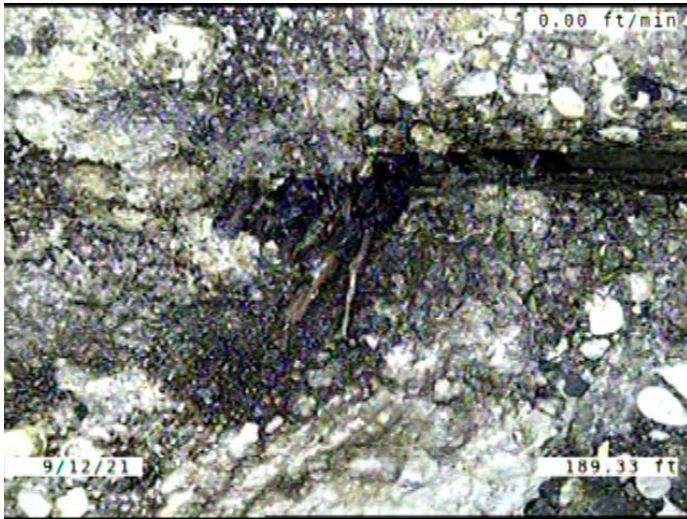
Code: **CM**
 Description: **Crack Multiple**

Distance (ft): **189.3**
 Structural Grade: **3**
 O&M Grade: **0**
 Clock Start/From: **9**
 Clock To: **10**
 1st Value:
 2nd Value:
 Value Percent:
 Continuous Index:
 Within 8" of Joint: **YES**
 Remarks:

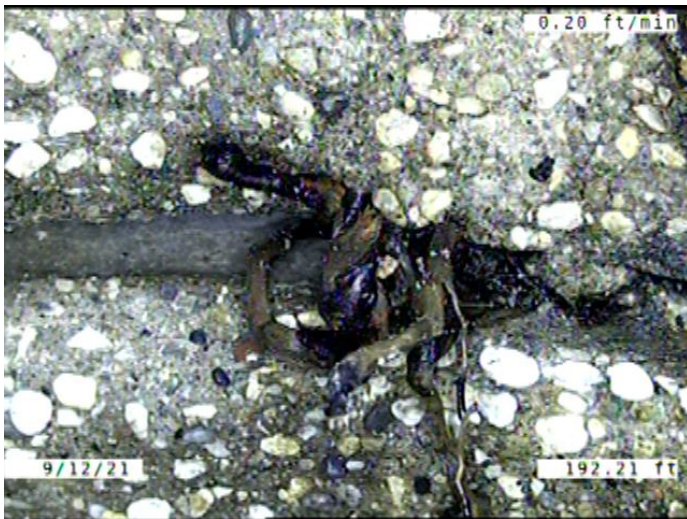
Code: **RFJ**
 Description: **Roots Fine Joint**

Distance (ft): **192.2**
 Structural Grade: **0**
 O&M Grade: **1**
 Clock Start/From: **8**
 Clock To: **9**
 1st Value:
 2nd Value:
 Value Percent:
 Continuous Index:
 Within 8" of Joint: **YES**
 Remarks:

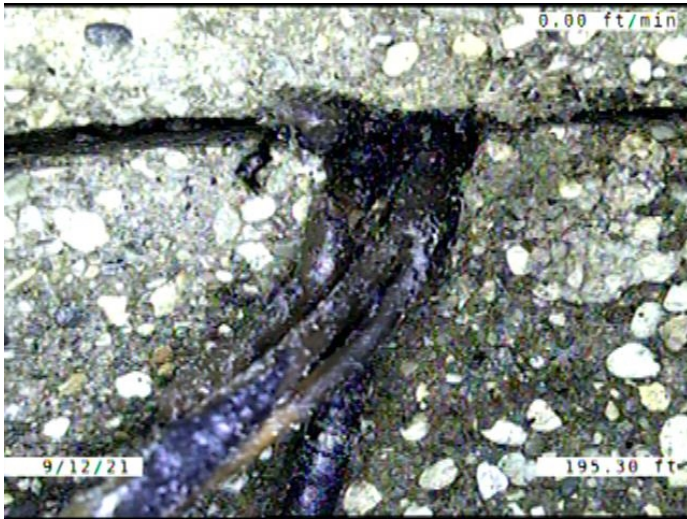
Code: **RFJ**
Description: **Roots Fine Joint**

Distance (ft): **195.3**
Structural Grade: **0**
O&M Grade: **1**
Clock Start/From: **9**
Clock To: **10**
1st Value:
2nd Value:
Value Percent:
Continuous Index:
Within 8" of Joint: **YES**
Remarks:
