Profile/Photo Observation Report

Date:	09/12/2021	Weather:		Coding:	PACP 7.0
Pipe Length (ft):	255.7	Owner:	City of Hobart	Pre Clean:	Heavy Cleaning
P.O.#:	YES502259	Surveyor:	S. Bucklin	PSR:	P-504-105-130
Customer:	City of Hobart	Clean Date:	08/28/2021	Shape:	C

Street:	North Virginia Street	Flow Control:	Not Controlled
City:	Hobart, IN	Year Renewed:	
Location:	Alley	Tape/Media #:	
Purpose:	Routine Assessment	Dia/Height:	12"
Use:	Sanitary Sewage Pipe	Material:	CP
Drain Area:		Lining:	None
Category:	NA		
Comment:			
Location Details:		Direction of Survey:	Downstream
US MH:	M-504-130	DS MH:	M-504-105
		Total Length Surveyed (ft):	255.7

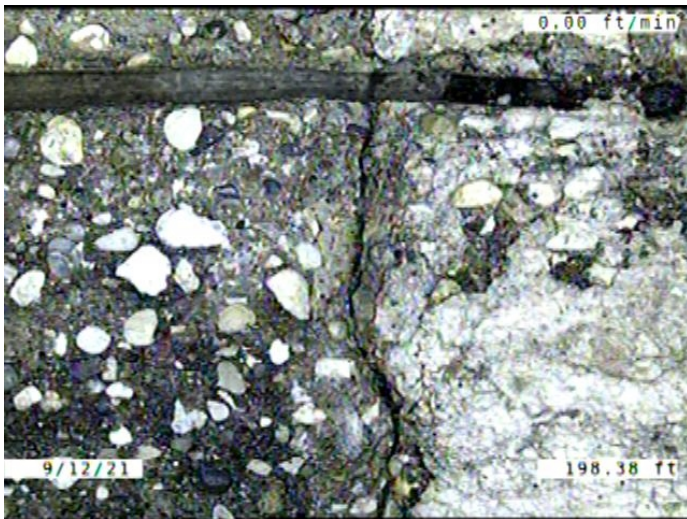
Code: **FL**
Description: **Fracture Longitudinal**

Distance (ft): **198.4**
Structural Grade: **3**
O&M Grade: **0**
Clock Start/From: **1**
Clock To:
1st Value:
2nd Value:
Value Percent:
Continuous Index:
Within 8" of Joint: **YES**
Remarks:

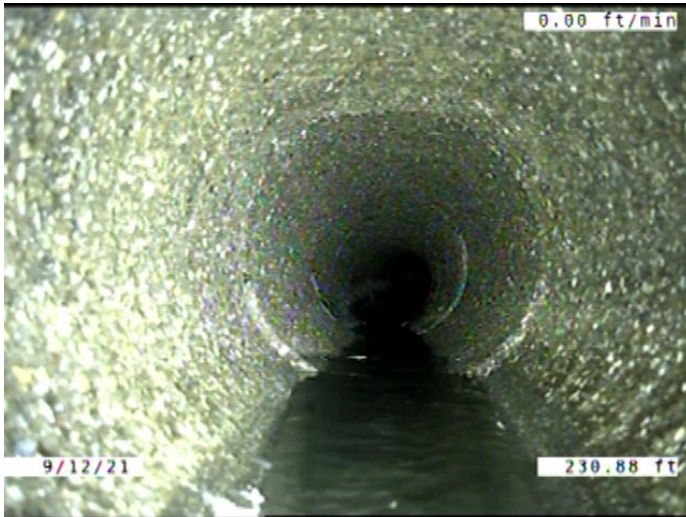
Code: **DAE**
 Description: **Deposits Attached Encrustation**

Distance (ft): **230.9**
 Structural Grade: **0**
 O&M Grade: **2**
 Clock Start/From: **9**
 Clock To: **3**
 1st Value:
 2nd Value:
 Value Percent: **5.000**
 Continuous Index: **F02**
 Within 8" of Joint: **YES**
 Remarks:

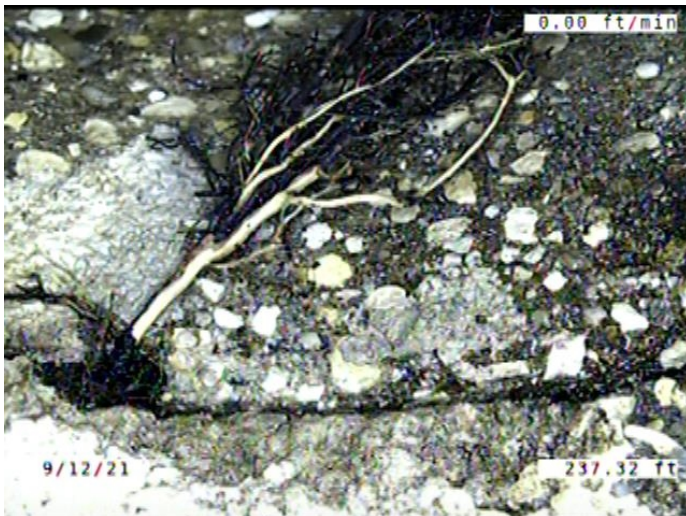
Code: **RFJ**
 Description: **Roots Fine Joint**

Distance (ft): **237.3**
 Structural Grade: **0**
 O&M Grade: **1**
 Clock Start/From: **8**
 Clock To:
 1st Value:
 2nd Value:
 Value Percent:
 Continuous Index:
 Within 8" of Joint: **YES**
 Remarks:

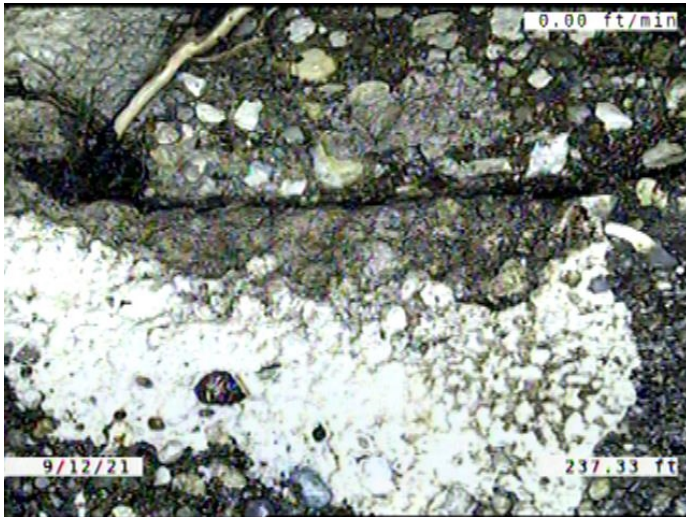
Code: **DAE**
 Description: **Deposits Attached Encrustation**

Distance (ft): **237.3**
 Structural Grade: **0**
 O&M Grade: **2**
 Clock Start/From: **7**
 Clock To: **9**
 1st Value:
 2nd Value:
 Value Percent: **5.000**
 Continuous Index:
 Within 8" of Joint: **YES**
 Remarks:

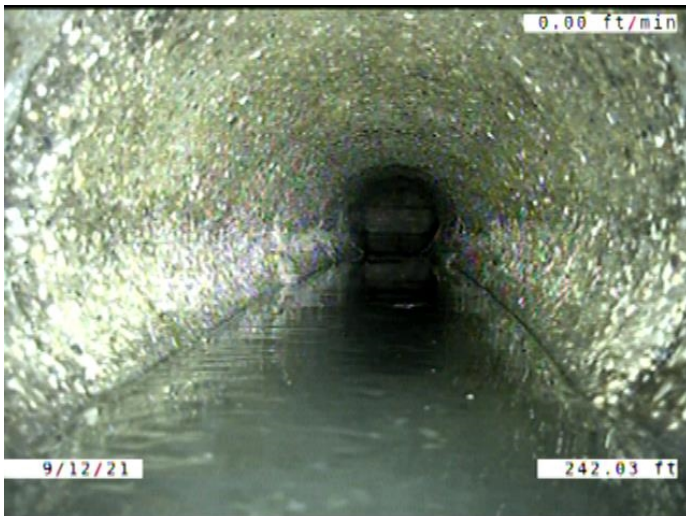
Code: **MWLS**
 Description: **Miscellaneous Water Level Sag**

Distance (ft): **242.0**
 Structural Grade: **2**
 O&M Grade: **0**
 Clock Start/From:
 Clock To:
 1st Value:
 2nd Value:
 Value Percent: **5.000**
 Continuous Index: **S03**
 Within 8" of Joint: **NO**
 Remarks:

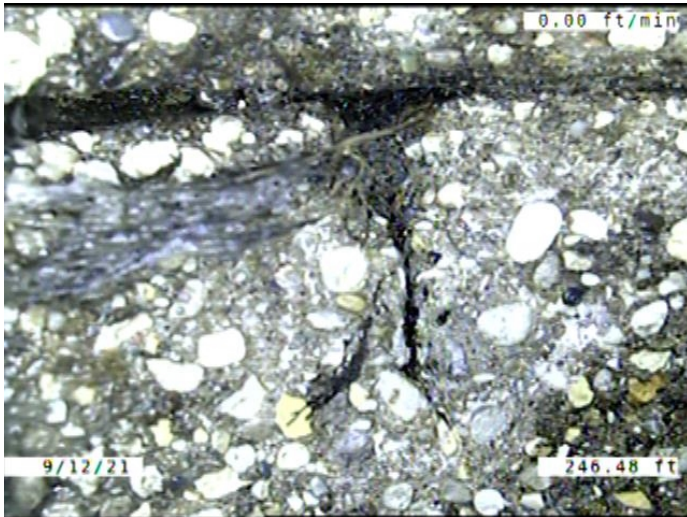
Code: **RFJ**
 Description: **Roots Fine Joint**

Distance (ft): **246.5**
 Structural Grade: **0**
 O&M Grade: **1**
 Clock Start/From: **9**
 Clock To:
 1st Value:
 2nd Value:
 Value Percent:
 Continuous Index:
 Within 8" of Joint: **YES**
 Remarks:

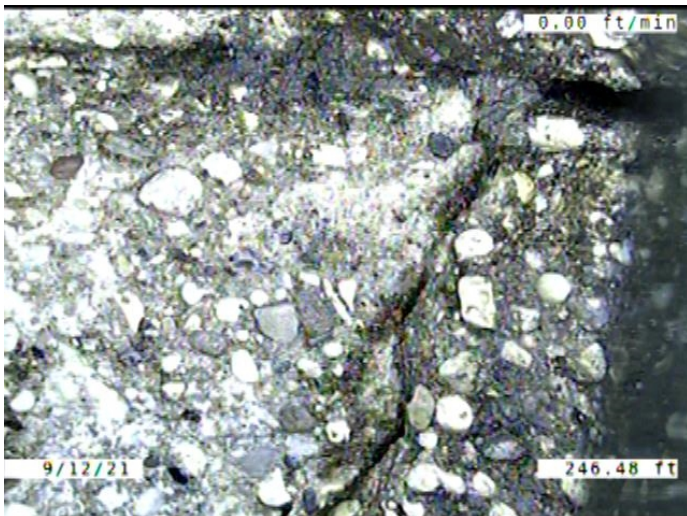
Code: **FS**
 Description: **Fracture Spiral**

Distance (ft): **246.5**
 Structural Grade: **3**
 O&M Grade: **0**
 Clock Start/From: **3**
 Clock To: **4**
 1st Value:
 2nd Value:
 Value Percent:
 Continuous Index:
 Within 8" of Joint: **YES**
 Remarks:

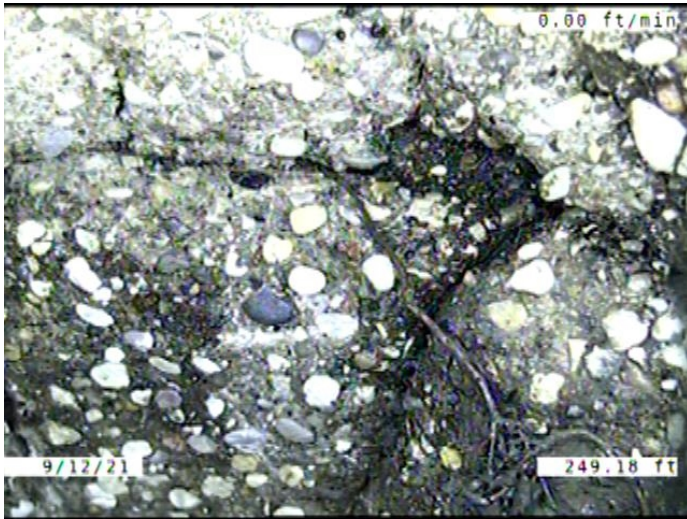
Code: **RFJ**
 Description: **Roots Fine Joint**

Distance (ft): **249.2**
 Structural Grade: **0**
 O&M Grade: **1**
 Clock Start/From: **3**
 Clock To:
 1st Value:
 2nd Value:
 Value Percent:
 Continuous Index:
 Within 8" of Joint: **YES**
 Remarks:

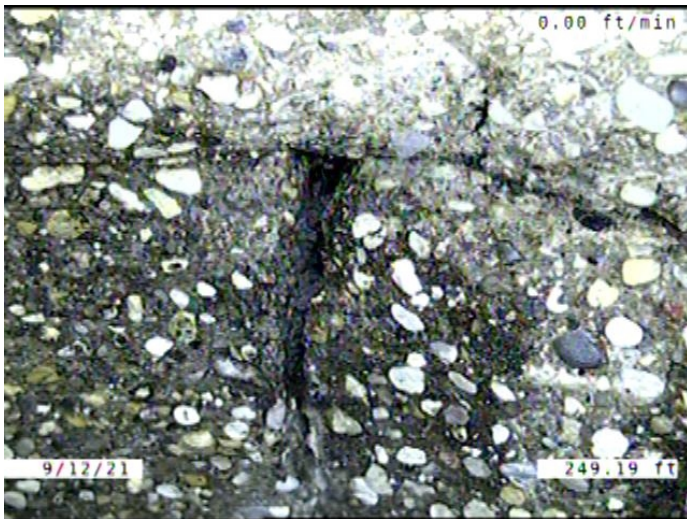
Code: **FM**
 Description: **Fracture Multiple**

Distance (ft): **249.2**
 Structural Grade: **4**
 O&M Grade: **0**
 Clock Start/From: **7**
 Clock To: **4**
 1st Value:
 2nd Value:
 Value Percent:
 Continuous Index:
 Within 8" of Joint: **YES**
 Remarks:

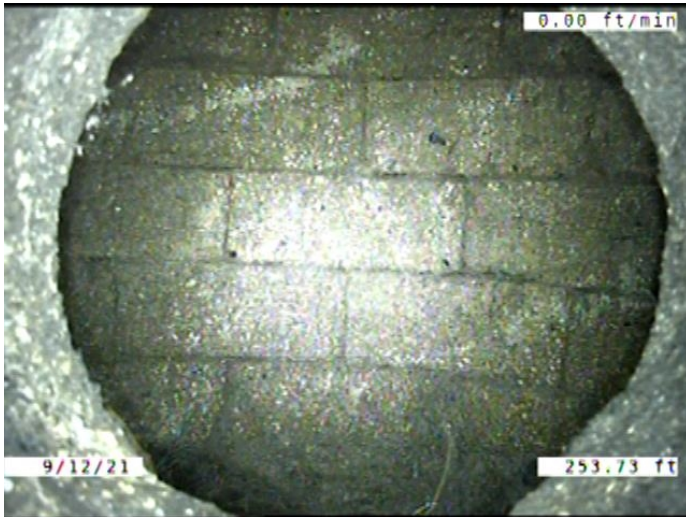
Code: **MWLS**
Description: **Miscellaneous Water Level Sag**

Distance (ft): **253.7**
Structural Grade: **2**
O&M Grade: **0**
Clock Start/From:
Clock To:
1st Value:
2nd Value:
Value Percent: **5.000**
Continuous Index: **F03**
Within 8" of Joint: **NO**
Remarks:

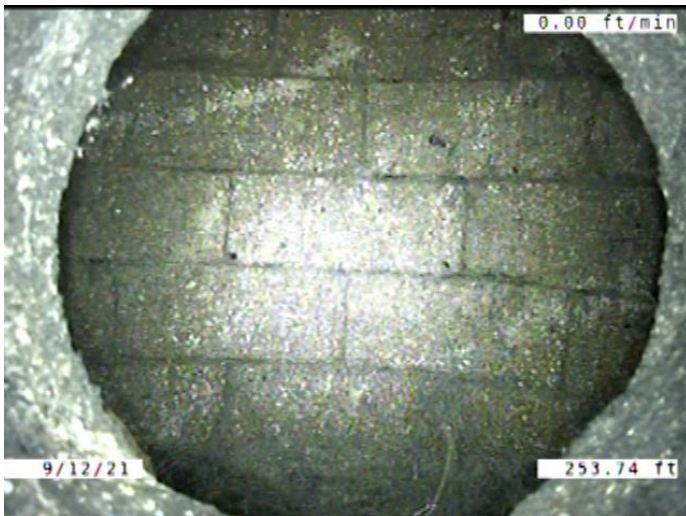
Code: **DSF**
Description: **Deposits Settled Fine**

Distance (ft): **253.7**
Structural Grade: **0**
O&M Grade: **2**
Clock Start/From: **5**
Clock To: **7**
1st Value:
2nd Value:
Value Percent: **5.000**
Continuous Index: **F01**
Within 8" of Joint: **YES**
Remarks:

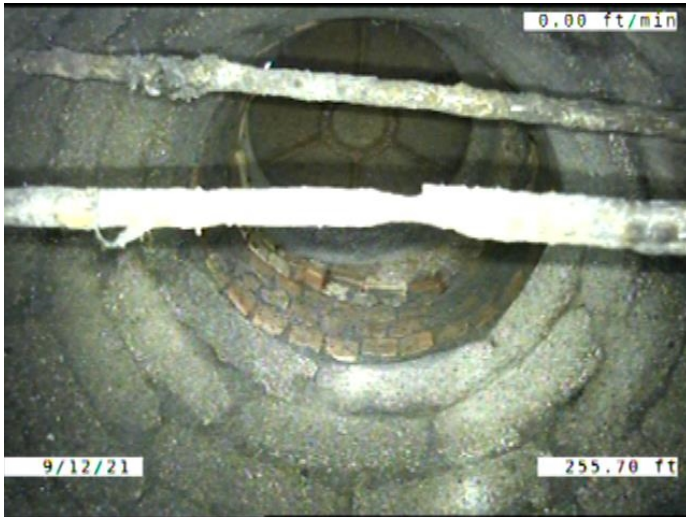
Code:	AMH
Description:	Manhole
Distance (ft):	255.7
Structural Grade:	0
O&M Grade:	0
Clock Start/From:	
Clock To:	
1st Value:	
2nd Value:	
Value Percent:	
Continuous Index:	
Within 8" of Joint:	NO
Remarks:	M-504-105
