Profile/Photo Observation Report

Date:	04/13/2018	Weather:		Coding:	PACP 6.0
Pipe Length (ft):		Owner:	City of Hobart	Pre Clean:	No Pre-Cleaning
P.O.#:	38-1	Surveyor:	M. Pielacha	PSR:	M-504-131-M-504-132
Customer:	City of Hobart	Clean Date:		Shape:	C

Street:	Off Virginia Street	Flow Control:	Not Controlled
City:	Hobart, IN	Year Renewed:	
Location:	Light Highway	Tape/Media #:	DEP 38
Purpose:	Routine Assessment	Dia/Height:	6"
Use:	Sanitary	Material:	VCP
Drain Area:		Lining:	
Category:	NA		
Comment:			
Location Details:		Direction of Survey:	Upstream
US MH:	M-504-131	DS MH:	M-504-132
		Total Length Surveyed (ft):	44.8

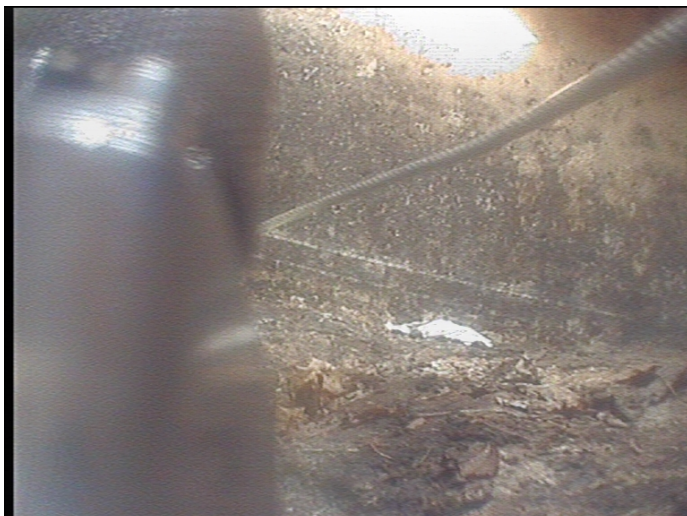
Code: **AMH**
Description: **Manhole**

Distance (ft): **.0**
Structural Grade: **0**
O&M Grade: **0**
Clock Start/From:
Clock To:
1st Value:
2nd Value:
Value Percent:
Continuous Index:
Within 8" of Joint: **NO**
Remarks: **M-504-132**

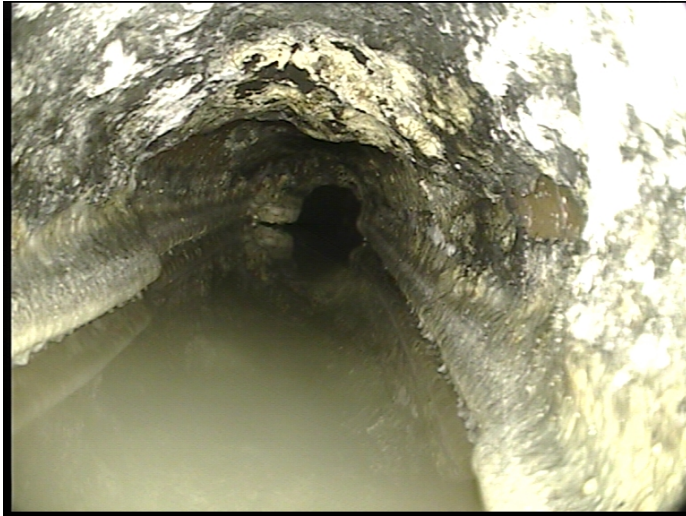
Code: **MWL**
Description: **Water Level**

Distance (ft): **.0**
Structural Grade: **0**
O&M Grade: **0**
Clock Start/From:
Clock To:
1st Value:
2nd Value:
Value Percent: **10.000**
Continuous Index:
Within 8" of Joint: **NO**
Remarks:

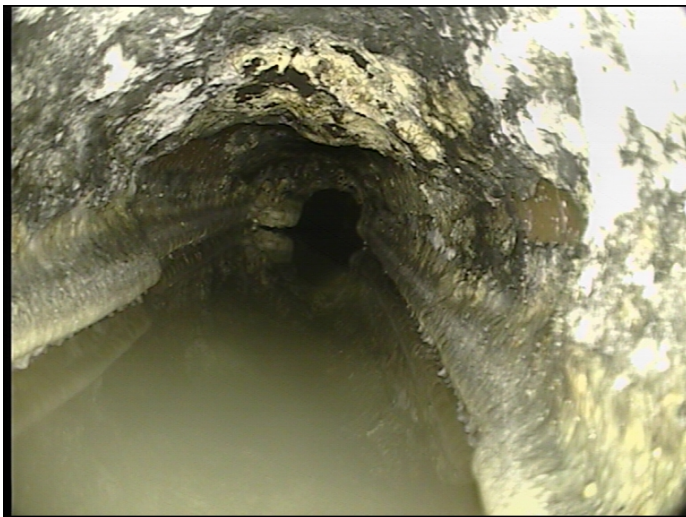
Code: **DAGS**
Description: **Deposits Attached Grease**

Distance (ft): **.0**
Structural Grade: **0**
O&M Grade: **3**
Clock Start/From: **8**
Clock To: **4**
1st Value:
2nd Value:
Value Percent: **15.000**
Continuous Index: **S01**
Within 8" of Joint: **YES**
Remarks:

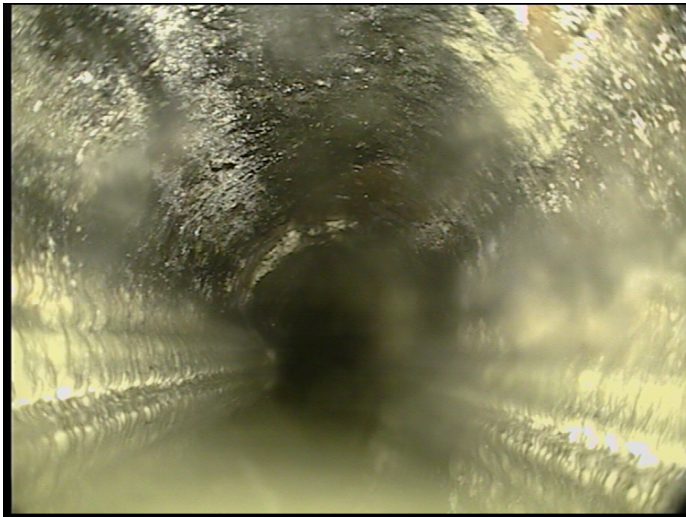
Code: **DAGS**
Description: **Deposits Attached Grease**

Distance (ft): **7.4**
Structural Grade: **0**
O&M Grade: **3**
Clock Start/From: **8**
Clock To: **4**
1st Value:
2nd Value:
Value Percent: **15.000**
Continuous Index: **F01**
Within 8" of Joint: **NO**
Remarks:

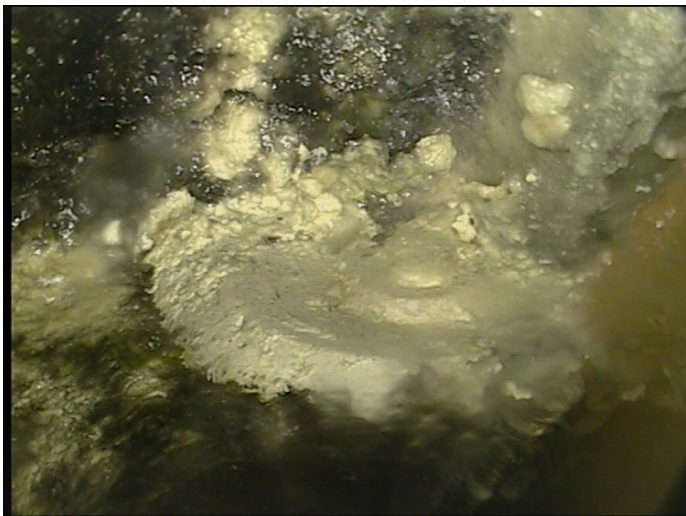
Code: **DAE**
Description: **Deposits Attached Encrustation**

Distance (ft): **9.9**
Structural Grade: **0**
O&M Grade: **2**
Clock Start/From: **1**
Clock To: **5**
1st Value:
2nd Value:
Value Percent: **10.000**
Continuous Index:
Within 8" of Joint: **YES**
Remarks:

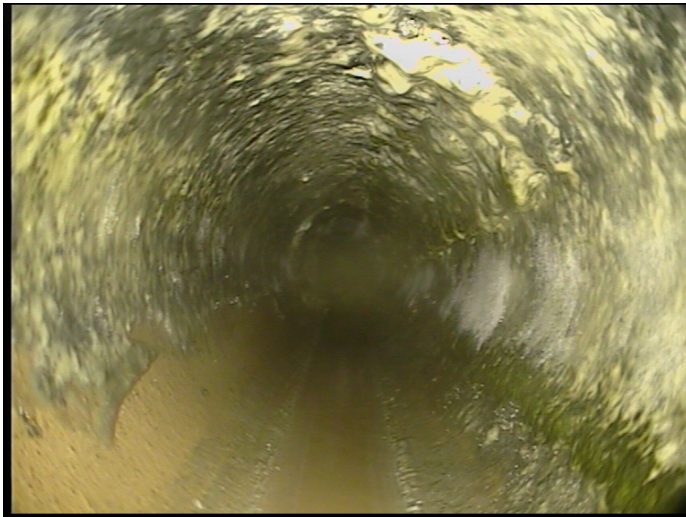
Code: **DAGS**
Description: **Deposits Attached Grease**

Distance (ft): **38.6**
Structural Grade: **0**
O&M Grade: **2**
Clock Start/From: **10**
Clock To: **2**
1st Value:
2nd Value:
Value Percent: **5.000**
Continuous Index: **S02**
Within 8" of Joint: **YES**
Remarks:

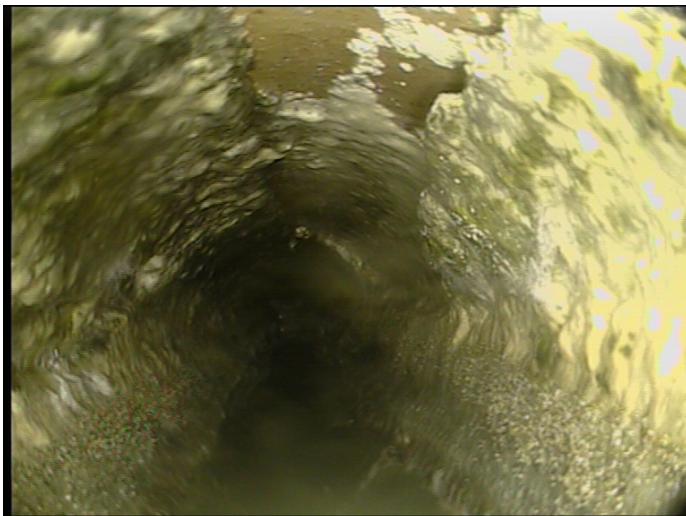
Code: **DAGS**
Description: **Deposits Attached Grease**

Distance (ft): **44.8**
Structural Grade: **0**
O&M Grade: **3**
Clock Start/From: **10**
Clock To: **2**
1st Value:
2nd Value:
Value Percent: **15.000**
Continuous Index: **F02**
Within 8" of Joint: **NO**
Remarks:

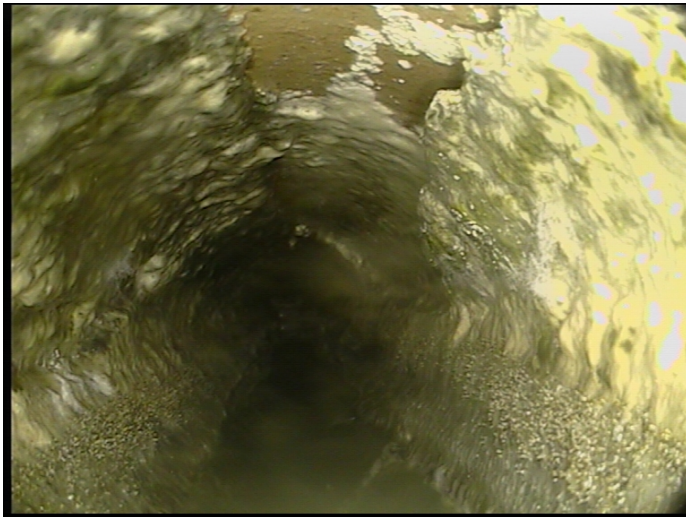
Code:	MSA
Description:	Abandoned Survey
Distance (ft):	44.8
Structural Grade:	0
O&M Grade:	0
Clock Start/From:	
Clock To:	
1st Value:	
2nd Value:	
Value Percent:	
Continuous Index:	
Within 8" of Joint:	NO
Remarks:	grease
