Profile/Photo Observation Report

Date:	04/13/2018	Weather:		Coding:	PACP 6.0
Pipe Length (ft):		Owner:	City of Hobart	Pre Clean:	No Pre-Cleaning
P.O.#:	38-1	Surveyor:	M. Pielacha	PSR:	M-504-131-M-504-132
Customer:	City of Hobart	Clean Date:		Shape:	C

Street:	Off Virginia Street	Flow Control:	Not Controlled
City:	Hobart, IN	Year Renewed:	
Location:	Light Highway	Tape/Media #:	DEP 38
Purpose:	Routine Assessment	Dia/Height:	6"
Use:	Sanitary	Material:	VCP
Drain Area:		Lining:	
Category:	NA		
Comment:			
Location Details:		Direction of Survey:	Upstream
US MH:	M-504-131	DS MH:	M-504-132
		Total Length Surveyed (ft):	44.8

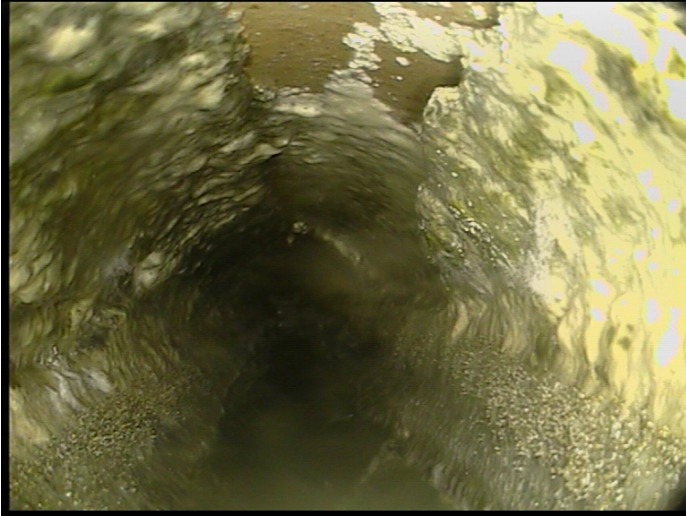
Code:	MSA
Description:	Abandoned Survey
Distance (ft):	44.8
Structural Grade:	0
O&M Grade:	0
Clock Start/From:	
Clock To:	
1st Value:	
2nd Value:	
Value Percent:	
Continuous Index:	
Within 8" of Joint:	NO
Remarks:	grease
