Profile/Photo Observation Report

Date:	04/26/2018	Weather:		Coding:	PACP 6.0
Pipe Length (ft):		Owner:	City of Hobart	Pre Clean:	No Pre-Cleaning
P.O.#:	98	Surveyor:	M. Pielacha	PSR:	P-505-004-003
Customer:	City of Hobart	Clean Date:		Shape:	C

Street:	3rd Place	Flow Control:	Not Controlled
City:	Hobart, IN	Year Renewed:	
Location:	Light Highway	Tape/Media #:	DEP 98
Purpose:	Routine Assessment	Dia/Height:	15"
Use:	Sanitary	Material:	CP
Drain Area:		Lining:	
Category:	NA		
Comment:	YES501824 Submittal 2		
Location Details:		Direction of Survey:	Downstream
US MH:	M-505-004	DS MH:	M-505-003
		Total Length Surveyed (ft):	162.6

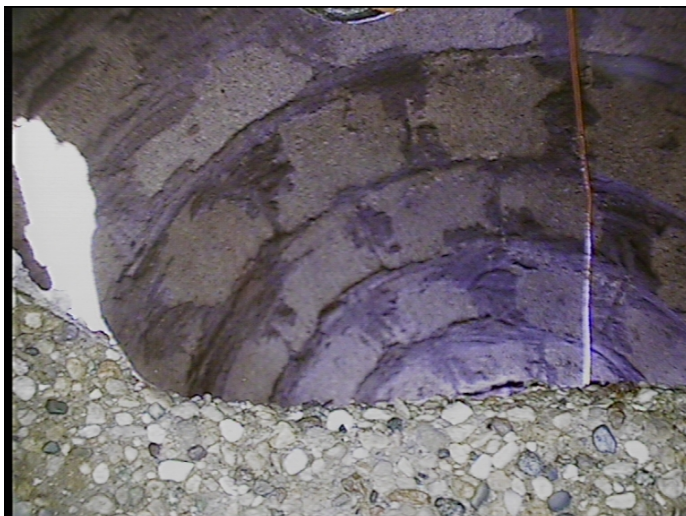
Code: **AMH**
 Description: **Manhole**

Distance (ft): **.0**
 Structural Grade: **0**
 O&M Grade: **0**
 Clock Start/From:
 Clock To:
 1st Value:
 2nd Value:
 Value Percent:
 Continuous Index:
 Within 8" of Joint: **NO**
 Remarks: **M-505-004**

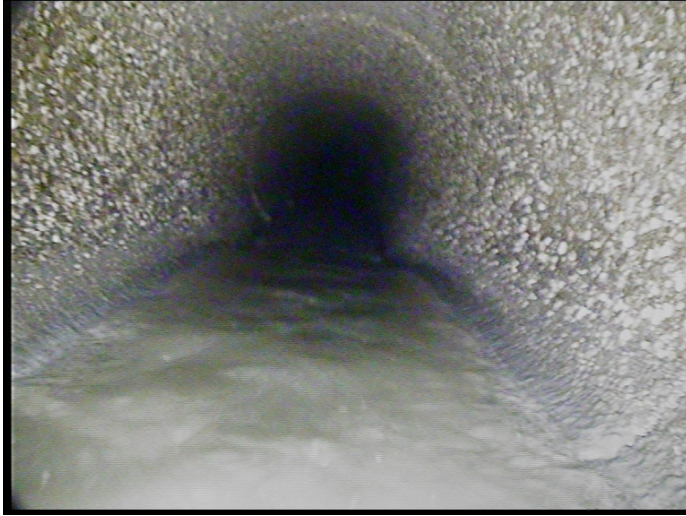
Code: **MWL**
Description: **Water Level**

Distance (ft): **.0**
Structural Grade: **0**
O&M Grade: **0**
Clock Start/From:
Clock To:
1st Value:
2nd Value:
Value Percent: **10.000**
Continuous Index:
Within 8" of Joint: **NO**
Remarks:

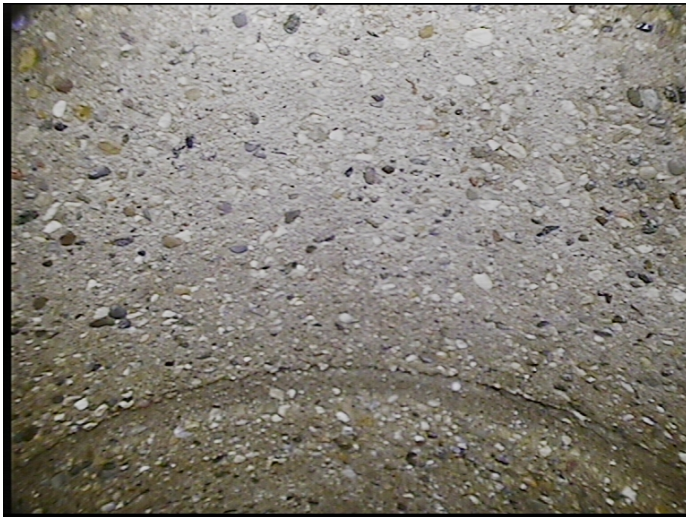
Code: **SAV**
Description: **Surface Aggregate Visible**

Distance (ft): **3.4**
Structural Grade: **3**
O&M Grade: **0**
Clock Start/From: **8**
Clock To: **4**
1st Value:
2nd Value:
Value Percent:
Continuous Index: **S01**
Within 8" of Joint: **YES**
Remarks:

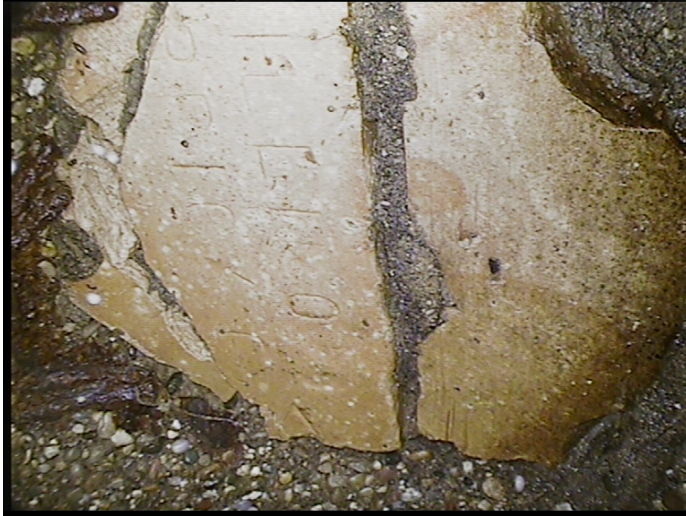
Code:	TBC
Description:	Tap Break-in Capped
Distance (ft):	84.0
Structural Grade:	0
O&M Grade:	2
Clock Start/From:	3
Clock To:	
1st Value:	6.000
2nd Value:	
Value Percent:	
Continuous Index:	
Within 8" of Joint:	NO
Remarks:

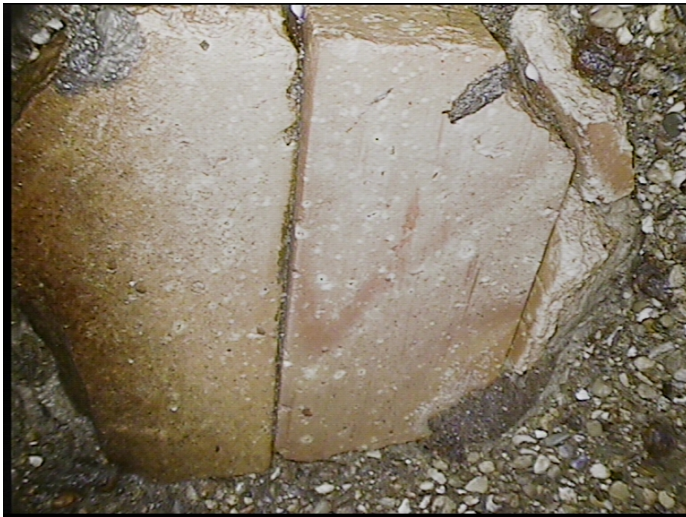
Code:	TBC
Description:	Tap Break-in Capped
Distance (ft):	87.1
Structural Grade:	0
O&M Grade:	2
Clock Start/From:	9
Clock To:	
1st Value:	4.000
2nd Value:	
Value Percent:	
Continuous Index:	
Within 8" of Joint:	NO
Remarks:

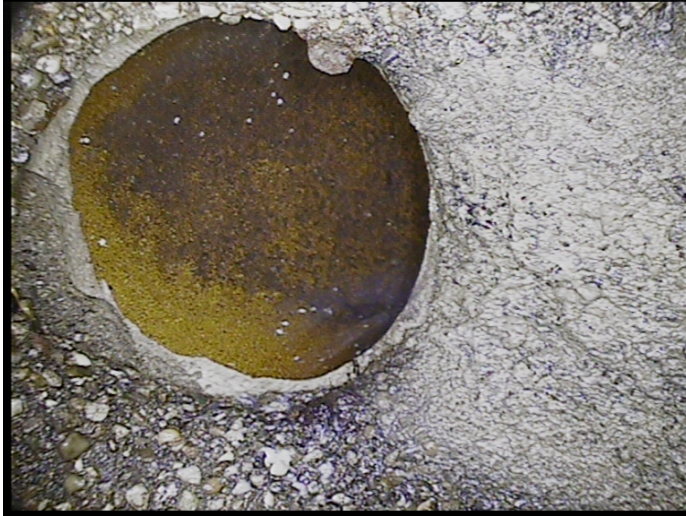
Code: **TB**
Description: **Tap Break-in**

Distance (ft): **92.5**
Structural Grade: **0**
O&M Grade: **0**
Clock Start/From: **1**
Clock To:
1st Value: **4.000**
2nd Value:
Value Percent:
Continuous Index:
Within 8" of Joint: **NO**
Remarks:

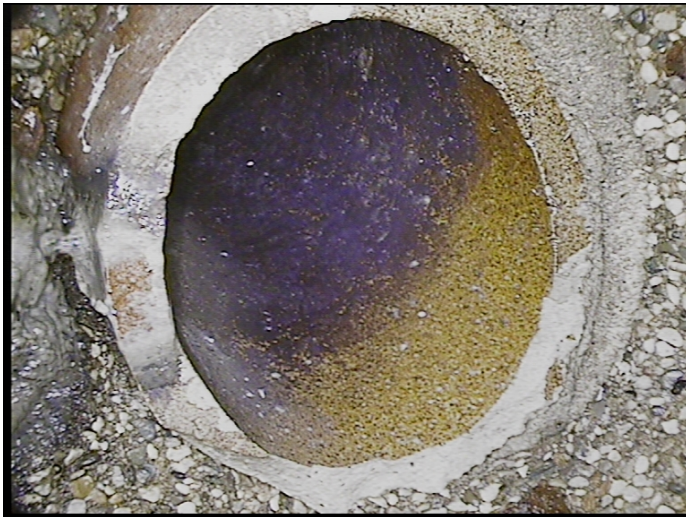
Code: **TBA**
Description: **Tap Break-in Active**

Distance (ft): **109.4**
Structural Grade: **0**
O&M Grade: **0**
Clock Start/From: **10**
Clock To:
1st Value: **4.000**
2nd Value:
Value Percent:
Continuous Index:
Within 8" of Joint: **NO**
Remarks:

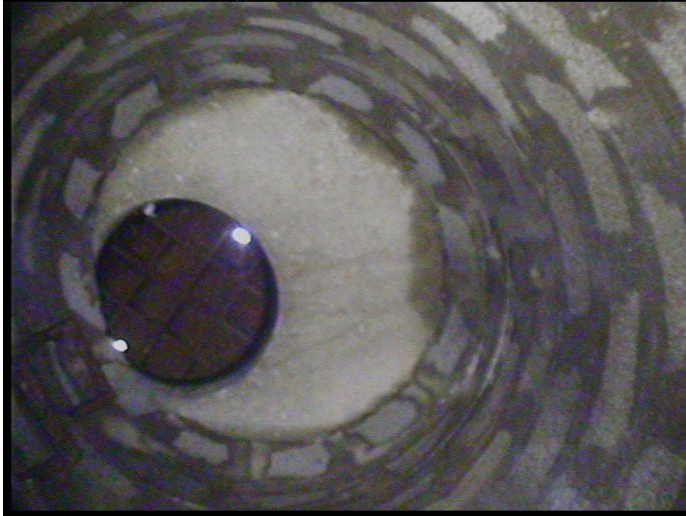
Code: **SAV**
Description: **Surface Aggregate Visible**

Distance (ft): **162.6**
Structural Grade: **3**
O&M Grade: **0**
Clock Start/From: **8**
Clock To: **4**
1st Value:
2nd Value:
Value Percent:
Continuous Index: **F01**
Within 8" of Joint: **NO**
Remarks:

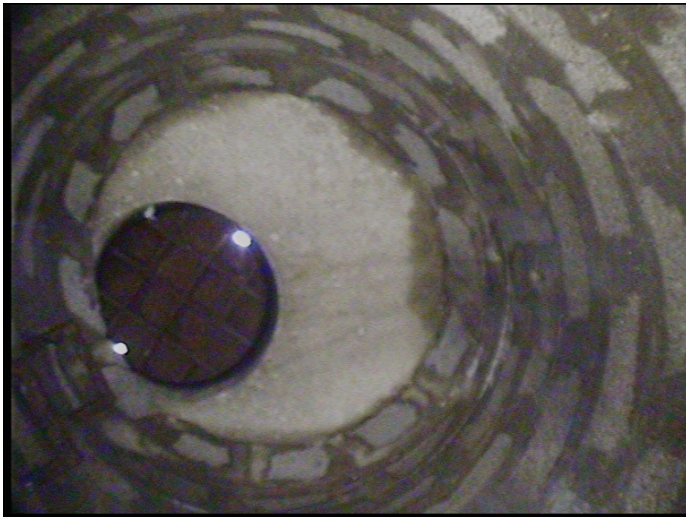
Code: **AMH**
Description: **Manhole**

Distance (ft): **162.6**
Structural Grade: **0**
O&M Grade: **0**
Clock Start/From:
Clock To:
1st Value:
2nd Value:
Value Percent:
Continuous Index:
Within 8" of Joint: **NO**
Remarks: **M-505-003**
