## Profile/Photo Observation Report

Date:	<b>04/26/2018</b>	Weather:		Coding:	<b>PACP 6.0</b>
Pipe Length (ft):		Owner:	<b>City of Hobart</b>	Pre Clean:	<b>No Pre-Cleaning</b>
P.O.#:	<b>100</b>	Surveyor:	<b>M. Pielacha</b>	PSR:	<b>P-505-005-004</b>
Customer:	<b>City of Hobart</b>	Clean Date:		Shape:	<b>C</b>

Street:	<b>California Street</b>	Flow Control:	<b>Not Controlled</b>
City:	<b>Hobart, IN</b>	Year Renewed:	
Location:	<b>Light Highway</b>	Tape/Media #:	<b>DEP 100</b>
Purpose:	<b>Routine Assessment</b>	Dia/Height:	<b>15"</b>
Use:	<b>Sanitary</b>	Material:	<b>VCP</b>
Drain Area:		Lining:	
Category:	<b>NA</b>		
Comment:	<b>YES501824 Submittal 2</b>		
Location Details:		Direction of Survey:	<b>Downstream</b>
US MH:	<b>M-505-005</b>	DS MH:	<b>M-505-004</b>
		Total Length Surveyed (ft):	<b>78.5</b>

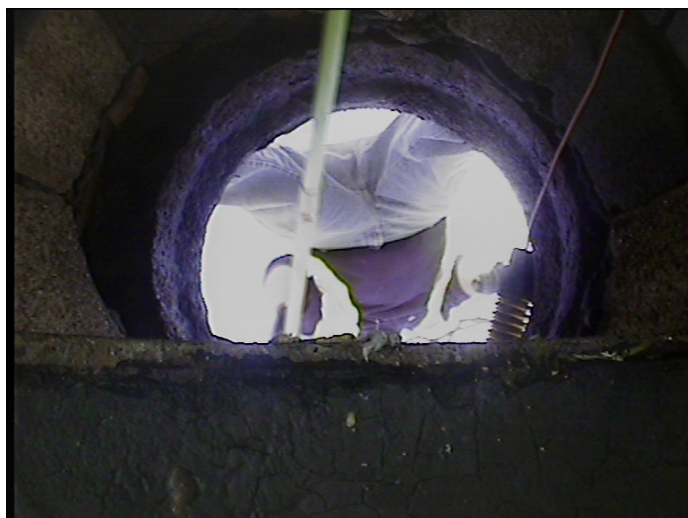
Code: **AMH**  
Description: **Manhole**

Distance (ft): **.0**  
Structural Grade: **0**  
O&M Grade: **0**  
Clock Start/From:  
Clock To:  
1st Value:  
2nd Value:  
Value Percent:  
Continuous Index:  
Within 8" of Joint: **NO**  
Remarks: **M-505-005**

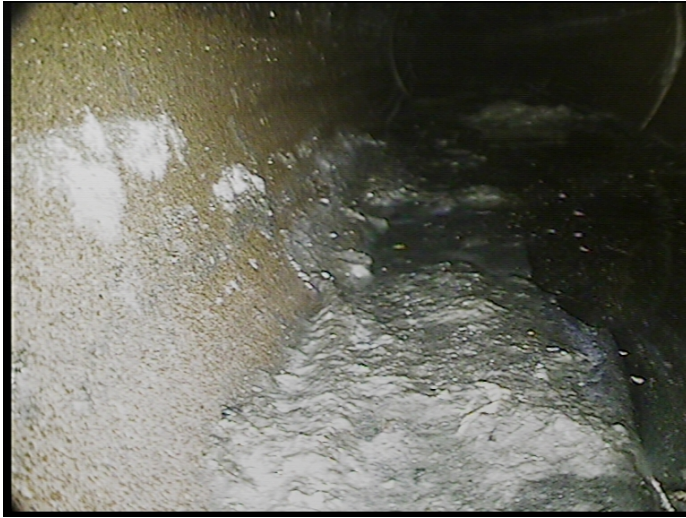
Code: **MWL**  
Description: **Water Level**

Distance (ft): **.0**  
Structural Grade: **0**  
O&M Grade: **0**  
Clock Start/From:  
Clock To:  
1st Value:  
2nd Value:  
Value Percent: **10.000**  
Continuous Index:  
Within 8" of Joint: **NO**  
Remarks:

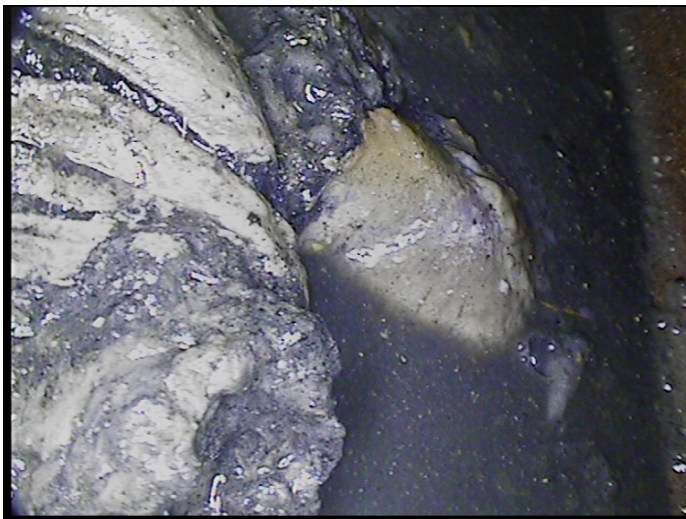
Code: **OBR**  
Description: **Obstacle Rocks**

Distance (ft): **3.5**  
Structural Grade: **0**  
O&M Grade: **2**  
Clock Start/From: **5**  
Clock To:  
1st Value:  
2nd Value:  
Value Percent: **10.000**  
Continuous Index:  
Within 8" of Joint: **NO**  
Remarks:

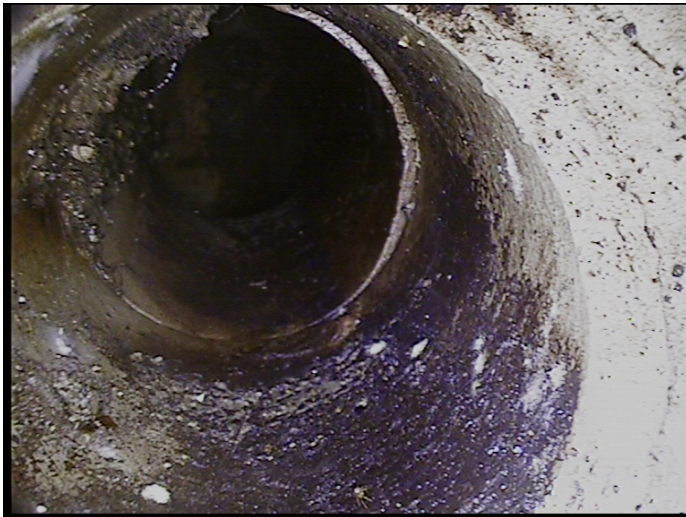
Code: **TF**  
Description: **Tap Factory**

Distance (ft): **23.7**  
Structural Grade: **0**  
O&M Grade: **0**  
Clock Start/From: **9**  
Clock To:  
1st Value: **4.000**  
2nd Value:  
Value Percent:  
Continuous Index:  
Within 8" of Joint: **NO**  
Remarks:

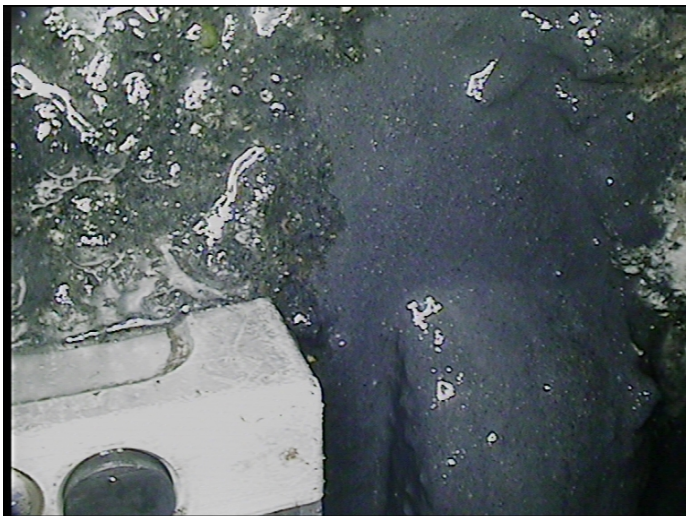
Code: **DSF**  
Description: **Deposits Settled Fine**

Distance (ft): **46.0**  
Structural Grade: **0**  
O&M Grade: **3**  
Clock Start/From: **4**  
Clock To: **8**  
1st Value:  
2nd Value:  
Value Percent: **20.000**  
Continuous Index: **S01**  
Within 8" of Joint: **YES**  
Remarks:

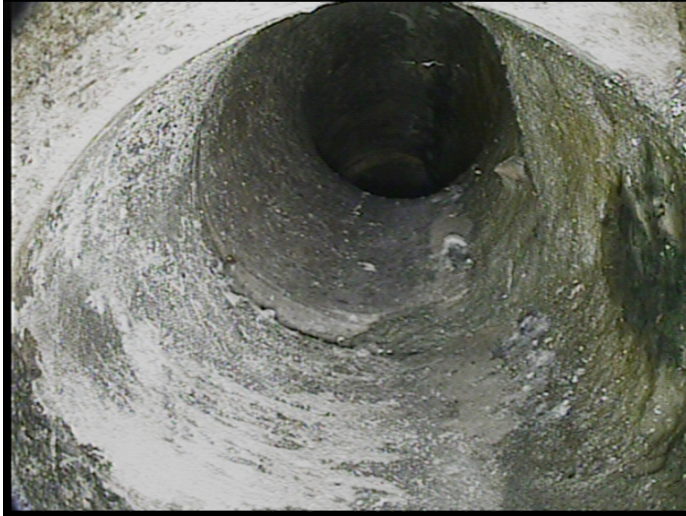
Code: **TF**  
Description: **Tap Factory**

Distance (ft): **53.2**  
Structural Grade: **0**  
O&M Grade: **0**  
Clock Start/From: **3**  
Clock To:  
1st Value: **4.000**  
2nd Value:  
Value Percent:  
Continuous Index:  
Within 8" of Joint: **NO**  
Remarks:

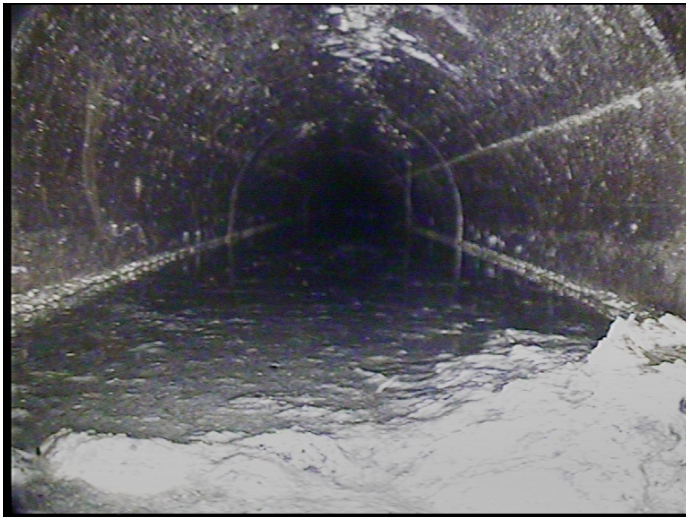
Code: **DSF**  
Description: **Deposits Settled Fine**

Distance (ft): **78.4**  
Structural Grade: **0**  
O&M Grade: **3**  
Clock Start/From: **4**  
Clock To: **8**  
1st Value:  
2nd Value:  
Value Percent: **20.000**  
Continuous Index: **F01**  
Within 8" of Joint: **NO**  
Remarks:

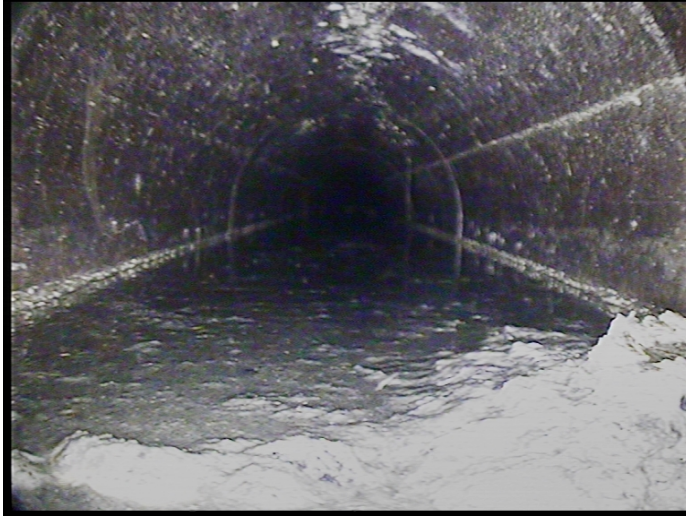
Code:	<b>MSA</b>
Description:	<b>Abandoned Survey</b>
Distance (ft):	<b>78.4</b>
Structural Grade:	<b>0</b>
O&M Grade:	<b>0</b>
Clock Start/From:	
Clock To:	
1st Value:	
2nd Value:	
Value Percent:	
Continuous Index:	
Within 8" of Joint:	<b>NO</b>
Remarks:	<b>sediment</b>
