Profile/Photo Observation Report

Date:	08/09/2022	Weather:		Coding:	PACP 7.0
Pipe Length (ft):	230.0	Owner:	City of Hobart	Pre Clean:	Heavy Cleaning
P.O.#:	YES502259	Surveyor:	S. Bucklin	PSR:	P-505-005-004
Customer:	City of Hobart	Clean Date:	07/23/2022	Shape:	C

Street:	Lake George Drive	Flow Control:	Not Controlled
City:	Hobart, IN	Year Renewed:	
Location:	Local rural streets with light traffic, t	Tape/Media #:	
Purpose:	Routine Assessment	Dia/Height:	15"
Use:	Sanitary Sewage Pipe	Material:	VCP
Drain Area:		Lining:	None
Category:	NA		
Comment:			
Location Details:		Direction of Survey:	Upstream
US MH:	M-505-004	DS MH:	M-505-005
		Total Length Surveyed (ft):	257.6

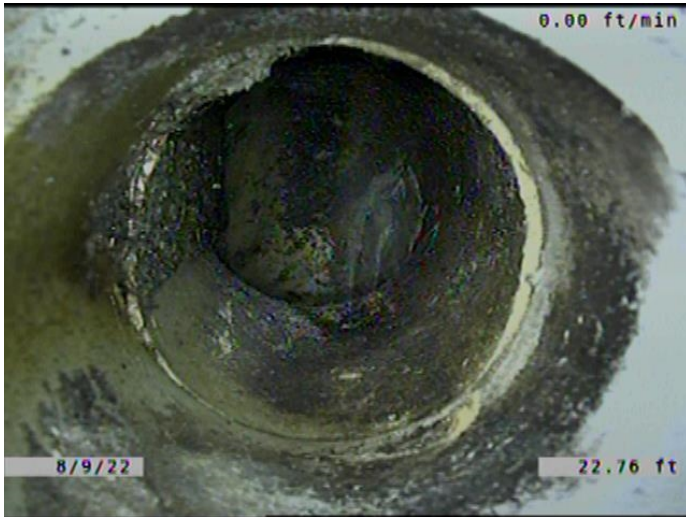
Code: **TF**
Description: **Tap Factory**

Distance (ft): **22.8**
Structural Grade: **0**
O&M Grade: **0**
Clock Start/From: **9**
Clock To:
1st Value: **6.000**
2nd Value:
Value Percent:
Continuous Index:
Within 8" of Joint: **YES**
Remarks: **ROOTS GROWING DOWN THE TAP.**

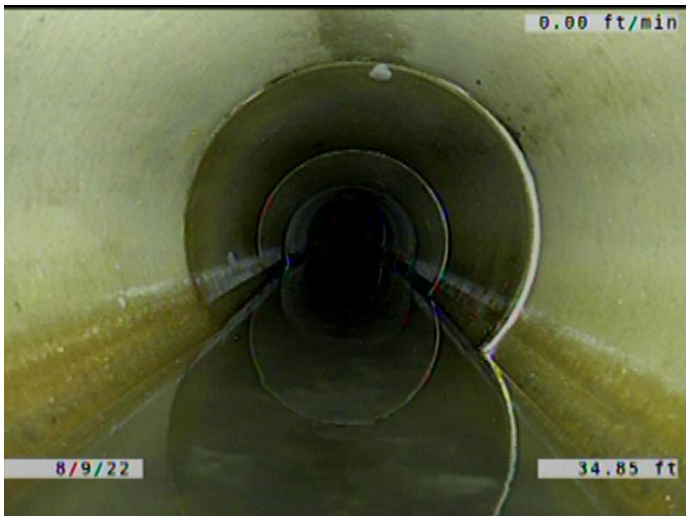
Code: **DSF**
Description: **Deposits Settled Fine**

Distance (ft): **34.8**
Structural Grade: **0**
O&M Grade: **2**
Clock Start/From: **5**
Clock To: **7**
1st Value:
2nd Value:
Value Percent: **5.000**
Continuous Index: **S01**
Within 8" of Joint: **YES**
Remarks:

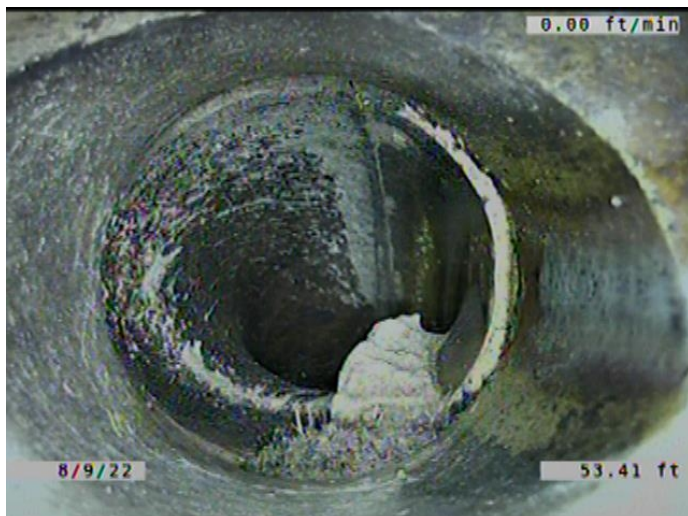
Code: **TF**
Description: **Tap Factory**

Distance (ft): **53.4**
Structural Grade: **0**
O&M Grade: **0**
Clock Start/From: **3**
Clock To:
1st Value: **6.000**
2nd Value:
Value Percent:
Continuous Index:
Within 8" of Joint: **YES**
Remarks: **ROOTS GROWING FROM THE JOINT.**

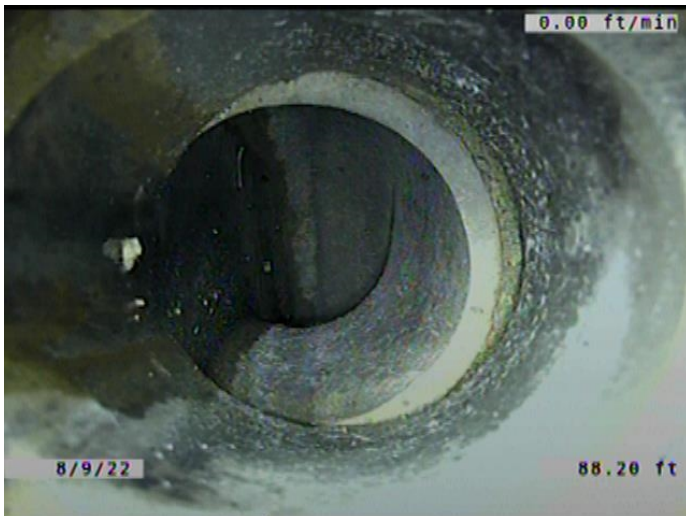
Code: **TF**
 Description: **Tap Factory**

Distance (ft): **88.2**
 Structural Grade: **0**
 O&M Grade: **0**
 Clock Start/From: **9**
 Clock To:
 1st Value: **6.000**
 2nd Value:
 Value Percent:
 Continuous Index:
 Within 8" of Joint: **YES**
 Remarks: **SERVICE OFFSET. SOIL VISIBLE.**

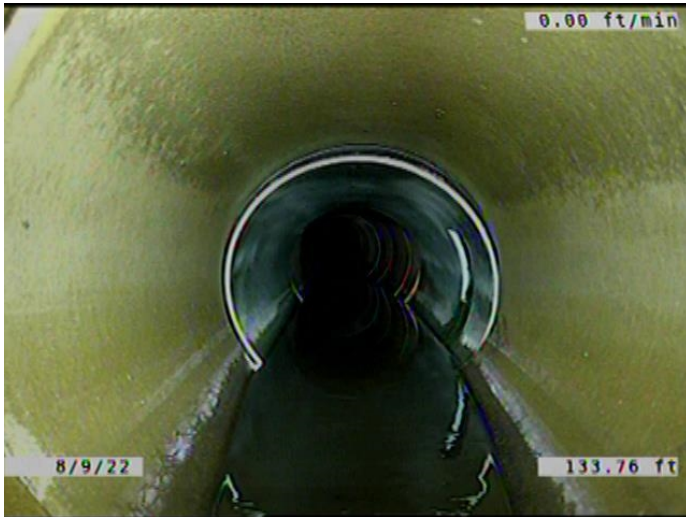
Code: **MWLS**
Description: **Miscellaneous Water Level Sag**

Distance (ft): **133.8**
Structural Grade: **2**
O&M Grade: **0**
Clock Start/From:
Clock To:
1st Value:
2nd Value:
Value Percent: **20.000**
Continuous Index: **S02**
Within 8" of Joint: **NO**
Remarks:

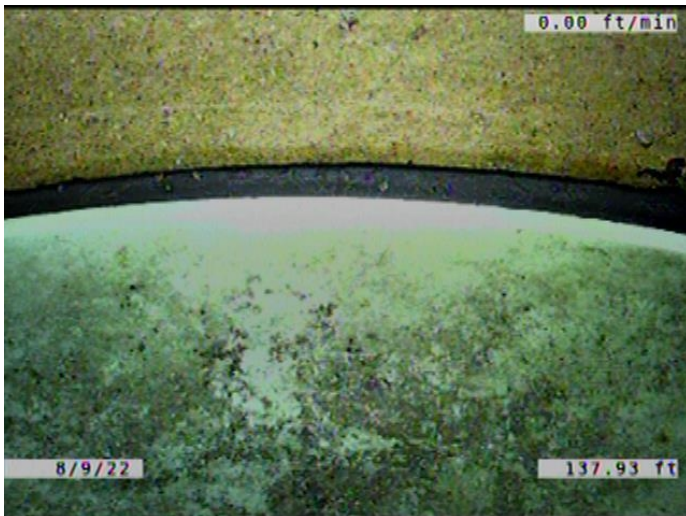
Code: **JOM**
Description: **Joint Offset Medium**

Distance (ft): **137.9**
Structural Grade: **3**
O&M Grade: **0**
Clock Start/From:
Clock To:
1st Value:
2nd Value:
Value Percent:
Continuous Index:
Within 8" of Joint: **NO**
Remarks:

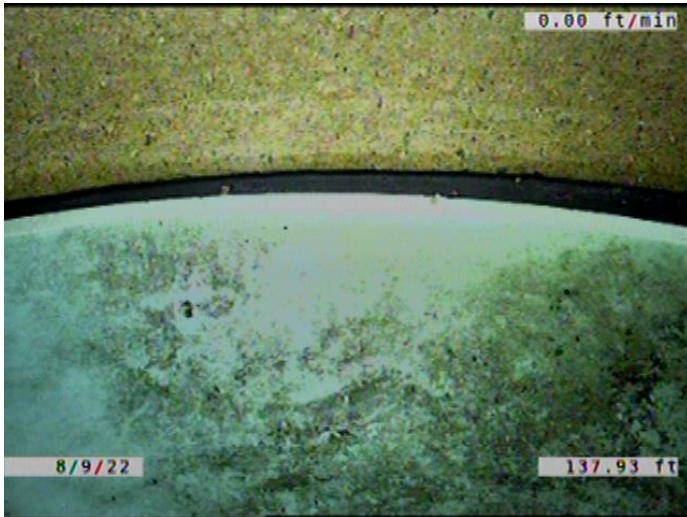
Code: **RPR**
 Description: **Point Repair Replacement**

Distance (ft): **137.9**
 Structural Grade: **0**
 O&M Grade: **0**
 Clock Start/From:
 Clock To:
 1st Value:
 2nd Value:
 Value Percent:
 Continuous Index: **S03**
 Within 8" of Joint: **YES**
 Remarks: **REPLACED WITH PVC.**

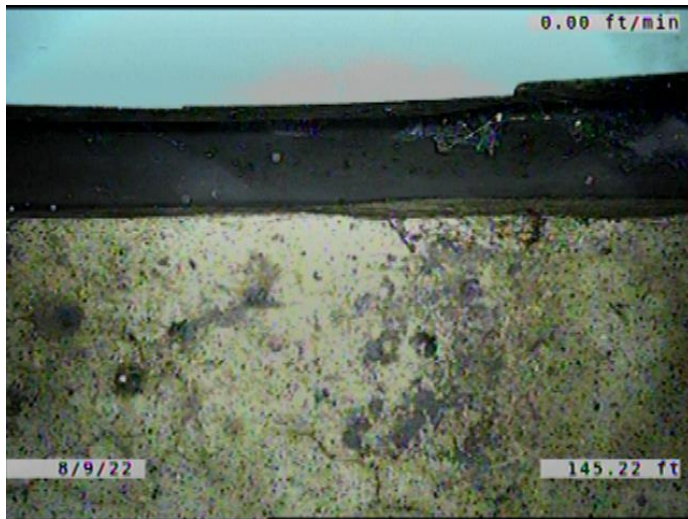
Code: **JOM**
 Description: **Joint Offset Medium**

Distance (ft): **145.2**
 Structural Grade: **3**
 O&M Grade: **0**
 Clock Start/From:
 Clock To:
 1st Value:
 2nd Value:
 Value Percent:
 Continuous Index:
 Within 8" of Joint: **NO**
 Remarks:

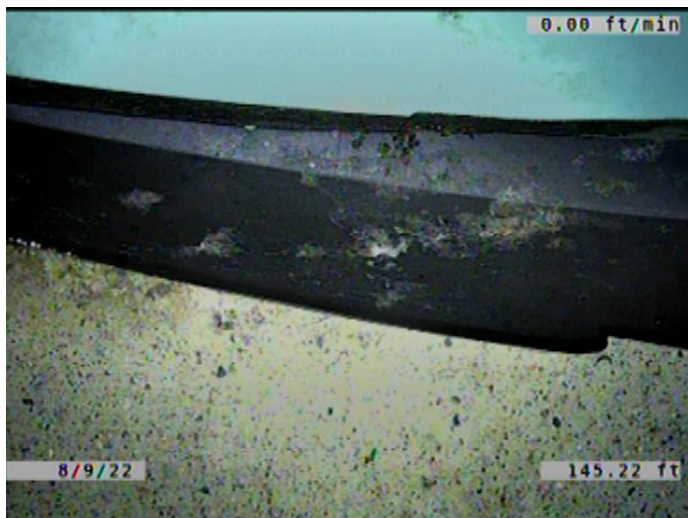
Code: **RPR**
 Description: **Point Repair Replacement**

Distance (ft): **145.2**
 Structural Grade: **0**
 O&M Grade: **0**
 Clock Start/From:
 Clock To:
 1st Value:
 2nd Value:
 Value Percent:
 Continuous Index: **F03**
 Within 8" of Joint: **YES**
 Remarks: **REPLACED WITH PVC.**

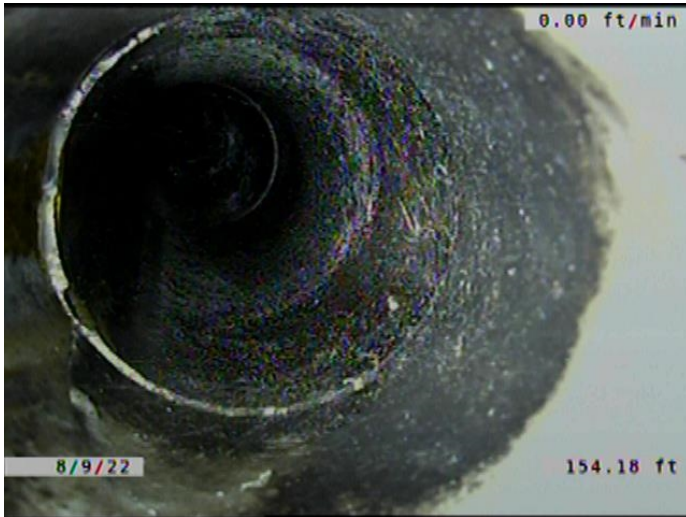
Code: **TFD**
Description: **Tap Factory Defective**

Distance (ft): **154.2**
Structural Grade: **0**
O&M Grade: **3**
Clock Start/From: **9**
Clock To:
1st Value: **6.000**
2nd Value:
Value Percent:
Continuous Index:
Within 8" of Joint: **YES**
Remarks: **TAP CRACKED.**

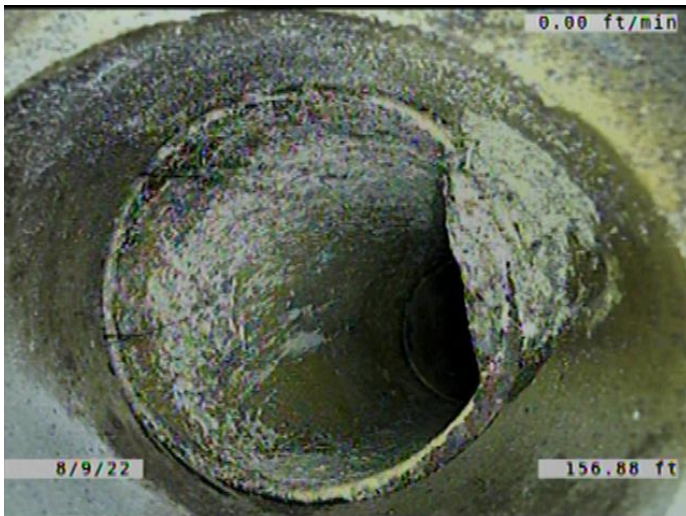
Code: **TF**
Description: **Tap Factory**

Distance (ft): **156.9**
Structural Grade: **0**
O&M Grade: **0**
Clock Start/From: **2**
Clock To:
1st Value: **6.000**
2nd Value:
Value Percent:
Continuous Index:
Within 8" of Joint: **YES**
Remarks: **ROOTS GROWING IN THE JOINT.**

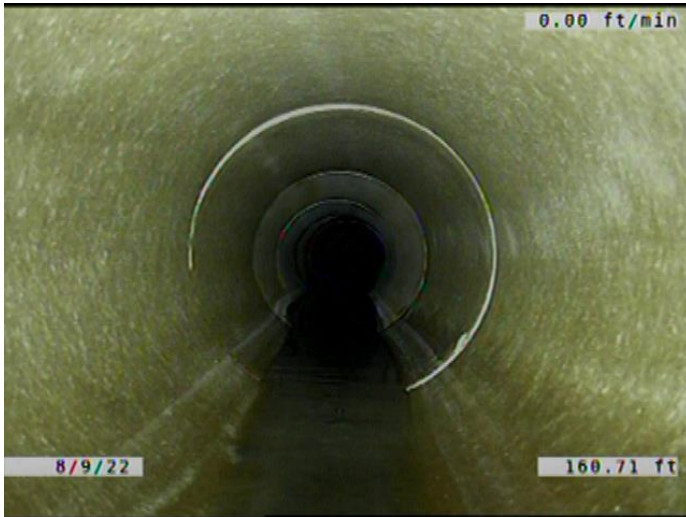
Code: **MWLS**
Description: **Miscellaneous Water Level Sag**

Distance (ft): **160.7**
Structural Grade: **2**
O&M Grade: **0**
Clock Start/From:
Clock To:
1st Value:
2nd Value:
Value Percent: **20.000**
Continuous Index: **F02**
Within 8" of Joint: **NO**
Remarks:

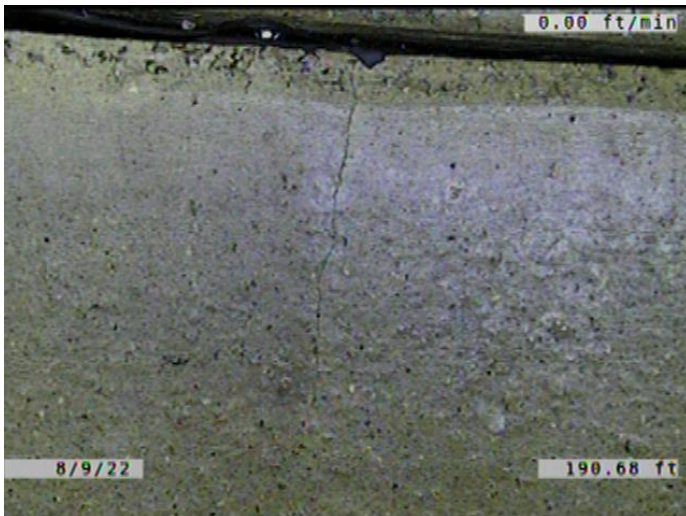
Code: **CL**
Description: **Crack Longitudinal**

Distance (ft): **190.7**
Structural Grade: **2**
O&M Grade: **0**
Clock Start/From: **3**
Clock To:
1st Value:
2nd Value:
Value Percent:
Continuous Index:
Within 8" of Joint: **YES**
Remarks:

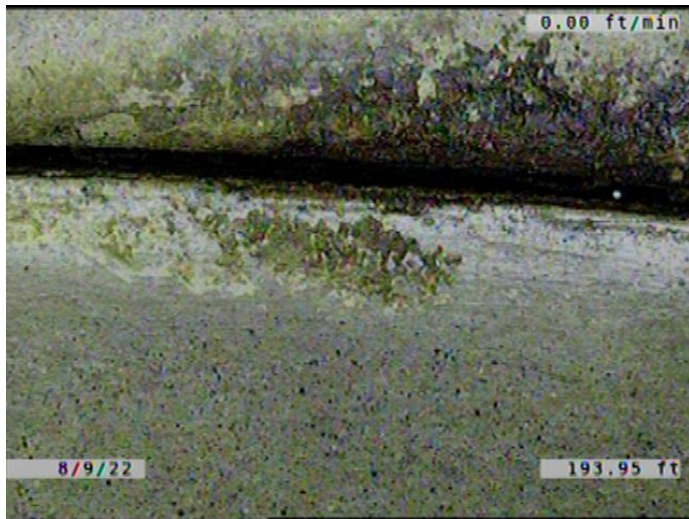
Code: **DAE**
 Description: **Deposits Attached Encrustation**

Distance (ft): **193.9**
 Structural Grade: **0**
 O&M Grade: **2**
 Clock Start/From: **1**
 Clock To: **4**
 1st Value:
 2nd Value:
 Value Percent: **5.000**
 Continuous Index:
 Within 8" of Joint: **YES**
 Remarks:

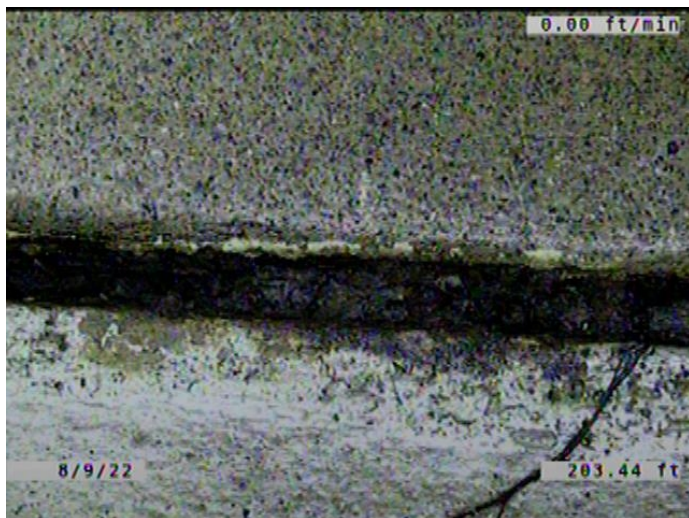
Code: **RFJ**
 Description: **Roots Fine Joint**

Distance (ft): **203.4**
 Structural Grade: **0**
 O&M Grade: **1**
 Clock Start/From: **8**
 Clock To: **4**
 1st Value:
 2nd Value:
 Value Percent:
 Continuous Index:
 Within 8" of Joint: **YES**
 Remarks:

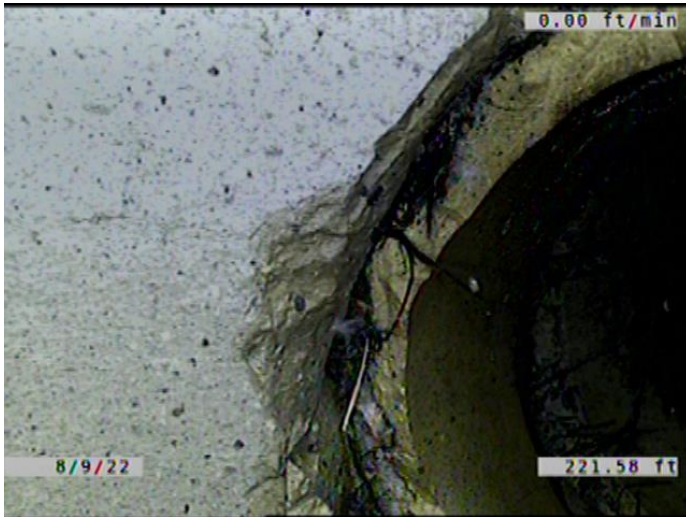
Code: **B**
Description: **Broken**

Distance (ft): **221.6**
Structural Grade: **4**
O&M Grade: **0**
Clock Start/From: **1**
Clock To: **3**
1st Value:
2nd Value:
Value Percent:
Continuous Index:
Within 8" of Joint: **YES**
Remarks:

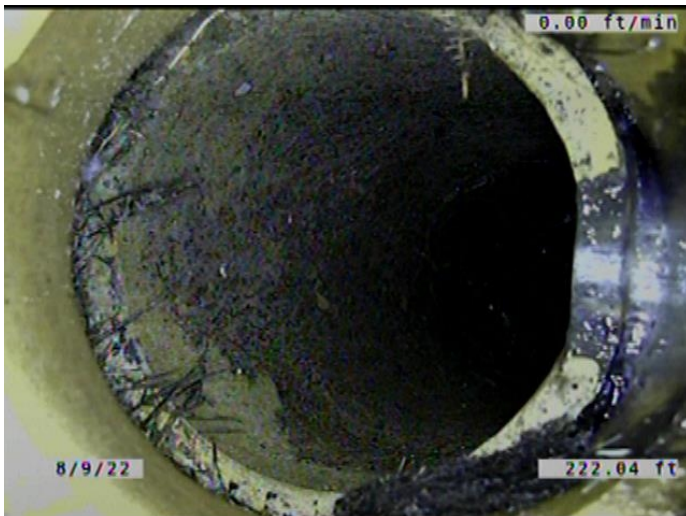
Code: **TBD**
Description: **Tap Break-in/Hammer Defective**

Distance (ft): **222.0**
Structural Grade: **0**
O&M Grade: **3**
Clock Start/From: **2**
Clock To:
1st Value: **6.000**
2nd Value:
Value Percent:
Continuous Index:
Within 8" of Joint: **YES**
Remarks: **SERVICE OFFSET. ROOTS GROWING IN THE JOINT.**

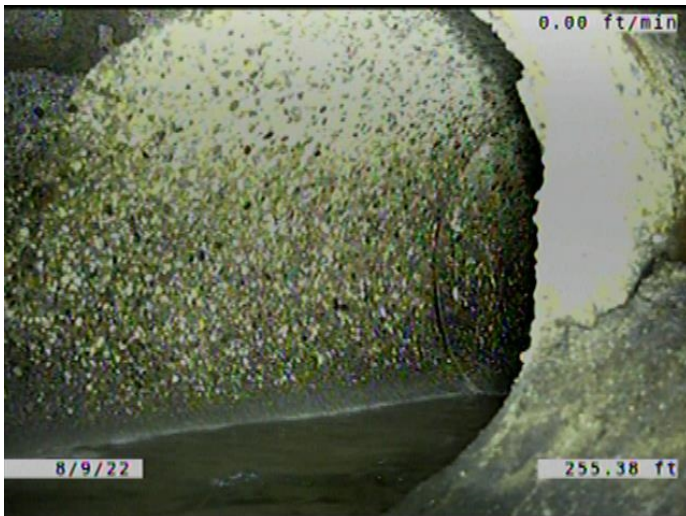
Code: **DSF**
 Description: **Deposits Settled Fine**

Distance (ft): **255.4**
 Structural Grade: **0**
 O&M Grade: **2**
 Clock Start/From: **5**
 Clock To: **7**
 1st Value:
 2nd Value:
 Value Percent: **5.000**
 Continuous Index: **F01**
 Within 8" of Joint: **YES**
 Remarks:
