## **Profile/Photo Observation Report**

Profile/Photo Observation Report								
Date: Pipe Length (ft P.O.#: Customer:	04/26/2018 t): 101 City of Hobart	Weather: Owner: Surveyor: Clean Date:	City of Hobart M. Pielacha	Coding: Pre Clean: PSR: Shape:	PACP 6.0 No Pre-Cleaning P-505-006-005 C			
Street:	California Street		Flow Control:	Not Controlle	d			
City:	Hobart, IN		Year Renewed:					
Location:	<b>Light Highway</b>		Tape/Media #:	DEP 101				
Purpose:	Routine Assessme	nt	Dia/Height:	15"				
Use:	Sanitary		Material:	VCP				
Drain Area:			Lining:					
Category:	NA							
Comment:	YES501824 Submit	al 2						
Location Detai	ls:		Direction of Surv	vey: <b>Upstream</b>				
US MH:	M-505-006	DS MH:	M-505-005	Total Length Surveyed (f	t): <b>91.1</b>			
O&M Index:	2.92	O&M Quick:	3A2	O&M Rating:	35.00			
Structural Index	0.00	Structural Qu	ıick: 000		0.00			
Overall Index:	2.92	Overall Quick			35.00

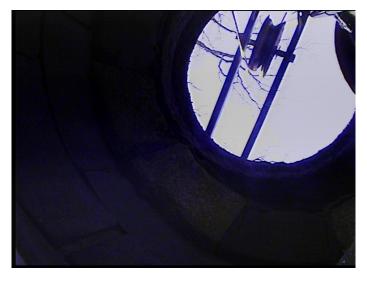
Code:	AMH
Description:	Manhole
Distance (ft):	.0
Structural Grade:	0
O&M Grade:	0
Clock Start/From:	
Clock To:	
1st Value:	
2nd Value:	
Value Percent:	
Continuous Index:	
Within 8" of Joint:	NO
Remarks:	M-505-005

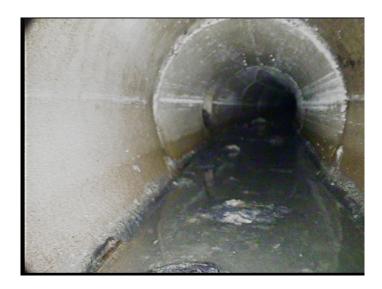
Code: MWL
Description: Water Level

Distance (ft): .0
Structural Grade: 0
O&M Grade: 0
Clock Start/From:
Clock To:

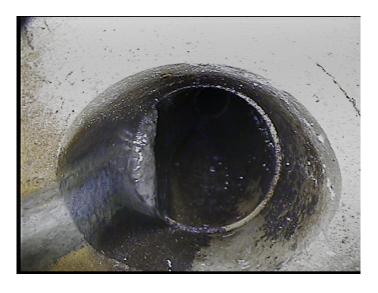
Code: TF
Description: Tap Factory

Distance (ft): 5.0
Structural Grade: 0
O&M Grade: 0
Clock Start/From: 9

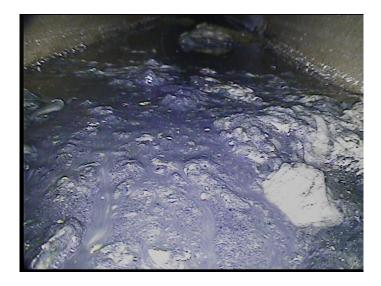
Code: **DSF**

Description: Deposits Settled Fine

Distance (ft): 14.3
Structural Grade: 0
O&M Grade: 3
Clock Start/From: 4
Clock To: 8

Value Percent: 20.000
Continuous Index: S01
Within 8" of Joint: YES

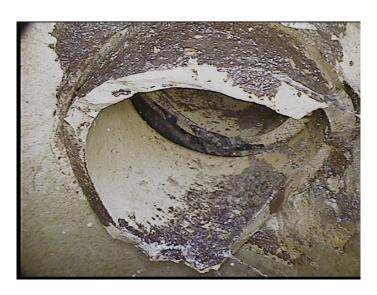
Code: TB

Description: Tap Break-in

Distance (ft): 25.5
Structural Grade: 0
O&M Grade: 0
Clock Start/From: 2

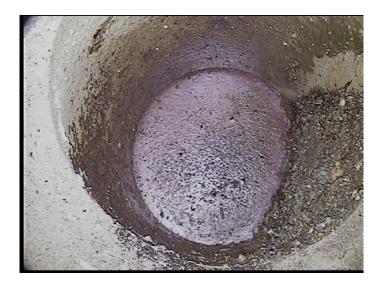
Code: TFC

Description: Tap Factory Capped

Distance (ft): 32.1
Structural Grade: 0

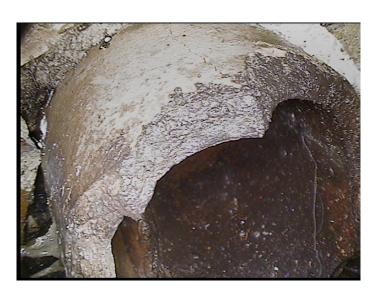
Code: TBI

Description: Tap Break-in Intruding

Distance (ft): 62.6
Structural Grade: 0

O&M Grade: 2

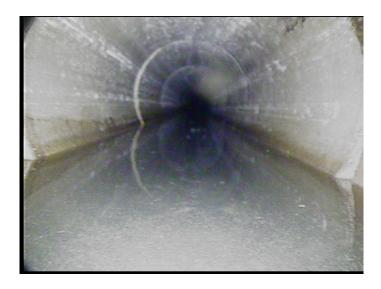
Code: **DSF**

Description: Deposits Settled Fine

Distance (ft): 64.8
Structural Grade: 0

O&M Grade: 3

Value Percent: 20.000
Continuous Index: F01
Within 8" of Joint: NO

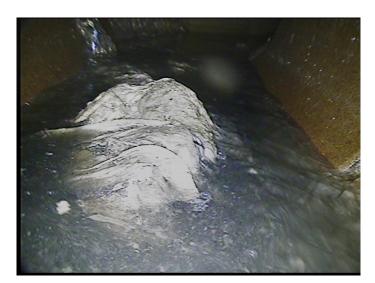
Code: OBR

Description: Obstacle Rocks

Distance (ft): 89.9
Structural Grade: 0
O&M Grade: 3
Clock Start/From: 6
Clock To:

Value Percent: 15.000

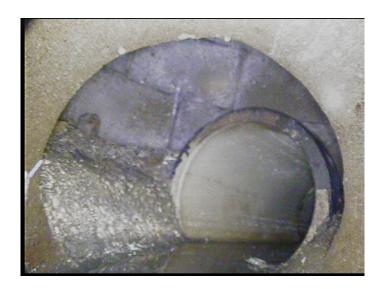
Code: AMH
Description: Manhole

Distance (ft): 91.1
Structural Grade: 0

Remarks: M-505-006
