Profile/Photo Observation Report

Date:	04/28/2018	Weather:		Coding:	PACP 6.0
Pipe Length (ft):		Owner:	City of Hobart	Pre Clean:	No Pre-Cleaning
P.O.#:	133	Surveyor:	M. Pielacha	PSR:	P-505-007-006
Customer:	City of Hobart	Clean Date:		Shape:	C

Street:	California Street	Flow Control:	Not Controlled
City:	Hobart, IN	Year Renewed:	
Location:	Light Highway	Tape/Media #:	DEP 133
Purpose:	Routine Assessment	Dia/Height:	15"
Use:	Sanitary	Material:	VCP
Drain Area:		Lining:	
Category:	NA		
Comment:	YES501824 Submittal 2		
Location Details:		Direction of Survey:	Upstream
US MH:	M-505-007	DS MH:	M-505-006
		Total Length Surveyed (ft):	6.6

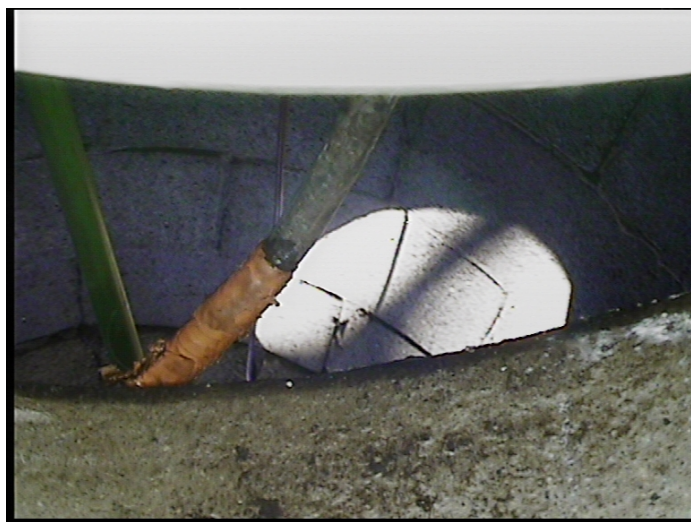
Code: **AMH**
 Description: **Manhole**

Distance (ft): **.0**
 Structural Grade: **0**
 O&M Grade: **0**
 Clock Start/From:
 Clock To:
 1st Value:
 2nd Value:
 Value Percent:
 Continuous Index:
 Within 8" of Joint: **NO**
 Remarks: **M-505-006**

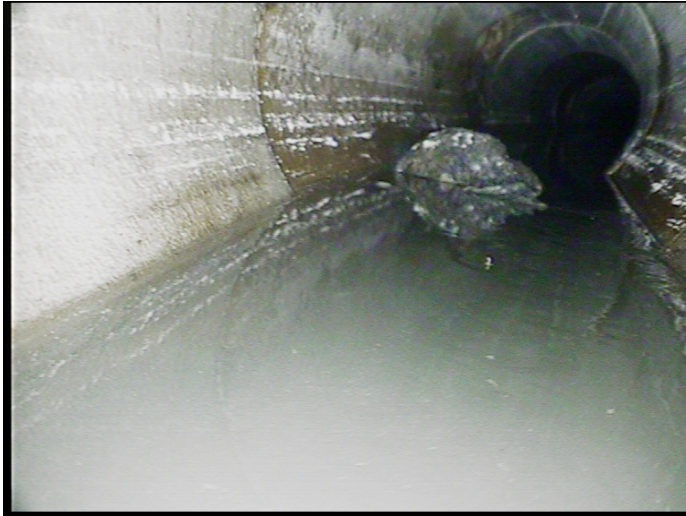
Code: **MWL**
Description: **Water Level**

Distance (ft): **.0**
Structural Grade: **0**
O&M Grade: **0**
Clock Start/From:
Clock To:
1st Value:
2nd Value:
Value Percent: **10.000**
Continuous Index:
Within 8" of Joint: **NO**
Remarks:

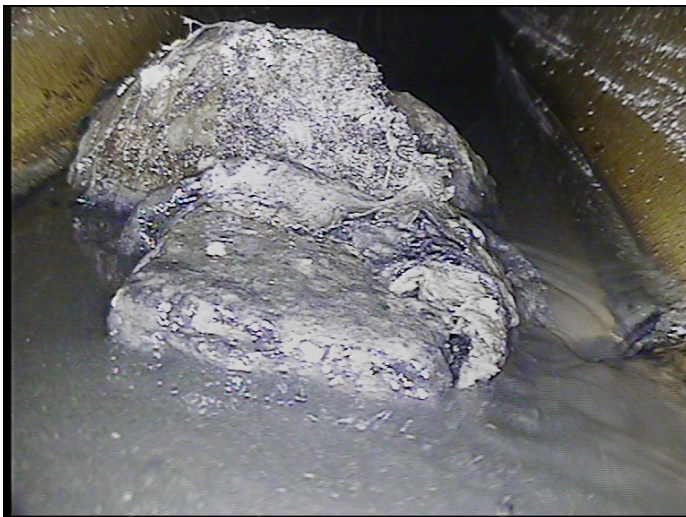
Code: **OBR**
Description: **Obstacle Rocks**

Distance (ft): **6.0**
Structural Grade: **0**
O&M Grade: **3**
Clock Start/From: **5**
Clock To: **7**
1st Value:
2nd Value:
Value Percent: **20.000**
Continuous Index:
Within 8" of Joint: **NO**
Remarks:

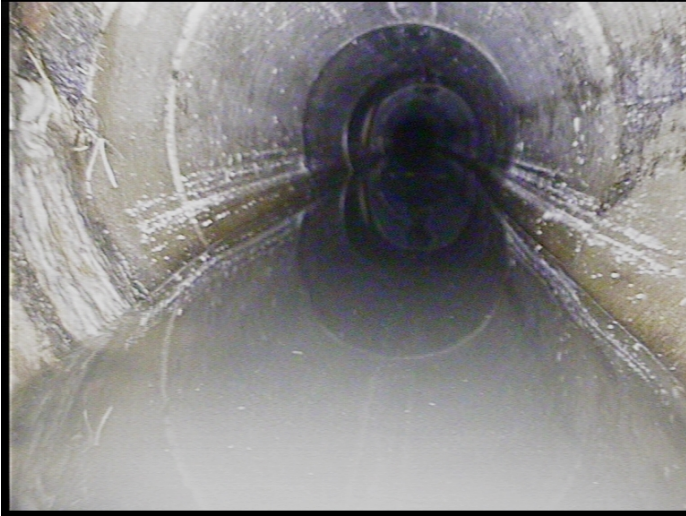
Code:	MSA
Description:	Abandoned Survey
Distance (ft):	6.0
Structural Grade:	0
O&M Grade:	0
Clock Start/From:	
Clock To:	
1st Value:	
2nd Value:	
Value Percent:	
Continuous Index:	
Within 8" of Joint:	NO
Remarks:	debris
