Profile/Photo Observation Report

Street:	Lake George Road	Flow Control:	Not Controlled
City:	Hobart, IN	Year Renewed:	
Location:	Light Highway	Tape/Media #:	DEP 88
Purpose:	Routine Assessment	Dia/Height:	15"
Use:	Sanitary	Material:	VCP
Drain Area:		Lining:	
Category:	NA		
Comment:	YES501824 Submittal 2		
Location Details:		Direction of Survey:	Upstream
US MH:	M-505-007	DS MH:	M-505-008
		Total Length Surveyed (ft):	3.1

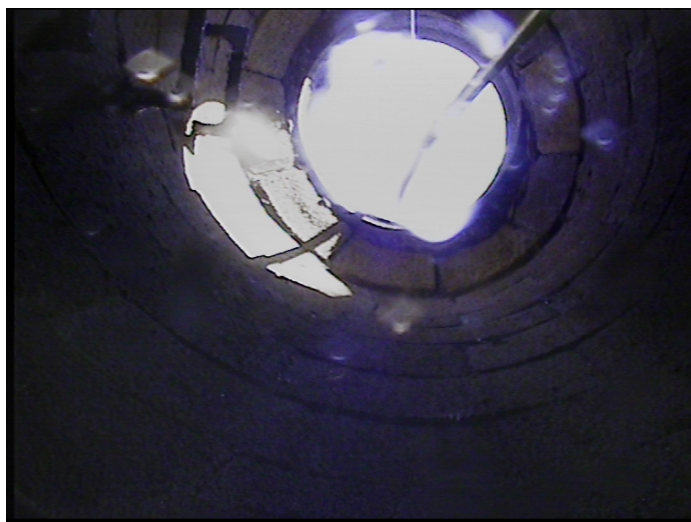
Code: **AMH**
Description: **Manhole**

Distance (ft): **.0**
Structural Grade: **0**
O&M Grade: **0**
Clock Start/From:
Clock To:
1st Value:
2nd Value:
Value Percent:
Continuous Index:
Within 8" of Joint: **NO**
Remarks: **M-505-008**

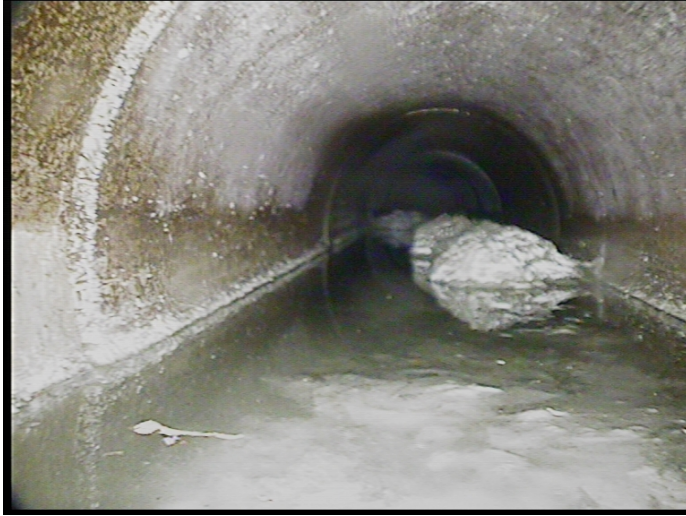
Code: **MWL**
Description: **Water Level**

Distance (ft): **.0**
Structural Grade: **0**
O&M Grade: **0**
Clock Start/From:
Clock To:
1st Value:
2nd Value:
Value Percent: **15.000**
Continuous Index:
Within 8" of Joint: **NO**
Remarks:

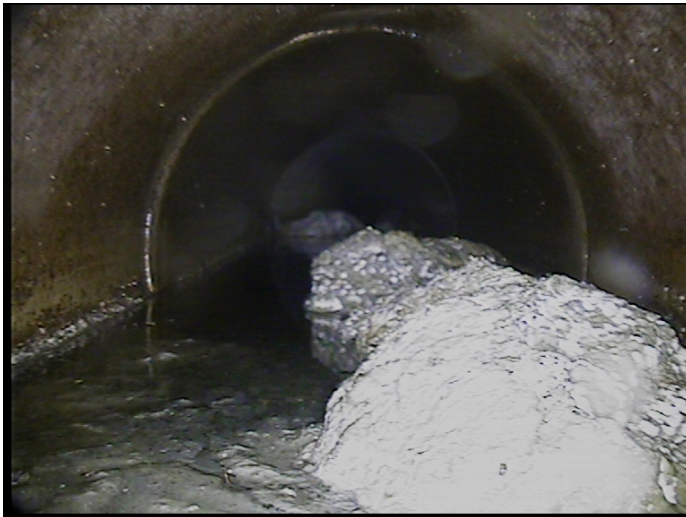
Code: **OBZ**
Description: **Obstacle Other**

Distance (ft): **3.1**
Structural Grade: **0**
O&M Grade: **4**
Clock Start/From: **3**
Clock To: **6**
1st Value:
2nd Value:
Value Percent: **25.000**
Continuous Index:
Within 8" of Joint: **NO**
Remarks: **Debris**

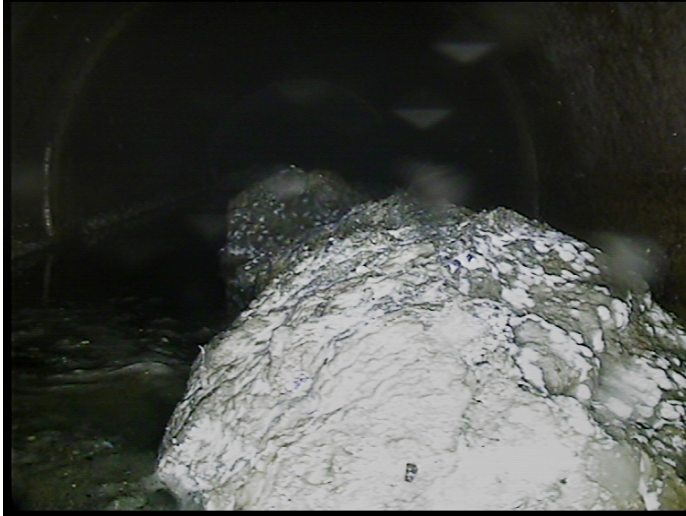
Code:	MSA
Description:	Abandoned Survey
Distance (ft):	3.1
Structural Grade:	0
O&M Grade:	0
Clock Start/From:	
Clock To:	
1st Value:	
2nd Value:	
Value Percent:	
Continuous Index:	
Within 8" of Joint:	NO
Remarks:	heavy debris
