Profile/Photo Observation Report

Date:	08/09/2022	Weather:		Coding:	PACP 7.0
Pipe Length (ft):	250.0	Owner:	City of Hobart	Pre Clean:	Heavy Cleaning
P.O.#:	YES502259	Surveyor:	S. Bucklin	PSR:	P-505-008-007
Customer:	City of Hobart	Clean Date:	07/22/2022	Shape:	C

Street:	Lake George Drive	Flow Control:	Not Controlled
City:	Hobart, IN	Year Renewed:	
Location:	Local rural streets with light traffic, t	Tape/Media #:	
Purpose:	Routine Assessment	Dia/Height:	15"
Use:	Sanitary Sewage Pipe	Material:	VCP
Drain Area:		Lining:	None
Category:	NA		
Comment:			
Location Details:		Direction of Survey:	Downstream
US MH:	M-505-007	DS MH:	M-505-008
		Total Length Surveyed (ft):	270.1

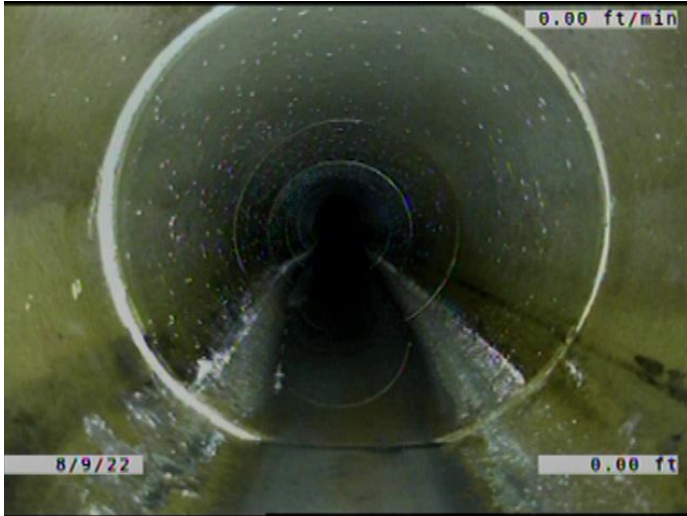
Code: **MWL**
Description: **Miscellaneous Water Level**

Distance (ft): **.0**
Structural Grade: **0**
O&M Grade: **0**
Clock Start/From:
Clock To:
1st Value:
2nd Value:
Value Percent: **5.000**
Continuous Index:
Within 8" of Joint: **NO**
Remarks:

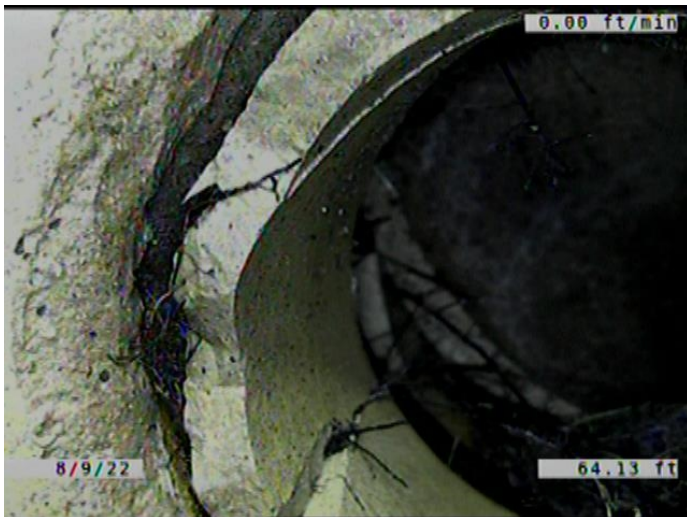
Code: **SSS**
Description: **Surface Damage Surface Spalling**

Distance (ft): **64.1**
Structural Grade: **2**
O&M Grade: **0**
Clock Start/From: **1**
Clock To: **3**
1st Value:
2nd Value:
Value Percent:
Continuous Index:
Within 8" of Joint: **YES**
Remarks:

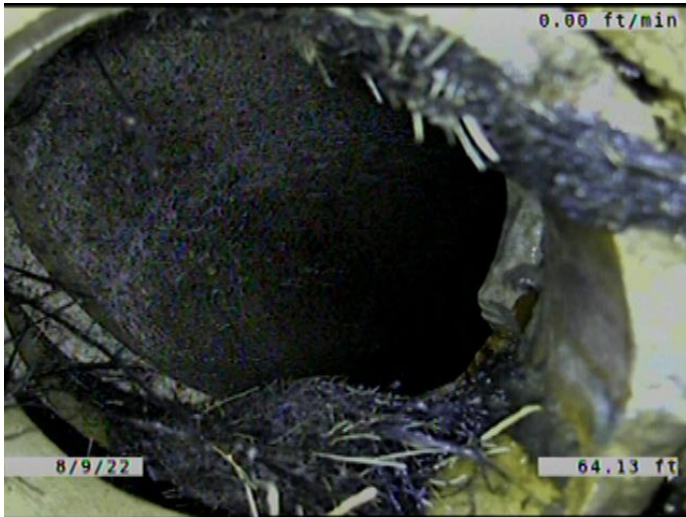
Code: **RFL**
 Description: **Roots Fine Lateral**

Distance (ft): **64.1**
 Structural Grade: **0**
 O&M Grade: **1**
 Clock Start/From: **2**
 Clock To:
 1st Value:
 2nd Value:
 Value Percent:
 Continuous Index:
 Within 8" of Joint: **NO**
 Remarks:

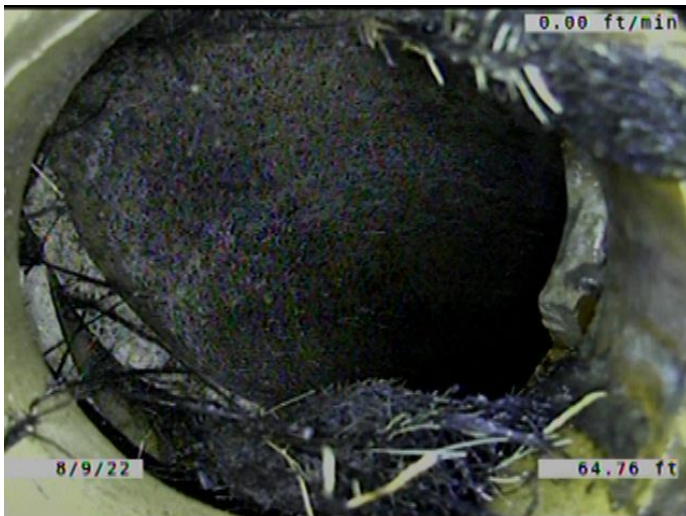
Code: **TBD**
 Description: **Tap Break-in/Hammer Defective**

Distance (ft): **64.8**
 Structural Grade: **0**
 O&M Grade: **3**
 Clock Start/From: **2**
 Clock To:
 1st Value: **6.000**
 2nd Value:
 Value Percent:
 Continuous Index:
 Within 8" of Joint: **YES**
 Remarks: **TAP/ SERVICE BROKEN. ROOTS GROWING IN AND AROUND IT.**

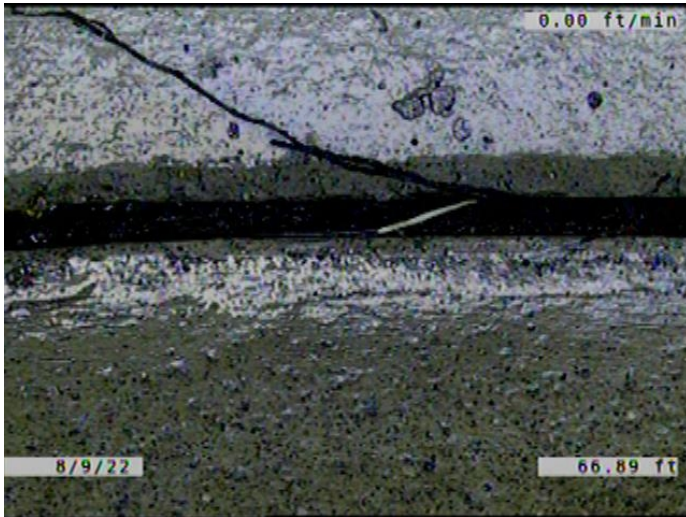
Code: **RFJ**
 Description: **Roots Fine Joint**

Distance (ft): **66.9**
 Structural Grade: **0**
 O&M Grade: **1**
 Clock Start/From: **9**
 Clock To: **1**
 1st Value:
 2nd Value:
 Value Percent:
 Continuous Index:
 Within 8" of Joint: **YES**
 Remarks:

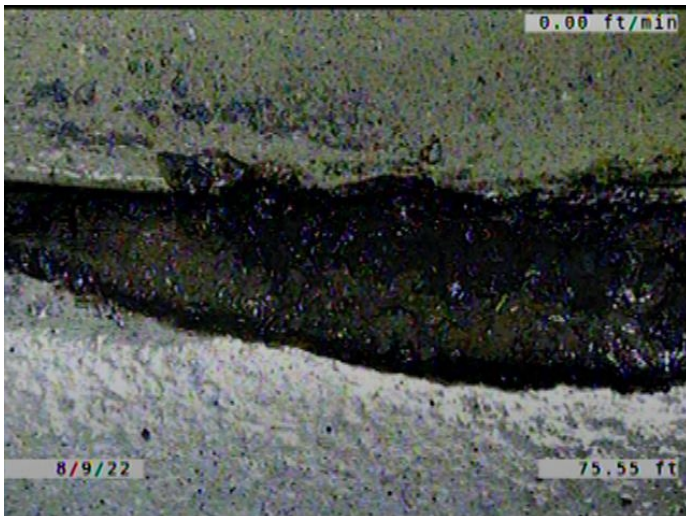
Code: **DAE**
 Description: **Deposits Attached Encrustation**

Distance (ft): **75.5**
 Structural Grade: **0**
 O&M Grade: **2**
 Clock Start/From: **2**
 Clock To: **4**
 1st Value:
 2nd Value:
 Value Percent: **5.000**
 Continuous Index:
 Within 8" of Joint: **YES**
 Remarks:

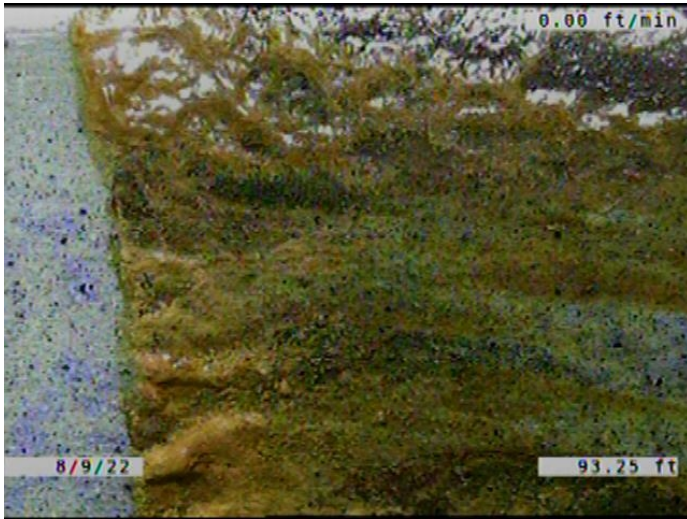
Code: **DAE**
 Description: **Deposits Attached Encrustation**

Distance (ft): **93.3**
 Structural Grade: **0**
 O&M Grade: **2**
 Clock Start/From: **8**
 Clock To: **5**
 1st Value:
 2nd Value:
 Value Percent: **5.000**
 Continuous Index: **S01**
 Within 8" of Joint: **YES**
 Remarks:

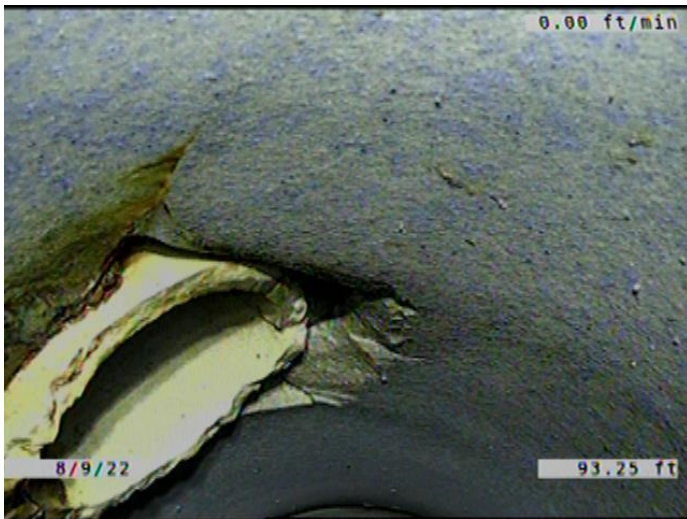
Code: **BSV**
 Description: **Broken Soil Visible**

Distance (ft): **93.3**
 Structural Grade: **5**
 O&M Grade: **0**
 Clock Start/From: **8**
 Clock To: **2**
 1st Value:
 2nd Value:
 Value Percent:
 Continuous Index:
 Within 8" of Joint: **YES**
 Remarks:

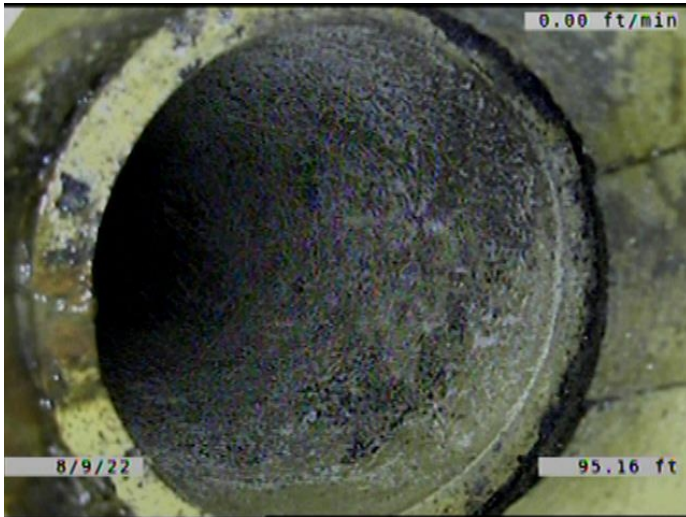
Code: **TBI**
 Description: **Tap Break-in Intruding**

Distance (ft): **95.2**
 Structural Grade: **0**
 O&M Grade: **2**
 Clock Start/From: **11**
 Clock To:
 1st Value: **6.000**
 2nd Value: **1.000**

Value Percent:
 Continuous Index:
 Within 8" of Joint: **YES**
 Remarks: **TAP BROKEN. CONSTANTLY RUNNING WATER.**

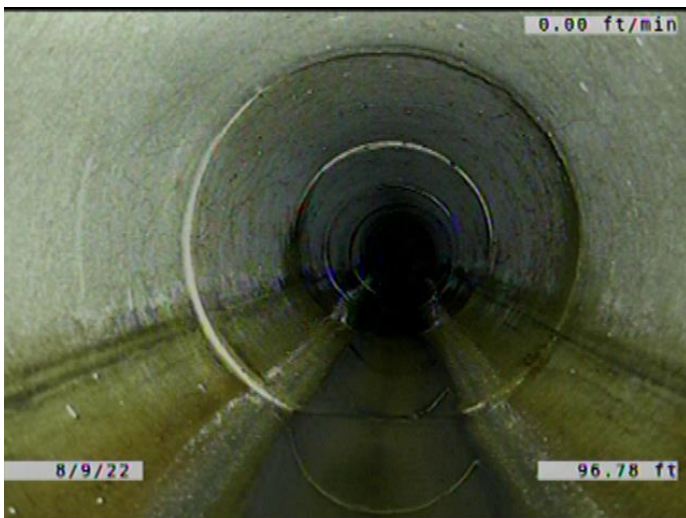
Code: **DAE**
 Description: **Deposits Attached Encrustation**

Distance (ft): **96.8**
 Structural Grade: **0**
 O&M Grade: **2**
 Clock Start/From: **8**
 Clock To: **5**
 1st Value:
 2nd Value:

Value Percent: **5.000**
 Continuous Index: **F01**
 Within 8" of Joint: **YES**
 Remarks:

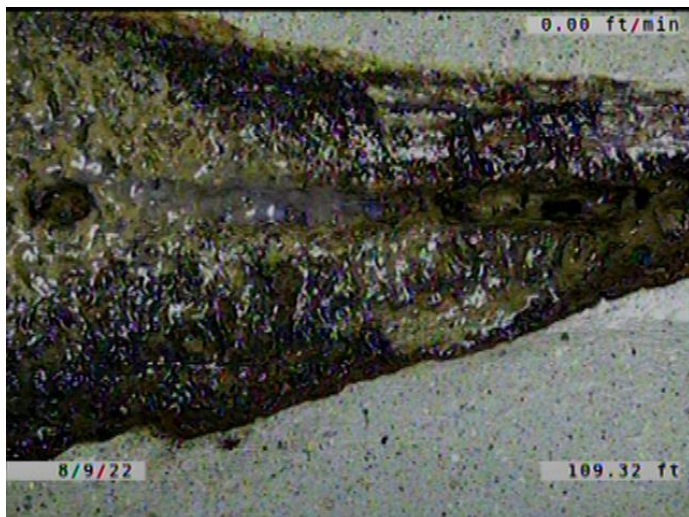
Code: **DAE**
 Description: **Deposits Attached Encrustation**

Distance (ft): **109.3**
 Structural Grade: **0**
 O&M Grade: **2**
 Clock Start/From: **8**
 Clock To: **4**
 1st Value:
 2nd Value:
 Value Percent: **5.000**
 Continuous Index: **S02**
 Within 8" of Joint: **YES**
 Remarks:

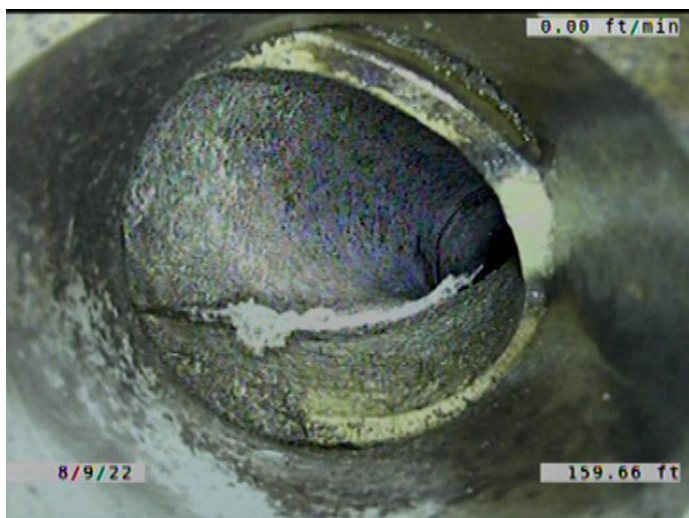
Code: **TF**
 Description: **Tap Factory**

Distance (ft): **159.7**
 Structural Grade: **0**
 O&M Grade: **0**
 Clock Start/From: **2**
 Clock To:
 1st Value: **6.000**
 2nd Value:
 Value Percent:
 Continuous Index:
 Within 8" of Joint: **YES**
 Remarks: **SERVICE ANGLED.**

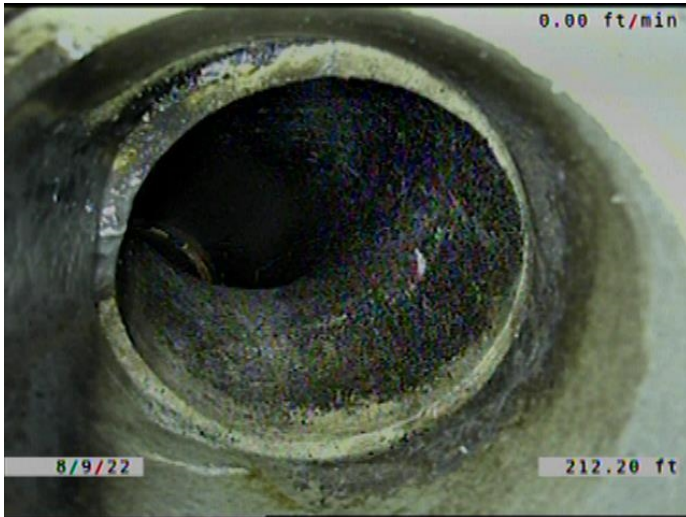
Code: **TFD**
Description: **Tap Factory Defective**

Distance (ft): **212.2**
Structural Grade: **0**
O&M Grade: **3**
Clock Start/From: **10**
Clock To:
1st Value: **6.000**
2nd Value:
Value Percent:
Continuous Index:
Within 8" of Joint: **YES**
Remarks: **TAP BROKEN. CONSTANTLY RUNNING WATER.**

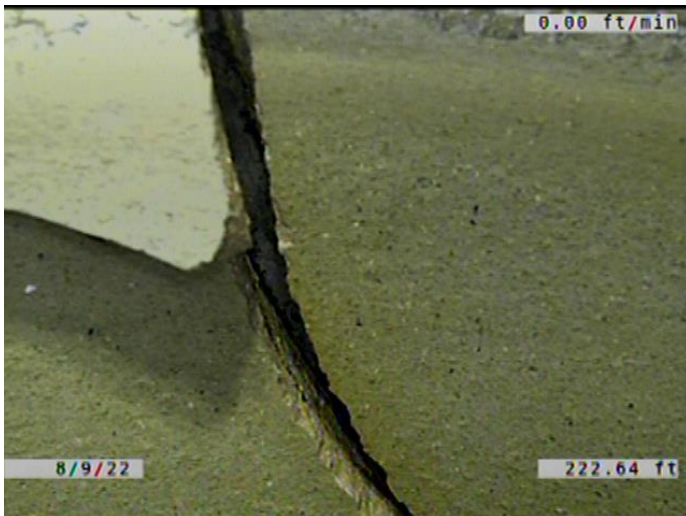
Code: **BSV**
Description: **Broken Soil Visible**

Distance (ft): **222.6**
Structural Grade: **5**
O&M Grade: **0**
Clock Start/From: **9**
Clock To: **5**
1st Value:
2nd Value:
Value Percent:
Continuous Index:
Within 8" of Joint: **YES**
Remarks:

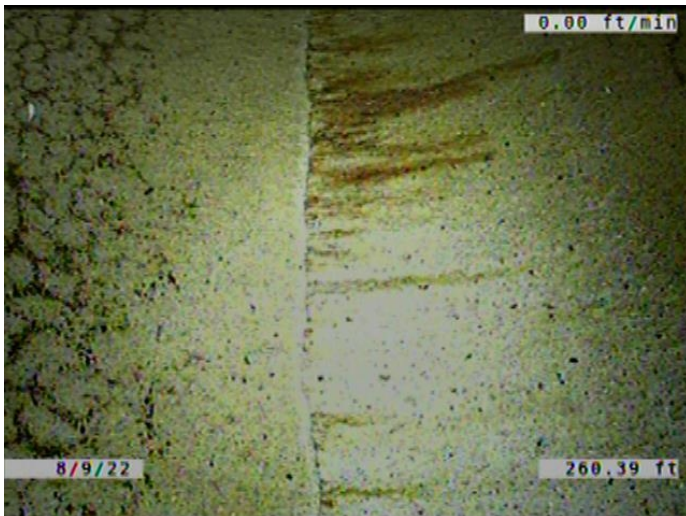
Code: **CS**
Description: **Crack Spiral**

Distance (ft): **260.4**
Structural Grade: **2**
O&M Grade: **0**
Clock Start/From: **8**
Clock To: **9**
1st Value:
2nd Value:
Value Percent:
Continuous Index:
Within 8" of Joint: **YES**
Remarks:

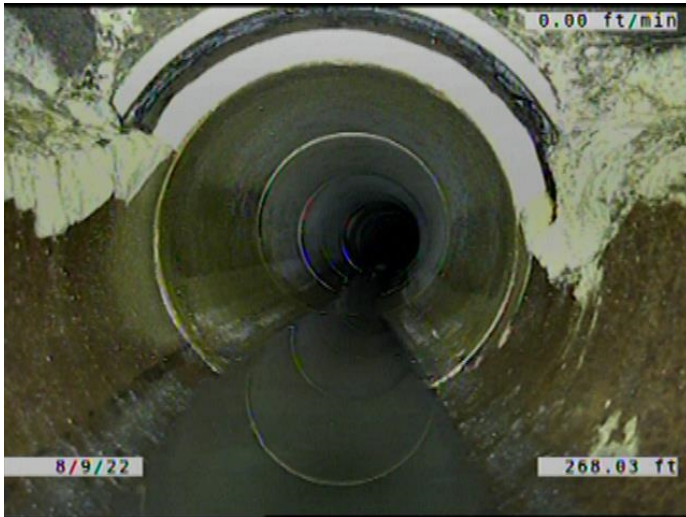
Code: **DAE**
 Description: **Deposits Attached Encrustation**

Distance (ft): **268.0**
 Structural Grade: **0**
 O&M Grade: **2**
 Clock Start/From: **8**
 Clock To: **4**
 1st Value:
 2nd Value:
 Value Percent: **5.000**
 Continuous Index: **F02**
 Within 8" of Joint: **YES**
 Remarks:
