Profile/Photo Observation Report

Date:	04/13/2018	Weather:		Coding:	PACP 6.0
Pipe Length (ft):	195.0	Owner:	NA	Pre Clean:	No Pre-Cleaning
P.O.#:		Surveyor:	Jen Costello	PSR:	P-505-009-008
Customer:		Clean Date:	01/01/1900	Shape:	C

Street:	S VIRGINIA ST & LAKE GEORGE DR	Flow Control:	Not Controlled
City:	Hobart, IN	Year Renewed:	
Location:	Yard	Tape/Media #:	
Purpose:	Routine Assessment	Dia/Height:	10"
Use:	Sanitary	Material:	VCP
Drain Area:	NA	Lining:	
Category:	NA		
Comment:

Location Details:		Direction of Survey:	Downstream
US MH:	M-505-008	DS MH:	M-505-009
		Total Length Surveyed (ft):	167.4

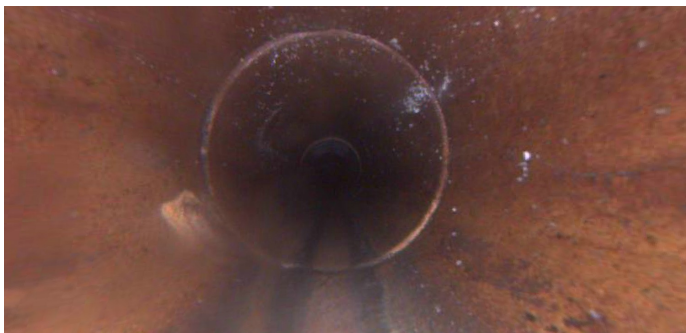
Code: **AMH**
Description: **Manhole**

Distance (ft): **.0**
Structural Grade: **0**
O&M Grade: **0**
Clock Start/From:
Clock To:
1st Value:
2nd Value:
Value Percent:
Continuous Index:
Within 8" of Joint: **NO**
Remarks: **M-505-008**

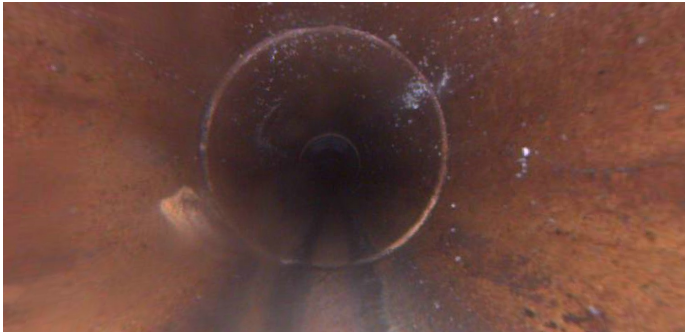
Code:	MWL
Description:	Water Level

Distance (ft):	.0
Structural Grade:	0
O&M Grade:	0
Clock Start/From:	
Clock To:	
1st Value:	
2nd Value:	
Value Percent:	5.000
Continuous Index:	
Within 8" of Joint:	NO
Remarks:

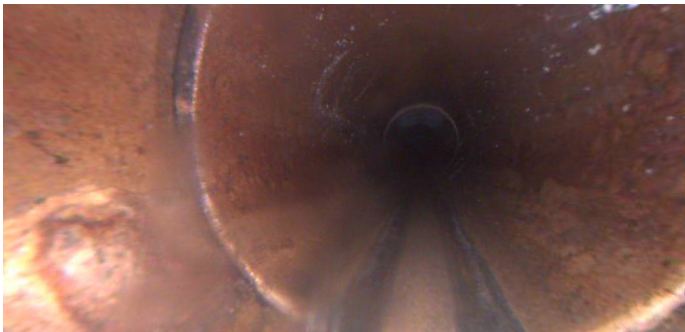
Code:	FL
Description:	Fracture Longitudinal

Distance (ft):	1.1
Structural Grade:	3
O&M Grade:	0
Clock Start/From:	8
Clock To:	
1st Value:	
2nd Value:	
Value Percent:	
Continuous Index:	
Within 8" of Joint:	YES
Remarks:

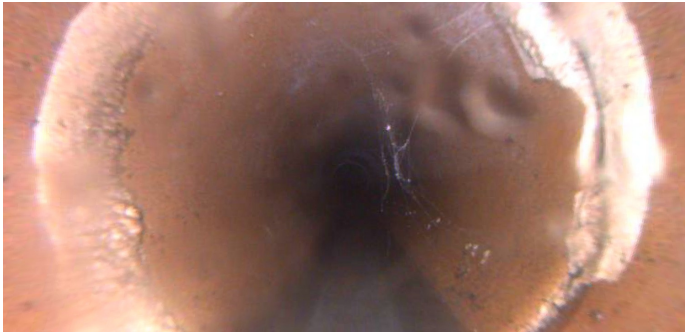
Code: **DAE**
Description: **Deposits Attached Encrustation**

Distance (ft): **36.8**
Structural Grade: **0**
O&M Grade: **2**
Clock Start/From: **8**
Clock To: **4**
1st Value:
2nd Value:
Value Percent: **5.000**
Continuous Index: **S01**
Within 8" of Joint: **YES**
Remarks:

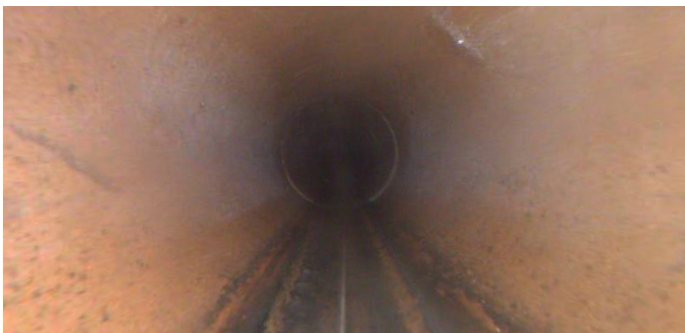
Code: **MGO**
Description: **General Observation**

Distance (ft): **66.1**
Structural Grade: **0**
O&M Grade: **0**
Clock Start/From:
Clock To:
1st Value:
2nd Value:
Value Percent:
Continuous Index:
Within 8" of Joint: **NO**
Remarks: **rear camera**

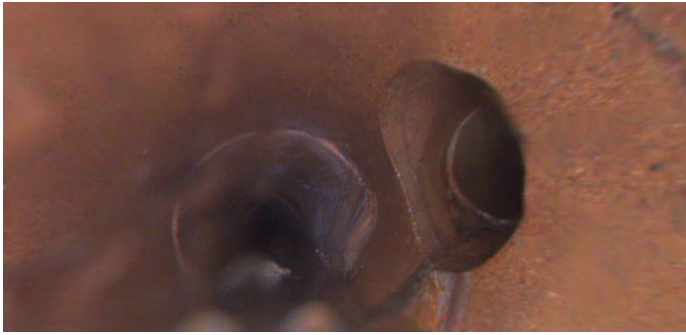
Code: **TFA**
Description: **Tap Factory Active**

Distance (ft): **86.2**
Structural Grade: **0**
O&M Grade: **0**
Clock Start/From: **3**
Clock To:
1st Value: **4.000**
2nd Value:
Value Percent:
Continuous Index:
Within 8" of Joint:
Remarks:

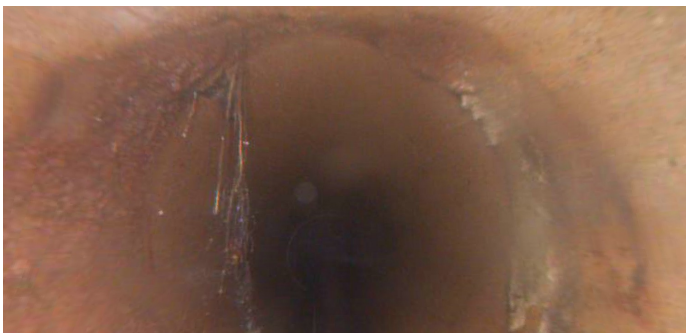
Code: **RFJ**
Description: **Roots Fine Joint**

Distance (ft): **99.8**
Structural Grade: **0**
O&M Grade: **1**
Clock Start/From: **1**
Clock To:
1st Value:
2nd Value:
Value Percent:
Continuous Index:
Within 8" of Joint: **YES**
Remarks:

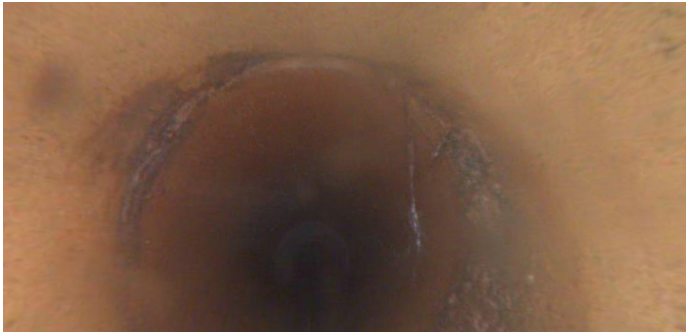
Code: **RFJ**
Description: **Roots Fine Joint**

Distance (ft): **105.9**
Structural Grade: **0**
O&M Grade: **1**
Clock Start/From: **11**
Clock To:
1st Value:
2nd Value:
Value Percent:
Continuous Index:
Within 8" of Joint: **YES**
Remarks:

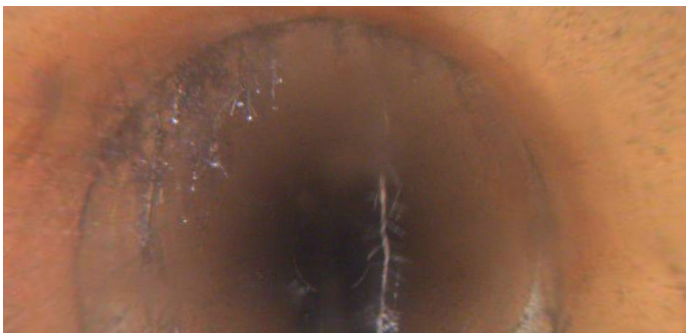
Code: **RMJ**
Description: **Roots Medium Joint**

Distance (ft): **117.5**
Structural Grade: **0**
O&M Grade: **3**
Clock Start/From: **8**
Clock To: **4**
1st Value:
2nd Value:
Value Percent: **5.000**
Continuous Index:
Within 8" of Joint: **YES**
Remarks:

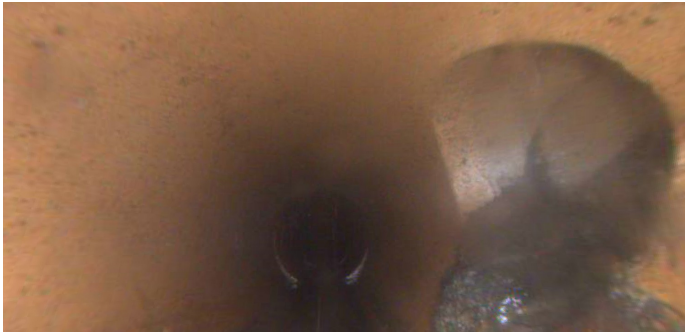
Code: **TFD**
Description: **Tap Factory Defective**

Distance (ft): **119.9**
Structural Grade: **0**
O&M Grade: **2**
Clock Start/From: **9**
Clock To:
1st Value: **4.000**
2nd Value:
Value Percent:
Continuous Index:
Within 8" of Joint:
Remarks: **roots**

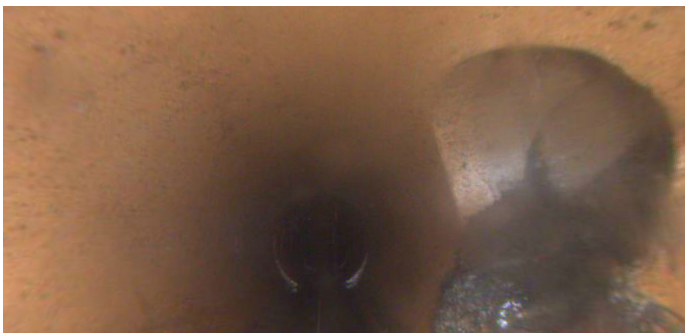
Code: **RML**
Description: **Roots Medium Lateral**

Distance (ft): **119.9**
Structural Grade: **0**
O&M Grade: **3**
Clock Start/From: **8**
Clock To: **9**
1st Value:
2nd Value:
Value Percent: **5.000**
Continuous Index:
Within 8" of Joint: **NO**
Remarks:

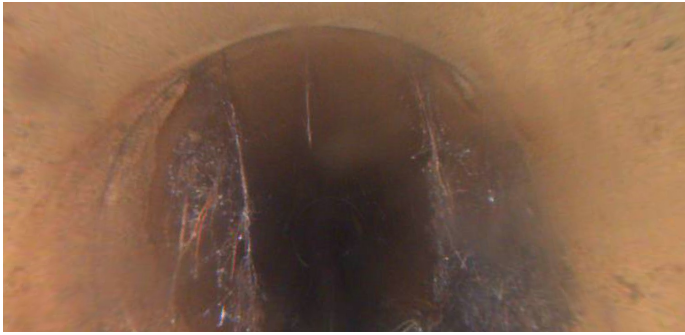
Code: **RMJ**
Description: **Roots Medium Joint**

Distance (ft): **123.5**
Structural Grade: **0**
O&M Grade: **3**
Clock Start/From: **8**
Clock To: **4**
1st Value:
2nd Value:
Value Percent: **20.000**
Continuous Index:
Within 8" of Joint: **YES**
Remarks:

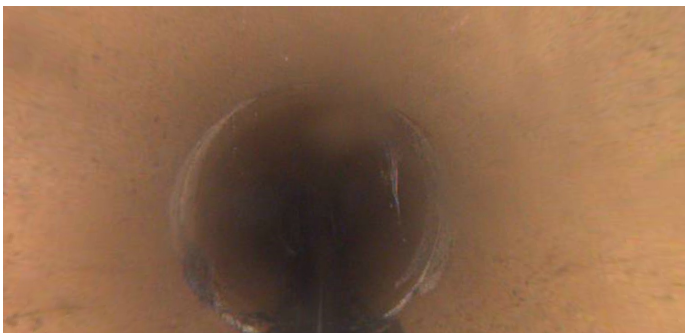
Code: **RFJ**
Description: **Roots Fine Joint**

Distance (ft): **126.8**
Structural Grade: **0**
O&M Grade: **1**
Clock Start/From: **8**
Clock To: **4**
1st Value:
2nd Value:
Value Percent:
Continuous Index: **S02**
Within 8" of Joint: **YES**
Remarks:

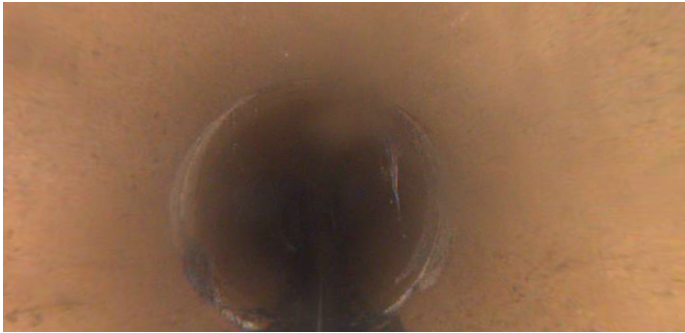
Code: **DAE**
Description: **Deposits Attached Encrustation**

Distance (ft): **126.8**
Structural Grade: **0**
O&M Grade: **2**
Clock Start/From: **8**
Clock To: **4**
1st Value:
2nd Value:
Value Percent: **5.000**
Continuous Index: **F01**
Within 8" of Joint: **YES**
Remarks:

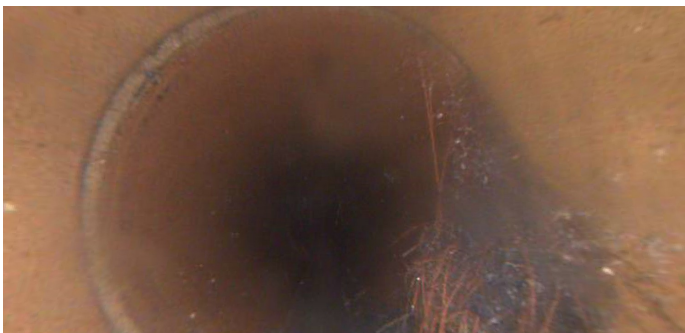
Code: **RMJ**
Description: **Roots Medium Joint**

Distance (ft): **162.1**
Structural Grade: **0**
O&M Grade: **3**
Clock Start/From: **7**
Clock To: **11**
1st Value:
2nd Value:
Value Percent: **10.000**
Continuous Index:
Within 8" of Joint: **YES**
Remarks:

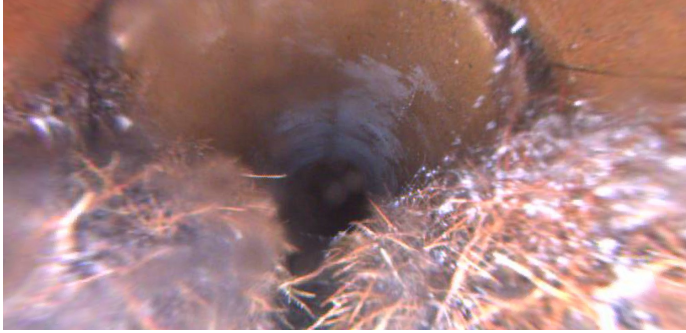
Code: **RMJ**
Description: **Roots Medium Joint**

Distance (ft): **166.8**
Structural Grade: **0**
O&M Grade: **3**
Clock Start/From: **3**
Clock To: **9**
1st Value:
2nd Value:
Value Percent: **40.000**
Continuous Index:
Within 8" of Joint: **YES**
Remarks:

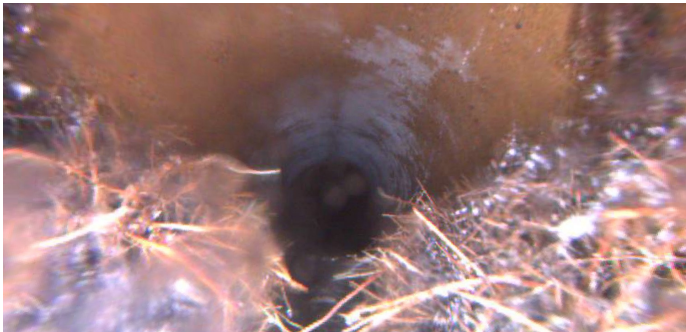
Code: **MSA**
Description: **Abandoned Survey**

Distance (ft): **167.4**
Structural Grade: **0**
O&M Grade: **0**
Clock Start/From:
Clock To:
1st Value:
2nd Value:
Value Percent:
Continuous Index:
Within 8" of Joint: **NO**
Remarks: **roots**

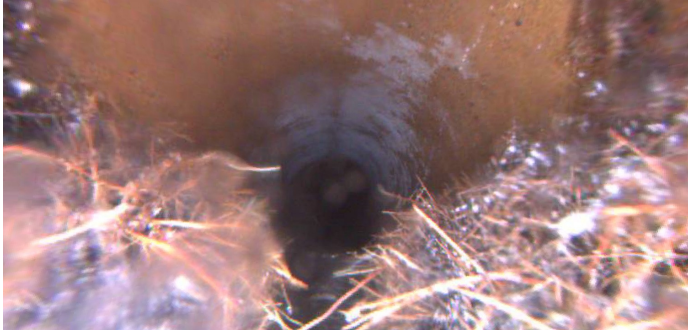
Code:	RFJ
Description:	Roots Fine Joint
Distance (ft):	167.4
Structural Grade:	0
O&M Grade:	1
Clock Start/From:	8
Clock To:	4
1st Value:	
2nd Value:	
Value Percent:	
Continuous Index:	F02
Within 8" of Joint:	YES
Remarks:
