Profile/Photo Observation Report

| Street: | FOXCROFT STREET | Flow Control: | Not Controlled |
| City: | Hobart, IN | Year Renewed: | |

| US MH: | M-505-008 | DS MH: | M-505-009 |

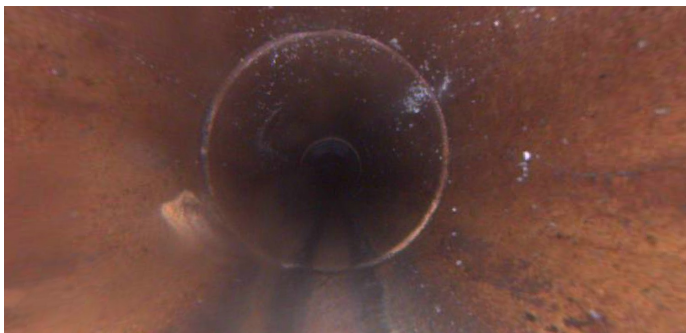
Code: **AMH**
Description: **Manhole**

Distance (ft): **.0**
Structural Grade: **0**
O&M Grade: **0**
Clock Start/From:
Clock To:
1st Value:
2nd Value:
Value Percent:
Continuous Index:
Within 8" of Joint: **NO**
Remarks: **M-505-008**

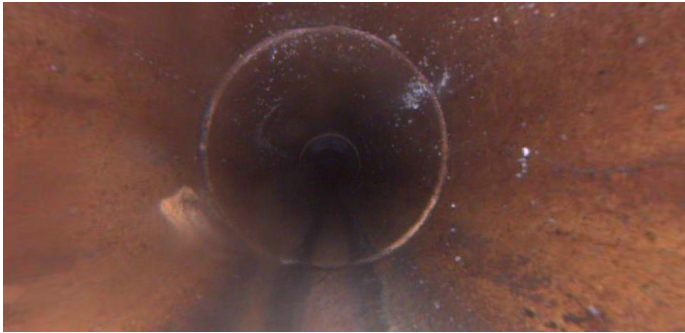
| Code: | MWL |
| Description: | Water Level |

| Value Percent: | 5.000 |

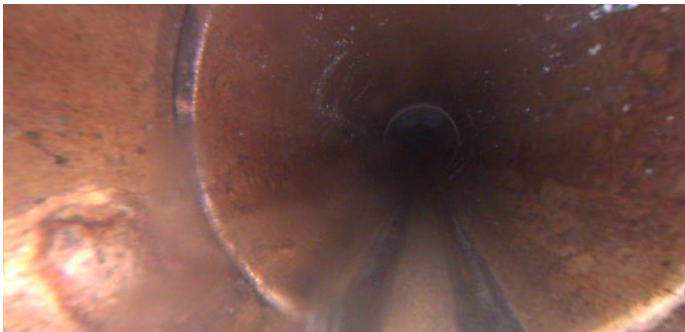
| Code: | FL |
| Description: | Fracture Longitudinal |

| Distance (ft): | 1.1 |
| Structural Grade: | 3 |
| Clock Start/From: | 8 |
| Within 8" of Joint: | YES |

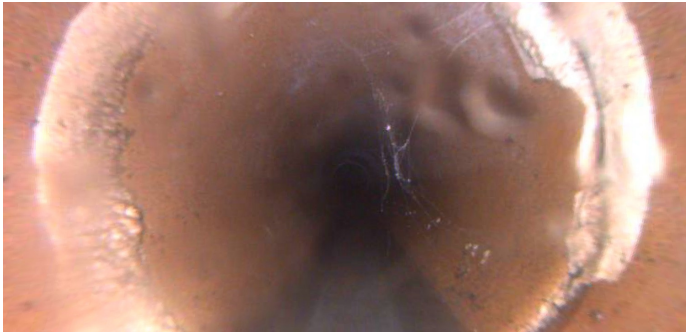
Code: **DAE**
Description: **Deposits Attached Encrustation**

Distance (ft): **36.8**
Structural Grade: **0**
O&M Grade: **2**
Clock Start/From: **8**
Clock To: **4**
1st Value:
2nd Value:
Value Percent: **5.000**
Continuous Index: **S01**
Within 8" of Joint: **YES**
Remarks:

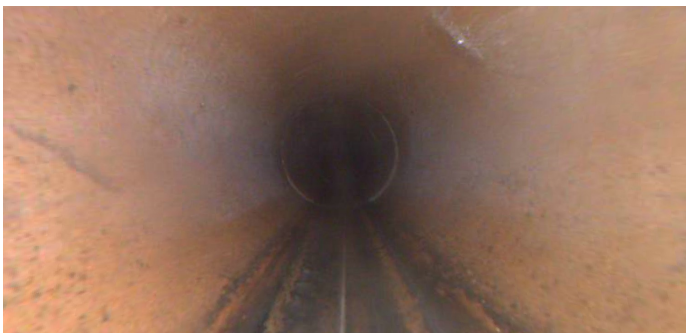
Code: **MGO**
Description: **General Observation**

Distance (ft): **66.1**
Structural Grade: **0**
O&M Grade: **0**
Clock Start/From:
Clock To:
1st Value:
2nd Value:
Value Percent:
Continuous Index:
Within 8" of Joint: **NO**
Remarks: **rear camera**

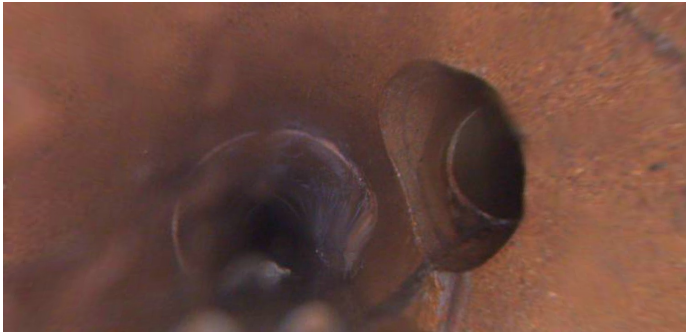
Code: **TFA**
Description: **Tap Factory Active**

Distance (ft): **86.2**
Structural Grade: **0**
O&M Grade: **0**
Clock Start/From: **3**
Clock To:
1st Value: **4.000**
2nd Value:
Value Percent:
Continuous Index:
Within 8" of Joint:
Remarks:

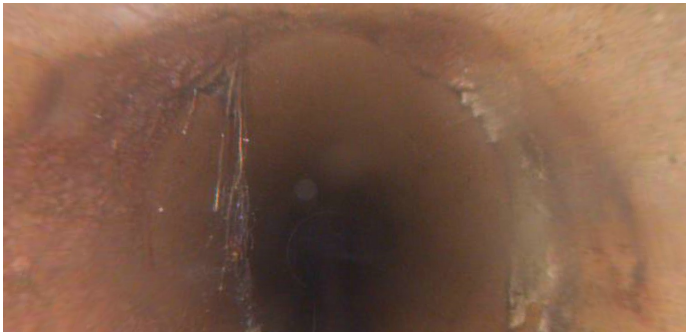
Code: **RFJ**
Description: **Roots Fine Joint**

Distance (ft): **99.8**
Structural Grade: **0**
O&M Grade: **1**
Clock Start/From: **1**
Clock To:
1st Value:
2nd Value:
Value Percent:
Continuous Index:
Within 8" of Joint: **YES**
Remarks:

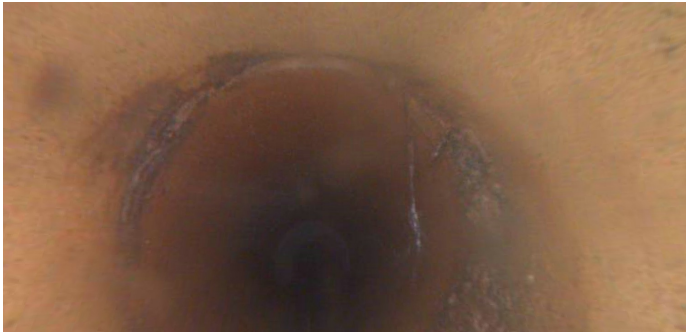
Code: **RFJ**
Description: **Roots Fine Joint**

Distance (ft): **105.9**
Structural Grade: **0**
O&M Grade: **1**
Clock Start/From: **11**
Clock To:
1st Value:
2nd Value:
Value Percent:
Continuous Index:
Within 8" of Joint: **YES**
Remarks:

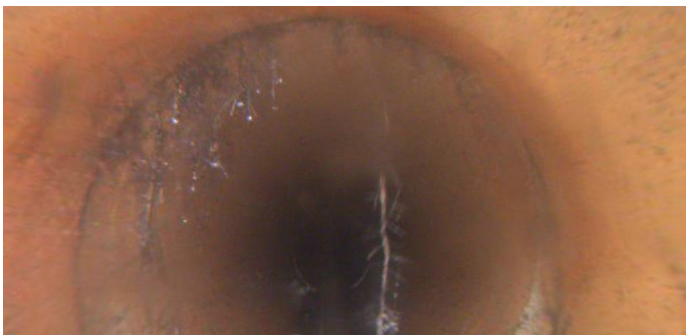
Code: **RMJ**
Description: **Roots Medium Joint**

Distance (ft): **117.5**
Structural Grade: **0**
O&M Grade: **3**
Clock Start/From: **8**
Clock To: **4**
1st Value:
2nd Value:
Value Percent: **5.000**
Continuous Index:
Within 8" of Joint: **YES**
Remarks:

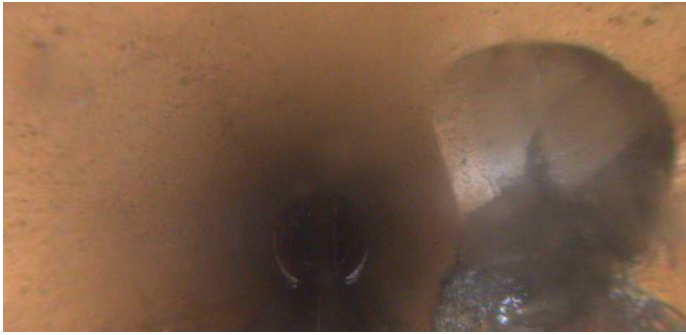
Code: **TFD**
Description: **Tap Factory Defective**

Distance (ft): **119.9**
Structural Grade: **0**
O&M Grade: **2**
Clock Start/From: **9**
Clock To:
1st Value: **4.000**
2nd Value:
Value Percent:
Continuous Index:
Within 8" of Joint:
Remarks: **roots**

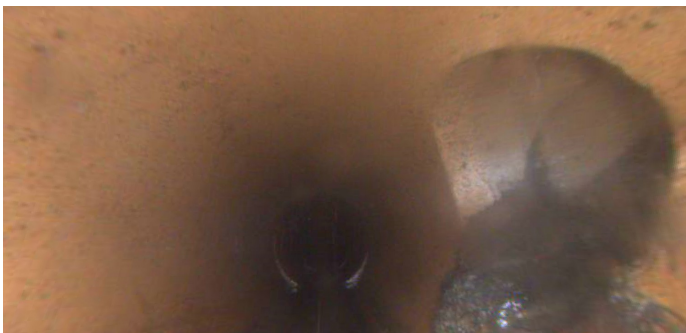
Code: **RML**
Description: **Roots Medium Lateral**

Distance (ft): **119.9**
Structural Grade: **0**
O&M Grade: **3**
Clock Start/From: **8**
Clock To: **9**
1st Value:
2nd Value:
Value Percent: **5.000**
Continuous Index:
Within 8" of Joint: **NO**
Remarks:

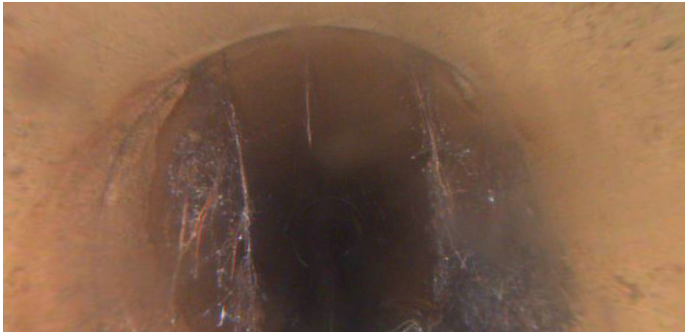
Code: **RMJ**
Description: **Roots Medium Joint**

Distance (ft): **123.5**
Structural Grade: **0**
O&M Grade: **3**
Clock Start/From: **8**
Clock To: **4**
1st Value:
2nd Value:
Value Percent: **20.000**
Continuous Index:
Within 8" of Joint: **YES**
Remarks:

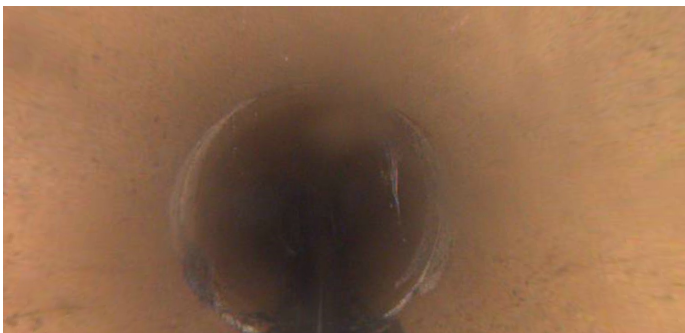
Code: **RFJ**
Description: **Roots Fine Joint**

Distance (ft): **126.8**
Structural Grade: **0**
O&M Grade: **1**
Clock Start/From: **8**
Clock To: **4**
1st Value:
2nd Value:
Value Percent:
Continuous Index: **S02**
Within 8" of Joint: **YES**
Remarks:

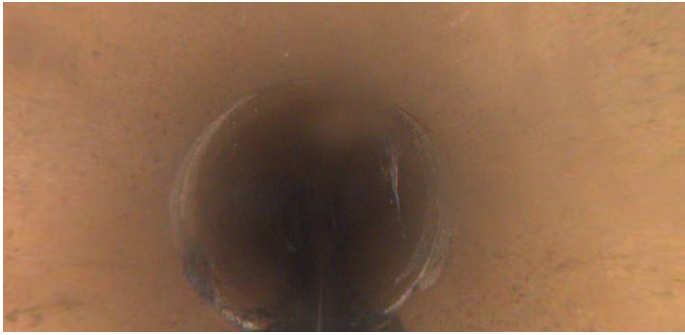
Code: **DAE**
Description: **Deposits Attached Encrustation**

Distance (ft): **126.8**
Structural Grade: **0**
O&M Grade: **2**
Clock Start/From: **8**
Clock To: **4**
1st Value:
2nd Value:
Value Percent: **5.000**
Continuous Index: **F01**
Within 8" of Joint: **YES**
Remarks:

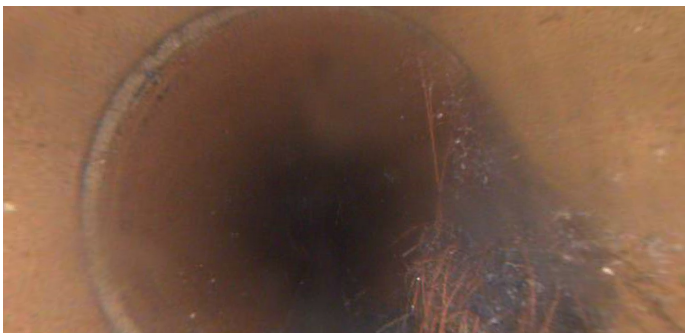
Code: **RMJ**
Description: **Roots Medium Joint**

Distance (ft): **162.1**
Structural Grade: **0**
O&M Grade: **3**
Clock Start/From: **7**
Clock To: **11**
1st Value:
2nd Value:
Value Percent: **10.000**
Continuous Index:
Within 8" of Joint: **YES**
Remarks:

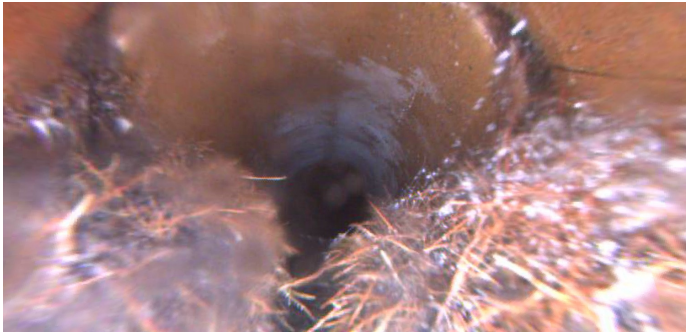
Code: **RMJ**
Description: **Roots Medium Joint**

Distance (ft): **166.8**
Structural Grade: **0**
O&M Grade: **3**
Clock Start/From: **3**
Clock To: **9**
1st Value:
2nd Value:
Value Percent: **40.000**
Continuous Index:
Within 8" of Joint: **YES**
Remarks:

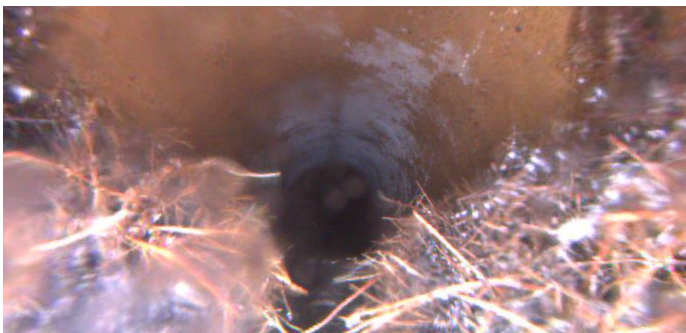
Code: **MSA**
Description: **Abandoned Survey**

Distance (ft): **167.4**
Structural Grade: **0**
O&M Grade: **0**
Clock Start/From:
Clock To:
1st Value:
2nd Value:
Value Percent:
Continuous Index:
Within 8" of Joint: **NO**
Remarks: **roots**

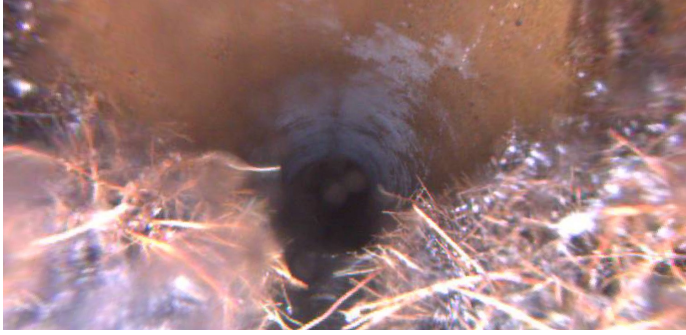
| Code: | RFJ |
| Description: | Roots Fine Joint |
| Distance (ft): | 167.4 |
| O&M Grade: | 1 |
