Profile/Photo Observation Report

Street:	Lake George Road	Flow Control:	Not Controlled
City:	Hobart, IN	Year Renewed:	
Location:	Light Highway	Tape/Media #:	DEP 90
Purpose:	Routine Assessment	Dia/Height:	15"
Use:	Sanitary	Material:	VCP
Drain Area:		Lining:	
Category:	NA		
Comment:	YES501824 Submittal 2		
Location Details:		Direction of Survey:	Upstream
US MH:	M-505-008	DS MH:	M-505-010
		Total Length Surveyed (ft):	32.6

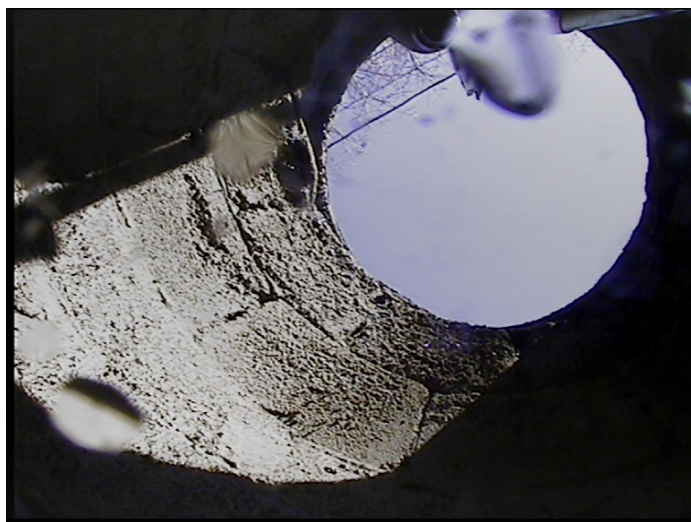
Code: **AMH**
Description: **Manhole**

Distance (ft): **.0**
Structural Grade: **0**
O&M Grade: **0**
Clock Start/From:
Clock To:
1st Value:
2nd Value:
Value Percent:
Continuous Index:
Within 8" of Joint: **NO**
Remarks: **M-505-010**

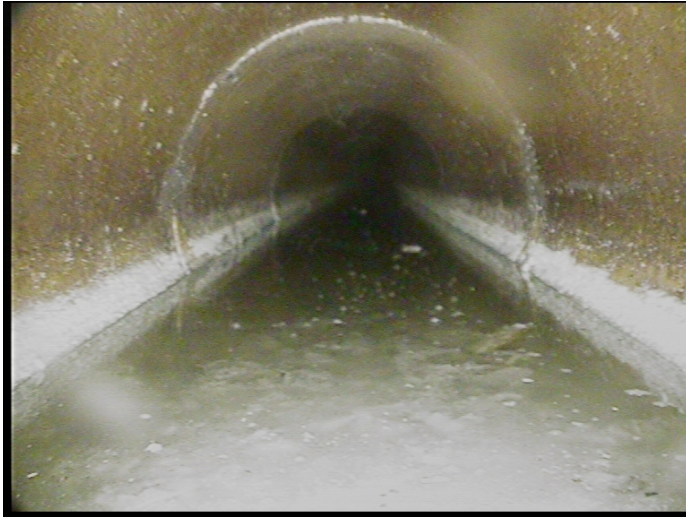
Code:	MWL
Description:	Water Level
Distance (ft):	.0
Structural Grade:	0
O&M Grade:	0
Clock Start/From:	
Clock To:	
1st Value:	
2nd Value:	
Value Percent:	15.000
Continuous Index:	
Within 8" of Joint:	NO
Remarks:

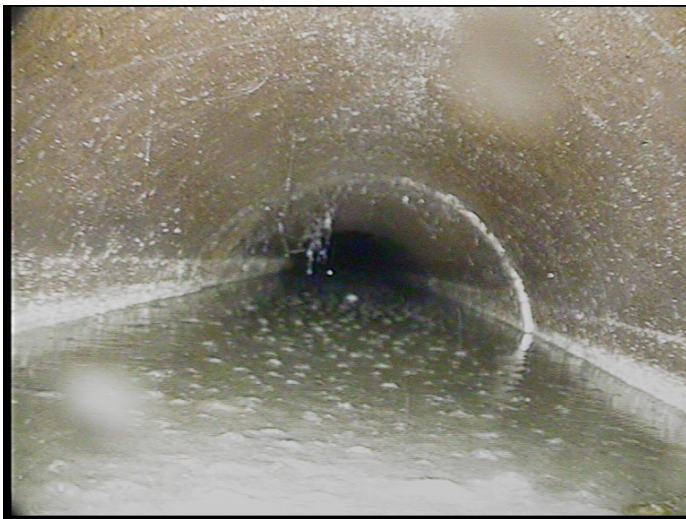
Code:	MWL
Description:	Water Level
Distance (ft):	25.8
Structural Grade:	0
O&M Grade:	0
Clock Start/From:	
Clock To:	
1st Value:	
2nd Value:	
Value Percent:	50.000
Continuous Index:	
Within 8" of Joint:	NO
Remarks:

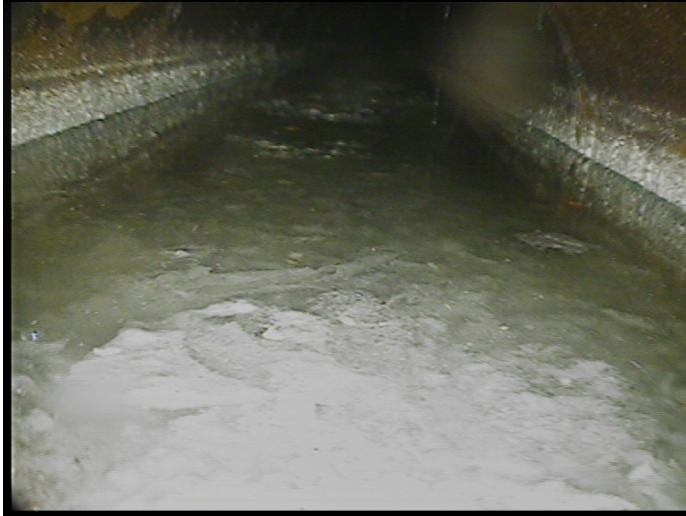
Code:	MSA
Description:	Abandoned Survey
Distance (ft):	32.5
Structural Grade:	0
O&M Grade:	0
Clock Start/From:	
Clock To:	
1st Value:	
2nd Value:	
Value Percent:	
Continuous Index:	
Within 8" of Joint:	NO
Remarks:	sediment/debris
