Profile/Photo Observation Report

Date: 08/09/2022 Weather: **PACP 7.0** Coding: Pipe Length (ft): 169.0 Owner: **City of Hobart** Pre Clean: **Heavy Cleaning** P.O.#: YES502259 S. Bucklin PSR: P-505-010-008 Surveyor: Customer: **City of Hobart** Clean Date: 07/20/2022 Shape: **Lake George Drive** Flow Control: **Not Controlled** Street: City: Hobart, IN Year Renewed: Local rural streets with light traffic, t Tape/Media #: Location: Purpose: **Routine Assessment** Dia/Height: 15" Use: **Sanitary Sewage Pipe** Material: **VCP** Drain Area: Lining: None Category: NA Comment: **Location Details:** Direction of Survey: **Downstream** US MH: M-505-008 DS MH: M-505-010 Total Length Surveyed (ft): 167.8 2.00 2D00 58.00 O&M Index: O&M Quick: **O&M** Rating:

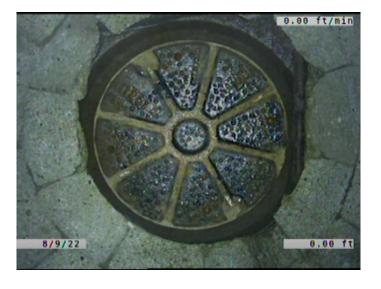
Code:	AMH
Description:	Manhole
Distance (ft):	.0
Structural Grade:	0
O&M Grade:	0
Clock Start/From:	
Clock To:	
1st Value:	
2nd Value:	
Value Percent:	
Continuous Index:	
Within 8" of Joint:	NO
Remarks:	M-505-008

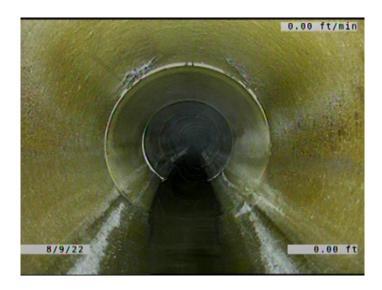
Code: MWL

Description: **Miscellaneous Water Level**

Distance (ft): .0 Structural Grade: 0 O&M Grade: 0

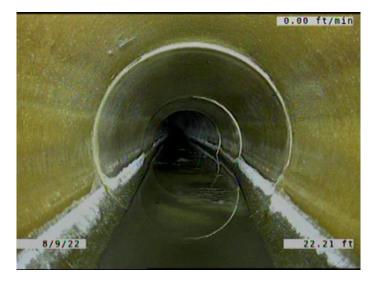
Code: **MWLS**

Description: **Miscellaneous Water Level Sag**

Distance (ft): 22.2 Structural Grade: 2 O&M Grade: 0

Value Percent: 15.000 Continuous Index: **S01** Within 8" of Joint: NO

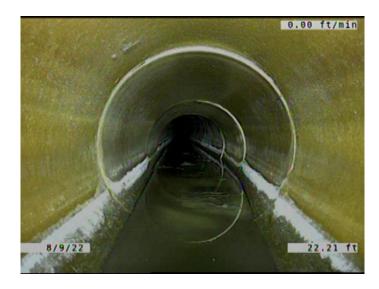
Code: **DSF**

Description: Deposits Settled Fine

Distance (ft): 22.2
Structural Grade: 0
O&M Grade: 2
Clock Start/From: 5
Clock To: 7

Value Percent: 5.000
Continuous Index: S02
Within 8" of Joint: YES

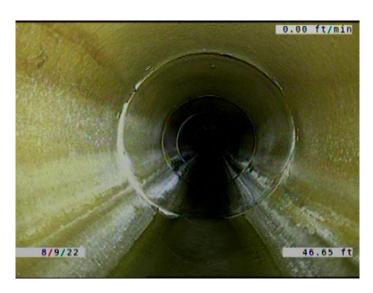
Code: MWLS

Description: Miscellaneous Water Level Sag

Distance (ft): 46.6
Structural Grade: 2
O&M Grade: 0

Value Percent: 15.000
Continuous Index: F01
Within 8" of Joint: NO

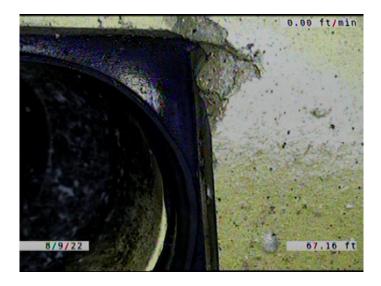
Code: SSS

Description: Surface Damage Surface Spalling

Distance (ft): 67.2
Structural Grade: 2
O&M Grade: 0
Clock Start/From: 1

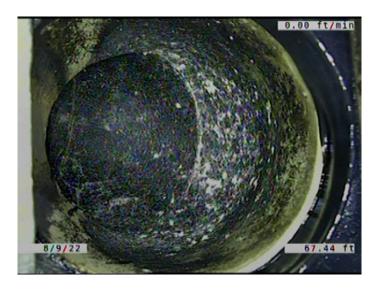
Code: TS

Description: Tap Saddle

Distance (ft): 67.4
Structural Grade: 0

Clock Start/From: 12

1st Value: **4.000**

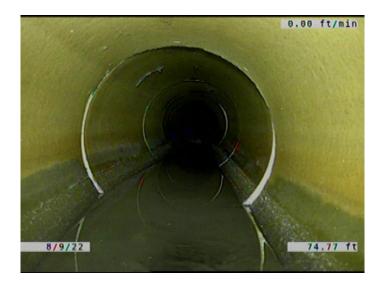
Code: MWLS

Description: Miscellaneous Water Level Sag

Distance (ft): 74.8
Structural Grade: 2
O&M Grade: 0

Value Percent: 10.000

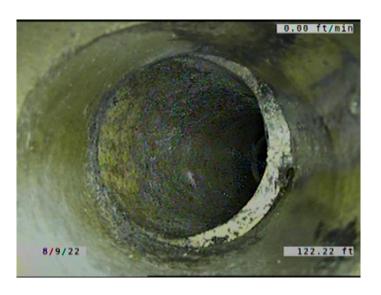
Code: TF

Description: Tap Factory

Distance (ft): 122.2
Structural Grade: 0
O&M Grade: 0
Clock Start/From: 2

1st Value: **6.000**

Remarks: CONSTANTLY RUNNING WATER.

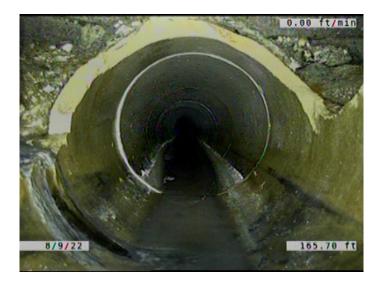
Code: **DSF**

Description: Deposits Settled Fine

Distance (ft): 165.7
Structural Grade: 0
O&M Grade: 2
Clock Start/From: 5
Clock To: 7

Value Percent: 5.000
Continuous Index: F02
Within 8" of Joint: YES

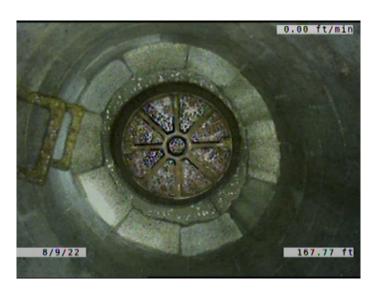
Code: AMH
Description: Manhole

Distance (ft): 167.8
Structural Grade: 0

Remarks: M-505-010
