Profile/Photo Observation Report

Date:	04/25/2018	Weather:		Coding:	PACP 6.0
Pipe Length (ft):		Owner:	City of Hobart	Pre Clean:	No Pre-Cleaning
P.O.#:	91	Surveyor:	M. Pielacha	PSR:	P-505-011-010
Customer:	City of Hobart	Clean Date:		Shape:	C

Street:	Lake George Road	Flow Control:	Not Controlled
City:	Hobart, IN	Year Renewed:	
Location:	Light Highway	Tape/Media #:	DEP 91
Purpose:	Routine Assessment	Dia/Height:	15"
Use:	Sanitary	Material:	VCP
Drain Area:		Lining:	
Category:	NA		
Comment:	YES501824 Submittal 2		
Location Details:		Direction of Survey:	Downstream
US MH:	M-505-010	DS MH:	M-505-011
		Total Length Surveyed (ft):	122.8

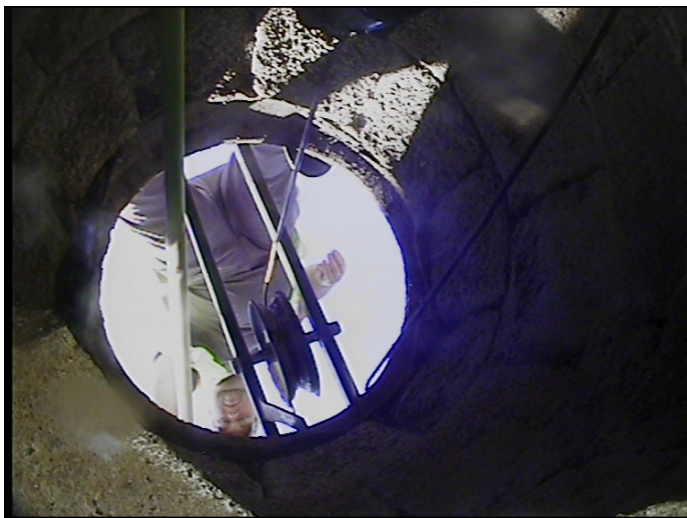
Code: **AMH**
 Description: **Manhole**

Distance (ft): **.0**
 Structural Grade: **0**
 O&M Grade: **0**
 Clock Start/From:
 Clock To:
 1st Value:
 2nd Value:
 Value Percent:
 Continuous Index:
 Within 8" of Joint: **NO**
 Remarks: **M-505-010**

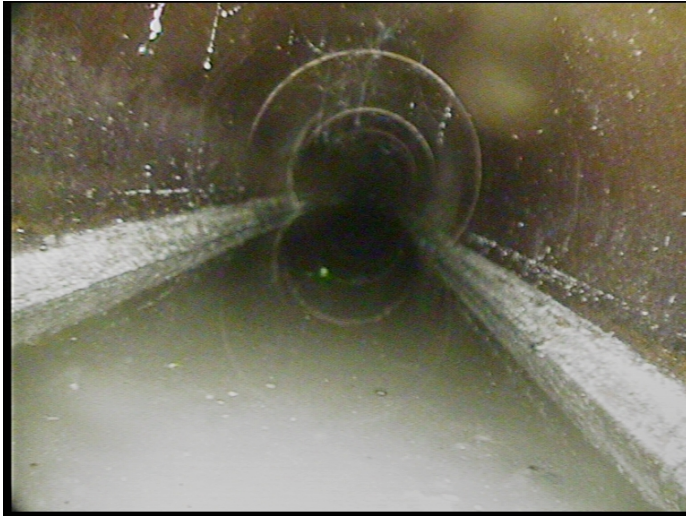
Code: **MWL**
Description: **Water Level**

Distance (ft): **.0**
Structural Grade: **0**
O&M Grade: **0**
Clock Start/From:
Clock To:
1st Value:
2nd Value:
Value Percent: **15.000**
Continuous Index:
Within 8" of Joint: **NO**
Remarks:

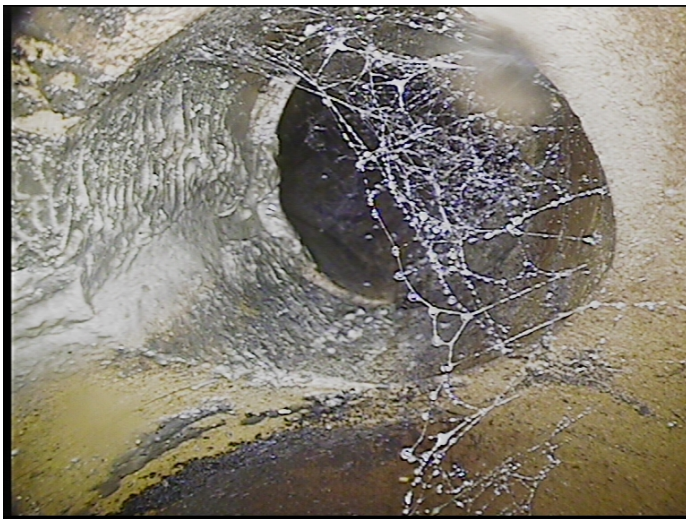
Code: **TF**
Description: **Tap Factory**

Distance (ft): **6.3**
Structural Grade: **0**
O&M Grade: **0**
Clock Start/From: **10**
Clock To:
1st Value: **4.000**
2nd Value:
Value Percent:
Continuous Index:
Within 8" of Joint: **NO**
Remarks:

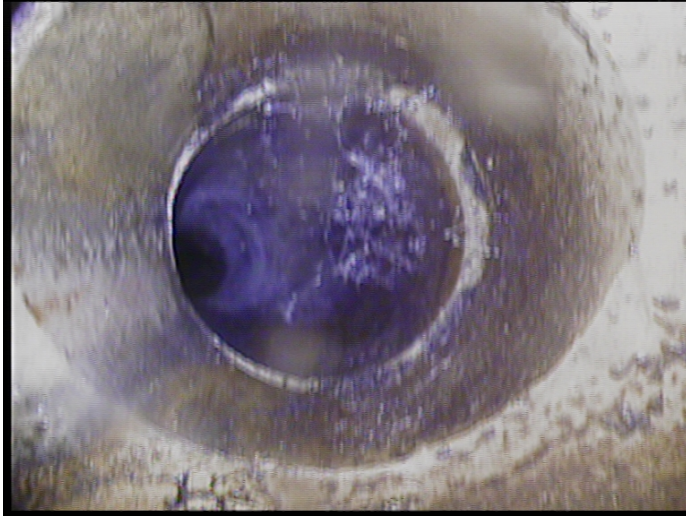
Code: **TF**
Description: **Tap Factory**

Distance (ft): **46.1**
Structural Grade: **0**
O&M Grade: **0**
Clock Start/From: **10**
Clock To:
1st Value: **4.000**
2nd Value:
Value Percent:
Continuous Index:
Within 8" of Joint: **NO**
Remarks:

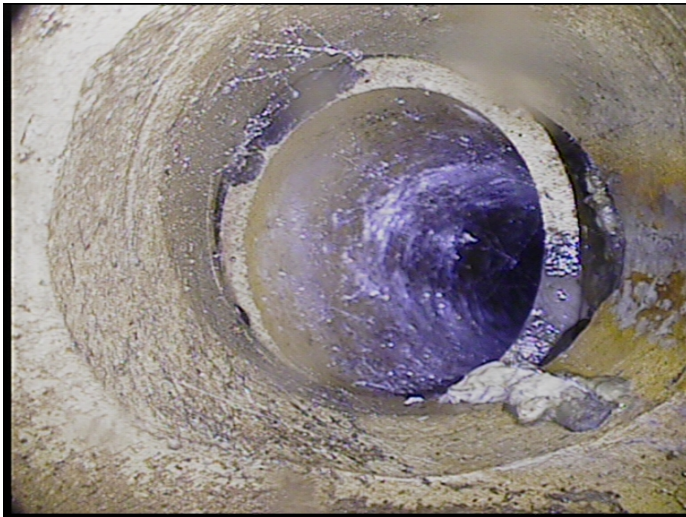
Code: **TFA**
Description: **Tap Factory Active**

Distance (ft): **67.4**
Structural Grade: **0**
O&M Grade: **0**
Clock Start/From: **2**
Clock To:
1st Value: **4.000**
2nd Value:
Value Percent:
Continuous Index:
Within 8" of Joint: **NO**
Remarks:

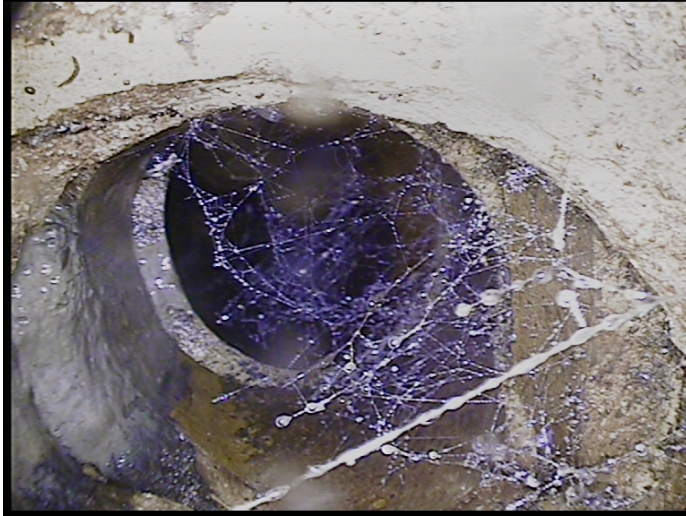
Code: **TF**
Description: **Tap Factory**

Distance (ft): **112.8**
Structural Grade: **0**
O&M Grade: **0**
Clock Start/From: **10**
Clock To:
1st Value: **4.000**
2nd Value:
Value Percent:
Continuous Index:
Within 8" of Joint: **NO**
Remarks:

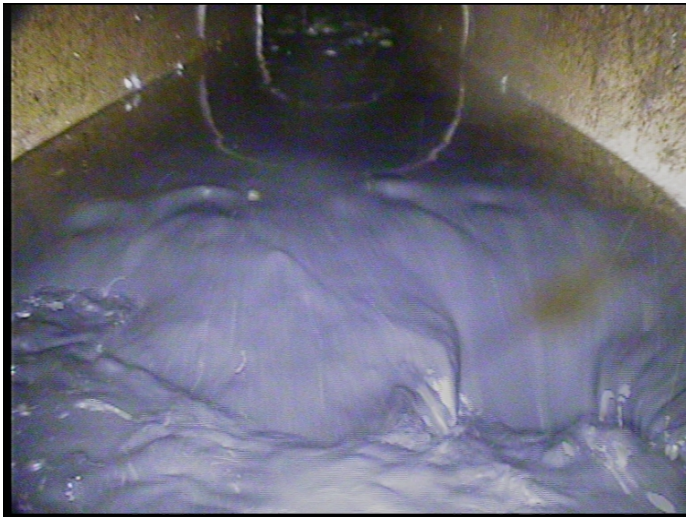
Code: **DSF**
Description: **Deposits Settled Fine**

Distance (ft): **116.2**
Structural Grade: **0**
O&M Grade: **3**
Clock Start/From: **4**
Clock To: **8**
1st Value:
2nd Value:
Value Percent: **15.000**
Continuous Index: **S01**
Within 8" of Joint: **YES**
Remarks:

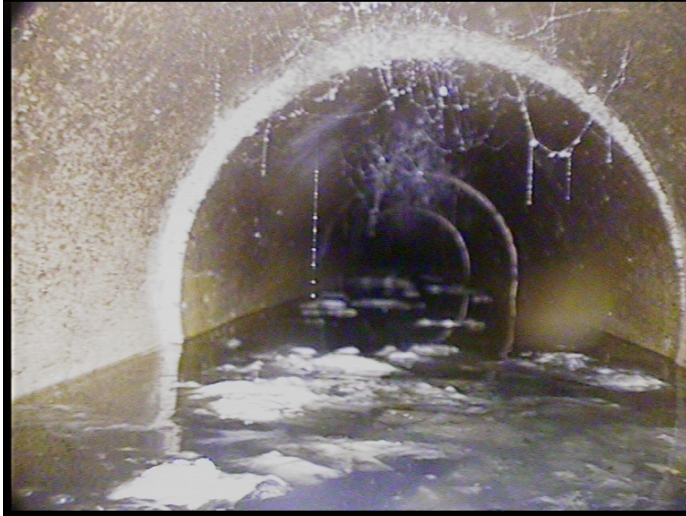
Code: **DSF**
 Description: **Deposits Settled Fine**

Distance (ft): **122.7**
 Structural Grade: **0**
 O&M Grade: **3**
 Clock Start/From: **4**
 Clock To: **8**
 1st Value:
 2nd Value:
 Value Percent: **15.000**
 Continuous Index: **F01**
 Within 8" of Joint: **NO**
 Remarks:

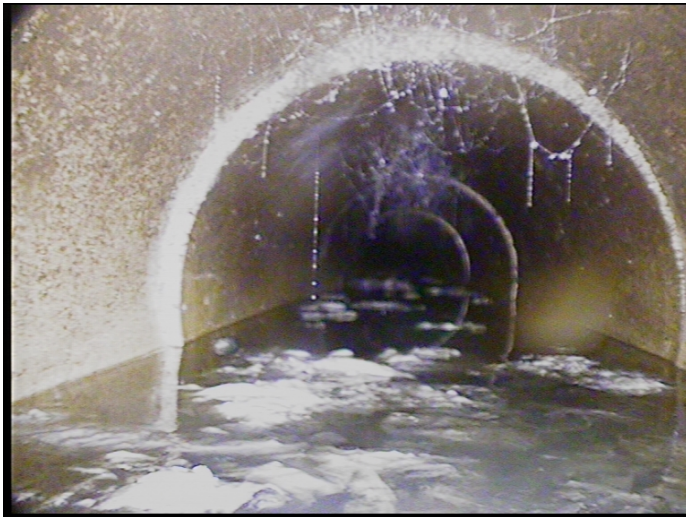
Code: **MSA**
 Description: **Abandoned Survey**

Distance (ft): **122.7**
 Structural Grade: **0**
 O&M Grade: **0**
 Clock Start/From:
 Clock To:
 1st Value:
 2nd Value:
 Value Percent:
 Continuous Index:
 Within 8" of Joint: **NO**
 Remarks: **sediment**
