Profile/Photo Observation Report

Date:	08/09/2022	Weather:		Coding:	PACP 7.0
Pipe Length (ft):	161.0	Owner:	City of Hobart	Pre Clean:	Heavy Cleaning
P.O.#:	YES502259	Surveyor:	S. Bucklin	PSR:	P-505-011-010
Customer:	City of Hobart	Clean Date:	07/20/2022	Shape:	C

Street:	Lake George Drive	Flow Control:	Not Controlled
City:	Hobart, IN	Year Renewed:	
Location:	Local rural streets with light traffic, t	Tape/Media #:	
Purpose:	Routine Assessment	Dia/Height:	15"
Use:	Sanitary Sewage Pipe	Material:	VCP
Drain Area:		Lining:	None
Category:	NA		
Comment:			
Location Details:		Direction of Survey:	Downstream
US MH:	M-505-010	DS MH:	M-505-011
		Total Length Surveyed (ft):	161.3

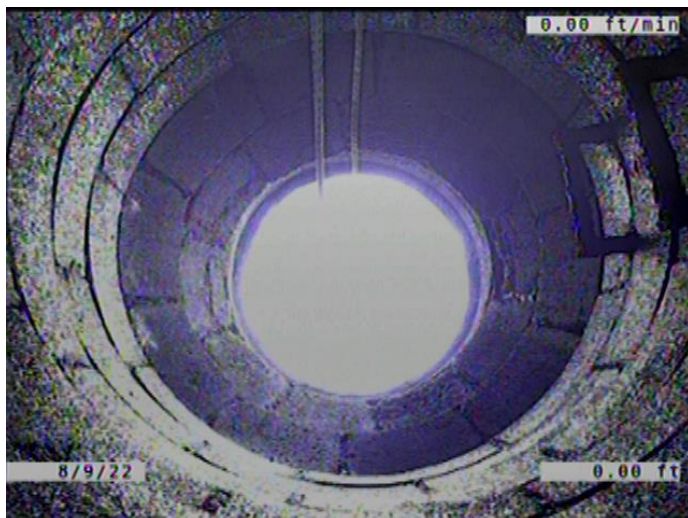
Code: **AMH**
Description: **Manhole**

Distance (ft): **.0**
Structural Grade: **0**
O&M Grade: **0**
Clock Start/From:
Clock To:
1st Value:
2nd Value:
Value Percent:
Continuous Index:
Within 8" of Joint: **NO**
Remarks: **M-505-010**

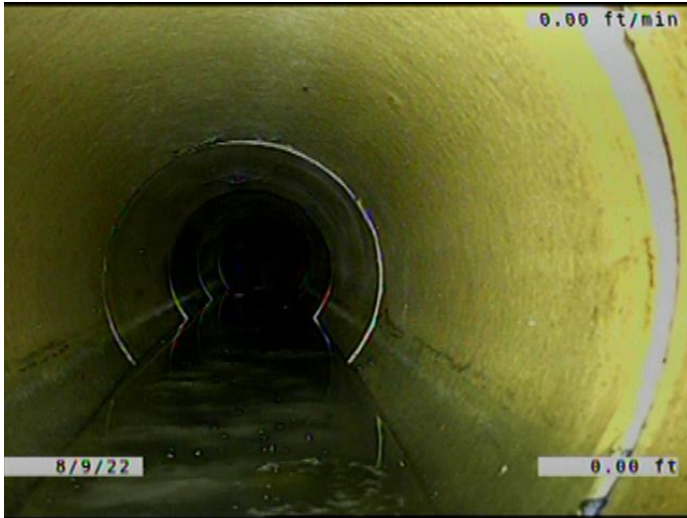
Code: **MWL**
Description: **Miscellaneous Water Level**

Distance (ft): **.0**
Structural Grade: **0**
O&M Grade: **0**
Clock Start/From:
Clock To:
1st Value:
2nd Value:
Value Percent: **10.000**
Continuous Index:
Within 8" of Joint: **NO**
Remarks:

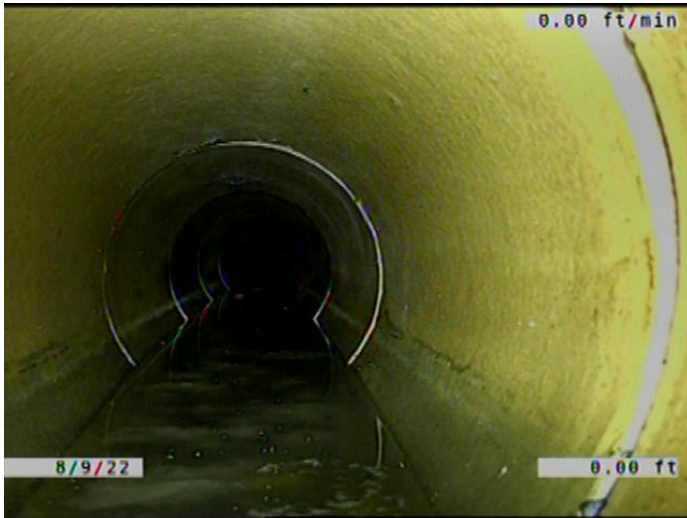
Code: **DSF**
Description: **Deposits Settled Fine**

Distance (ft): **.0**
Structural Grade: **0**
O&M Grade: **2**
Clock Start/From: **5**
Clock To: **7**
1st Value:
2nd Value:
Value Percent: **5.000**
Continuous Index: **S01**
Within 8" of Joint: **YES**
Remarks:

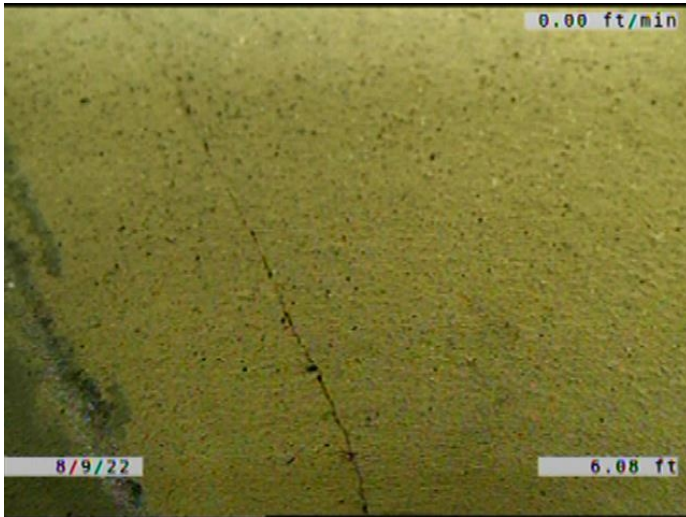
Code: **CS**
 Description: **Crack Spiral**

Distance (ft): **6.1**
 Structural Grade: **2**
 O&M Grade: **0**
 Clock Start/From: **8**
 Clock To: **10**
 1st Value:
 2nd Value:
 Value Percent:
 Continuous Index:
 Within 8" of Joint: **YES**
 Remarks:

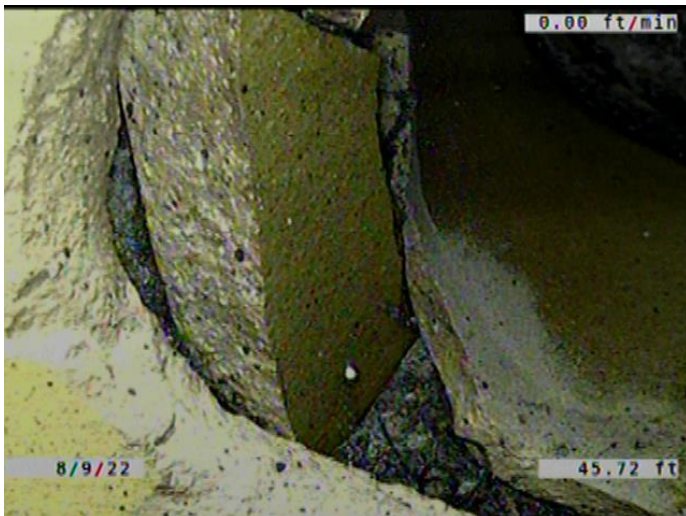
Code: **SSS**
 Description: **Surface Damage Surface Spalling**

Distance (ft): **45.7**
 Structural Grade: **2**
 O&M Grade: **0**
 Clock Start/From: **1**
 Clock To: **3**
 1st Value:
 2nd Value:
 Value Percent:
 Continuous Index:
 Within 8" of Joint: **NO**
 Remarks:

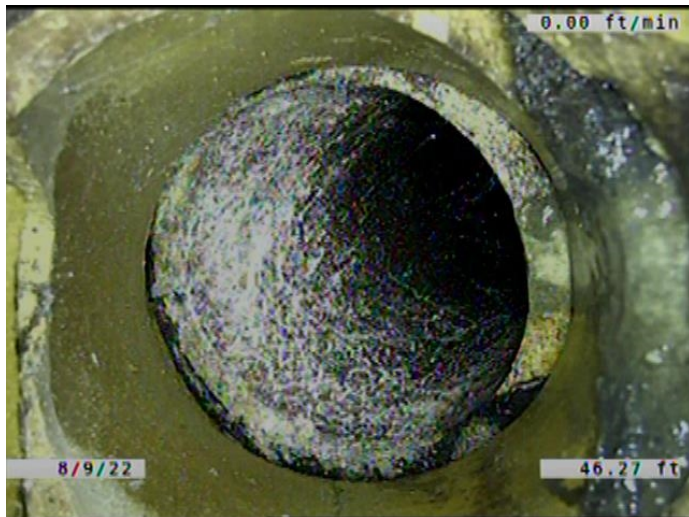
Code: **TBD**
 Description: **Tap Break-in/Hammer Defective**

Distance (ft): **46.3**
 Structural Grade: **0**
 O&M Grade: **3**
 Clock Start/From: **2**
 Clock To:
 1st Value: **6.000**
 2nd Value:
 Value Percent:
 Continuous Index:
 Within 8" of Joint: **NO**
 Remarks: **Broken**

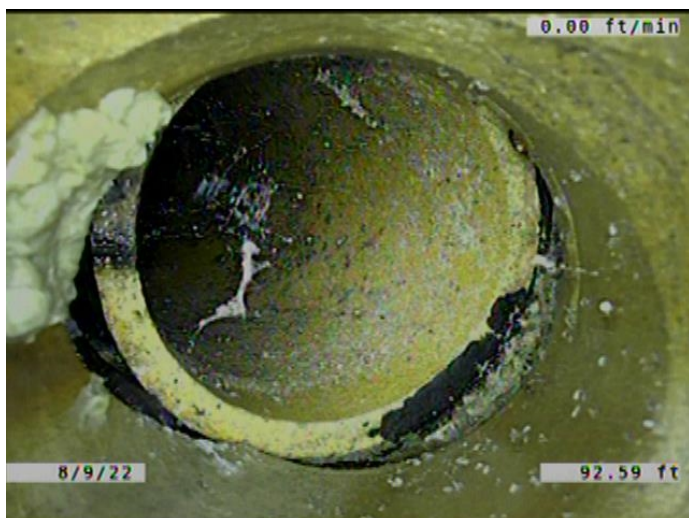
Code: **TFD**
 Description: **Tap Factory Defective**

Distance (ft): **92.6**
 Structural Grade: **0**
 O&M Grade: **3**
 Clock Start/From: **10**
 Clock To:
 1st Value: **6.000**
 2nd Value:
 Value Percent:
 Continuous Index:
 Within 8" of Joint: **YES**
 Remarks: **TAP BROKEN. PART MISSING. AT THE CONNECTION TO THE SERVICE.**

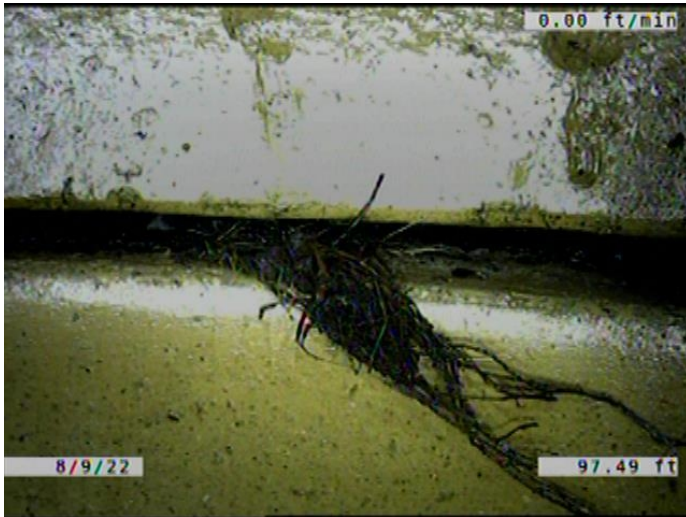
Code: **RFJ**
 Description: **Roots Fine Joint**

Distance (ft): **97.5**
 Structural Grade: **0**
 O&M Grade: **1**
 Clock Start/From: **3**
 Clock To:
 1st Value:
 2nd Value:
 Value Percent:
 Continuous Index:
 Within 8" of Joint: **YES**
 Remarks:

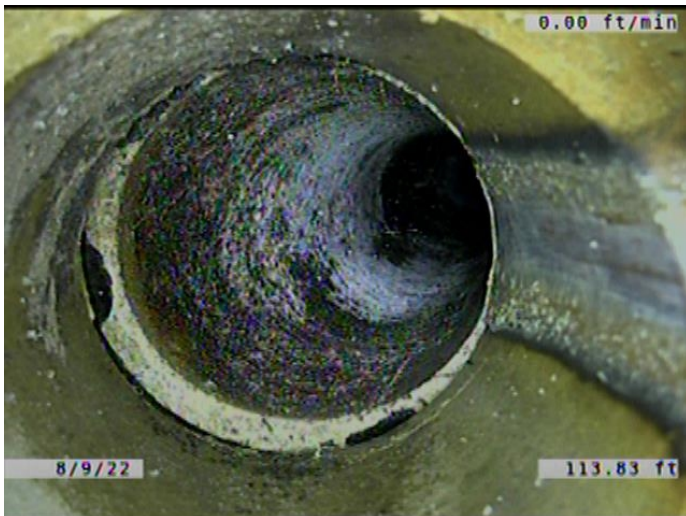
Code: **TF**
 Description: **Tap Factory**

Distance (ft): **113.8**
 Structural Grade: **0**
 O&M Grade: **0**
 Clock Start/From: **2**
 Clock To:
 1st Value: **6.000**
 2nd Value:
 Value Percent:
 Continuous Index:
 Within 8" of Joint: **YES**
 Remarks:

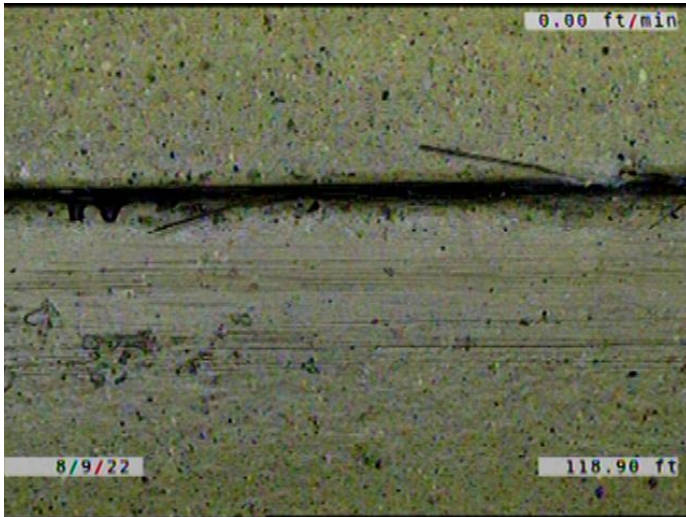
Code: **RFJ**
 Description: **Roots Fine Joint**

Distance (ft): **118.9**
 Structural Grade: **0**
 O&M Grade: **1**
 Clock Start/From: **10**
 Clock To: **11**
 1st Value:
 2nd Value:
 Value Percent:
 Continuous Index:
 Within 8" of Joint: **YES**
 Remarks:

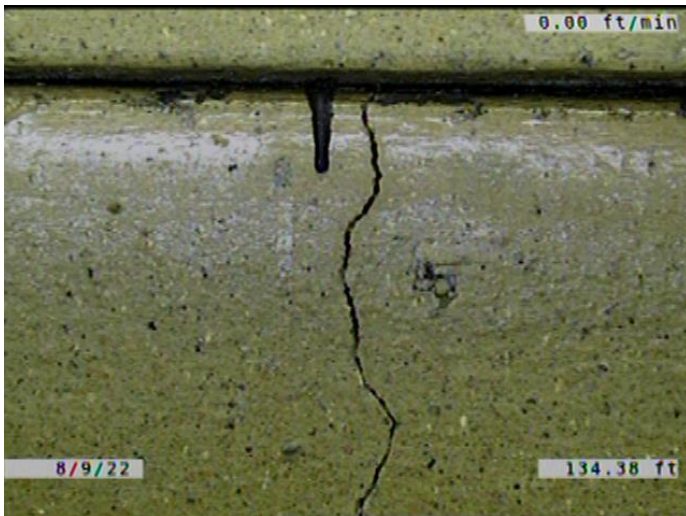
Code: **FM**
 Description: **Fracture Multiple**

Distance (ft): **134.4**
 Structural Grade: **4**
 O&M Grade: **0**
 Clock Start/From: **12**
 Clock To: **12**
 1st Value:
 2nd Value:
 Value Percent:
 Continuous Index: **S02**
 Within 8" of Joint: **YES**
 Remarks:

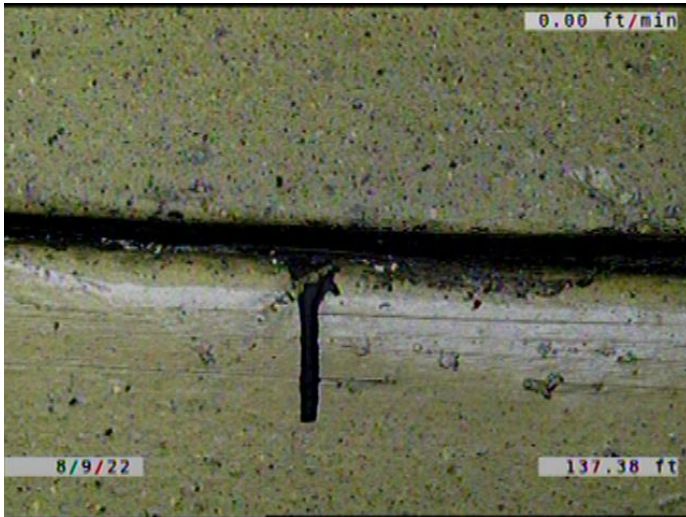
Code: **RFJ**
Description: **Roots Fine Joint**

Distance (ft): **137.4**
Structural Grade: **0**
O&M Grade: **1**
Clock Start/From: **2**
Clock To:
1st Value:
2nd Value:
Value Percent:
Continuous Index:
Within 8" of Joint: **YES**
Remarks:

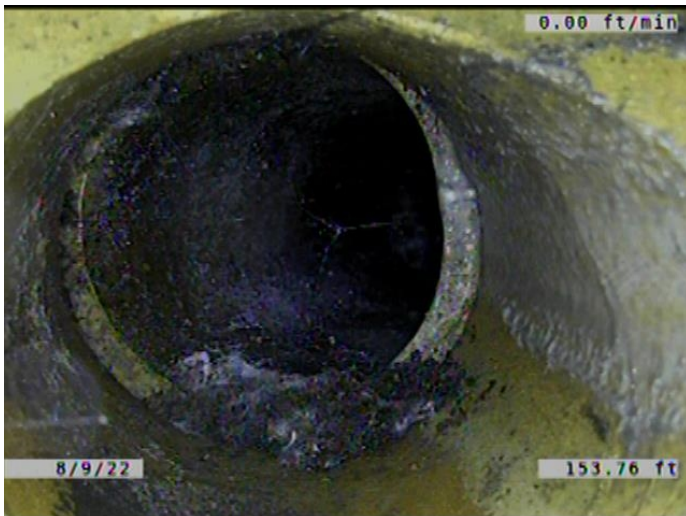
Code: **TF**
Description: **Tap Factory**

Distance (ft): **153.8**
Structural Grade: **0**
O&M Grade: **0**
Clock Start/From: **2**
Clock To:
1st Value: **6.000**
2nd Value:
Value Percent:
Continuous Index:
Within 8" of Joint: **YES**
Remarks: **CONSTANTLY RUNNING WATER.**

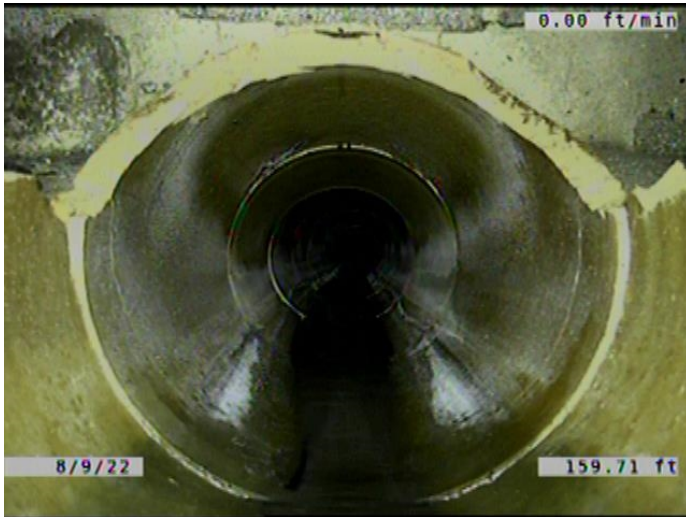
Code: **DSF**
Description: **Deposits Settled Fine**

Distance (ft): **159.7**
Structural Grade: **0**
O&M Grade: **2**
Clock Start/From: **5**
Clock To: **7**
1st Value:
2nd Value:
Value Percent: **5.000**
Continuous Index: **F01**
Within 8" of Joint: **YES**
Remarks:

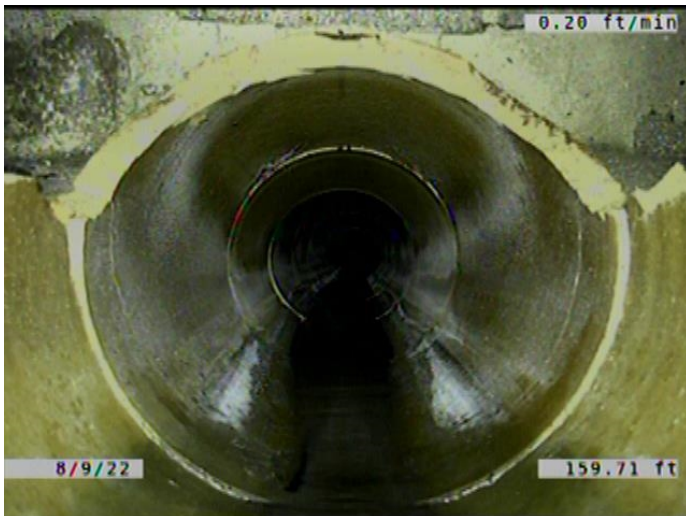
Code: **FM**
Description: **Fracture Multiple**

Distance (ft): **159.7**
Structural Grade: **4**
O&M Grade: **0**
Clock Start/From: **12**
Clock To: **12**
1st Value:
2nd Value:
Value Percent:
Continuous Index: **F02**
Within 8" of Joint: **YES**
Remarks:

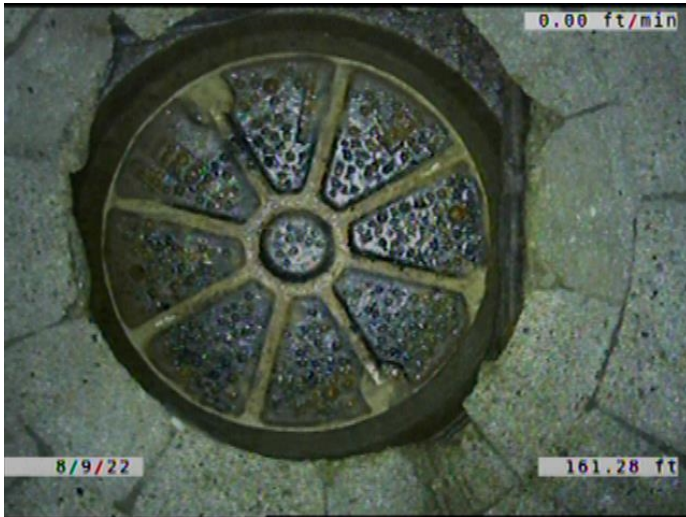
Code:	AMH
Description:	Manhole
Distance (ft):	161.3
Structural Grade:	0
O&M Grade:	0
Clock Start/From:	
Clock To:	
1st Value:	
2nd Value:	
Value Percent:	
Continuous Index:	
Within 8" of Joint:	NO
Remarks:	M-505-011
