Profile/Photo Observation Report

Date:	04/16/2018	Weather:		Coding:	PACP 6.0
Pipe Length (ft):		Owner:	City of Hobart	Pre Clean:	No Pre-Cleaning
P.O.#:	56-2	Surveyor:	M. Pielacha	PSR:	M-505-034-M-605-050
Customer:	City of Hobart	Clean Date:		Shape:	C

Street:	Colorado Street	Flow Control:	Not Controlled
City:	Hobart, IN	Year Renewed:	
Location:	Light Highway	Tape/Media #:	DEP 56
Purpose:	Routine Assessment	Dia/Height:	18"
Use:	Sanitary	Material:	VCP
Drain Area:		Lining:

US MH: **M-505-034** DS MH: **M-605-050** Total Length Surveyed (ft): **156.6**

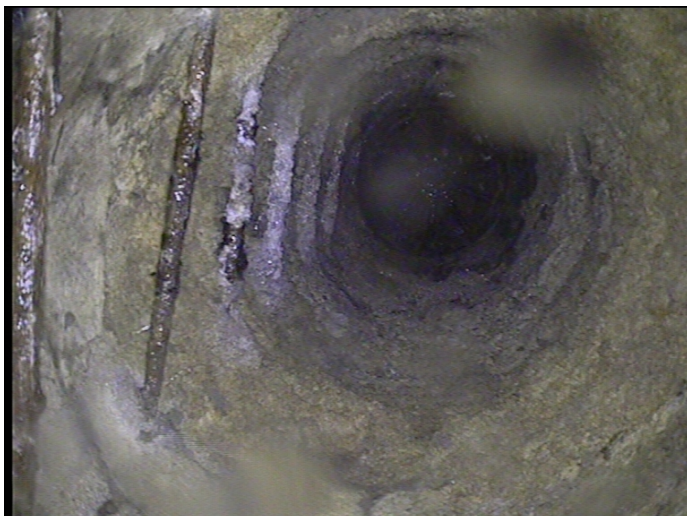
Code: **AMH**
 Description: **Manhole**

Distance (ft): **.0**
 Structural Grade: **0**
 O&M Grade: **0**
 Clock Start/From:
 Clock To:
 1st Value:
 2nd Value:
 Value Percent:
 Continuous Index:
 Within 8" of Joint: **NO**
 Remarks: **M-505-034**

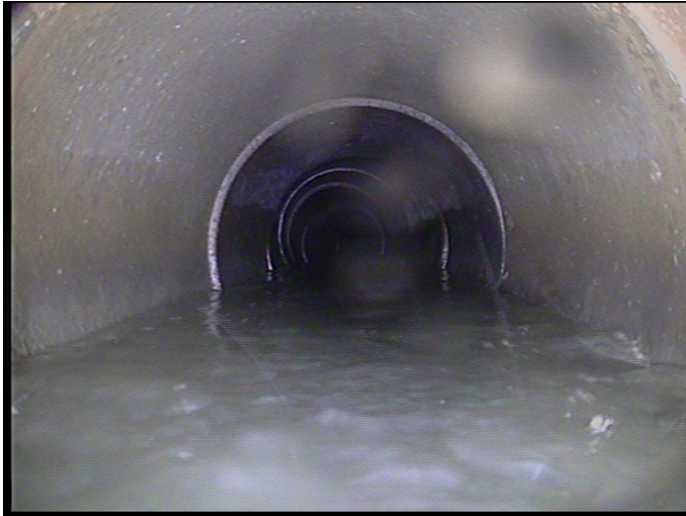
Code: **MWL**
Description: **Water Level**

Distance (ft): **.0**
Structural Grade: **0**
O&M Grade: **0**
Clock Start/From:
Clock To:
1st Value:
2nd Value:
Value Percent: **20.000**
Continuous Index:
Within 8" of Joint: **NO**
Remarks:

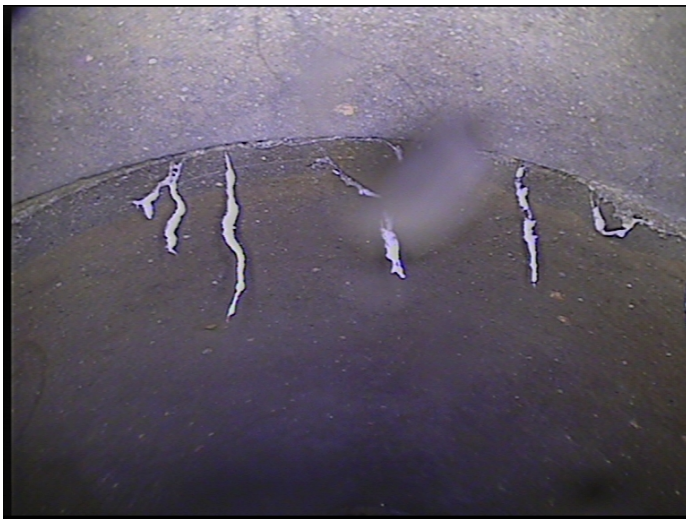
Code: **RFJ**
Description: **Roots Fine Joint**

Distance (ft): **37.1**
Structural Grade: **0**
O&M Grade: **1**
Clock Start/From: **11**
Clock To: **1**
1st Value:
2nd Value:
Value Percent:
Continuous Index: **S01**
Within 8" of Joint: **YES**
Remarks:

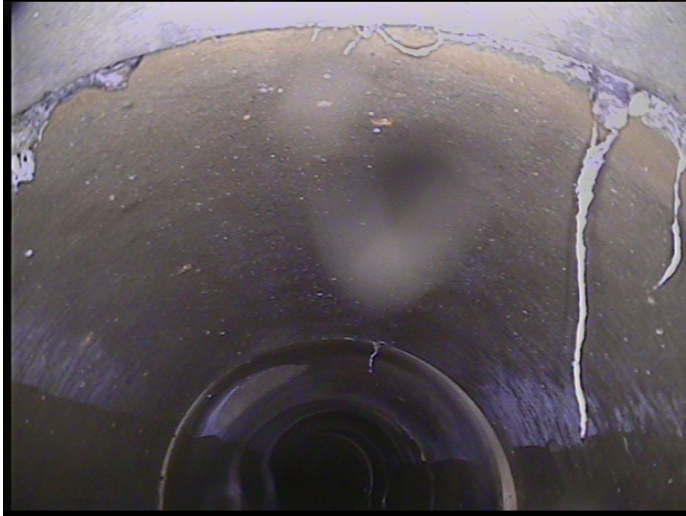
Code: **RFJ**
Description: **Roots Fine Joint**

Distance (ft): **60.3**
Structural Grade: **0**
O&M Grade: **1**
Clock Start/From: **11**
Clock To: **1**
1st Value:
2nd Value:
Value Percent:
Continuous Index: **F01**
Within 8" of Joint: **YES**
Remarks:

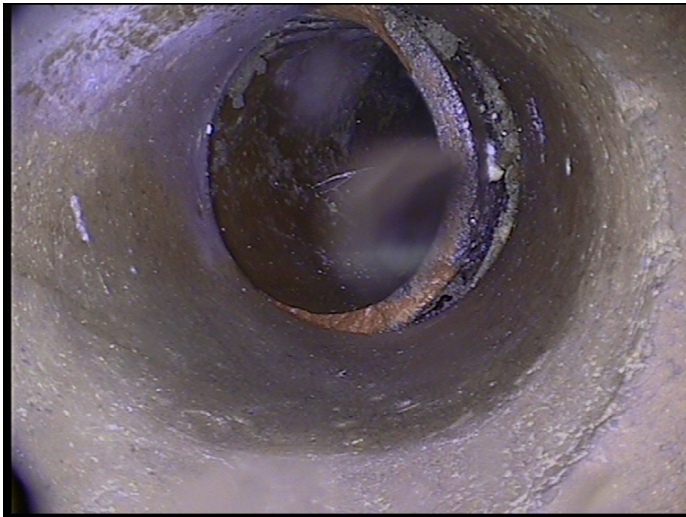
Code: **TF**
Description: **Tap Factory**

Distance (ft): **65.1**
Structural Grade: **0**
O&M Grade: **0**
Clock Start/From: **10**
Clock To:
1st Value: **4.000**
2nd Value:
Value Percent:
Continuous Index:
Within 8" of Joint: **NO**
Remarks:

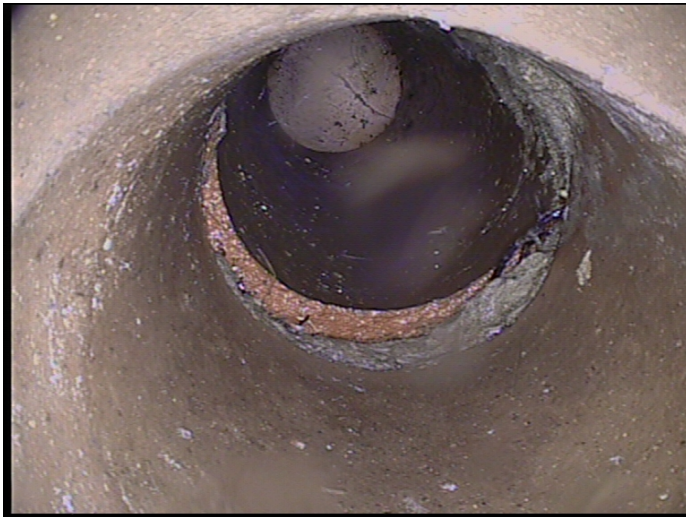
Code: **TFC**
Description: **Tap Factory Capped**

Distance (ft): **67.6**
Structural Grade: **0**
O&M Grade: **0**
Clock Start/From: **2**
Clock To:
1st Value: **4.000**
2nd Value:
Value Percent:
Continuous Index:
Within 8" of Joint: **NO**
Remarks:

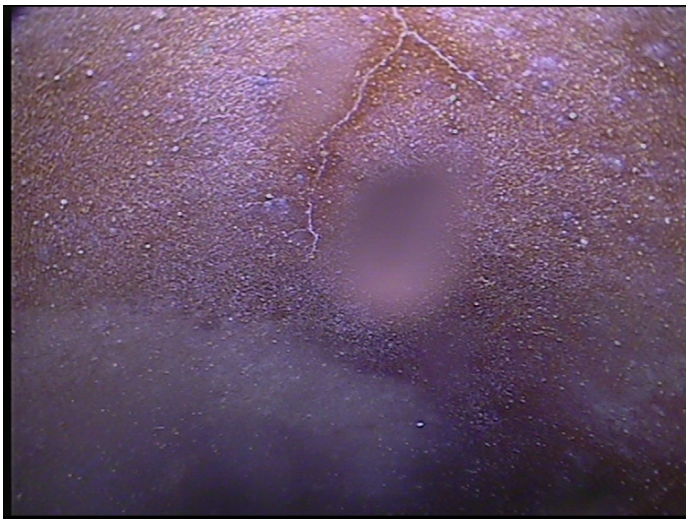
Code: **CM**
Description: **Crack Multiple**

Distance (ft): **110.7**
Structural Grade: **3**
O&M Grade: **0**
Clock Start/From: **1**
Clock To: **2**
1st Value:
2nd Value:
Value Percent:
Continuous Index:
Within 8" of Joint: **YES**
Remarks:

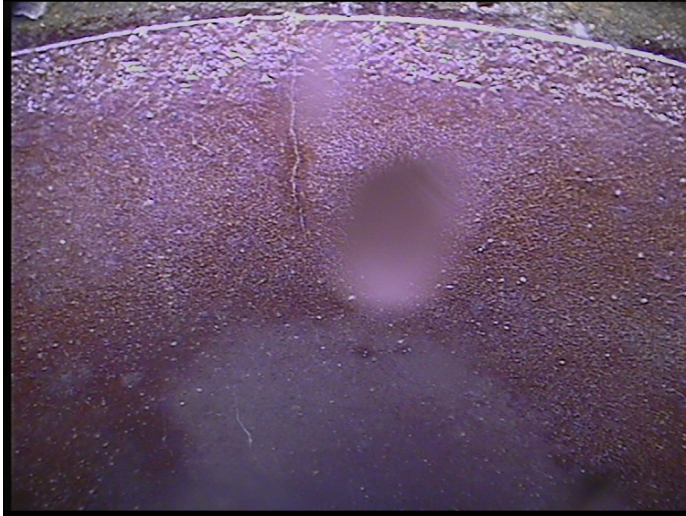
Code: **CL**
Description: **Crack Longitudinal**

Distance (ft): **110.7**
Structural Grade: **2**
O&M Grade: **0**
Clock Start/From: **11**
Clock To:
1st Value:
2nd Value:
Value Percent:
Continuous Index:
Within 8" of Joint: **YES**
Remarks:

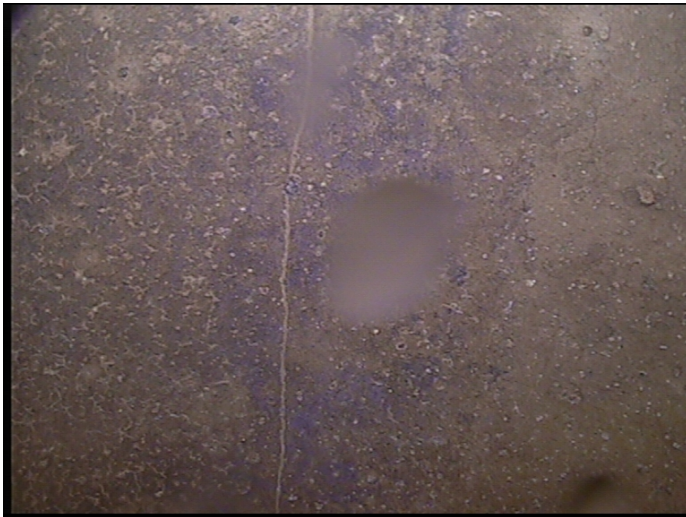
Code: **CL**
Description: **Crack Longitudinal**

Distance (ft): **130.6**
Structural Grade: **2**
O&M Grade: **0**
Clock Start/From: **2**
Clock To:
1st Value:
2nd Value:
Value Percent:
Continuous Index:
Within 8" of Joint: **YES**
Remarks:

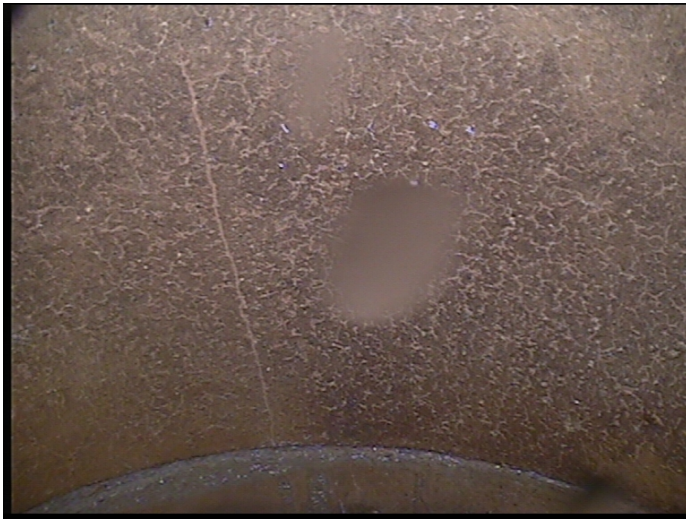
Code:	CL
Description:	Crack Longitudinal
Distance (ft):	130.6
Structural Grade:	2
O&M Grade:	0
Clock Start/From:	11
Clock To:	
1st Value:	
2nd Value:	
Value Percent:	
Continuous Index:	
Within 8" of Joint:	YES
Remarks:

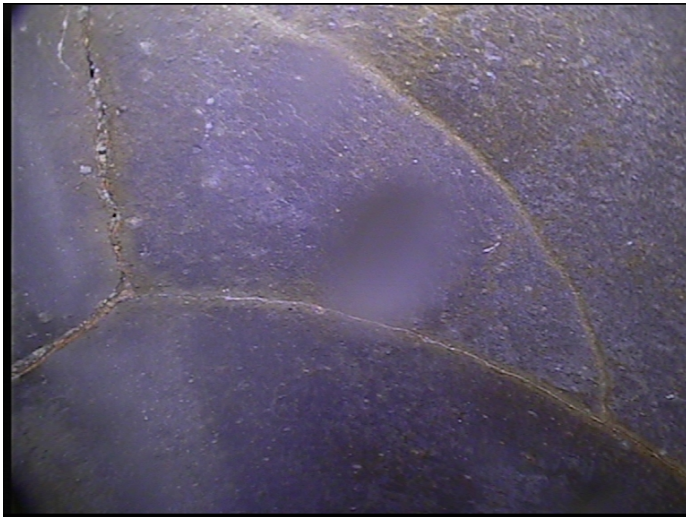
Code:	FM
Description:	Fracture Multiple
Distance (ft):	152.3
Structural Grade:	4
O&M Grade:	0
Clock Start/From:	9
Clock To:	3
1st Value:	
2nd Value:	
Value Percent:	
Continuous Index:	
Within 8" of Joint:	YES
Remarks:

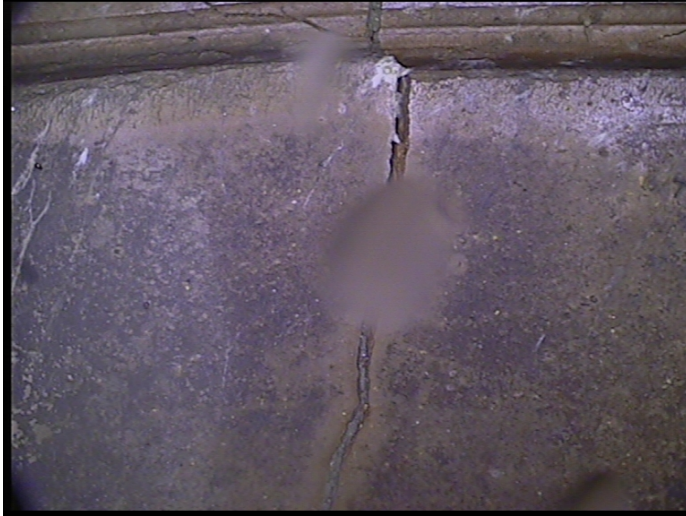
Code:	FC
Description:	Fracture Circumferential
Distance (ft):	154.8
Structural Grade:	2
O&M Grade:	0
Clock Start/From:	7
Clock To:	10
1st Value:	
2nd Value:	
Value Percent:	
Continuous Index:	
Within 8" of Joint:	YES
Remarks:

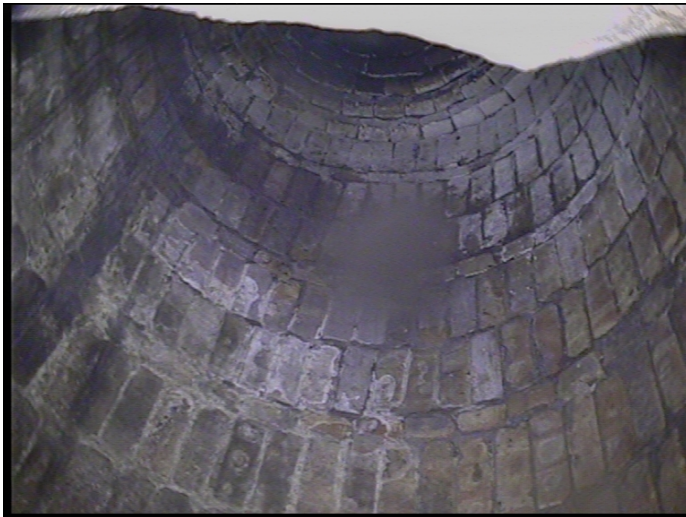
Code:	AMH
Description:	Manhole
Distance (ft):	156.6
Structural Grade:	0
O&M Grade:	0
Clock Start/From:	
Clock To:	
1st Value:	
2nd Value:	
Value Percent:	
Continuous Index:	
Within 8" of Joint:	NO
Remarks:	M-605-050
