Date:	04/25/2018	Weather:		Coding:	PACP 6.0
Pipe Length (ft)	: 342.0	Owner:	NA	Pre Clean:	Not Known
P.O.#:		Surveyor:	Jen Costello	PSR:	P-505-035-036
Customer:		Clean Date:	01/01/1900	Shape:	С
Street:	California		Flow Control:	Not Controlle	d
City:	Hobart, IN		Year Renewed:		
Location:	Other		Tape/Media #:		
Purpose:	Not Known		Dia/Height:	12"	
Use:	Sanitary		Material:	VCP	
Drain Area:	NA		Lining:	Cured in Place	2
Category:	NA				
Comment:	Flow direction wr	ong.			
Location Details:			Direction of Surv	vey: Upstream	
US MH:	M-505-036	DS MH:	M-505-035	Total Length Surveyed (f	t): <b>35.8</b>
D&M Index:	0.00	O&M Quick:	000	0 O&M Rating:	0.00
itructural Index: 0.00		Structural Qu	uick: 000		
Overall Index: 0.00		Overall Quic			0.00

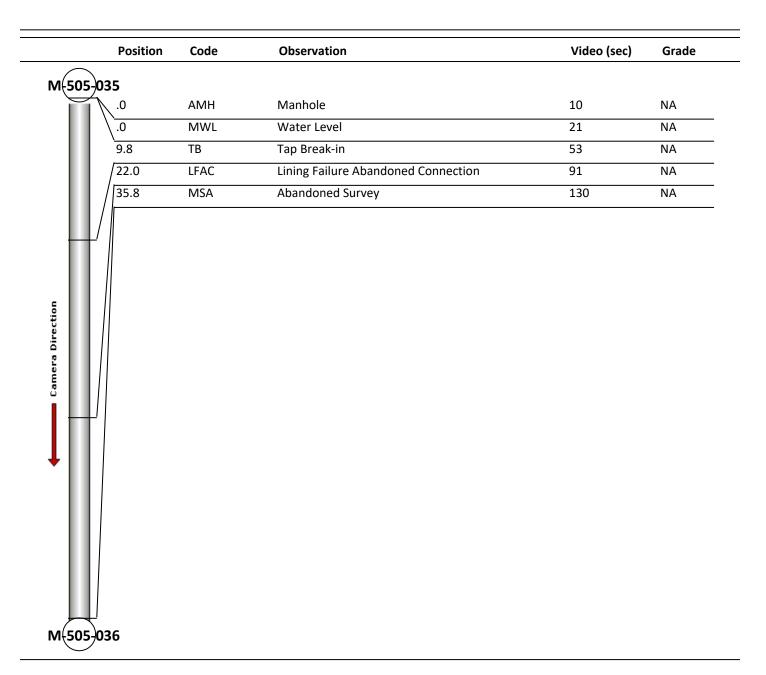
Code: Description:	AMH Manhole
Distance (ft):	.0
Structural Grade:	0
O&M Grade:	0
Clock Start/From:	
Clock To:	
1st Value:	
2nd Value:	
Value Percent:	
Continuous Index:	
Within 8" of Joint:	NO
Remarks:	M-505-035
