## Profile/Photo Observation Report

Street:	<b>California</b>	Flow Control:	<b>Not Controlled</b>
City:	<b>Hobart, IN</b>	Year Renewed:	
Location:	<b>Other</b>	Tape/Media #:	
Purpose:	<b>Not Known</b>	Dia/Height:	<b>12"</b>
Use:	<b>Sanitary</b>	Material:	<b>VCP</b>
Drain Area:	<b>NA</b>	Lining:	<b>Cured in Place</b>
Category:	<b>NA</b>		
Comment:	<b>Flow direction wrong. Reverse setup.</b>

Location Details:		Direction of Survey:	<b>Downstream</b>
US MH:	<b>M-505-036</b>	DS MH:	<b>M-505-035</b>
		Total Length Surveyed (ft):	<b>36.2</b>

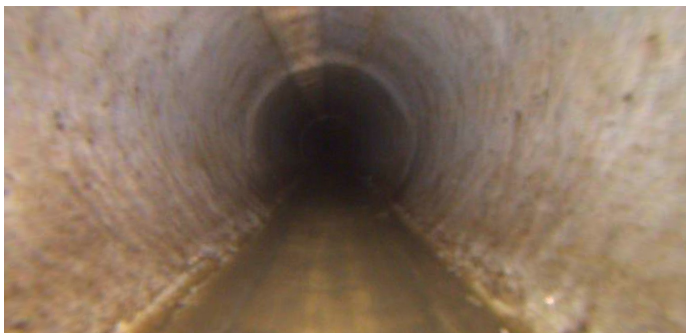
Code: **AMH**  
Description: **Manhole**

Distance (ft): **.0**  
Structural Grade: **0**  
O&M Grade: **0**  
Clock Start/From:  
Clock To:  
1st Value:  
2nd Value:  
Value Percent:  
Continuous Index:  
Within 8" of Joint: **NO**  
Remarks: **M-505-036**

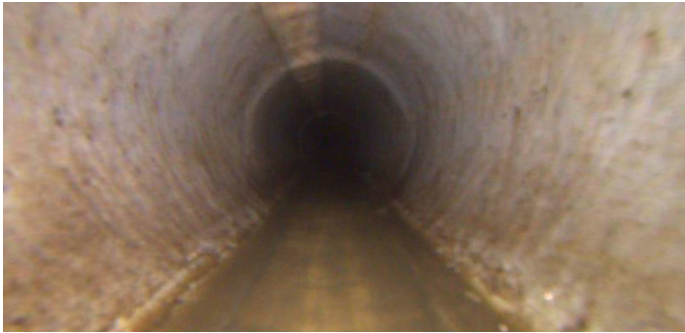
Code:	<b>MWL</b>
Description:	<b>Water Level</b>

Distance (ft):	<b>.0</b>
Structural Grade:	<b>0</b>
O&M Grade:	<b>0</b>
Clock Start/From:	
Clock To:	
1st Value:	
2nd Value:	
Value Percent:	<b>5.000</b>
Continuous Index:	
Within 8" of Joint:	<b>NO</b>
Remarks:

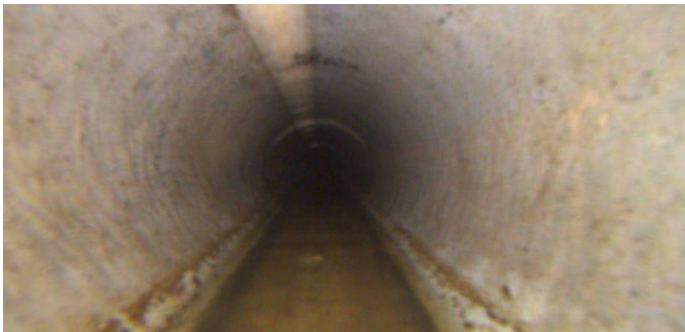
Code:	<b>MSA</b>
Description:	<b>Abandoned Survey</b>

Distance (ft):	<b>36.2</b>
Structural Grade:	<b>0</b>
O&M Grade:	<b>0</b>
Clock Start/From:	
Clock To:	
1st Value:	
2nd Value:	
Value Percent:	
Continuous Index:	
Within 8" of Joint:	<b>NO</b>
Remarks:	<b>unknown</b>
