Profile/Photo Observation Report

Street:	S CALIFORNIA ST	Flow Control:	Not Controlled
City:	Hobart, IN	Year Renewed:	
Location:	Other	Tape/Media #:	
Purpose:	Not Known	Dia/Height:	12"
Use:	Sanitary	Material:	VCP
Drain Area:	NA	Lining:	Cured in Place
Category:	NA		
Comment:	Flow direction wrong. Reverse setup. Unknown reason for stop.		
Location Details:		Direction of Survey:	Downstream
US MH:	M-505-036	DS MH:	M-505-035
		Total Length Surveyed (ft):	55.3

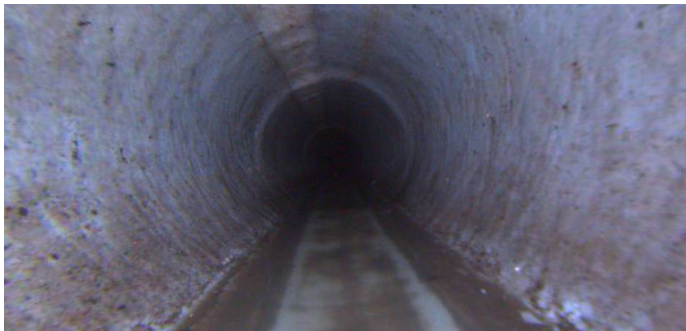
Code: **AMH**
Description: **Manhole**

Distance (ft): **.0**
Structural Grade: **0**
O&M Grade: **0**
Clock Start/From:
Clock To:
1st Value:
2nd Value:
Value Percent:
Continuous Index:
Within 8" of Joint: **NO**
Remarks: **M-505-036**

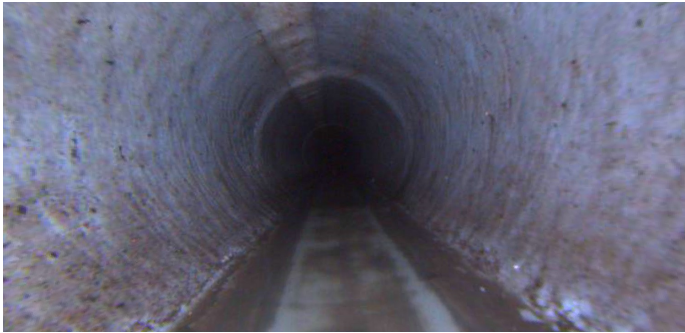
Code:	MWL
Description:	Water Level

Distance (ft):	.0
Structural Grade:	0
O&M Grade:	0
Clock Start/From:	
Clock To:	
1st Value:	
2nd Value:	
Value Percent:	5.000
Continuous Index:	
Within 8" of Joint:	NO
Remarks:

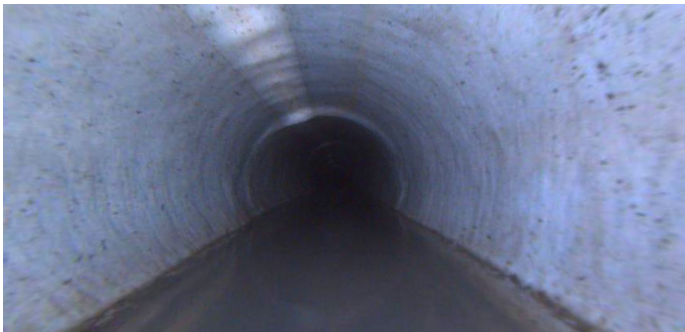
Code:	MWL
Description:	Water Level

Distance (ft):	40.6
Structural Grade:	0
O&M Grade:	0
Clock Start/From:	
Clock To:	
1st Value:	
2nd Value:	
Value Percent:	20.000
Continuous Index:	
Within 8" of Joint:	NO
Remarks:

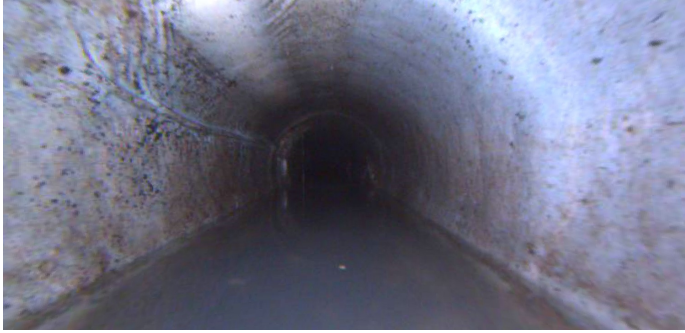
Code: **LFW**
Description: **Lining Failure Wrinkled**

Distance (ft): **55.3**
Structural Grade: **3**
O&M Grade: **0**
Clock Start/From: **10**
Clock To: **12**
1st Value:
2nd Value:
Value Percent:
Continuous Index:
Within 8" of Joint: **NO**
Remarks:

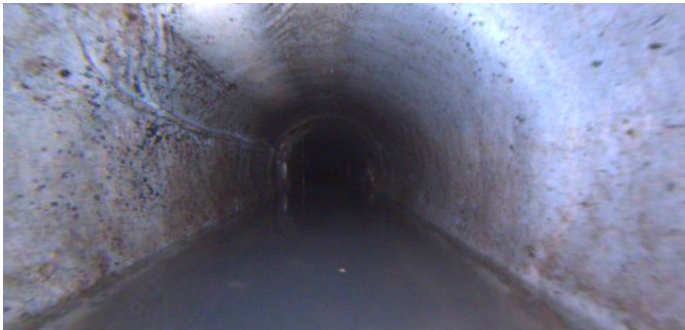
Code: **MSA**
Description: **Abandoned Survey**

Distance (ft): **55.3**
Structural Grade: **0**
O&M Grade: **0**
Clock Start/From:
Clock To:
1st Value:
2nd Value:
Value Percent:
Continuous Index:
Within 8" of Joint: **NO**
Remarks: **UNKNOWN**
