Profile/Photo Observation Report

Date:	04/25/2018	Weather:		Coding:	PACP 6.0
Pipe Length (ft):	342.0	Owner:	NA	Pre Clean:	Not Known
P.O.#:		Surveyor:	Jen Costello	PSR:	P-505-035-036
Customer:		Clean Date:	01/01/1900	Shape:	C

Street:	California	Flow Control:	Not Controlled
City:	Hobart, IN	Year Renewed:	
Location:	Other	Tape/Media #:	
Purpose:	Not Known	Dia/Height:	12"
Use:	Sanitary	Material:	VCP
Drain Area:	NA	Lining:	Cured in Place
Category:	NA		
Comment:	Flow direction wrong. Reverse setup. Unknown reason for stop.		
Location Details:		Direction of Survey:	Downstream
US MH:	M-505-036	DS MH:	M-505-035
		Total Length Surveyed (ft):	55.3

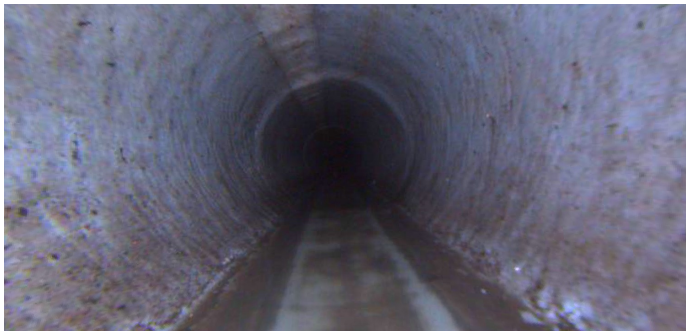
Code: **AMH**
Description: **Manhole**

Distance (ft): **.0**
Structural Grade: **0**
O&M Grade: **0**
Clock Start/From:
Clock To:
1st Value:
2nd Value:
Value Percent:
Continuous Index:
Within 8" of Joint: **NO**
Remarks: **M-505-036**

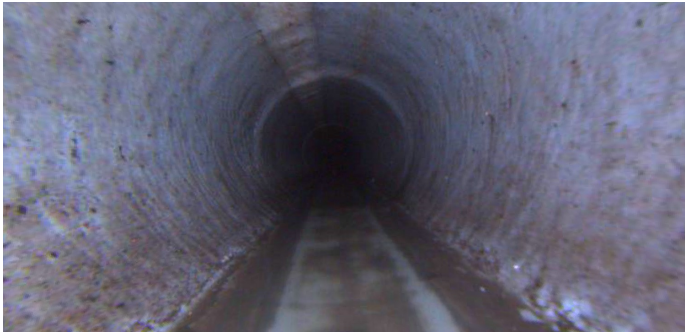
Code:	MWL
Description:	Water Level

Distance (ft):	.0
Structural Grade:	0
O&M Grade:	0
Clock Start/From:	
Clock To:	
1st Value:	
2nd Value:	
Value Percent:	5.000
Continuous Index:	
Within 8" of Joint:	NO
Remarks:

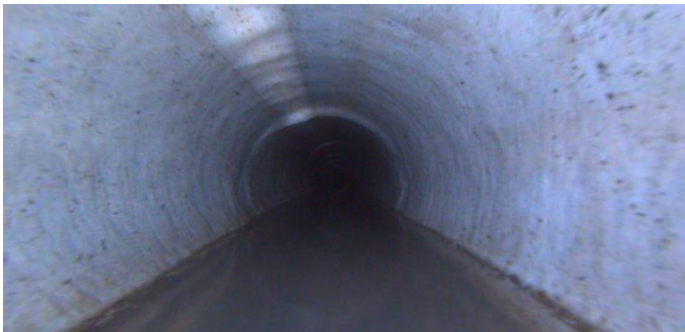
Code:	MWL
Description:	Water Level

Distance (ft):	40.6
Structural Grade:	0
O&M Grade:	0
Clock Start/From:	
Clock To:	
1st Value:	
2nd Value:	
Value Percent:	20.000
Continuous Index:	
Within 8" of Joint:	NO
Remarks:

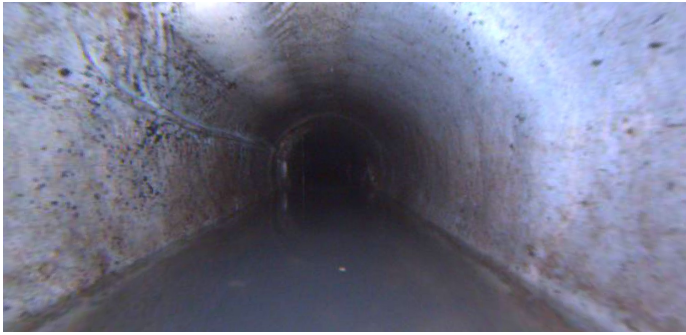
Code: **LFW**
Description: **Lining Failure Wrinkled**

Distance (ft): **55.3**
Structural Grade: **3**
O&M Grade: **0**
Clock Start/From: **10**
Clock To: **12**
1st Value:
2nd Value:
Value Percent:
Continuous Index:
Within 8" of Joint: **NO**
Remarks:

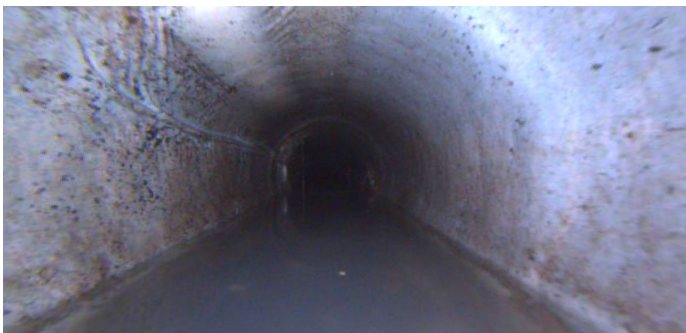
Code: **MSA**
Description: **Abandoned Survey**

Distance (ft): **55.3**
Structural Grade: **0**
O&M Grade: **0**
Clock Start/From:
Clock To:
1st Value:
2nd Value:
Value Percent:
Continuous Index:
Within 8" of Joint: **NO**
Remarks: **UNKNOWN**
