## Profile/Photo Observation Report

Street:	<b>S CALIFORNIA ST</b>	Flow Control:	<b>Not Controlled</b>
City:	<b>Hobart, IN</b>	Year Renewed:	
Location:	<b>Other</b>	Tape/Media #:	
Purpose:	<b>Not Known</b>	Dia/Height:	<b>12"</b>
Use:	<b>Sanitary</b>	Material:	<b>VCP</b>
Drain Area:	<b>NA</b>	Lining:	<b>Cured in Place</b>
Category:	<b>NA</b>		
Comment:	<b>Flow direction wrong. Redeployment..</b>		
Location Details:		Direction of Survey:	<b>Upstream</b>
US MH:	<b>M-505-036</b>	DS MH:	<b>M-505-035</b>
		Total Length Surveyed (ft):	<b>51.7</b>

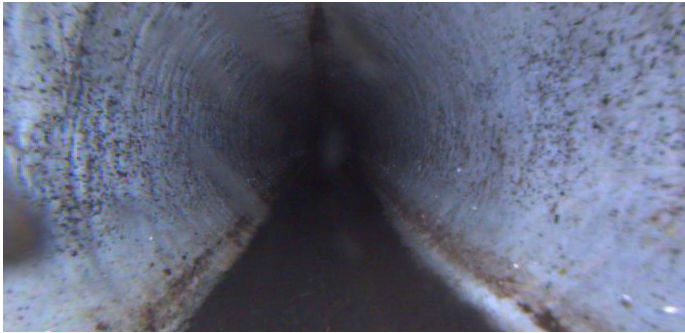
Code:	<b>MWL</b>
Description:	<b>Water Level</b>

Distance (ft):	<b>.0</b>
Structural Grade:	<b>0</b>
O&M Grade:	<b>0</b>
Clock Start/From:	
Clock To:	
1st Value:	
2nd Value:	
Value Percent:	<b>5.000</b>
Continuous Index:	
Within 8" of Joint:	<b>NO</b>
Remarks:

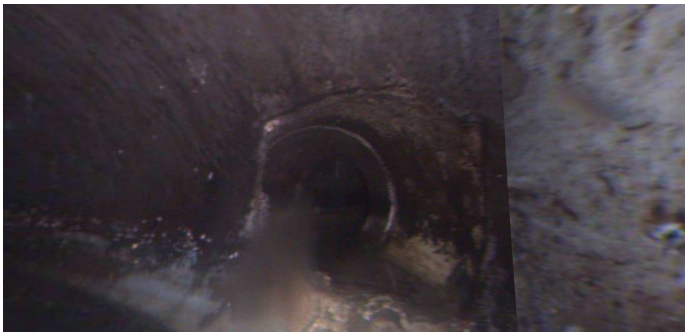
Code:	<b>TBA</b>
Description:	<b>Tap Break-in Active</b>

Distance (ft):	<b>10.0</b>
Structural Grade:	<b>0</b>
O&M Grade:	<b>0</b>
Clock Start/From:	<b>9</b>
Clock To:	
1st Value:	<b>4.000</b>
2nd Value:	
Value Percent:	
Continuous Index:	
Within 8" of Joint:	
Remarks:

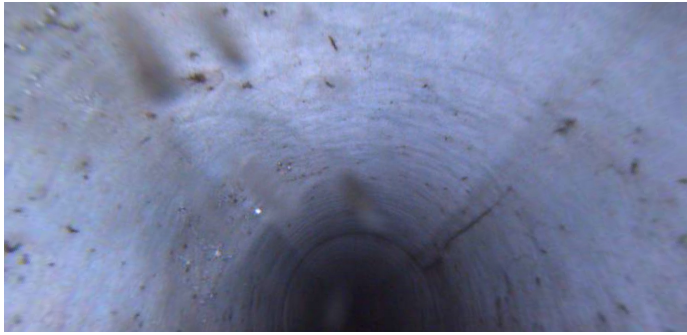
Code:	<b>LFAC</b>
Description:	<b>Lining Failure Abandoned Connection</b>
Distance (ft):	<b>22.4</b>
Structural Grade:	<b>0</b>
O&M Grade:	<b>0</b>
Clock Start/From:	<b>10</b>
Clock To:	
1st Value:	
2nd Value:	
Value Percent:	
Continuous Index:	
Within 8" of Joint:	<b>NO</b>
Remarks:

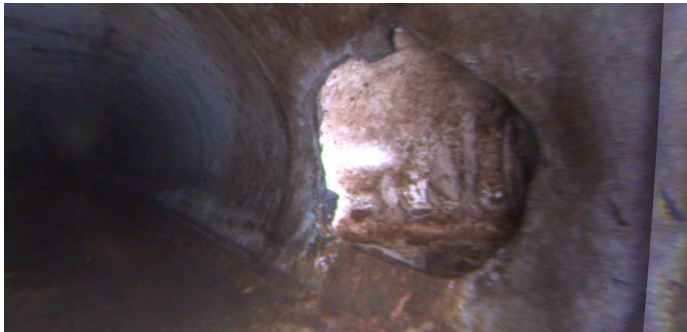
Code:	<b>TB</b>
Description:	<b>Tap Break-in</b>
Distance (ft):	<b>43.3</b>
Structural Grade:	<b>0</b>
O&M Grade:	<b>0</b>
Clock Start/From:	<b>3</b>
Clock To:	
1st Value:	<b>4.000</b>
2nd Value:	
Value Percent:	
Continuous Index:	
Within 8" of Joint:	
Remarks:

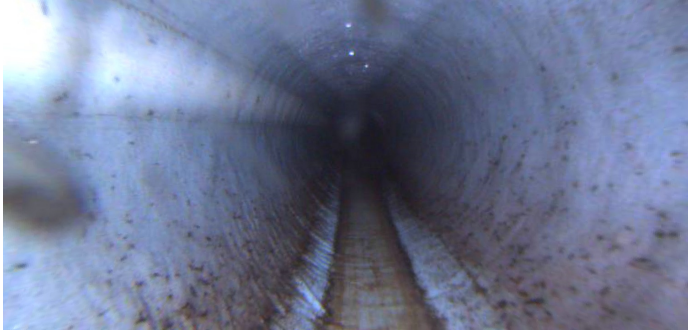
Code:	<b>MSA</b>
Description:	<b>Abandoned Survey</b>
Distance (ft):	<b>51.7</b>
Structural Grade:	<b>0</b>
O&M Grade:	<b>0</b>
Clock Start/From:	
Clock To:	
1st Value:	
2nd Value:	
Value Percent:	
Continuous Index:	
Within 8" of Joint:	<b>NO</b>
Remarks:	<b>UNKNOWN</b>
