## Profile/Photo Observation Report

Date:	<b>04/25/2018</b>	Weather:		Coding:	<b>PACP 6.0</b>
Pipe Length (ft):	<b>342.0</b>	Owner:	<b>NA</b>	Pre Clean:	<b>Not Known</b>
P.O.#:		Surveyor:	<b>Jen Costello</b>	PSR:	<b>P-505-035-036</b>
Customer:		Clean Date:	<b>01/01/1900</b>	Shape:	<b>C</b>

Street:	<b>California</b>	Flow Control:	<b>Not Controlled</b>
City:	<b>Hobart, IN</b>	Year Renewed:	
Location:	<b>Other</b>	Tape/Media #:	
Purpose:	<b>Not Known</b>	Dia/Height:	<b>12"</b>
Use:	<b>Sanitary</b>	Material:	<b>VCP</b>
Drain Area:	<b>NA</b>	Lining:	<b>Cured in Place</b>
Category:	<b>NA</b>		
Comment:	<b>Flow direction wrong. Redeployment..</b>		
Location Details:		Direction of Survey:	<b>Upstream</b>
US MH:	<b>M-505-036</b>	DS MH:	<b>M-505-035</b>
		Total Length Surveyed (ft):	<b>51.7</b>

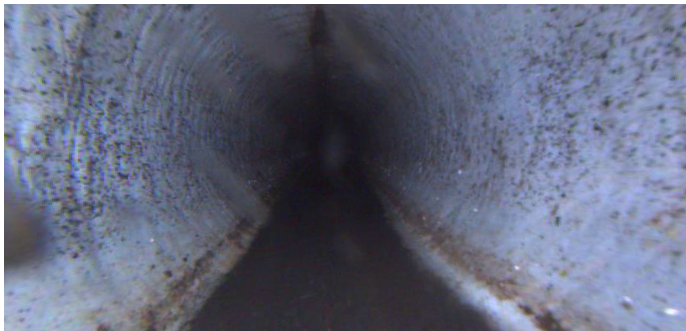
Code: **AMH**  
Description: **Manhole**

Distance (ft): **.0**  
Structural Grade: **0**  
O&M Grade: **0**  
Clock Start/From:  
Clock To:  
1st Value:  
2nd Value:  
Value Percent:  
Continuous Index:  
Within 8" of Joint: **NO**  
Remarks: **M-505-035**

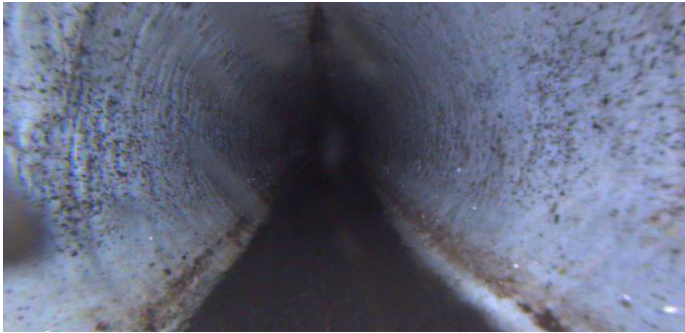
Code:	<b>MWL</b>
Description:	<b>Water Level</b>

Distance (ft):	<b>.0</b>
Structural Grade:	<b>0</b>
O&M Grade:	<b>0</b>
Clock Start/From:	
Clock To:	
1st Value:	
2nd Value:	
Value Percent:	<b>5.000</b>
Continuous Index:	
Within 8" of Joint:	<b>NO</b>
Remarks:

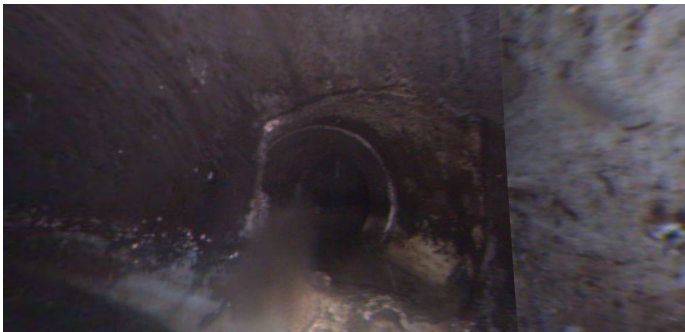
Code:	<b>TBA</b>
Description:	<b>Tap Break-in Active</b>

Distance (ft):	<b>10.0</b>
Structural Grade:	<b>0</b>
O&M Grade:	<b>0</b>
Clock Start/From:	<b>9</b>
Clock To:	
1st Value:	<b>4.000</b>
2nd Value:	
Value Percent:	
Continuous Index:	
Within 8" of Joint:	
Remarks:

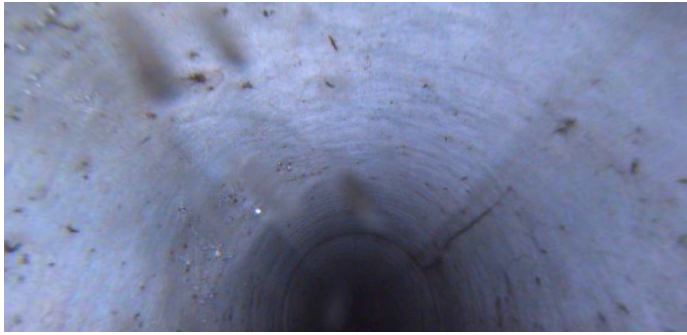
Code:	<b>LFAC</b>
Description:	<b>Lining Failure Abandoned Connection</b>
Distance (ft):	<b>22.4</b>
Structural Grade:	<b>0</b>
O&M Grade:	<b>0</b>
Clock Start/From:	<b>10</b>
Clock To:	
1st Value:	
2nd Value:	
Value Percent:	
Continuous Index:	
Within 8" of Joint:	<b>NO</b>
Remarks:

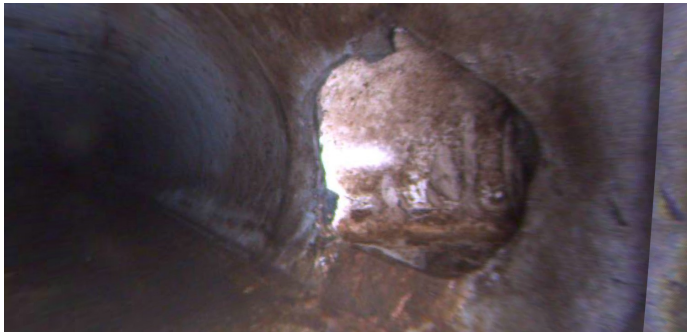
Code:	<b>TB</b>
Description:	<b>Tap Break-in</b>
Distance (ft):	<b>43.3</b>
Structural Grade:	<b>0</b>
O&M Grade:	<b>0</b>
Clock Start/From:	<b>3</b>
Clock To:	
1st Value:	<b>4.000</b>
2nd Value:	
Value Percent:	
Continuous Index:	
Within 8" of Joint:	
Remarks:

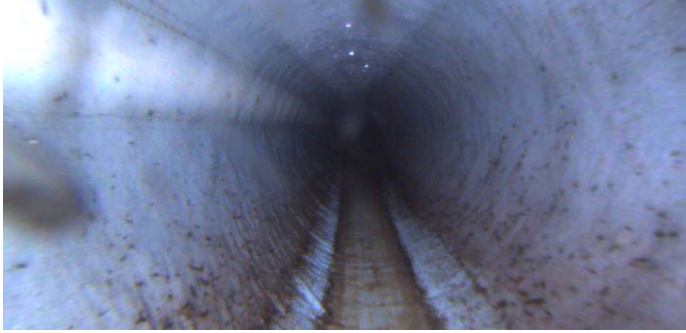
Code:	<b>MSA</b>
Description:	<b>Abandoned Survey</b>
Distance (ft):	<b>51.7</b>
Structural Grade:	<b>0</b>
O&M Grade:	<b>0</b>
Clock Start/From:	
Clock To:	
1st Value:	
2nd Value:	
Value Percent:	
Continuous Index:	
Within 8" of Joint:	<b>NO</b>
Remarks:	<b>UNKNOWN</b>
