Profile/Photo Observation Report

Date:	04/26/2018	Weather:		Coding:	PACP 6.0
Pipe Length (ft):	342.0	Owner:	NA	Pre Clean:	Not Known
P.O.#:		Surveyor:	Mark Ruby	PSR:	P-505-035-036
Customer:		Clean Date:	01/01/1900	Shape:	C

Street:	California	Flow Control:	Not Controlled
City:	Hobart, IN	Year Renewed:	
Location:	Other	Tape/Media #:	
Purpose:	Not Known	Dia/Height:	12"
Use:	Sanitary	Material:	VCP
Drain Area:	NA	Lining:	Cured in Place
Category:	NA		
Comment:	Flow direction wrong. Redeployment. Debris at 228'.		
Location Details:		Direction of Survey:	Upstream
US MH:	M-505-036	DS MH:	M-505-035
		Total Length Surveyed (ft):	230.2

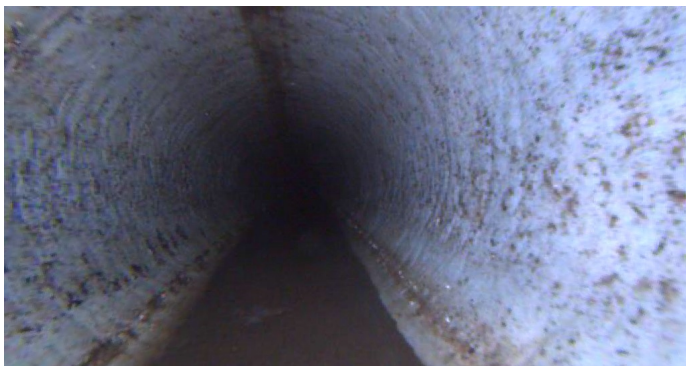
Code: **AMH**
Description: **Manhole**

Distance (ft): **.0**
Structural Grade: **0**
O&M Grade: **0**
Clock Start/From:
Clock To:
1st Value:
2nd Value:
Value Percent:
Continuous Index:
Within 8" of Joint: **NO**
Remarks: **M-505-035**

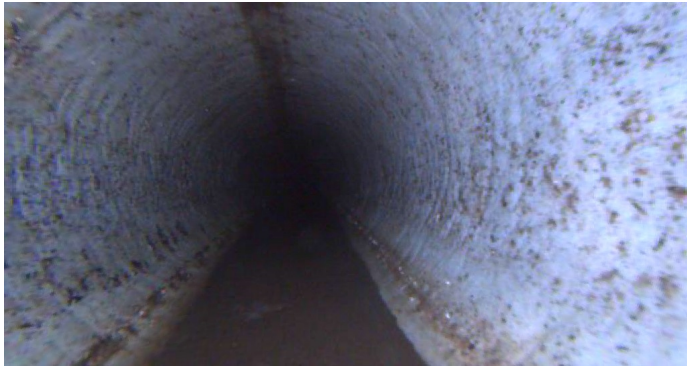
Code:	MWL
Description:	Water Level
Distance (ft):	.0
Structural Grade:	0
O&M Grade:	0
Clock Start/From:	
Clock To:	
1st Value:	
2nd Value:	
Value Percent:	10.000
Continuous Index:	
Within 8" of Joint:	NO
Remarks:

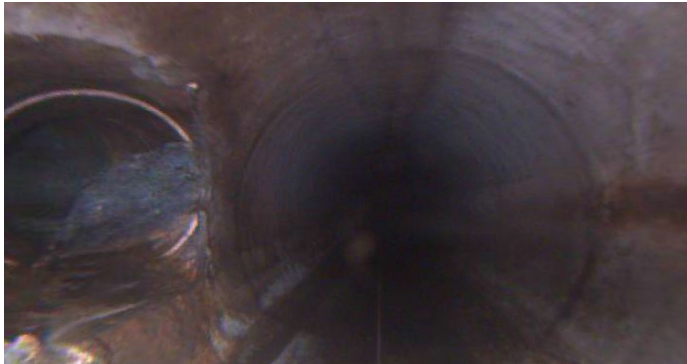
Code:	TF
Description:	Tap Factory
Distance (ft):	44.2
Structural Grade:	0
O&M Grade:	0
Clock Start/From:	4
Clock To:	
1st Value:	4.000
2nd Value:	
Value Percent:	
Continuous Index:	
Within 8" of Joint:	
Remarks:

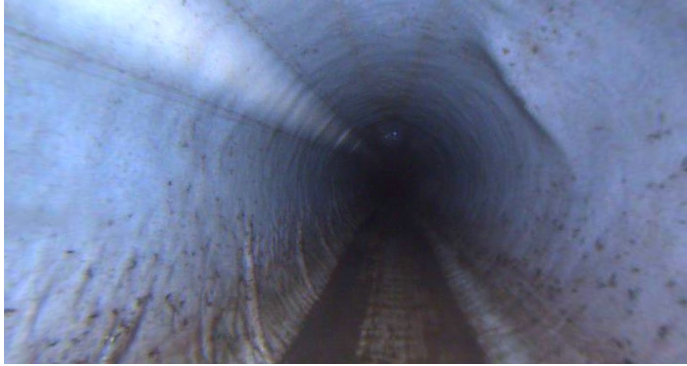
Code:	LFAC
Description:	Lining Failure Abandoned Connection
Distance (ft):	55.6
Structural Grade:	0
O&M Grade:	0
Clock Start/From:	2
Clock To:	
1st Value:	
2nd Value:	
Value Percent:	
Continuous Index:	
Within 8" of Joint:	NO
Remarks:

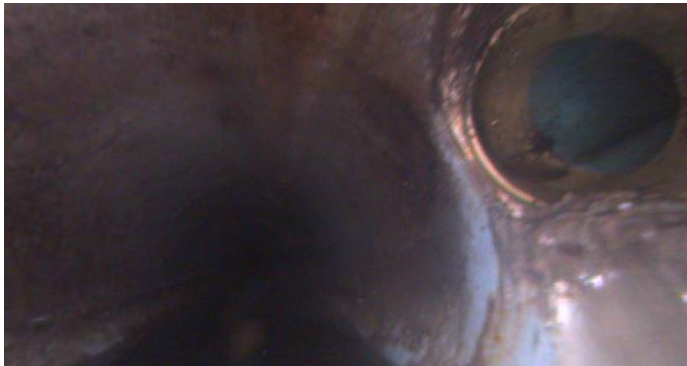
Code:	TF
Description:	Tap Factory
Distance (ft):	75.1
Structural Grade:	0
O&M Grade:	0
Clock Start/From:	9
Clock To:	
1st Value:	4.000
2nd Value:	
Value Percent:	
Continuous Index:	
Within 8" of Joint:	
Remarks:

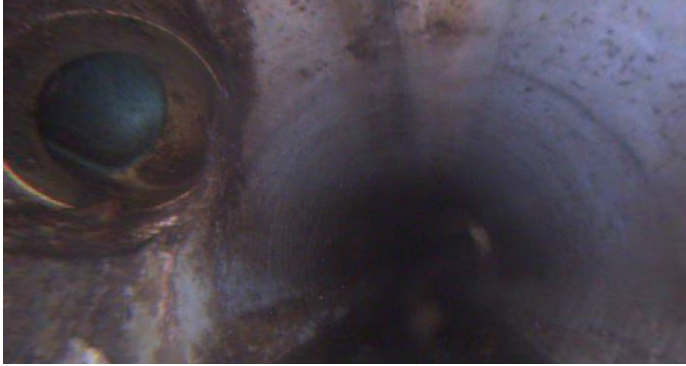
Code: **TF**
Description: **Tap Factory**

Distance (ft): **77.8**
Structural Grade: **0**
O&M Grade: **0**
Clock Start/From: **3**
Clock To:
1st Value: **4.000**
2nd Value:
Value Percent:
Continuous Index:
Within 8" of Joint:
Remarks:

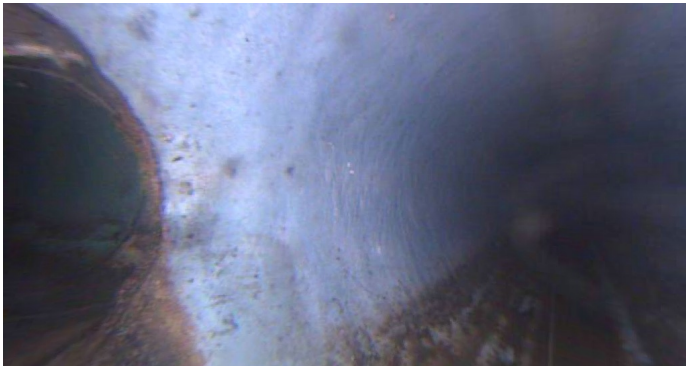
Code: **TF**
Description: **Tap Factory**

Distance (ft): **140.9**
Structural Grade: **0**
O&M Grade: **0**
Clock Start/From: **4**
Clock To:
1st Value: **4.000**
2nd Value:
Value Percent:
Continuous Index:
Within 8" of Joint:
Remarks:

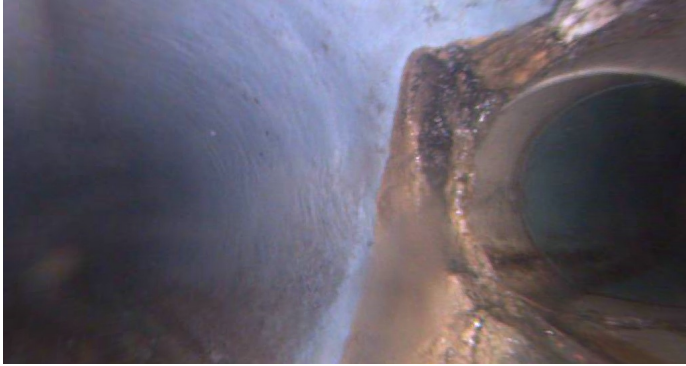
Code: **TF**
Description: **Tap Factory**

Distance (ft): **158.2**
Structural Grade: **0**
O&M Grade: **0**
Clock Start/From: **8**
Clock To:
1st Value: **4.000**
2nd Value:
Value Percent:
Continuous Index:
Within 8" of Joint:
Remarks:

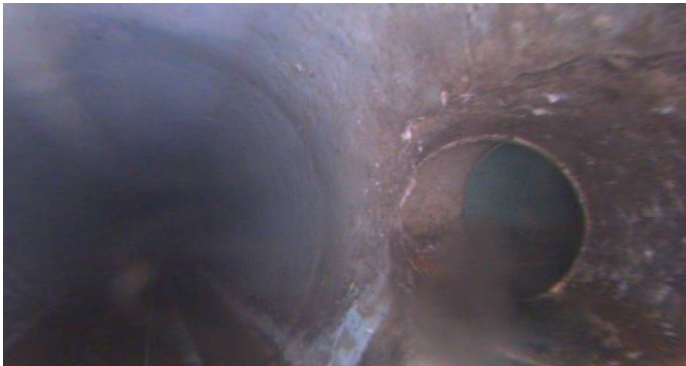
Code: **TF**
Description: **Tap Factory**

Distance (ft): **194.7**
Structural Grade: **0**
O&M Grade: **0**
Clock Start/From: **8**
Clock To:
1st Value: **4.000**
2nd Value:
Value Percent:
Continuous Index:
Within 8" of Joint:
Remarks:

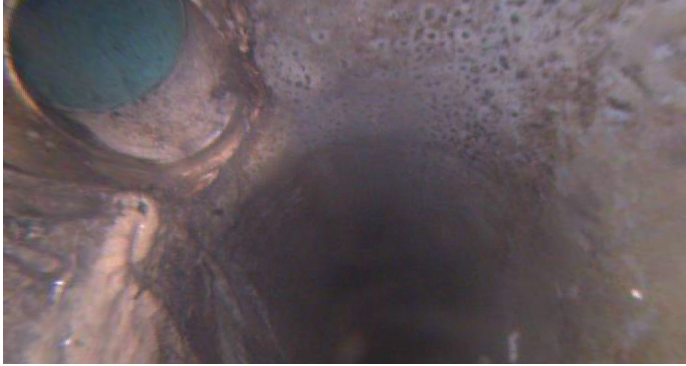
Code: **TF**
Description: **Tap Factory**

Distance (ft): **208.9**
Structural Grade: **0**
O&M Grade: **0**
Clock Start/From: **2**
Clock To:
1st Value: **4.000**
2nd Value:
Value Percent:
Continuous Index:
Within 8" of Joint:
Remarks:

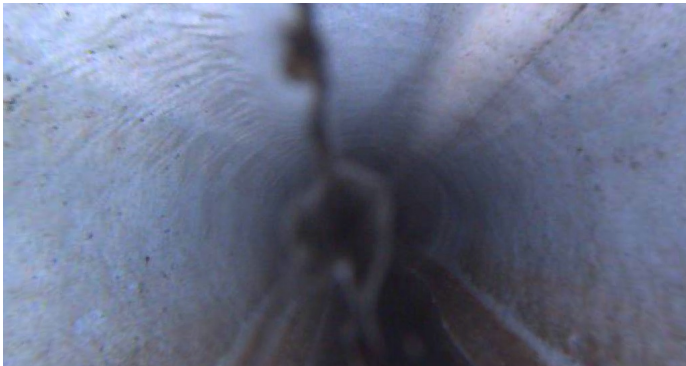
Code: **MSA**
Description: **Abandoned Survey**

Distance (ft): **230.2**
Structural Grade: **0**
O&M Grade: **0**
Clock Start/From:
Clock To:
1st Value:
2nd Value:
Value Percent:
Continuous Index:
Within 8" of Joint: **NO**
Remarks: **No blockage**
