## Profile/Photo Observation Report

Date:	<b>04/16/2018</b>	Weather:		Coding:	<b>PACP 6.0</b>
Pipe Length (ft):		Owner:	<b>City of Hobart</b>	Pre Clean:	<b>No Pre-Cleaning</b>
P.O.#:	<b>56-1</b>	Surveyor:	<b>M. Pielacha</b>	PSR:	<b>M-505-037-M-505-034</b>
Customer:	<b>City of Hobart</b>	Clean Date:		Shape:	<b>C</b>

Street:	<b>Colorado Street</b>	Flow Control:	<b>Not Controlled</b>
City:	<b>Hobart, IN</b>	Year Renewed:	
Location:	<b>Light Highway</b>	Tape/Media #:	<b>DEP 56</b>
Purpose:	<b>Routine Assessment</b>	Dia/Height:	<b>18"</b>
Use:	<b>Sanitary</b>	Material:	<b>VCP</b>
Drain Area:		Lining:	
Category:	<b>NA</b>		
Comment:			
Location Details:		Direction of Survey:	<b>Downstream</b>
US MH:	<b>M-505-037</b>	DS MH:	<b>M-505-034</b>
		Total Length Surveyed (ft):	<b>165.2</b>

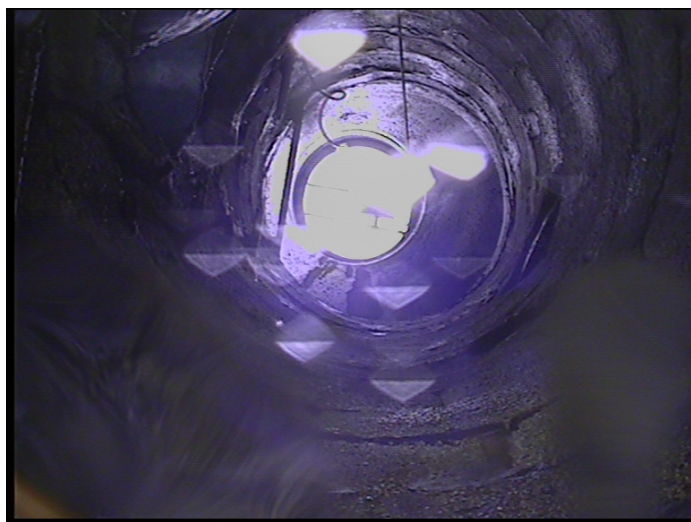
Code: **AMH**  
Description: **Manhole**

Distance (ft): **.0**  
Structural Grade: **0**  
O&M Grade: **0**  
Clock Start/From:  
Clock To:  
1st Value:  
2nd Value:  
Value Percent:  
Continuous Index:  
Within 8" of Joint: **NO**  
Remarks: **M-505-037**
