## Profile/Photo Observation Report

Date:	<b>04/16/2018</b>	Weather:		Coding:	<b>PACP 6.0</b>
Pipe Length (ft):		Owner:	<b>City of Hobart</b>	Pre Clean:	<b>No Pre-Cleaning</b>
P.O.#:	<b>56-1</b>	Surveyor:	<b>M. Pielacha</b>	PSR:	<b>M-505-037-M-505-034</b>
Customer:	<b>City of Hobart</b>	Clean Date:		Shape:	<b>C</b>

Street:	<b>Colorado Street</b>	Flow Control:	<b>Not Controlled</b>
City:	<b>Hobart, IN</b>	Year Renewed:	
Location:	<b>Light Highway</b>	Tape/Media #:	<b>DEP 56</b>
Purpose:	<b>Routine Assessment</b>	Dia/Height:	<b>18"</b>
Use:	<b>Sanitary</b>	Material:	<b>VCP</b>
Drain Area:		Lining:

US MH: **M-505-037** DS MH: **M-505-034** Total Length Surveyed (ft): **165.2**

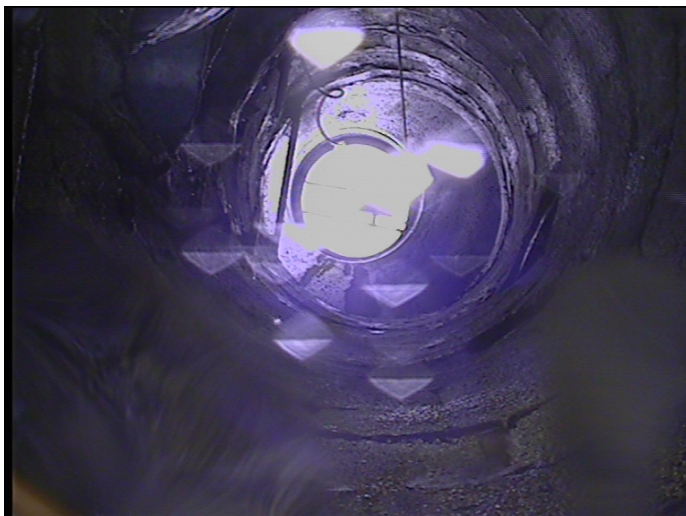
Code: **AMH**  
Description: **Manhole**

Distance (ft): **.0**  
Structural Grade: **0**  
O&M Grade: **0**  
Clock Start/From:  
Clock To:  
1st Value:  
2nd Value:  
Value Percent:  
Continuous Index:  
Within 8" of Joint: **NO**  
Remarks: **M-505-037**

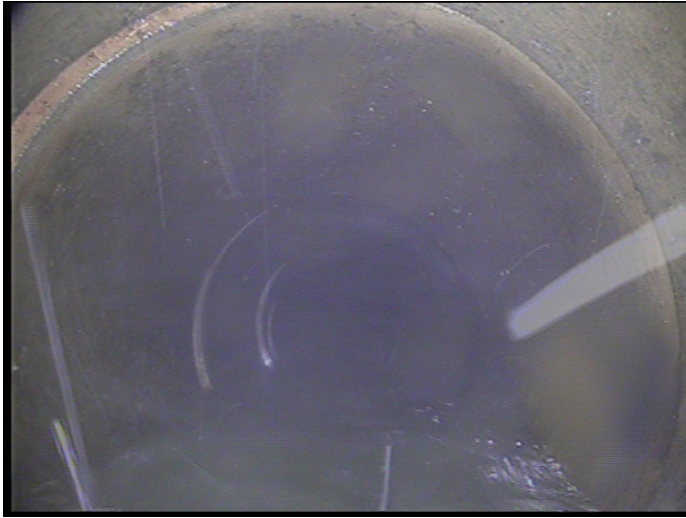
Code: **MWL**  
Description: **Water Level**

Distance (ft): **.0**  
Structural Grade: **0**  
O&M Grade: **0**  
Clock Start/From:  
Clock To:  
1st Value:  
2nd Value:  
Value Percent: **20.000**  
Continuous Index:  
Within 8" of Joint: **NO**  
Remarks:

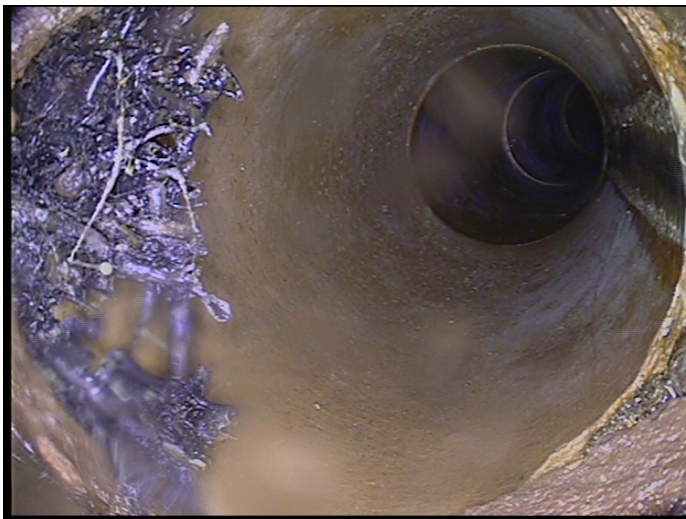
Code: **TBA**  
Description: **Tap Break-in Active**

Distance (ft): **28.6**  
Structural Grade: **0**  
O&M Grade: **0**  
Clock Start/From: **2**  
Clock To:  
1st Value: **4.000**  
2nd Value:  
Value Percent:  
Continuous Index:  
Within 8" of Joint: **NO**  
Remarks:

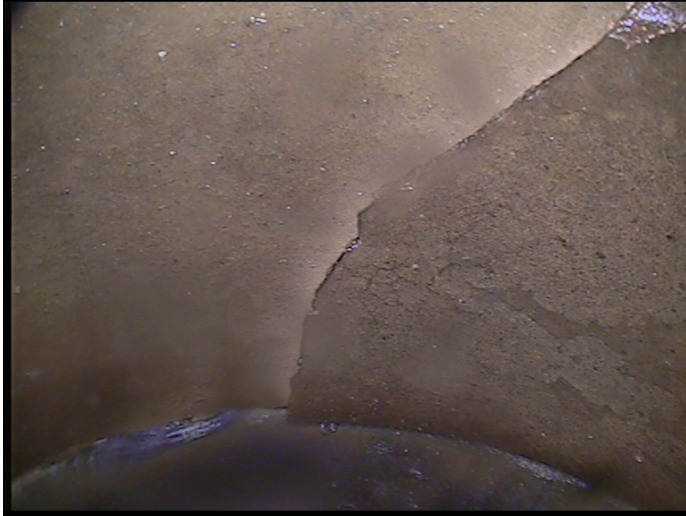
Code:	<b>FL</b>
Description:	<b>Fracture Longitudinal</b>
Distance (ft):	<b>28.6</b>
Structural Grade:	<b>3</b>
O&M Grade:	<b>0</b>
Clock Start/From:	<b>2</b>
Clock To:	
1st Value:	
2nd Value:	
Value Percent:	
Continuous Index:	
Within 8" of Joint:	<b>YES</b>
Remarks:

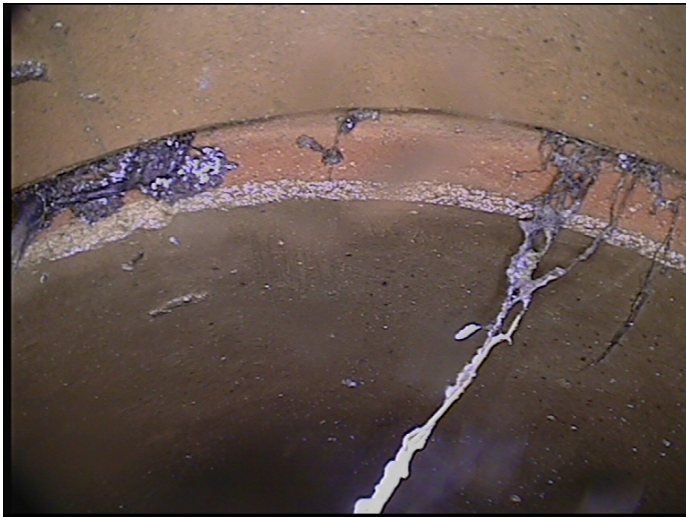
Code:	<b>RFJ</b>
Description:	<b>Roots Fine Joint</b>
Distance (ft):	<b>86.1</b>
Structural Grade:	<b>0</b>
O&M Grade:	<b>1</b>
Clock Start/From:	<b>12</b>
Clock To:	
1st Value:	
2nd Value:	
Value Percent:	
Continuous Index:	
Within 8" of Joint:	<b>YES</b>
Remarks:

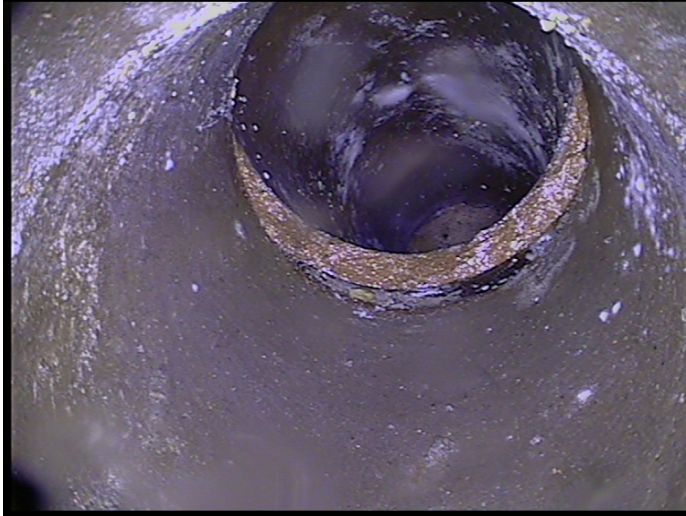
Code:	<b>TFC</b>
Description:	<b>Tap Factory Capped</b>
Distance (ft):	<b>98.3</b>
Structural Grade:	<b>0</b>
O&M Grade:	<b>0</b>
Clock Start/From:	<b>10</b>
Clock To:	
1st Value:	<b>4.000</b>
2nd Value:	
Value Percent:	
Continuous Index:	
Within 8" of Joint:	<b>NO</b>
Remarks:

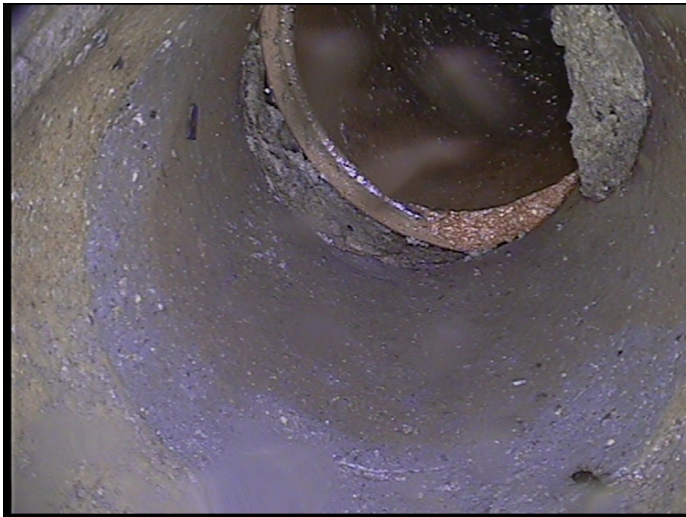
Code:	<b>TF</b>
Description:	<b>Tap Factory</b>
Distance (ft):	<b>100.9</b>
Structural Grade:	<b>0</b>
O&M Grade:	<b>0</b>
Clock Start/From:	<b>2</b>
Clock To:	
1st Value:	<b>4.000</b>
2nd Value:	
Value Percent:	
Continuous Index:	
Within 8" of Joint:	<b>NO</b>
Remarks:

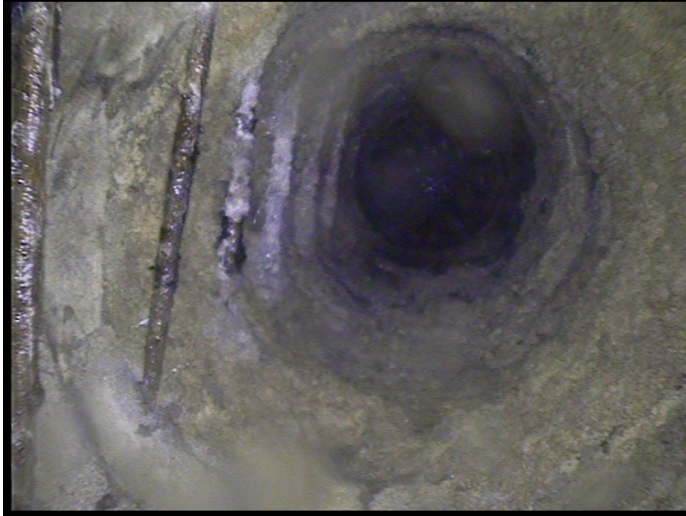
Code:	<b>AMH</b>
Description:	<b>Manhole</b>
Distance (ft):	<b>165.2</b>
Structural Grade:	<b>0</b>
O&M Grade:	<b>0</b>
Clock Start/From:	
Clock To:	
1st Value:	
2nd Value:	
Value Percent:	
Continuous Index:	
Within 8" of Joint:	<b>NO</b>
Remarks:	<b>M-505-034</b>
