Profile/Photo Observation Report

Date:	04/25/2018	Weather:		Coding:	PACP 6.0
Pipe Length (ft):	283.0	Owner:	NA	Pre Clean:	Not Known
P.O.#:		Surveyor:	Jen Costello	PSR:	P-505-036-037
Customer:		Clean Date:	01/01/1900	Shape:	C

Street:	S CALIFORNIA ST	Flow Control:	Not Controlled
City:	Hobart, IN	Year Renewed:	
Location:	Light Highway	Tape/Media #:	
Purpose:	Not Known	Dia/Height:	12"
Use:	Sanitary	Material:	PVC
Drain Area:	NA	Lining:	Cured in Place
Category:	NA		
Comment:

Location Details:		Direction of Survey:	Downstream
US MH:	M-505-037	DS MH:	M-505-036
		Total Length Surveyed (ft):	123.7

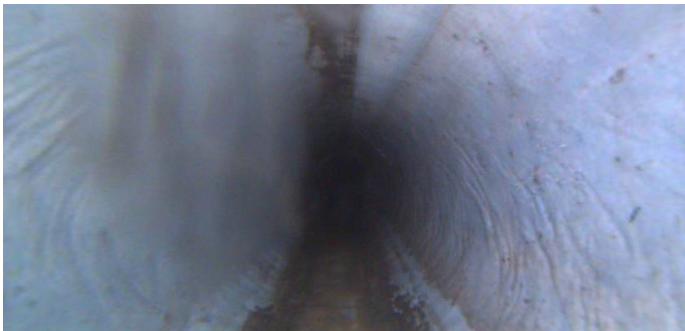
Code: **AMH**
Description: **Manhole**

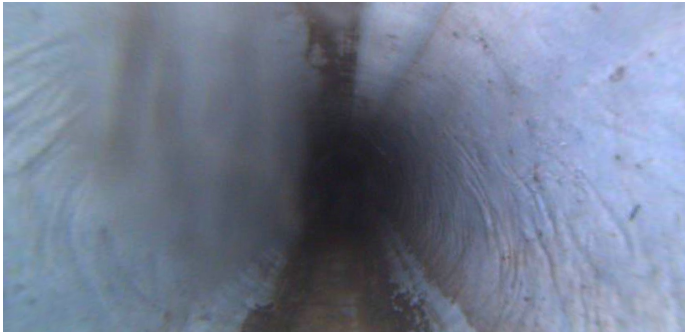
Code:	MWL
Description:	Water Level

Distance (ft):	.0
Structural Grade:	0
O&M Grade:	0
Clock Start/From:	
Clock To:	
1st Value:	
2nd Value:	
Value Percent:	5.000
Continuous Index:	
Within 8" of Joint:	NO
Remarks:

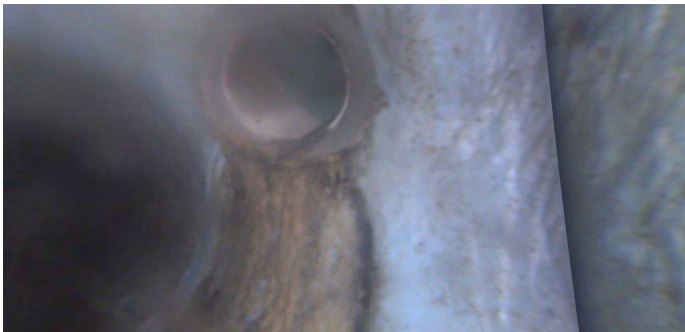
Code:	TF
Description:	Tap Factory

Distance (ft):	6.5
Structural Grade:	0
O&M Grade:	0
Clock Start/From:	10
Clock To:	
1st Value:	4.000
2nd Value:	
Value Percent:	
Continuous Index:	
Within 8" of Joint:	
Remarks:

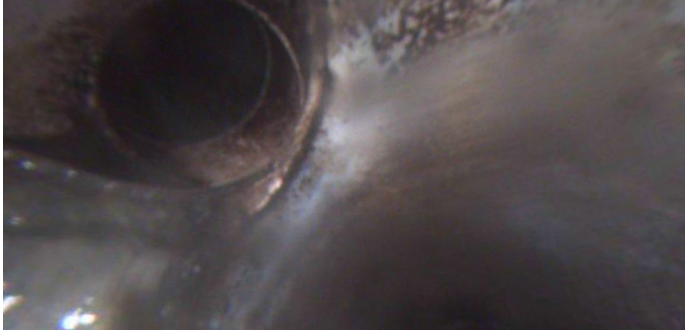
Code: **TFA**
Description: **Tap Factory Active**

Distance (ft): **9.5**
Structural Grade: **0**
O&M Grade: **0**
Clock Start/From: **2**
Clock To:
1st Value: **4.000**
2nd Value:
Value Percent:
Continuous Index:
Within 8" of Joint:
Remarks:

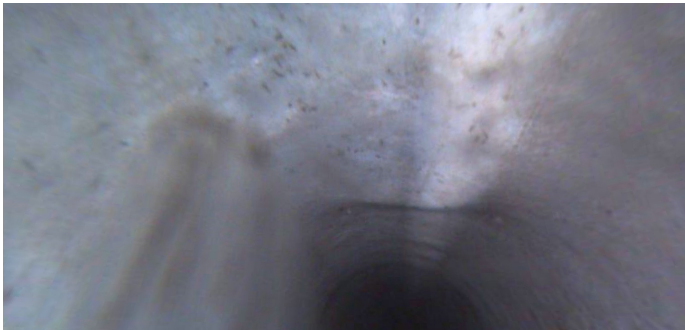
Code: **LFAC**
Description: **Lining Failure Abandoned Connection**

Distance (ft): **12.8**
Structural Grade: **0**
O&M Grade: **0**
Clock Start/From: **12**
Clock To:
1st Value:
2nd Value:
Value Percent:
Continuous Index:
Within 8" of Joint: **NO**
Remarks:

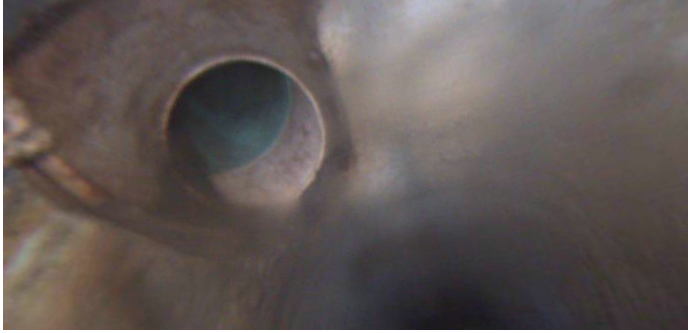
Code: **TFA**
Description: **Tap Factory Active**

Distance (ft): **54.8**
Structural Grade: **0**
O&M Grade: **0**
Clock Start/From: **2**
Clock To:
1st Value: **4.000**
2nd Value:
Value Percent:
Continuous Index:
Within 8" of Joint:
Remarks:

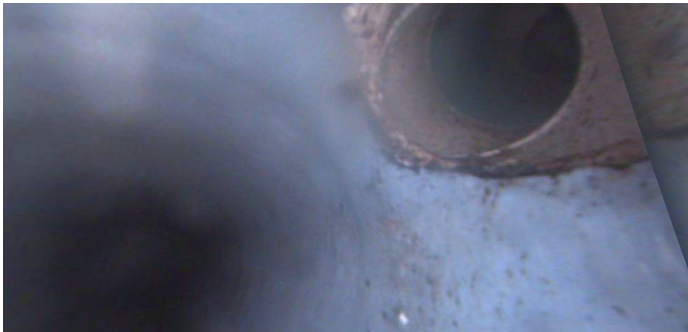
Code: **TF**
Description: **Tap Factory**

Distance (ft): **88.1**
Structural Grade: **0**
O&M Grade: **0**
Clock Start/From: **10**
Clock To:
1st Value: **4.000**
2nd Value:
Value Percent:
Continuous Index:
Within 8" of Joint:
Remarks:

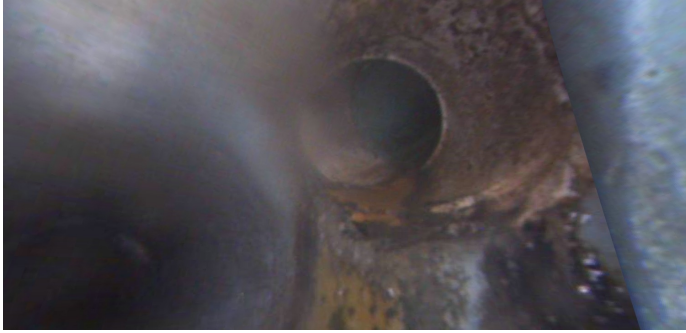
Code: **TFA**
Description: **Tap Factory Active**

Distance (ft): **91.8**
Structural Grade: **0**
O&M Grade: **0**
Clock Start/From: **10**
Clock To:
1st Value: **4.000**
2nd Value:
Value Percent:
Continuous Index:
Within 8" of Joint:
Remarks:

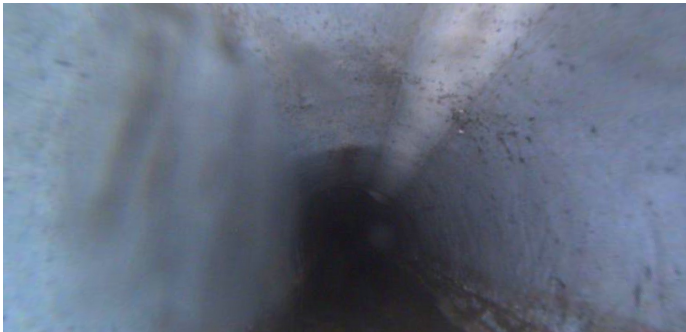
Code: **LFAC**
Description: **Lining Failure Abandoned Connection**

Distance (ft): **117.2**
Structural Grade: **0**
O&M Grade: **0**
Clock Start/From: **12**
Clock To:
1st Value:
2nd Value:
Value Percent:
Continuous Index:
Within 8" of Joint: **NO**
Remarks:

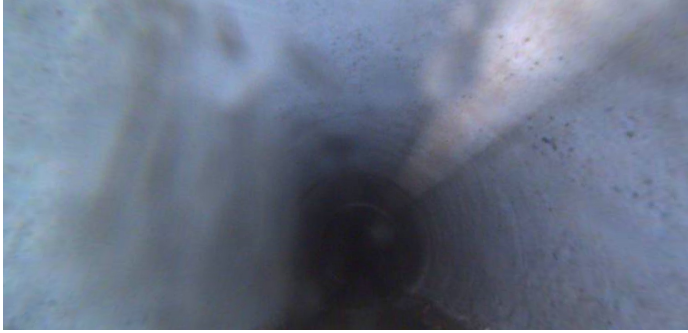
Code:	MSA
Description:	Abandoned Survey
Distance (ft):	123.7
Structural Grade:	0
O&M Grade:	0
Clock Start/From:	
Clock To:	
1st Value:	
2nd Value:	
Value Percent:	
Continuous Index:	
Within 8" of Joint:	NO
Remarks:	unknown
